THE EFFECTS OF ICING ON COMMERCIAL FISHING VESSELS

An Interactive Qualifying Project Report
For the United States Coast Guard

WORCESTER POLYTECHNIC INSTITUTE

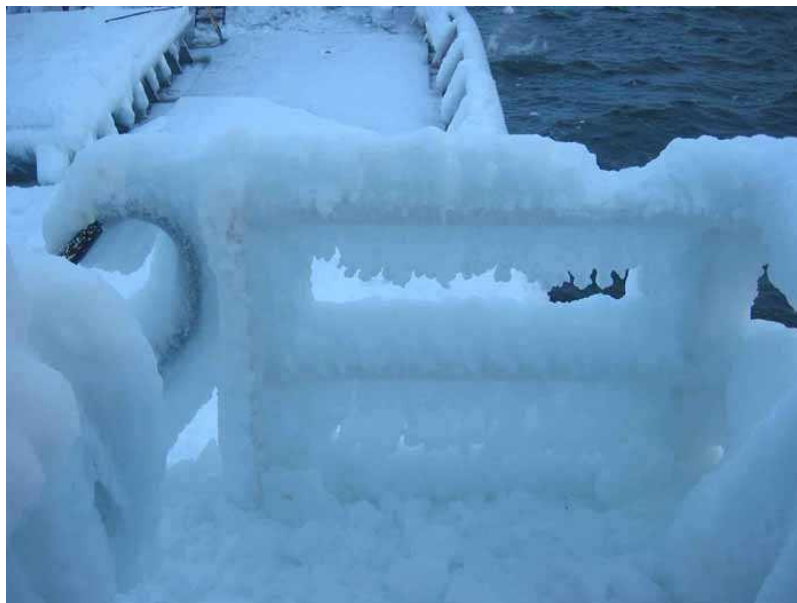
Figure 2-1: Moderate ice build up on the deck and railings of a vessel.

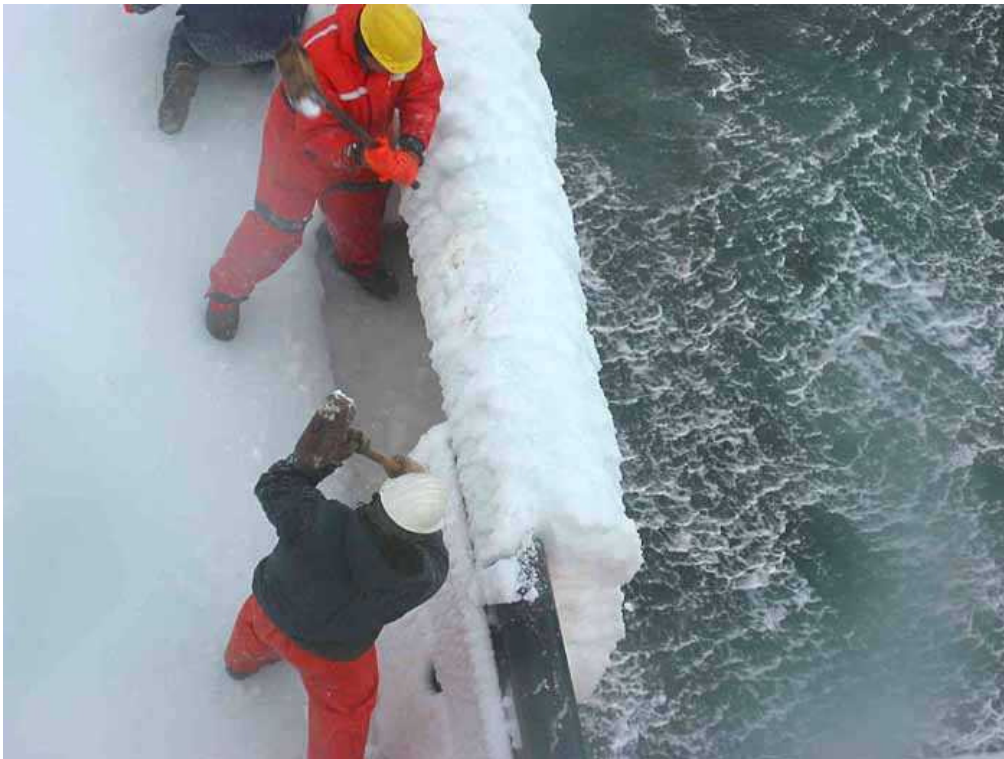
Figure 2-6: Crewmembers breaking ice off of a vessel's railing with mallets.

Currently the most commonly utilized methods to battle the accretion of ice on a vessel's structure, hull, and deck is the use of wooden mallets or baseball bats to literally break off the ice (see figure 2-6). Another method for the mitigation and avoidance of vessel icing involves ship maneuvers (Guest, 2008). When severe conditions arise that favor icing, the best

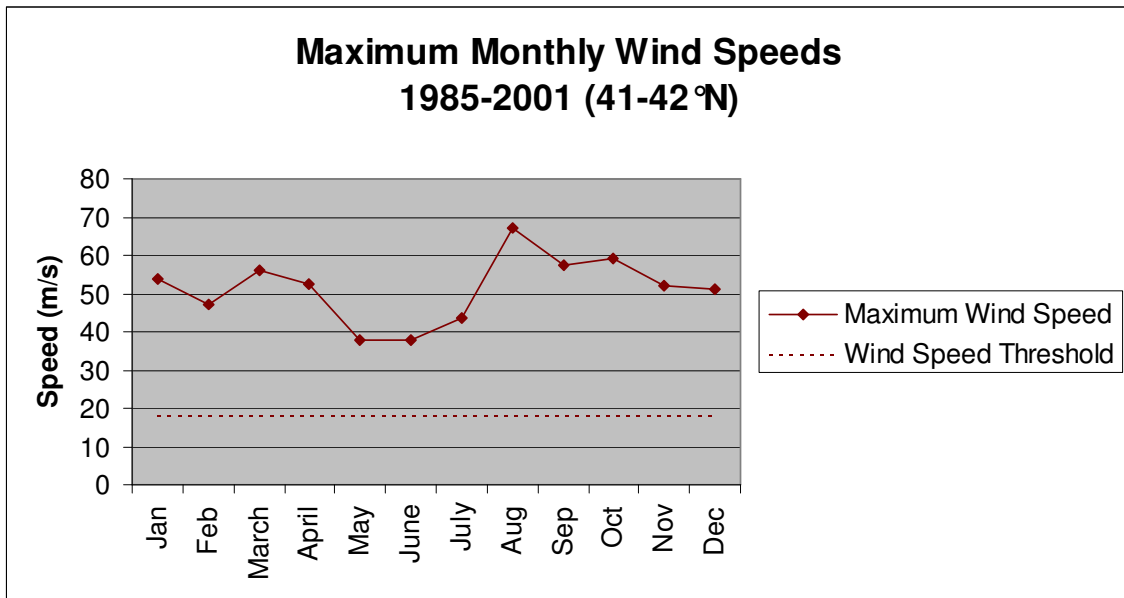
Figure 4-5: Maximum Monthly Wind Speeds between 1985 and 2001.

The plot clearly shows that there are several months where all three factors surpass their respective thresholds. This means that icing conditions were present in zone 4 during the months of December through April, and yet zone 4 is currently outside the regulated region. (for further results showing distribution see Appendix F)

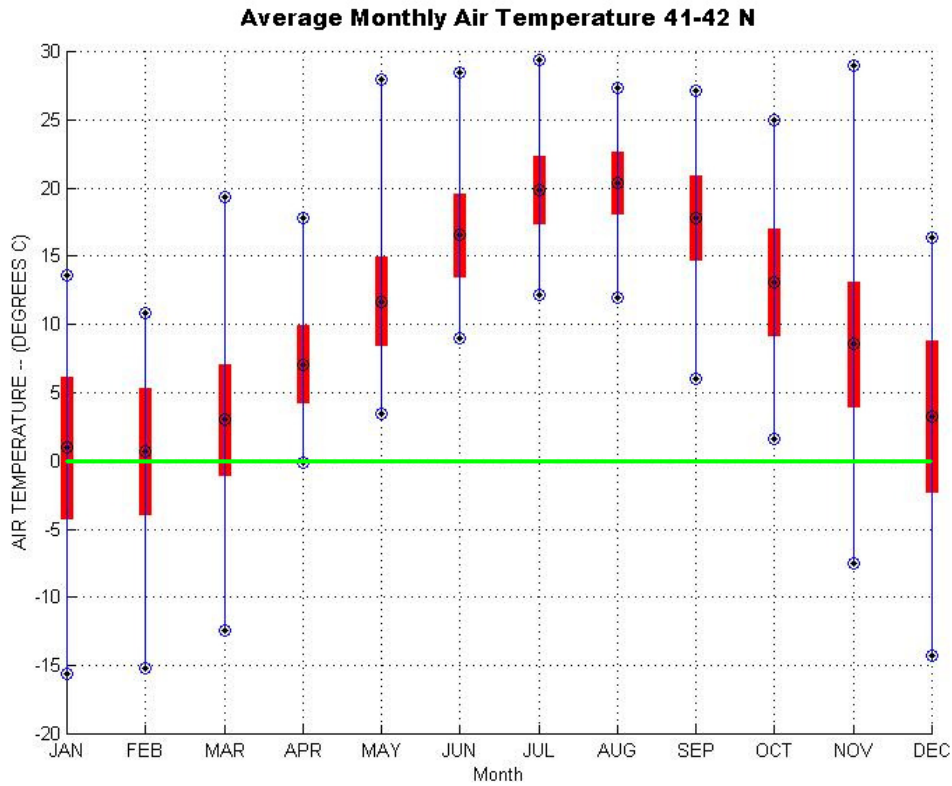
Average Monthly SST 41-42 N

The following three graphs show the average monthly distribution for air temperature, sea surface temperature (SST), and wind speed. The top and bottom data points represent the maximum and minimum extremes respectively. The red area represents the middle 50% distribution from 25%-75%, and the green line represents the threshold for when icing is more likely to occur. We used these graphs in our preliminary results for finding the proper region to analyze (source: NOAA, 2008).
