Project Code: MQP JRB 0501

Thermal Manikin Testing of Fire Fighter Ensembles

A Major Qualifying Project Report

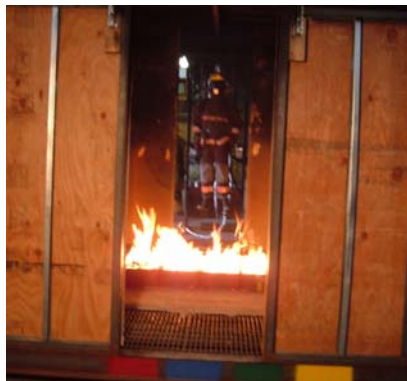
Figure 2-1 Alden Research Lab Facility

The facility took shape as a modified ISO 9705 room. The modifications were necessary to allow an instrumented manikin to travel through the burn room, while a large enough fire was burning to produce the required fire conditions. The track system allows the manikin to be supported from the ceiling of the room, minimizing unwanted thermal interference by a support structure. Additional burners allows the typical fire size in an ISO 9705 room (approximately 200 kW) to increase to over 3 MW after adding a fuel vaporizer (Fay, 42). This was important because in current test methods fire fighter turnout gear is tested at heat fluxes near 84 kW/m^2 which requires a fire size of nearly 1.5 MW in this facility (Fay, 41, 75). The vaporizer is included to provide the fuel at a steady flow and pressure, which results in higher and more consistent heat release rates at the burners (Fay, 42).

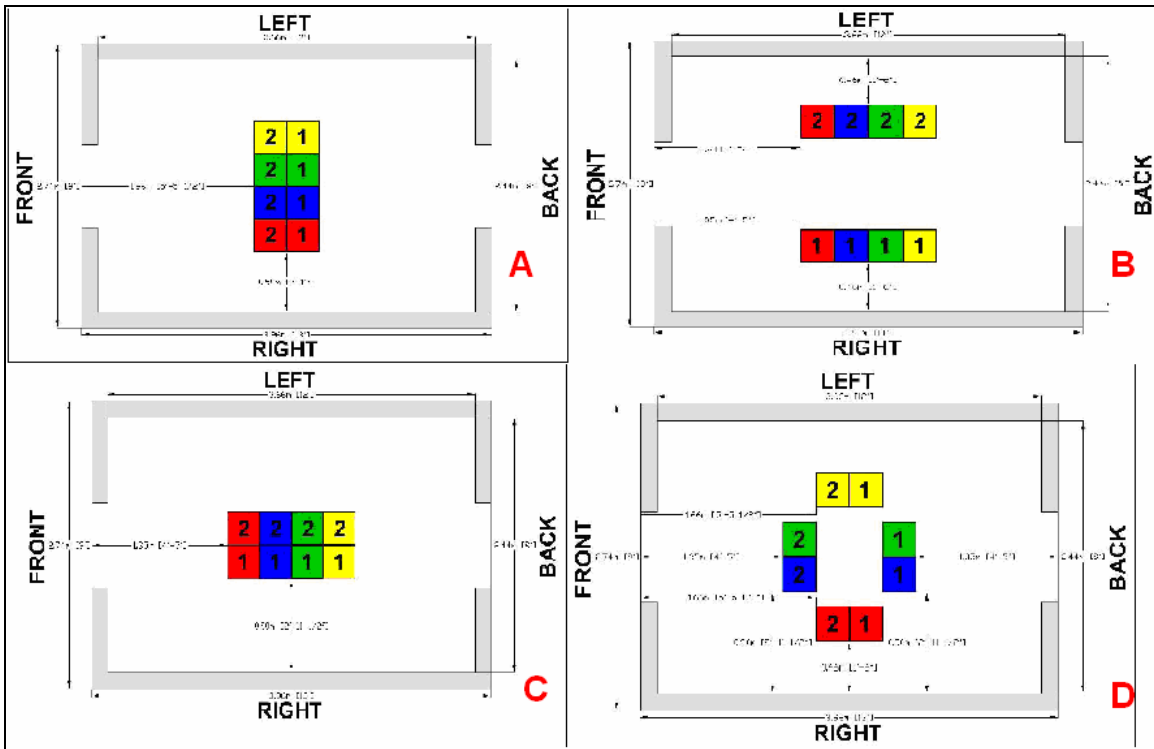
Figure 2-3: Burner Configurations (Woodward, 7-8)

Next, Woodward took over research in the laboratory. He focused his research on determining what be the effects of different burner configurations representing different fire scenarios. His scenarios can be seen in Figure 2-3 and included the following:

- Configuration A: Original configuration designed to apply an even distribution of flames over the manikin's surface.
- Configuration B: Provide "intense radiation" to the manikin, while limiting the flame impingement on the material.
- Configuration C: Considered the worst possible scenario, this design created flashover conditions in the lower doorway after 90 seconds.
- Configuration D: Used to represent wild fire scenarios with low flame heights, approximately waist high.

After recording this data, Woodward compared the results for the different fire scenarios. In his final conclusions, he determined that configurations A and C had the potential to expose the suit to the 84 kW/m^2 , with A producing the most repeatable results (Woodward, 56). He also noted that there is an issue when testing in cooler ambient conditions. When the ambient temperature approaches zero degrees Celsius, the pressure within the propane tanks drops too low to allow for appropriate fuel flow through the system, this then causes deviations in fire sizes (Woodward, 61).

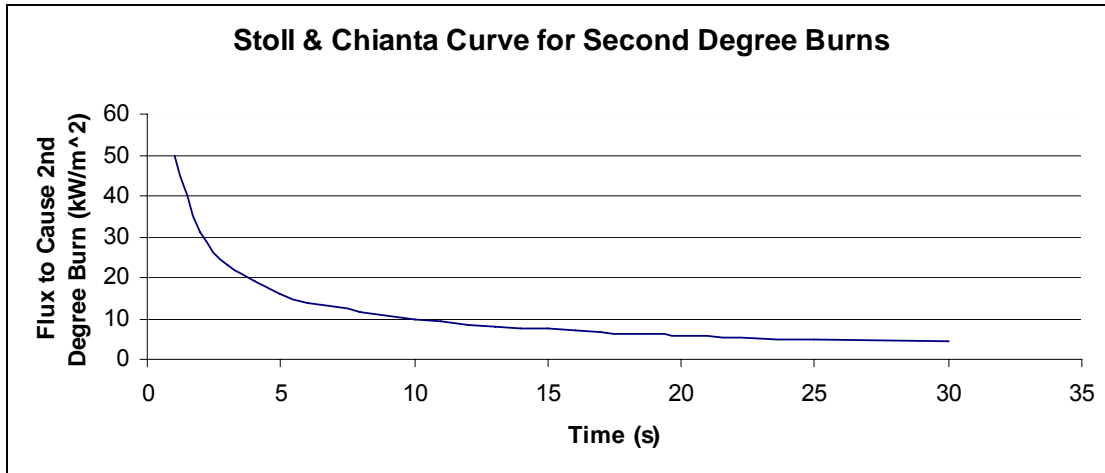
Figure 2-5 Stoll and Chianta Curve for Second Degree Burns (Sipe, 23)

Stoll and Chianta developed a method to predict time to second degree burns based on experimental observations. Charting the temperature rise with heat flux of a copper slug, according to ASTM E 457-96, Stoll and Chianta created a simplified means of determining whether a second degree burn would occur (Sipe, 22). When the Stoll and Chianta curve (see Figure 2-5) is overlaid with the results of any copper slug subjected to a square wave thermal insult, the intersection point is where a second degree burn would occur (Sipe, 22). The values of this curve are in Table 2-5. The total energy absorbed is seen in Figure 2-6.

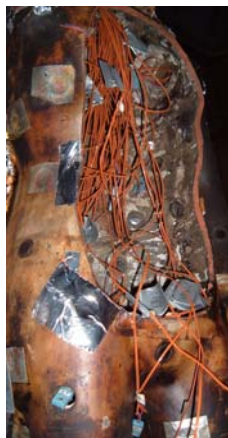
Figure 3-1: Wiring the Manikin

Once the lab was organized, maintenance on the equipment was required. The sensors on the manikin were tested to ensure they were functioning properly and any wiring problems were repaired. Poor connections were soldered or secured with electrical clips. The new sensors, provided by the United States Navy, were wired from the computer to the manikin similar to the existing sensors (Figure 3-1).

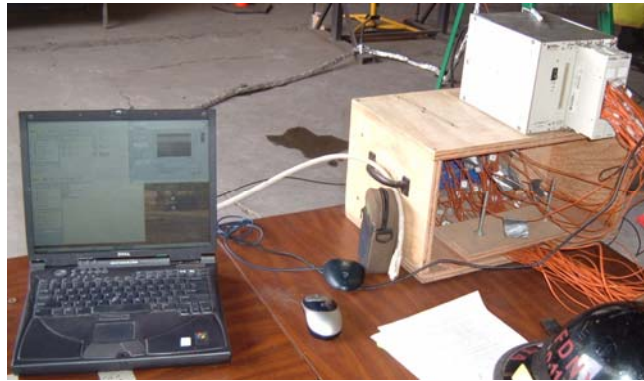
The NCTRF provided more recent additions of current hardware to be used with the LabView program for collecting data. To accommodate the hardware update, LabView 7.1 and Windows XP were installed. The virtual instrument program (VI) in LabView had to be rewritten to work with all the upgrades. Once all hardware and software issues were mitigated, the computer station was ready for data collection (see Figure 3-2).

Figure 3-2: Laboratory Computer Station

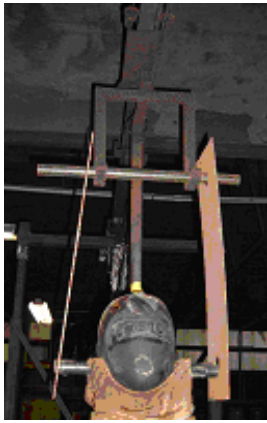
The original mechanism was designed to support a manikin and a partial ensemble; including jacket, pants, gloves, and boots. Figure 3-4 was apparatus formerly used to support the manikin. Figure 3-5 shows the stabilizing bar and side rear view of that hanger mechanism (pictures were taken with the manikin in a lower position so the entire existing support mechanism could be clearly viewed). The manikin has a metal rod through its head which rested on two hooks from the support mechanism during testing.

Figure 3-4: Existing Support Apparatus

In order to complete a full ensemble test, a helmet and breathing apparatus must be placed on the manikin. The original support system was inadequate because the U-shaped hanger element attaching to the bar in the manikin's head was too narrow to accommodate a helmet. Also, the vertical stabilizing rod prevented the addition of an SCBA.

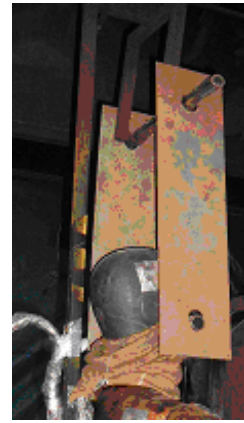
Figure 3-5: Sway Bar Behind Manikin

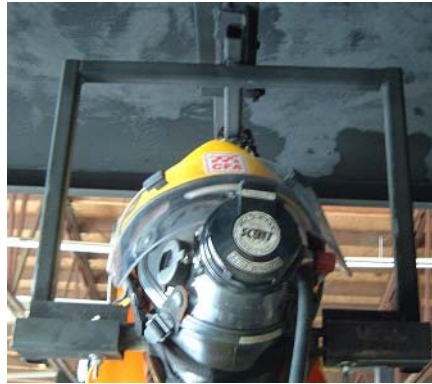
Figure 3-6: Suspension System

been successfully used in several full ensemble tests, proving to be an appropriate design for this application.

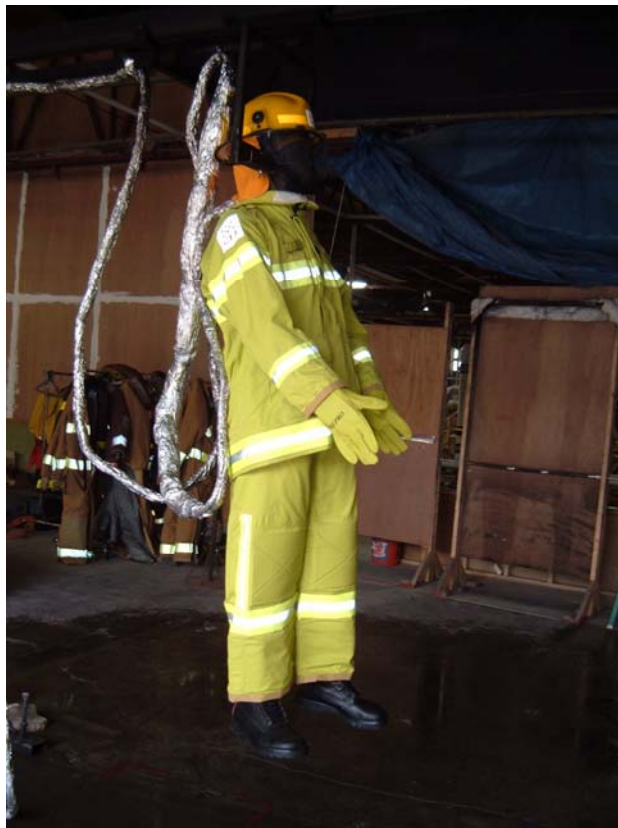
The first ensemble evaluated at these higher energy exposures was the new Australian fire fighter ensemble. This ensemble consisted of an Australian structural helmet, green gloves, Australian boots and a green three layer suit. Also, the ensemble was completed with a Scott self-contained breathing apparatus. The protective suit itself consisted of a Nomex 3A outer shell, Laminate to Nomex scrim moisture barrier, Sonatara E89 Thermal Barrier. Figure 4-21 demonstrates the manikin clothed in preparation for testing.

Figure 4-21: Australian Ensemble 1 Pre-Test

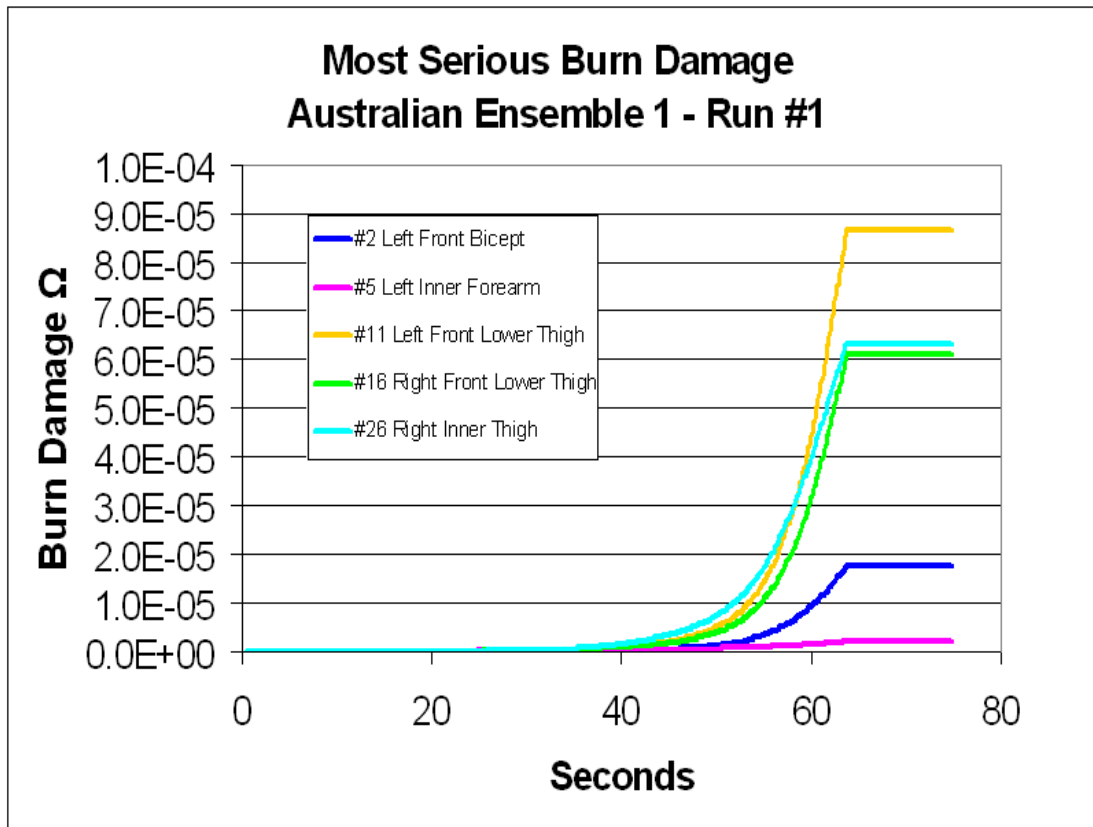
Figure 4-22: Australian Ensemble 1 Doorway Run 1

The first test conducted on this ensemble involved holding the manikin in the doorway plane for 30 seconds, a calculated exposure of 504 kJ/m², comparable to the ASTM F 1930 six-second exposure, without any flame impingement. Using the temperature of the thermocouples in the manikin's sensors, the incident radiative flux was calculated. This value was then used to calculate an expected basal layer temperature, which then lead to the derivation of the exposed skin burn parameter using Henrique's Burn Integral. The five most severely affected sensors' data is recorded in Figure 4-22. Remembering that a second degree burn occurs at parameter values greater than 1.0, it can be stated that no sensors were exposed to enough energy to cause burns. Actually, the top sensors recorded almost one ten-thousandth of the second degree burn parameter during this exposure.

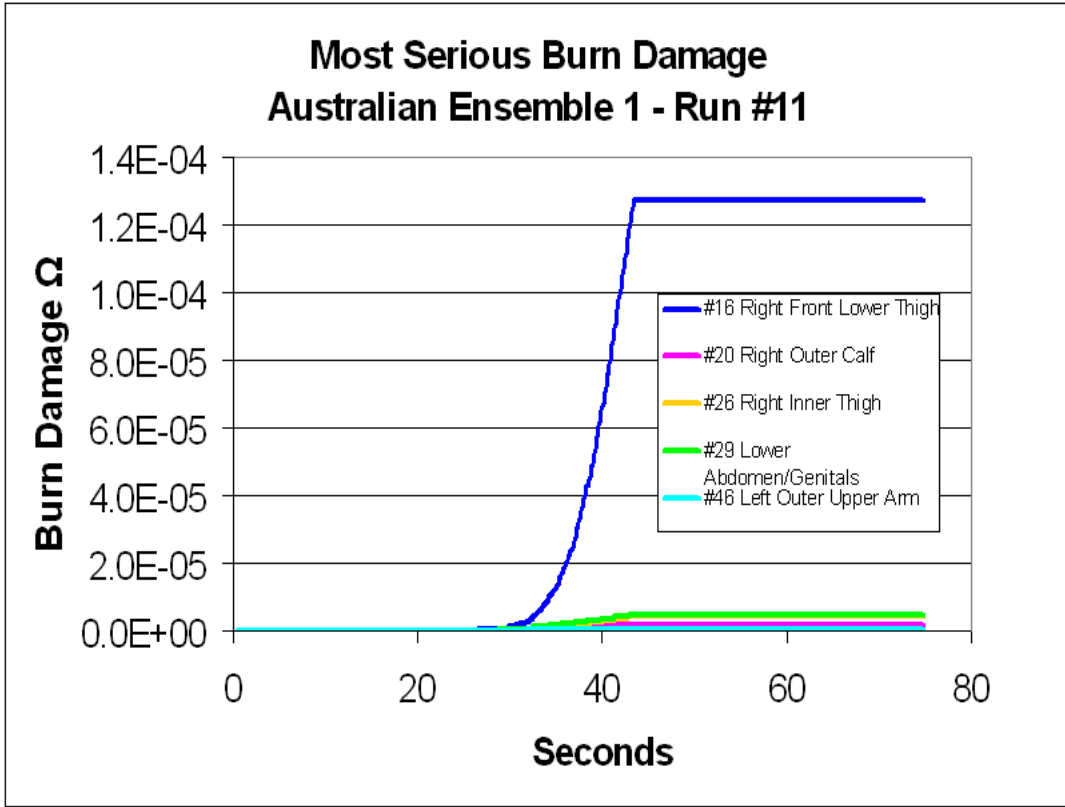
After cooling the manikin's sensors back to ambient conditions, the manikin was then tested twice at the same energy exposure, but while traversing the room. Although the incident energy on the manikin's sensors was not expected to increase during these runs, these tests introduced flame impingement to the protective clothing, as well as providing exposure rates of over 80 kW/m^2 at the burner centerline. Figure 4-23 and Figure 4-24 demonstrate the first and second runs at the speed of 0.27 m/s . As is demonstrated by these burn parameter calculations, once again, the Australian Ensembles were not exposed to any second degree burns. Also, it can be noted that the burn parameters are of comparable magnitude to the calculated values in the doorway (Figure 4-22). The difference between the calculated values for these two runs is due to unknown changes to the laboratory set up. Possibilities include changes in wind direction, or a burner being slightly clogged during the first test. However, the differences between the skin burn parameters can be considered negligible.

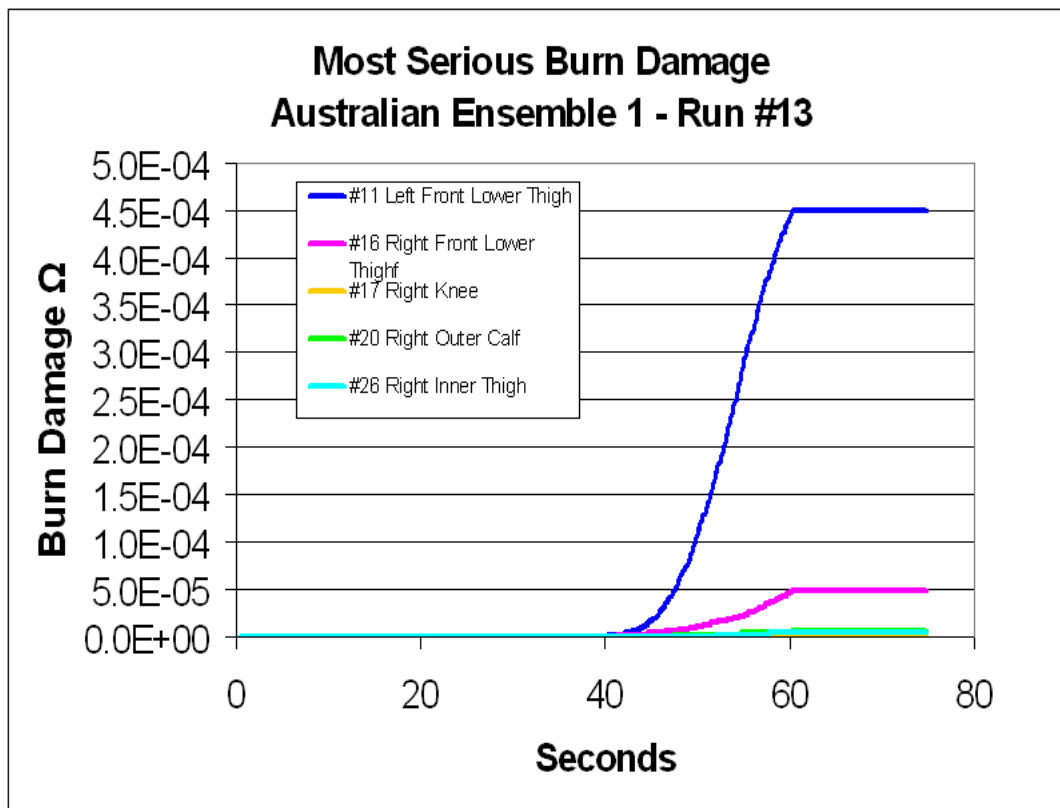
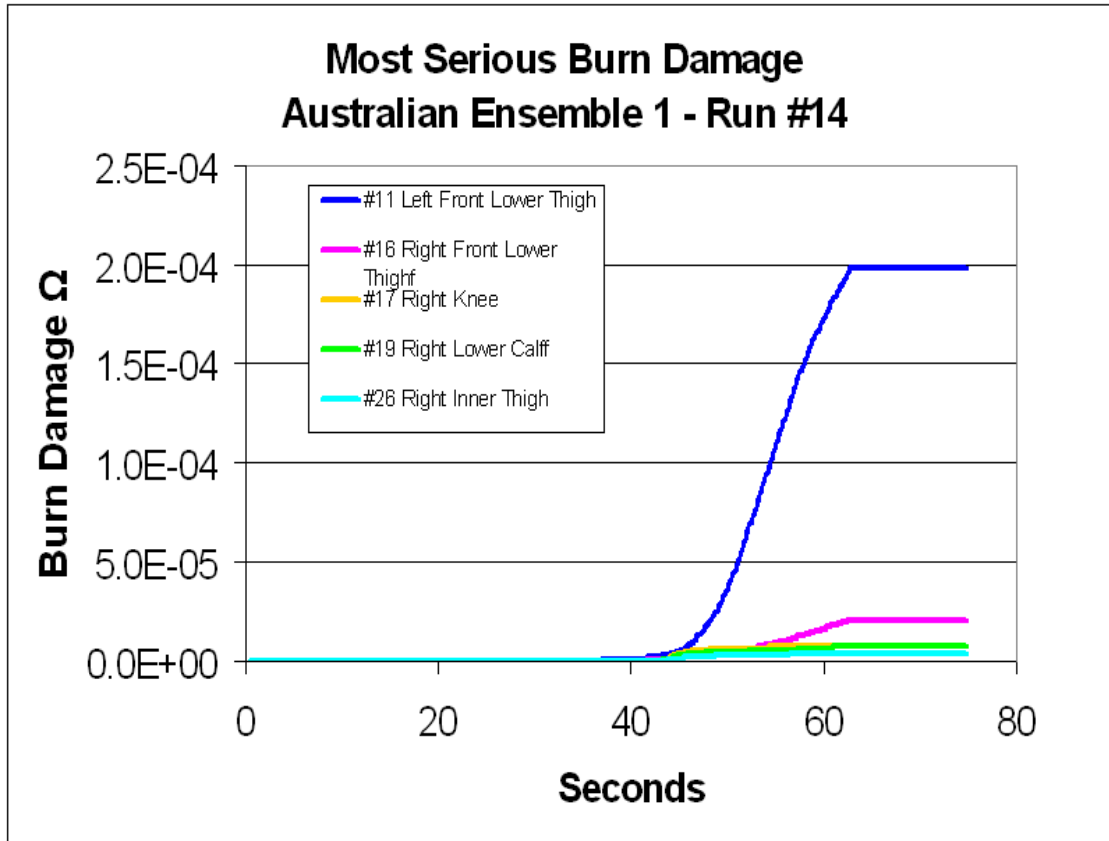
Next, the ensemble was exposed to two additional runs at a slower speed of 0.16 m/s, equivalent to the ASTM F 1930 ten second exposure, or 840 kJ/m². Here, it was expected that the manikins' sensors would be exposed to more energy, and therefore the skin burn parameter calculations should reveal higher burn parameters. The collected data can be seen in Figure 4-25 and Figure 4-26, representing the first and second tests respectively. These results demonstrate consistently higher burn parameters; however, these values are still well below the threshold of 1.0 for a second degree burn. Based on these results, it can be determined that the manikin was not exposed to any second degree burns at the tests highest energy exposure level.

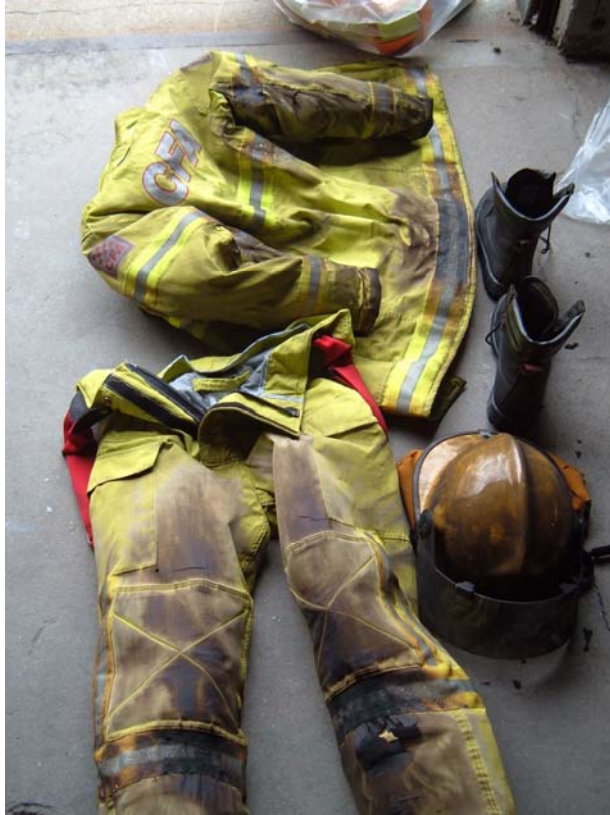
Figure 4-28: Australian Ensemble 1 Post-Test

After the ensemble had been tested, it had charring on the undersides of the arms, the lower back, and especially on the front legs. The boots maintained their support and structure, while the helmet appeared sooty, with no damage to it. Finally, the gloves were slightly discolored on the bottom sides, but maintained their integrity. The final condition of the ensemble can be seen in Figure 4-28.

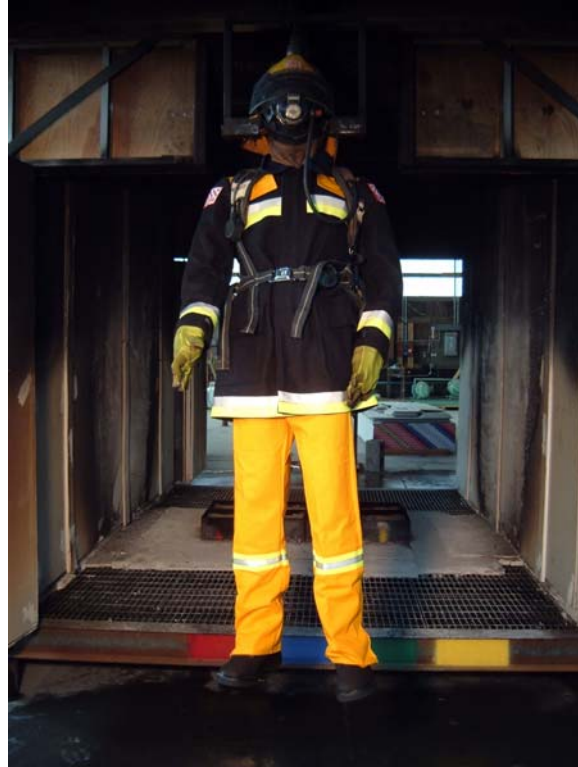
The next ensemble to be tested in the laboratory was the original Australian structural ensemble comprised of a wool coat and fire resistant cotton pants. The remainder of the tested ensemble consisted of the same gloves, helmet, SCBA, and boots that were tested on the first Australian ensemble. The coat was constructed of a 100% Wool Shell, and a 100% Cotton Thermal Liner while the pants were made out of fire resistant cotton. The outfitted manikin can be seen in Figure 4-29.

Figure 4-29: Australian Ensemble 2 Pre-Test

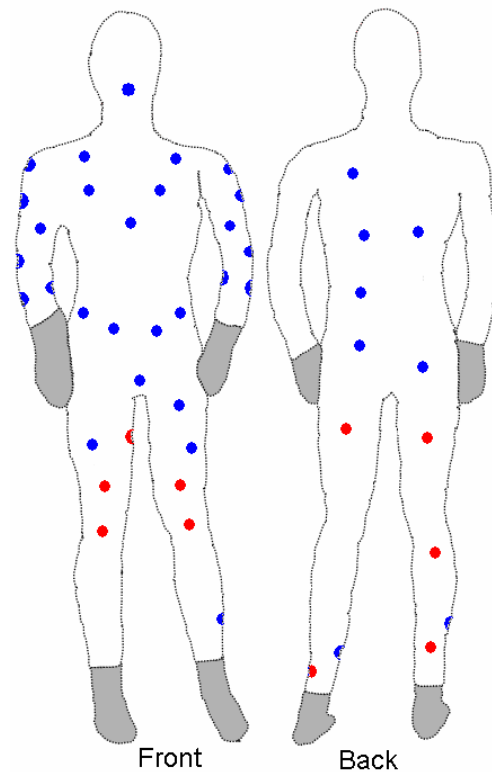
Figure 4-34: Australian Ensemble 2 Skin Burn Locations

The locations of the top ten sensors acquiring skin burns can be seen in Figure 4-34. Each of the top ten burned sensors are located on the manikin's legs, which would be expected since the pants disintegrated during the test. Also, it is important to note that it does not appear that any of the sensors that were protected by the wool coat would have failed, although burn parameter calculations were not conducted on those sensors. Overall, it can be stated that over twenty percent of the body would have experienced skin burn injuries if exposed to a fire of this magnitude, wearing this ensemble.

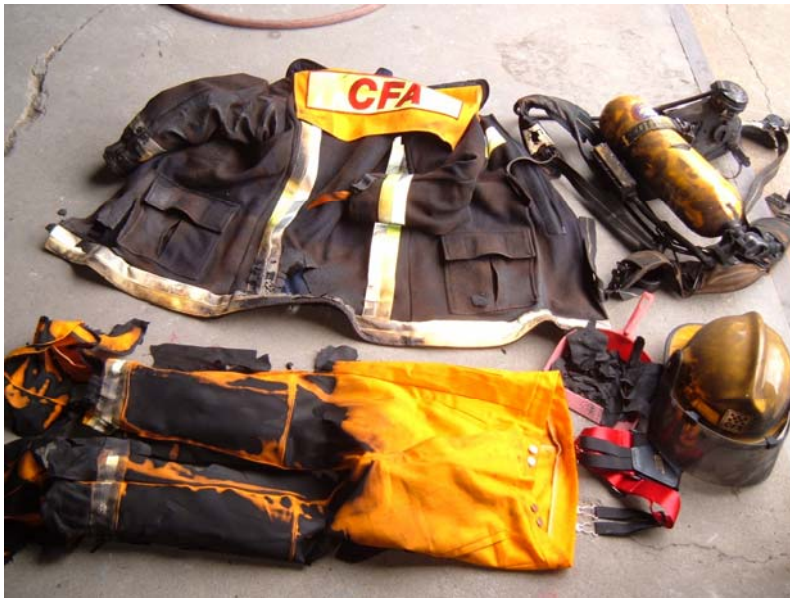
Figure 4-35: Australian Ensemble 2 Post-Test

Figure 4-35. The dustpan in this picture contains pieces of the pants that had fallen off during the fire. As the picture depicts, the pants lost their integrity, and did not pass the ensemble test.

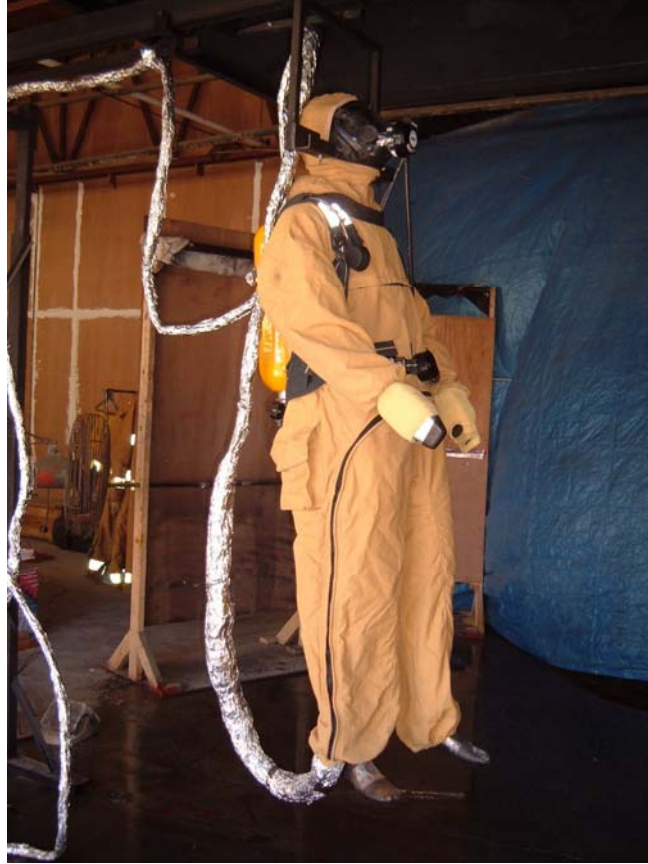
The Navy ensemble consisted of the United States Navy's First Attack fire suit, a Navy helmet and gloves, as well as a Scott SCBA and regular rubber boots. The suit is constructed of a Kevlar/PBI Outer Shell, Nomex Moisture Barrier, and a Kevlar Batt Thermal Liner. The ensemble can be seen as tested in Figure 4-36, without the navy helmet and gloves, and rubber boots.

Figure 4-36: Navy Ensemble Pre-Test

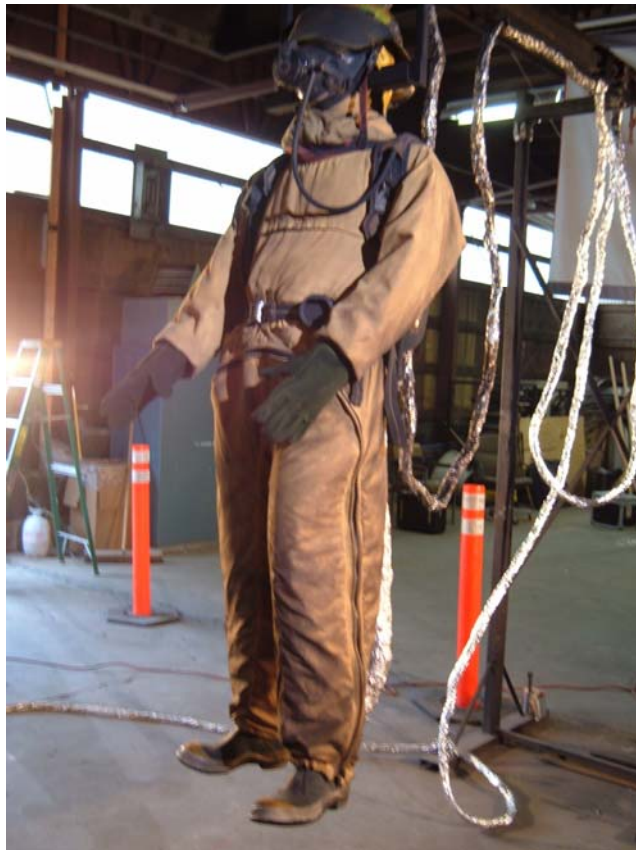
After testing was completed on the ensemble, there were a few noticeable changes to the appearance of the protective gear. First, there was much charring in the leg region of the suit, and the helmet and facemask continued to acquire more and more soot. Also, one of the hoses on the SCBA that was exposed near the waist of the manikin melted, exposing the inner aluminum tubing. Since this piece of the apparatus was not designed for use by the person wearing the SCBA, this was not considered a failure. Also, it is possible that the use of this SCBA for so many fire tests caused degradation to the mechanism, which resulted in this failure during the test. Overall, the protective clothing was still in pretty good shape, considering the large fires that it had been exposed to. A picture of the gear post-testing can be seen in Figure 4-43.

Figure 4-43: Navy Ensemble Post-Test

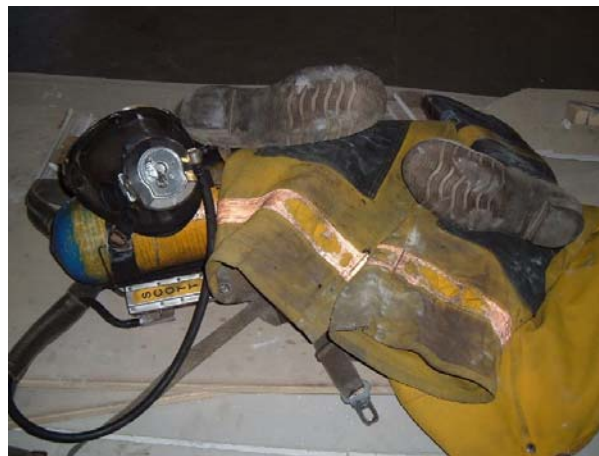
Figure 0-8 is a photograph of the Traditional Ensemble’s pants, boots, and SCBA after testing was completed. As you can see, there was some slight melting of the bottom of the boots and the reflective trim. Other than that, the majority of the char on the clothing and any other damage was attributed to past wear and tear since these garments were previously used in fire fighting operations.

Figure 0-8: Traditional Ensemble After Testing was Complete

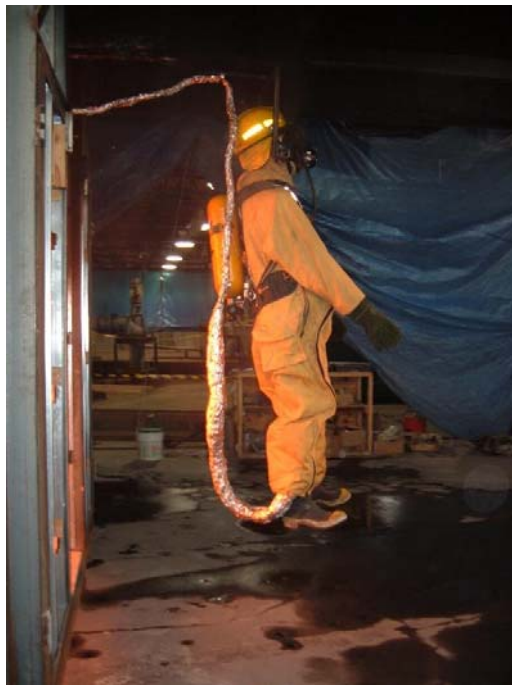
Next, tests were conducted using the United States Navy's newest single piece suit in conjunction with a new Scott Health and Safety SCBA, rubber boots, and United States Navy helmet and gloves (Figure 0-9). As this was the second set of tests conducted in the facility, some changes were made to the test protocol as deemed appropriate from the results of the Traditional Ensemble. For this test, seven runs were conducted. The first, similar to the previous set of tests was a doorway test. The next two tests were conducted at the faster speed setting, followed by two slower tests. Then, the doorway test was repeated. The evaluation was completed by conducting a test at the slowest traversal speed setting.

Figure 0-9: United States Navy Ensemble on Manikin

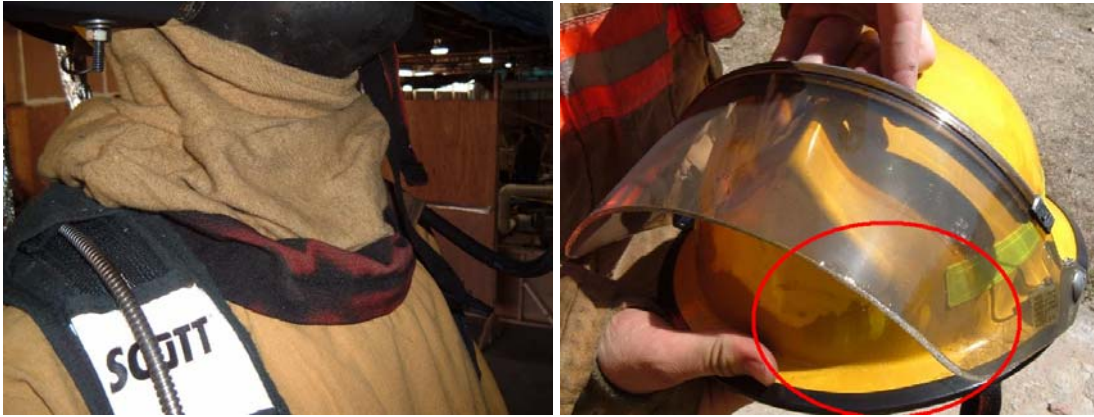
After each test was completed, the gear was inspected for any deformities. Figure 0-15 demonstrates two such deformities that occurred after the initial doorway test. In the picture to the left in Figure 0-15, the neck fabric was changed from black to a red tinge due to the extreme heat. Also, within the circle to the right is the beginning of the

degradation of the helmet face shield. This was not considered an ensemble failure because the face shield is a secondary source of protection designed to protect the SCBA face piece, not the wearer directly.

Figure 0-15: Navy Ensemble Neck Discoloration and Helmet Deformity after Initial Doorway Test

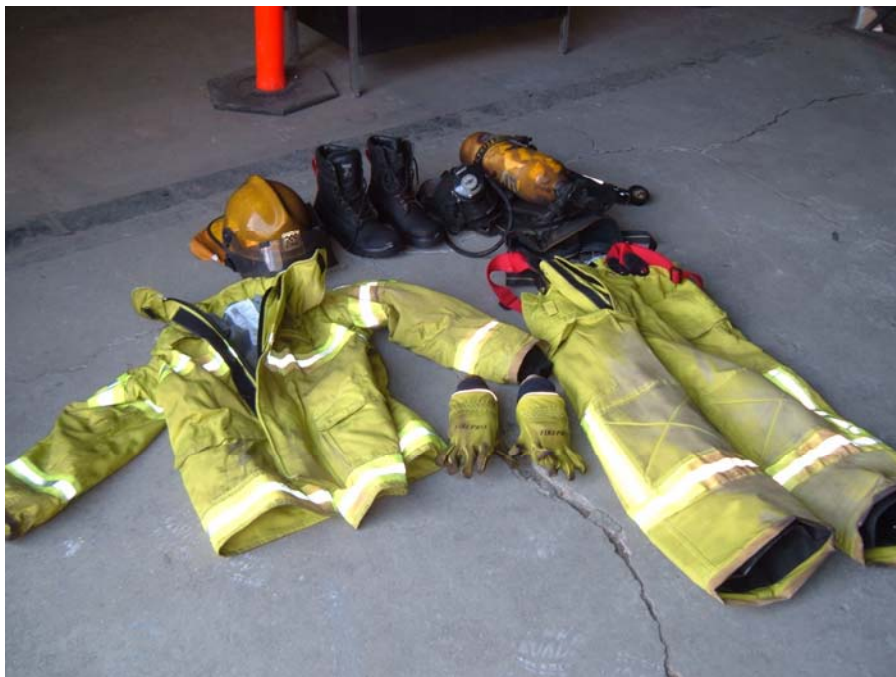
Figure 0-21: Australian Ensemble 1 Post-Test

After the tests were completed on the first Australian Ensemble, the legs appeared singed, but still intact. Also, the reflective trim on the ensemble had melted in a few places. The helmet was fully intact, but slightly sooty, and the gloves appeared to turn brownish-black in the fire, but were still intact. The boots had very slight melting on the soles, but seemed to hold up very well during the testing. After these tests, there was no evidence of any life threatening equipment failures.
