## **Renovation of the Kaven Hall Attic**

A Major Qualifying Project Report:

**WORCESTER POLYTECHNIC INSTITUTE**

Date: April 14, 2009

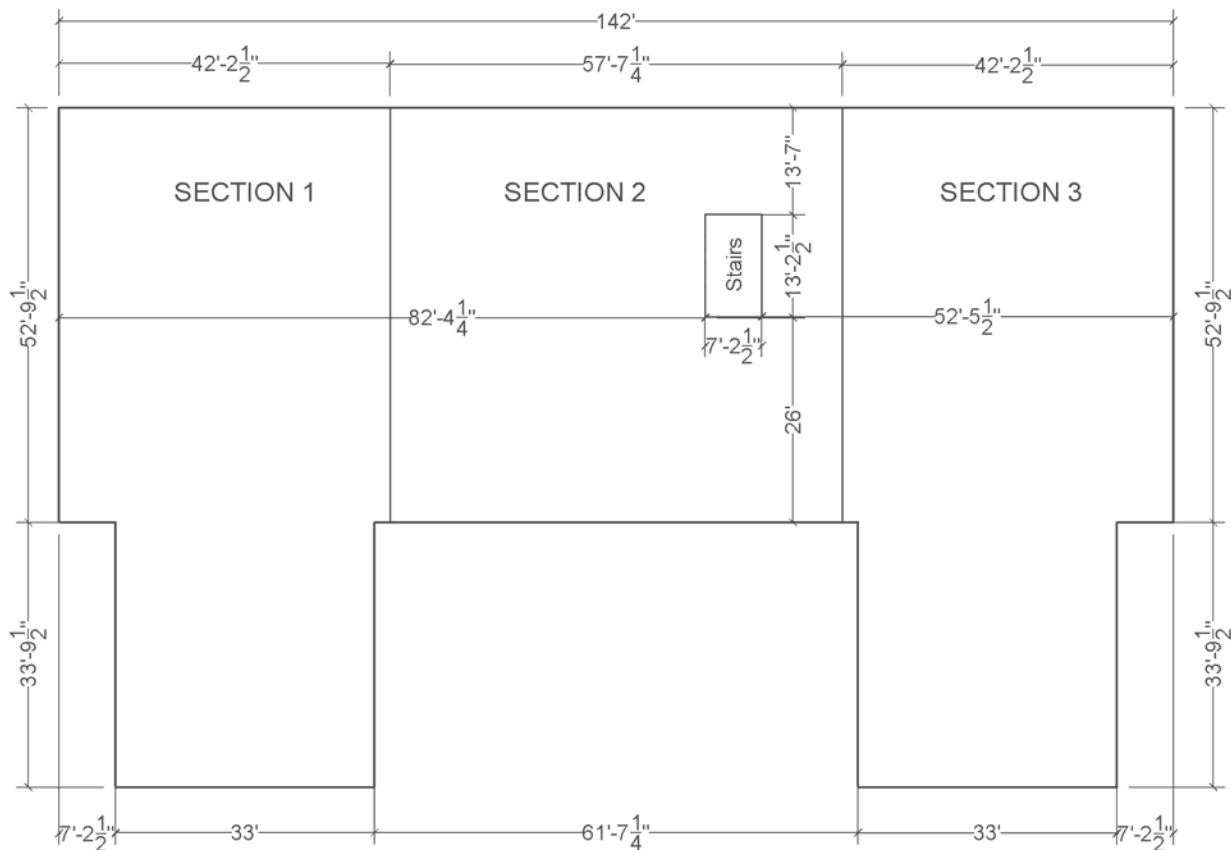
Figure 2.2 Existing Walls and Sections

A visit to the attic revealed that it is divided into three sections by two walls which run the width of the building. The only entrance to the attic (from the stairs located on the second floor behind a door labeled “205”) opens into the main/center room. On either side of this room are identical rooms, each with an extension. These rooms will be referred to as Section 1, Section 2 and Section 3 in accordance with the labels in Figure 2.2. Section 1 and 3 contain the

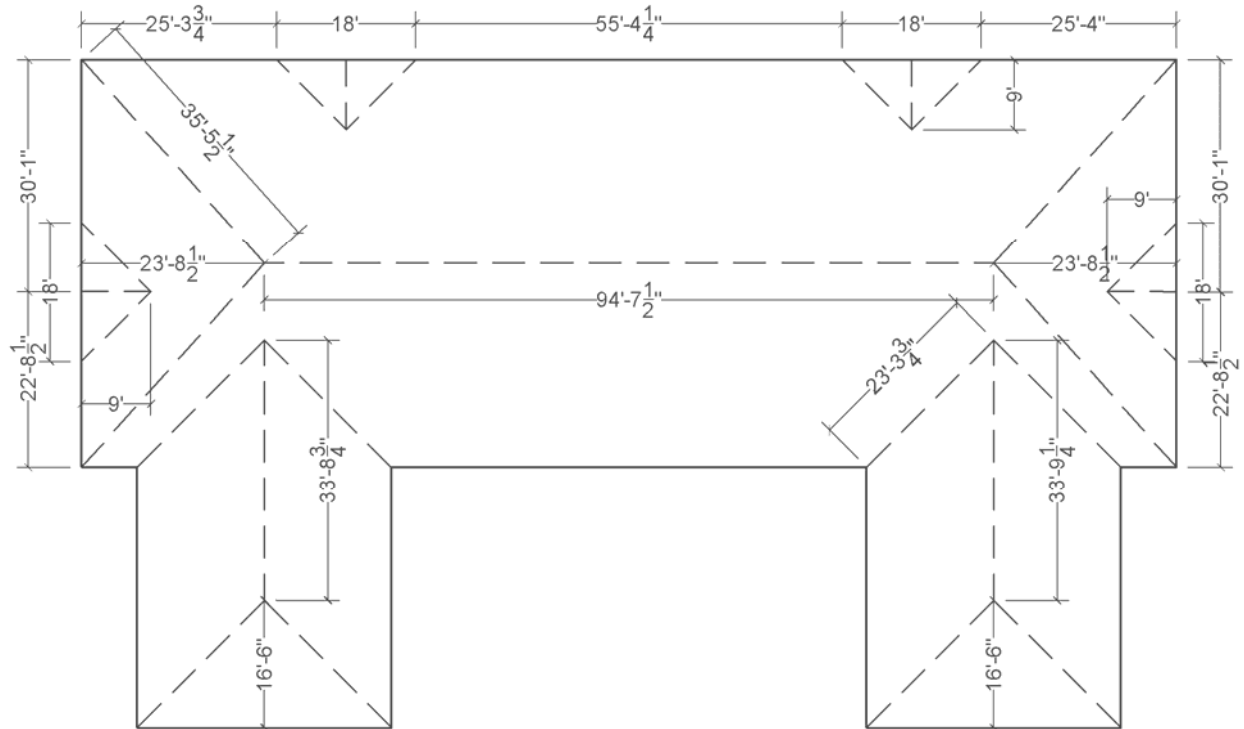
Figure 2.3 Existing Dormer and Roof Dimensions

The roof also includes four dormers which can be seen in Figure 2.3. Two dormers face the west, which is the side of the building that faces the rest of campus. There is another dormer facing north, and one more facing south. All of these dormers have the same dimensions. They are nine feet deep, eighteen feet wide and five feet tall (Brodeur, Elliot, Fox). A picture of the two dormers facing campus can also be seen in Figure 2.4.

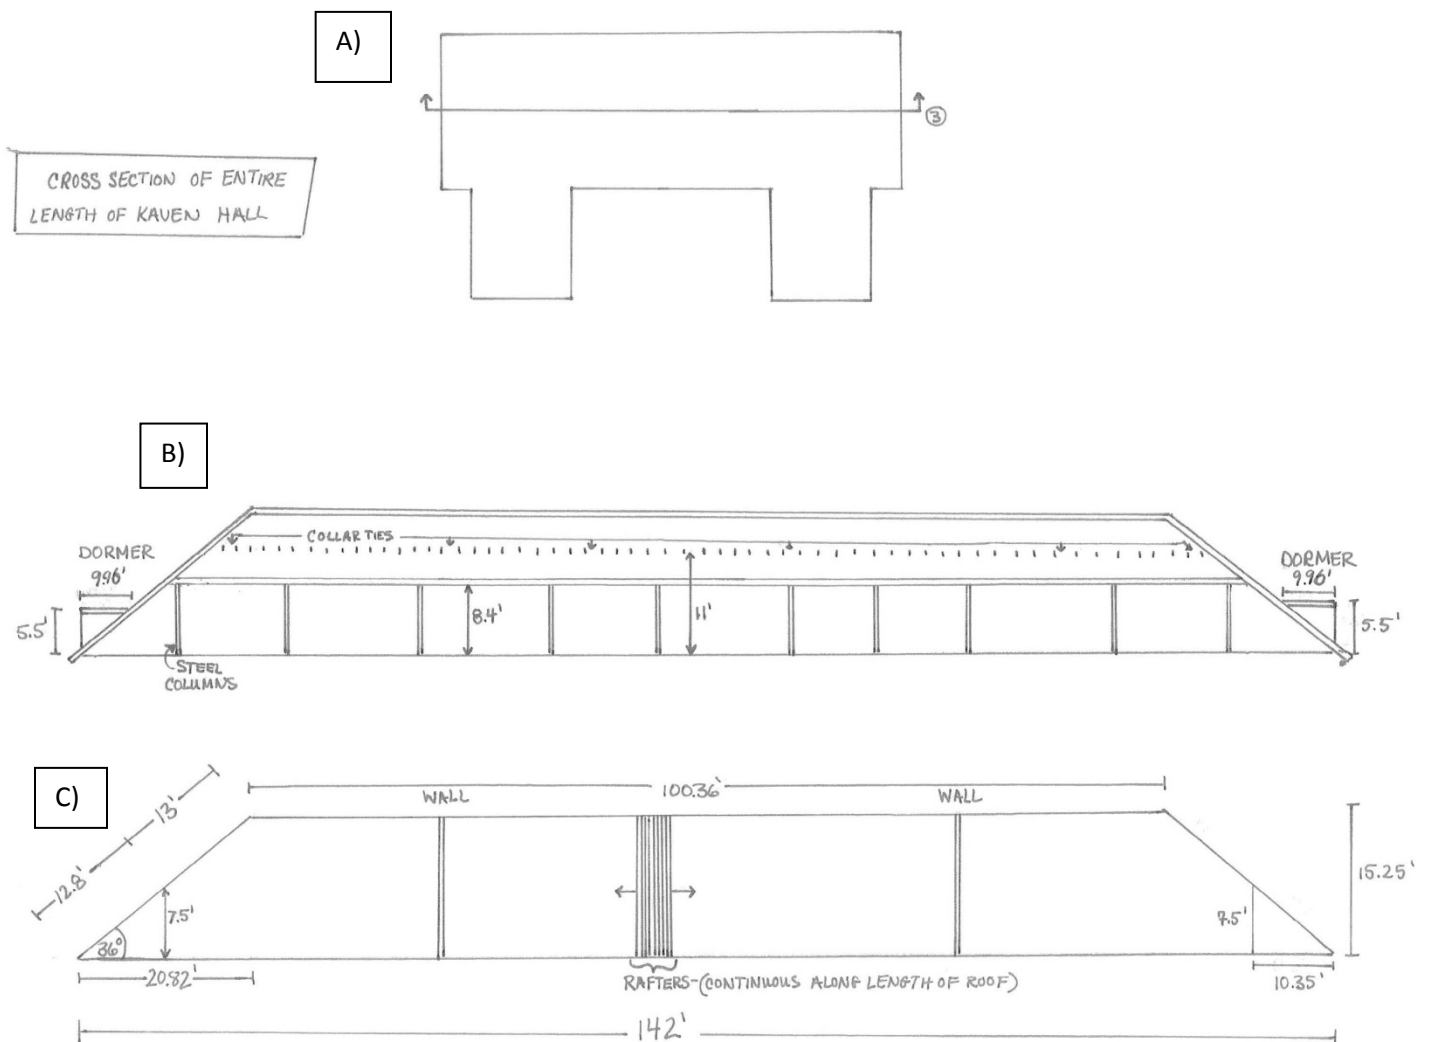
Figure 2.5 Cross Section of Length of Attic

Collar ties also run along the length of the attic roof and along the extensions. The collar ties are 2" by 8" Douglas-Fir and stand 11' from the floor along the length of the main roof and 7' along the extension roofs. The collar ties and rafters can be seen in the various cross section drawings in Figures 2.5 and 2.6. Part A of Figure 2.5 shows where the cross section was taken while part B illustrates the collar ties and steel columns. Part C illustrates the inner walls and the roof rafters. Figure 2.6 entails the steel columns and collar ties in part A while part B illustrates the area of the room.

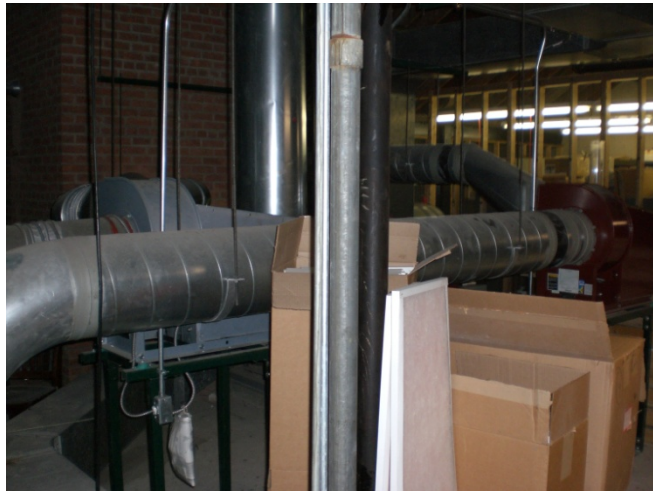
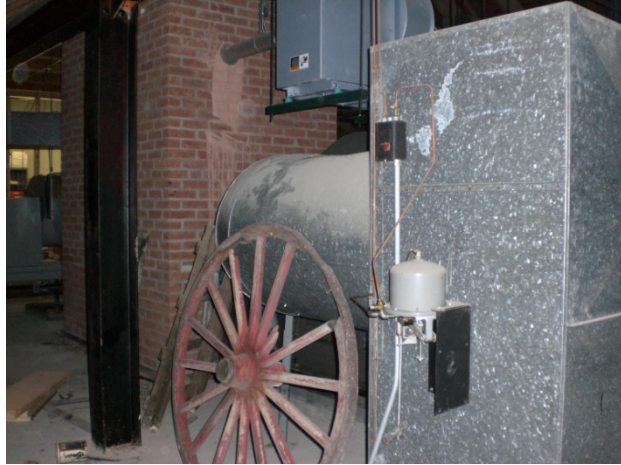
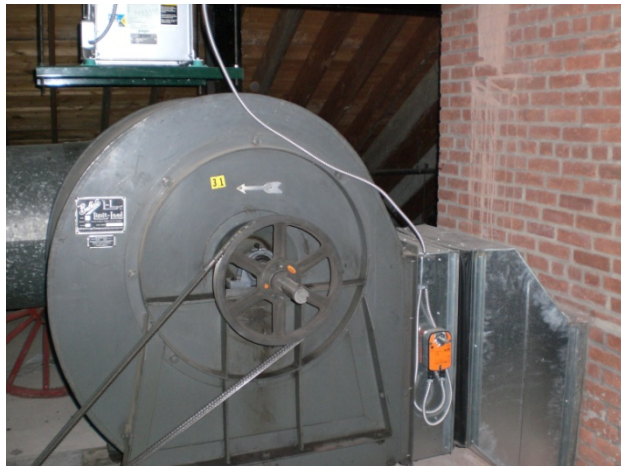
In the attic, it is apparent that there are two ventilation systems in the main room which occupy most of the floor space. One is used primarily for ventilation in the labs of the basement, while the other is used for the general exhaust of the building (Christopher Salter, Facilities). Photographs of these ventilation systems can be found in Figures 2.7, 2.8, and 2.9.

Figure 2.7 Primary Ventilation System

Figure 2.8 Secondary Ventilation System, Side View

Figure 2.9 Secondary Ventilation System, Front View

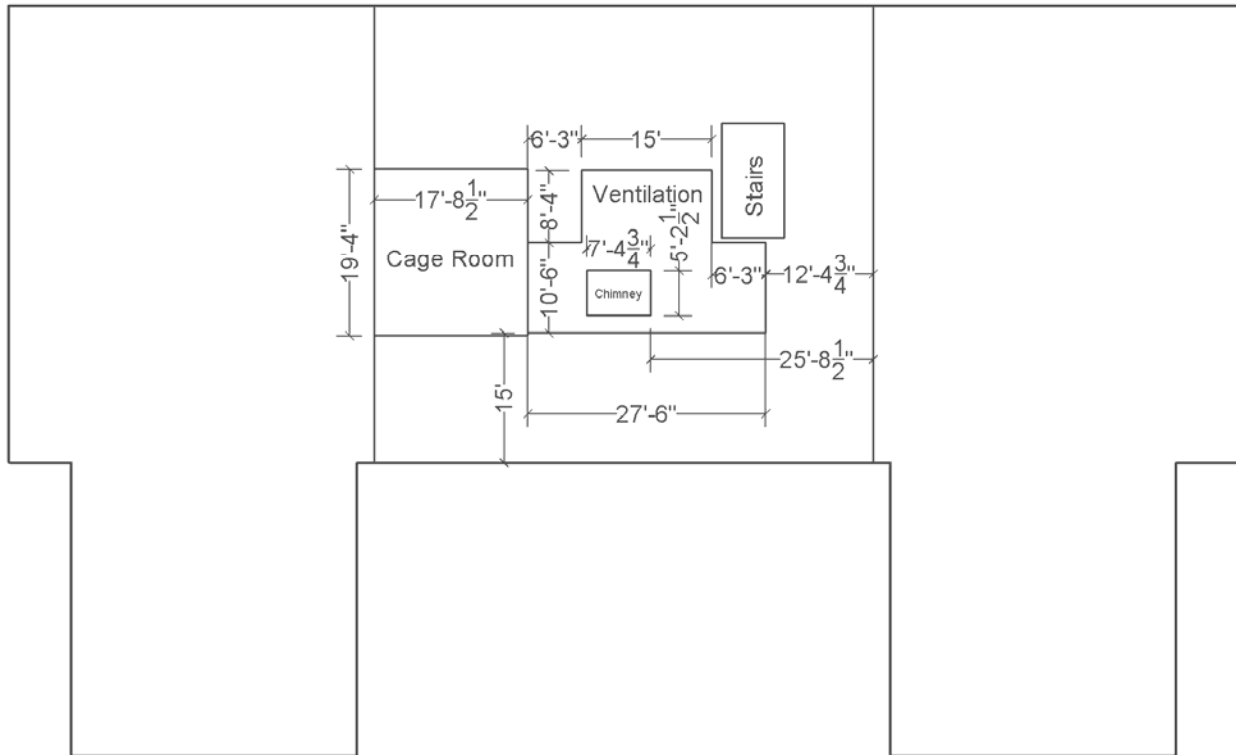
Figure 2.10 Location of Cage Room, Chimney, and Ventilation Systems

far back as 1954 when the building was first opened. If cleaned out and dry-walled, this room could be used in the new floor plan. In fact, it is one of the only usable spaces in the main room. The location of the cage room, brick chimney, and both ventilation systems can be seen on the floor plan in Figure 2.10.

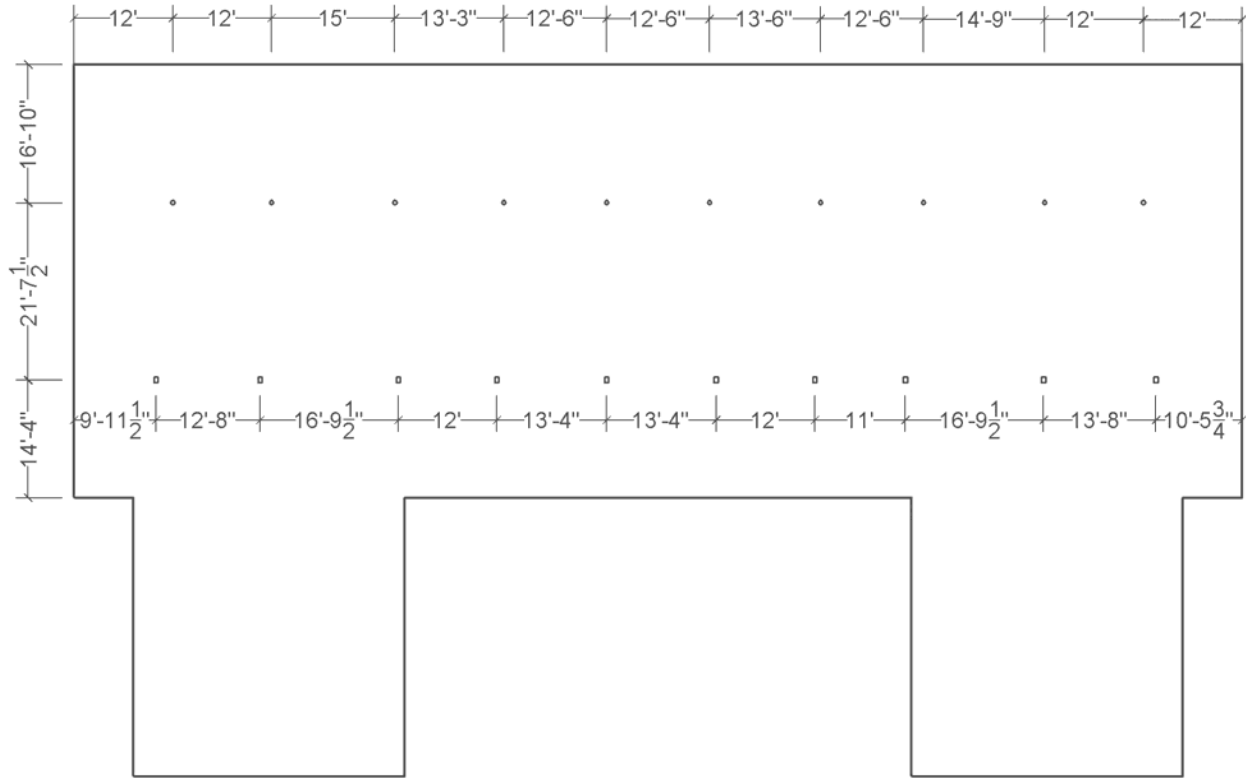
Figure 2.11 Location of Structural Steel Columns

Other fixed items located in the attic included the structural steel columns discussed in Section 2.2. The location of each of these columns in relation to the perimeter of the building can be seen in Figure 2.11. These columns produced an obstacle for the purpose of this project, as they would need to be planned around. In order to convert the attic into usable space, these columns could not be allowed to obstruct any means of egress.

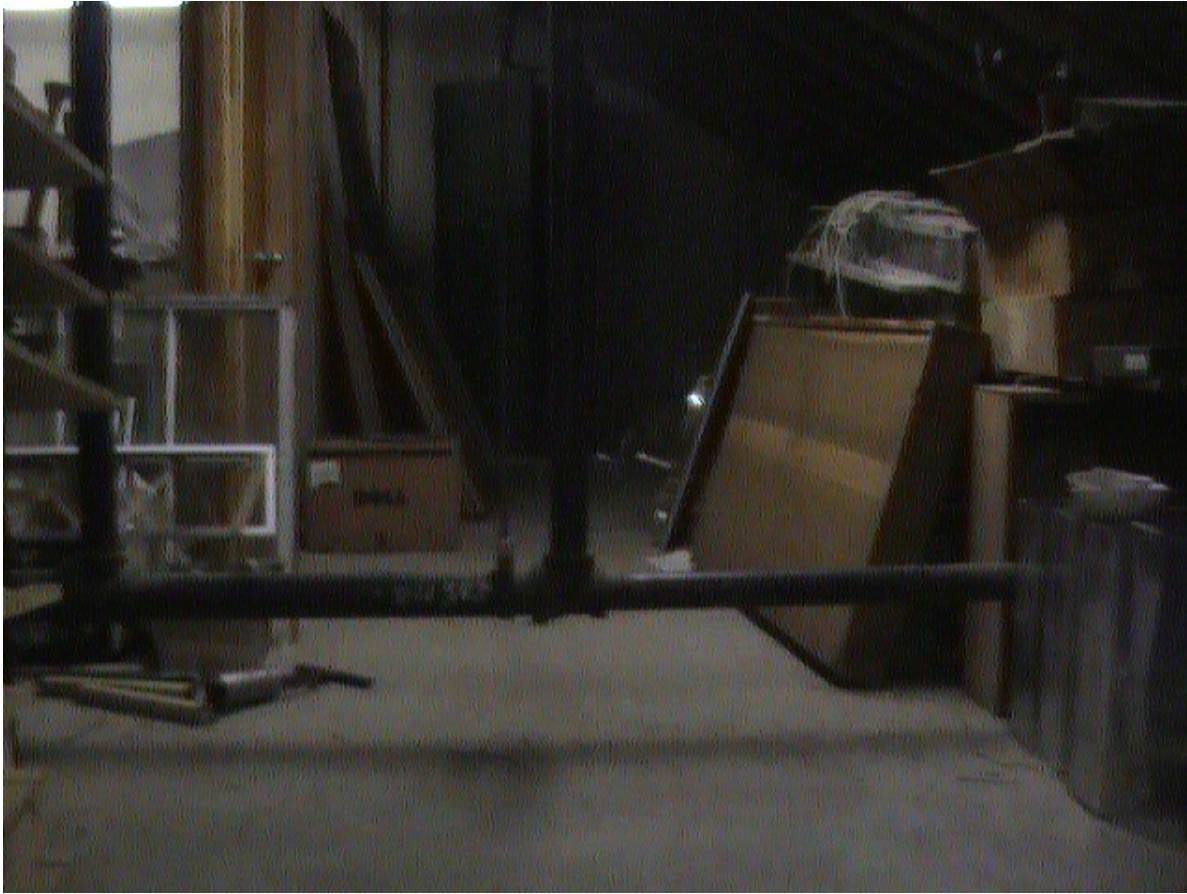
Figure 2.12 Problematic Sprinkler Pipe

Another obstacle found in the attic is a steel pipe running along the floor one foot above the floor located in between the cage room and the ventilation system. This pipe can be seen in Figure 2.12. The pipe is part of the sprinkler system, and would have to be moved in order to not impede egress. This can be done by one of two methods. The first; put in a whole new sprinkler system that could be hidden behind walls and the ceiling. The second; move this pipe elsewhere where it would not take away usable space or impede egress. A new system would be the most beneficial and reasonable since the renovated attic will need a fire protection system in order to comply with the *CMR*.

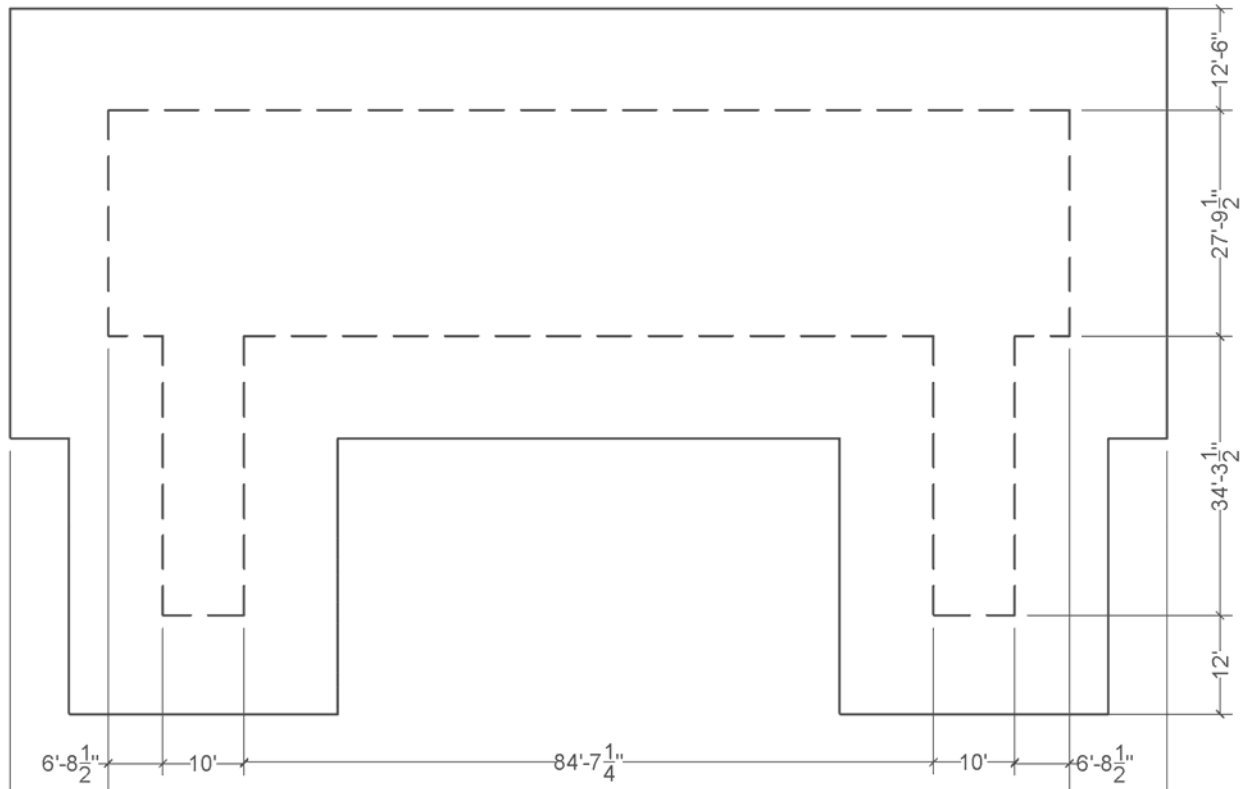
Figure 2.13 Area with 7'-6" of Head Room or Greater

Since the attic is enclosed by a slanting roof instead of vertical exterior walls, the usable area (in square feet) is not the same as the area formed by the perimeter of the building. According to the Massachusetts Code of Regulations; the amount of head space required needs to be no less than seven and a half feet (780 CMR 1208.2). In order to determine the actual amount of available floor space, a tape measure was used to determine the location at which the rafters were 7'-6" from the concrete slab. The distance from this location on the floor to where the floor meets the roof was then measured. This was done along every wall. It was found that the location at which the rafters were 7'-6" from the floor was between 12' and 12'-6" from where the roof meets the floor for all sides of the building. The area of the attic which has 7'-6" of head room or more is outlined by the dashed line in Figure 2.13.

From there, the structural and fixed items were superimposed on the drawing shown in Figure 2.13 to determine the actual usable square footage. This area was the area of the attic with

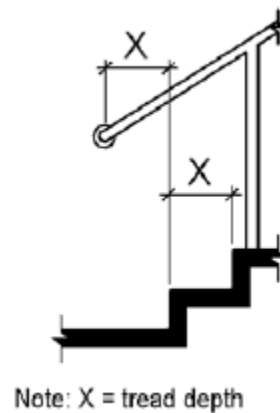
Figure 3.3 Requirement for Handrails at Bottom of Stairs

There are also standard for the size of the rail used, depending on the cross sectional shape of the rail. If a circular rail is chosen, the cross sectional diameter cannot exceed two inches and must be greater than 1 ¼". If a non-circular rail is chosen, the perimeter must be at least four inches but no greater than 6 ¼". A non-circular rail also cannot have a cross section greater than 2 ¼" (ADA 505.7.2). The rail must extend one foot past the top step, going up the stairs, by code (ADA 505.10.2) as shown in Figure 3.2. Also, when going down the stairs, the rail must extend past the last step by a length equal to the tread depth (ADA 505.10.3) as shown in Figure 3.3.

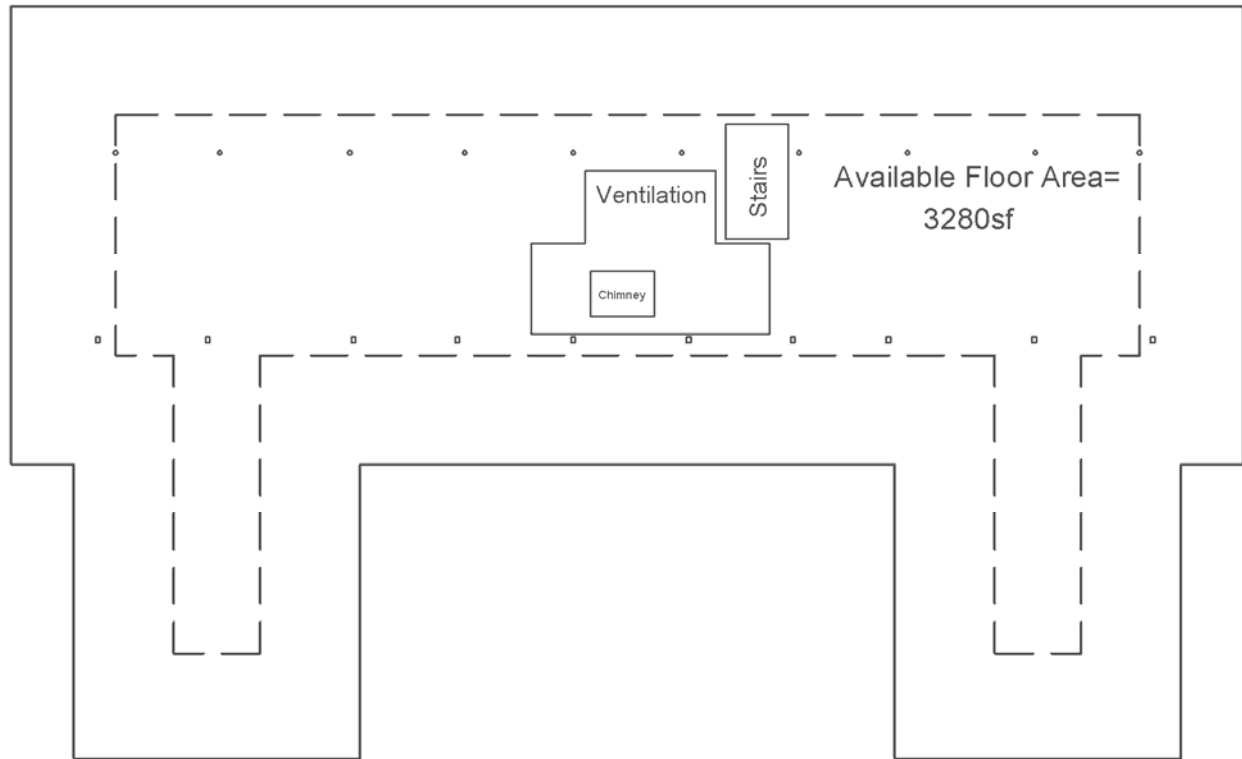
Figure 4.1 Usable Area in Attic

In addition to the loss of floor space due to these fixed items, there was even more floor space lost due to the slope of the roof. According to 780 CMR 2108.2, ceiling heights in all occupiable spaces must be no less than seven and a half feet. This meant that most of the floor space in the attic would be lost because the roof clearance was too low. In fact, roughly twelve and a half feet was lost around the perimeter of the attic due to the low ceiling height. After the usable floor area with at least seven and a half feet of head room was determined, it was then possible to find the amount of actual floor space that could be used for renovation. This area was the floor area with at least seven and a half feet of head room minus the fixed items in the attic. Out of the 9,728sf of floor space, only 3,280sf could be renovated and used as occupiable spaces. See Figure 4.1 to see the usable floor area.

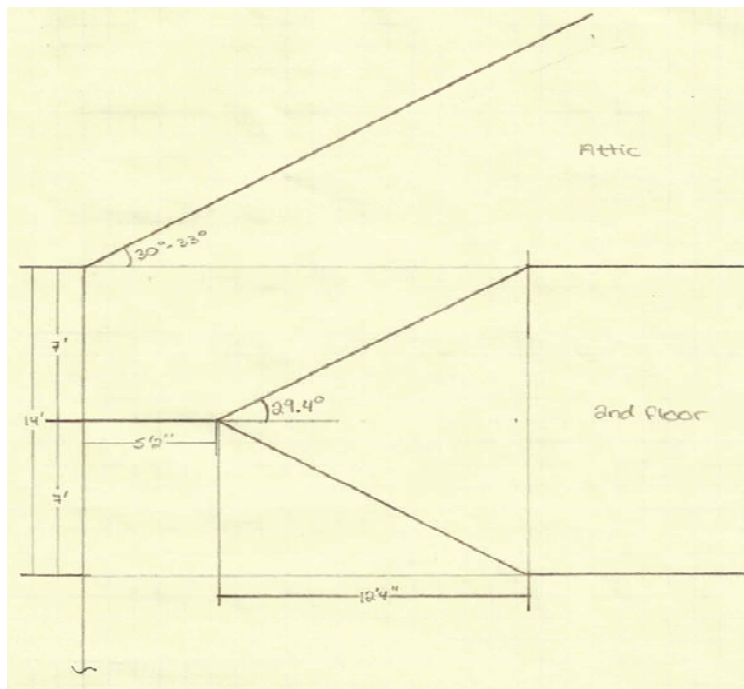
Figure 5.5 Cross Section of Stairs in Reference to Headroom

For both aesthetics and consistency, it was decided that continuing the design of the existing staircases up to the attic would be best, provided the design is structurally up to code. A loading analysis was performed to determine the maximum live load that could be supported by the existing stair design. A maximum live load of 1500lb/ft was calculated and found to be more than sufficient. The design calculations for the stairs can be found in Appendix B. A copy of the cross sections of the stairs can be found below in Figure 5.5.

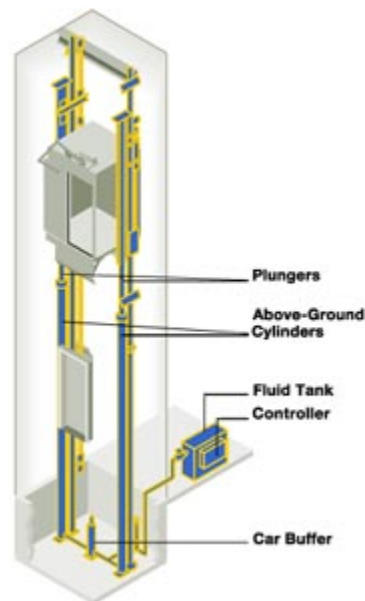
Figure 5.6 Hydraulic Elevator Shaft (Otis Elevator Company, 2008)

for this type of elevator varies from 125fpm to 150 fpm (Otis, 2008). Another reason why the Roped Holeless Hydraulic Elevator is a good fit for Kaven Hall is because these types of elevators are recommended for existing buildings that do not have existing elevators installed (Otis, 2008).

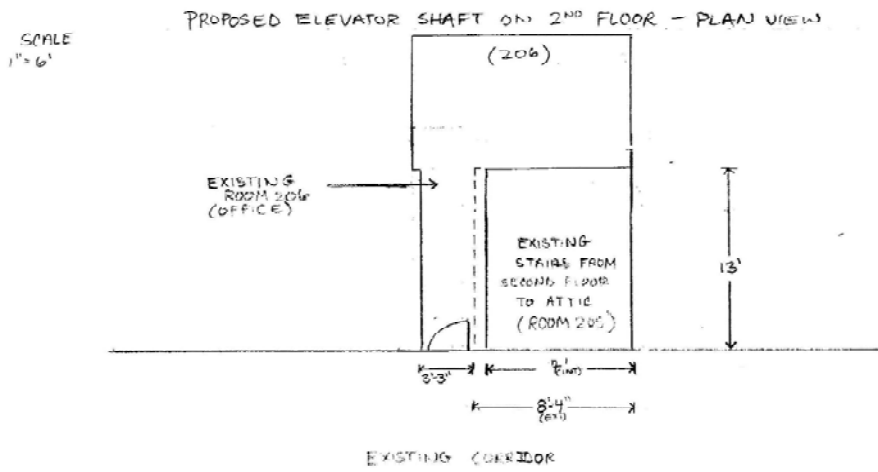
Figure 5.9 Proposed Location of Elevator Shaft on 2nd Floor

- SHAFT FOR EXISTING STAIRWELL TO ATTIC WILL BE USED BUT WILL NEED TO BE RECONSTRUCTED TO ALLOW FOR 8" THICK SHAFT WALLS. THE CURRENT INTERIOR DIM. ARE 7' X 12'-2"
- ROOM 206 WILL NEED TO BE CUT INTO TO ALLOW FOR RECEIVING OF SHAFT
- 3'-3" WIDTH IS MORE THAN 3' REQUIRED CLEARWAY WIDTH

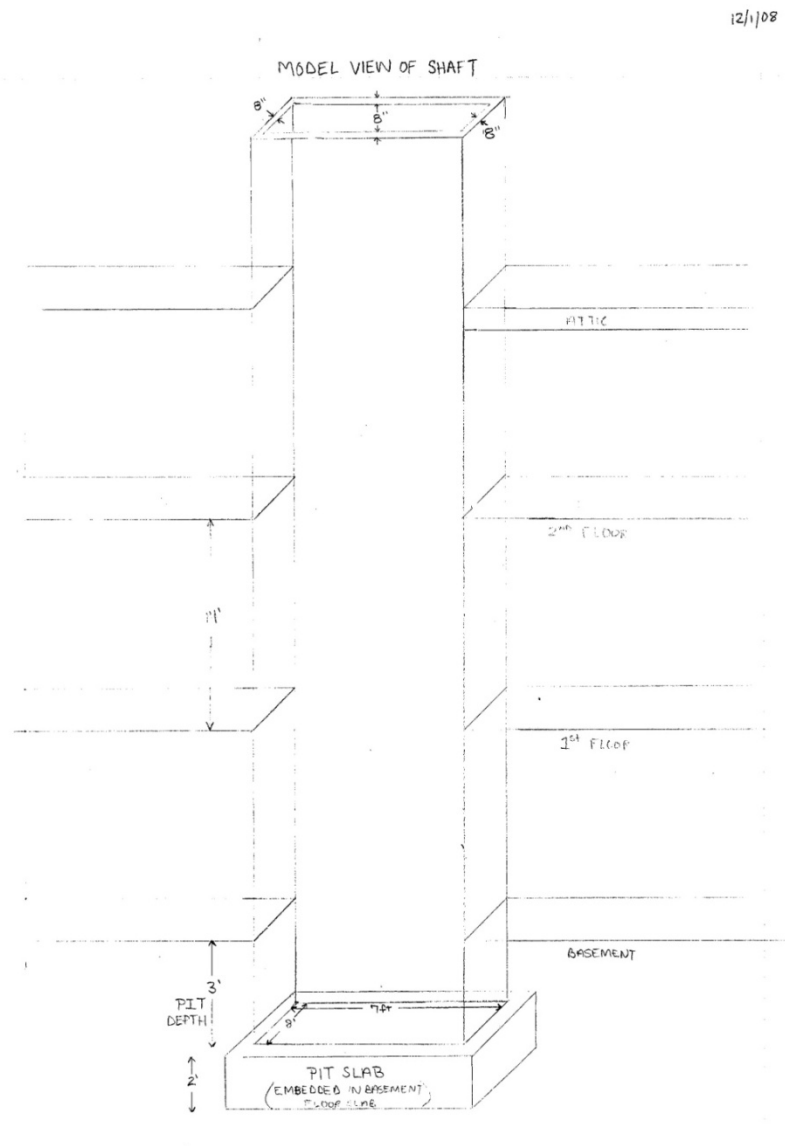
Figure 5.11 Model View of Elevator Shaft

In order to withstand the total loading of 67psi, the current slab in the basement must be removed and rebuilt. A Roped Holeless Hydraulic Elevator does not require the typical pit volume underneath the ground floor that other elevators do. It does however need a pit, just a smaller one than normal (Otis, 2008). The bottom of the pit needed for this elevator would need to withstand the factored loading of 67 psi. This pit will need to be three feet deep; from the top of the basement floor slab to the top of the pit slab supporting the elevator and shaft. A cast-in-place reinforced concrete slab that is two feet thick will be able to withstand this new loading (Wang, Salmon, Pincheira, 2007).

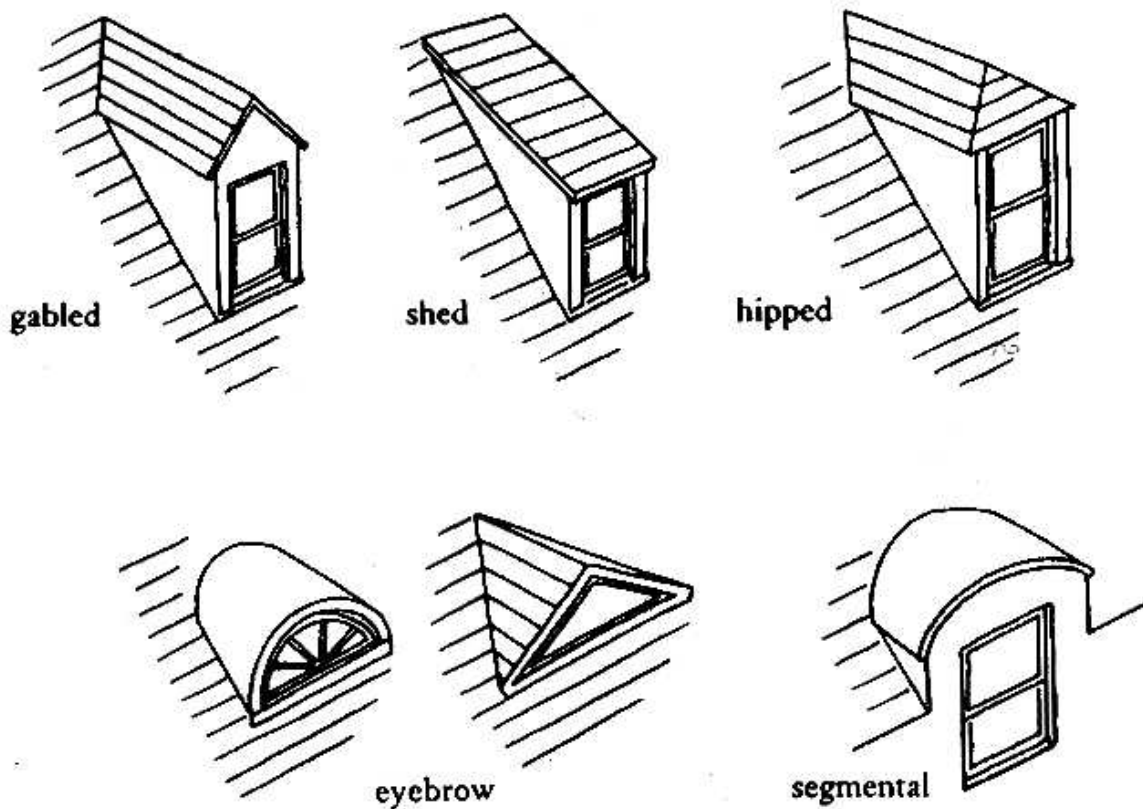
Figure 5.12 Dormer Styles

Currently, there are four existing gable dormers on the roof-top of Kaven Hall (a typical gable dormer can be seen in Figure 5.12 along with other commonly-used dormers.) There is one directly above each of the existing stairwells on the north and south ends of the building. There are two additional dormers, both of which are on the east side of the building, facing away from campus. These dormers can all be seen from the plan view representation in Figure 5.13. None of these dormers, however, are used to provide the attic with the necessary natural lighting that is needed. The one accomplishment these dormers offer is the ventilation provided by each dormer.

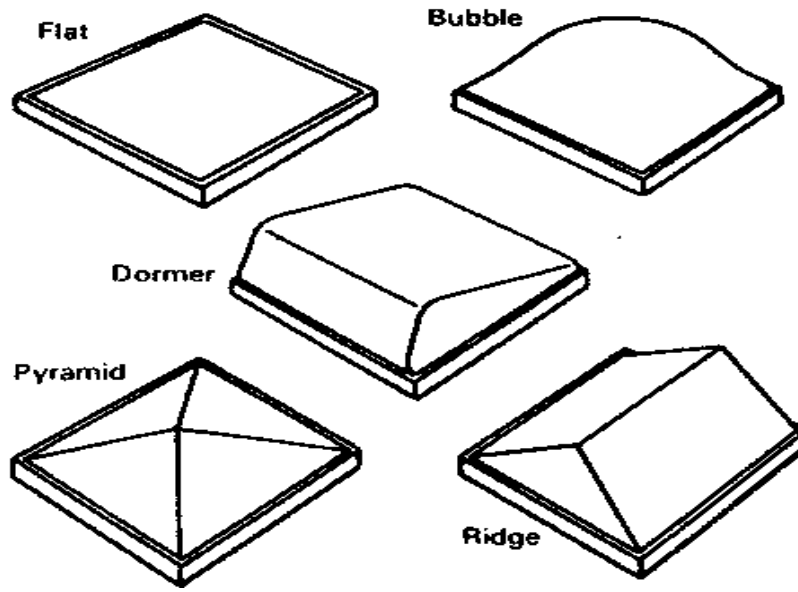
Figure 5.14 Skylight Styles

The type of skylight to be designed is a typical flat skylight that if necessary can be opened for ventilation purposes. The skylight size should never be more than 5% of the floor area and no more than 15% of the room's total floor area for spaces with few to no windows. The skylight provided will be at a 30 degree slope and use a single glazing aluminum frame with a metal spacer. In order to determine heat loss it is found that this type of skylight will supply a U-factor of 1.9. A U-factor is the rate at which a window, door, or skylight conducts non-solar heat flow into a building or room. It is usually expressed in units of Btu/hr-ft<sup>2</sup>-F. For skylights, windows, or glass doors, a U-factor may refer to just the glass or glazing alone. Glazing is when multiple glass panes or "lites" are assembled into units, which are commonly referred to as "insulated glass". Installed skylights typically have a higher effective U-factor than windows of the same materials, construction, and size, resulting in 35%-45% greater heat losses during cold weather. This is caused by three main factors convection, which is the movement of molecules within fluids, radiation, and the supporting frame. Below in figure 5.14 are a sample of different skylights, the first is the design that was used.

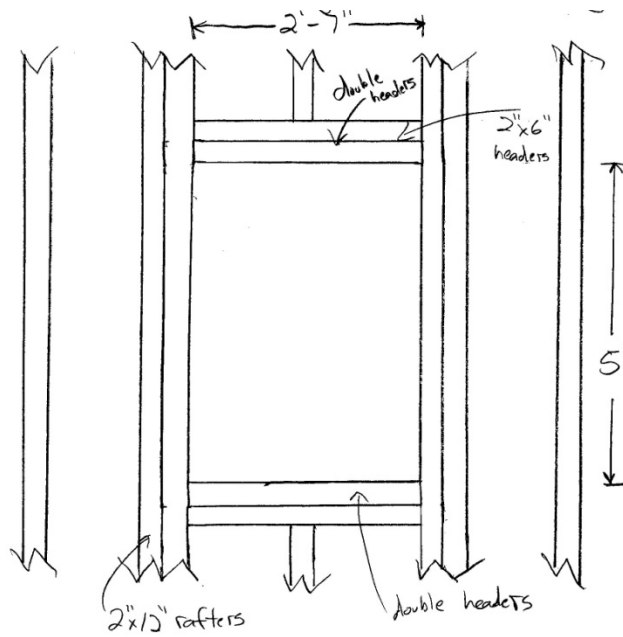
Figure 5.16 Proposed Skylight Framing

The design for the structural support of the skylights is shown in Appendix B: Structural Analysis and Design. Every skylight will have the same dimensions. The skylights will be located over the rooms' tech suite 1, tech suite 2, the individual study area, the lounge area, and the conference room. The skylights will all have the dimensions of 5'-4" x 5'. The design of the skylights involved a structural timber analysis for the supports that will make up for the rafters being cut when the skylights are installed. The upper header will support the distributed loads carried out by the cut rafters through the sidewalls down to the lower header and then distributed to the existing rafters. The wooden member to be used for the headers is determined to be 2"x6" Douglas Fir rafters. The skylight locations on the Kaven Hall roof are shown in Figure 5.15 on the next page. Figure 5.16 shows the framing and supports of the designed skylight.

The framing for the second skylight design is the same as above with the exception of the width being 5'-4\"/>

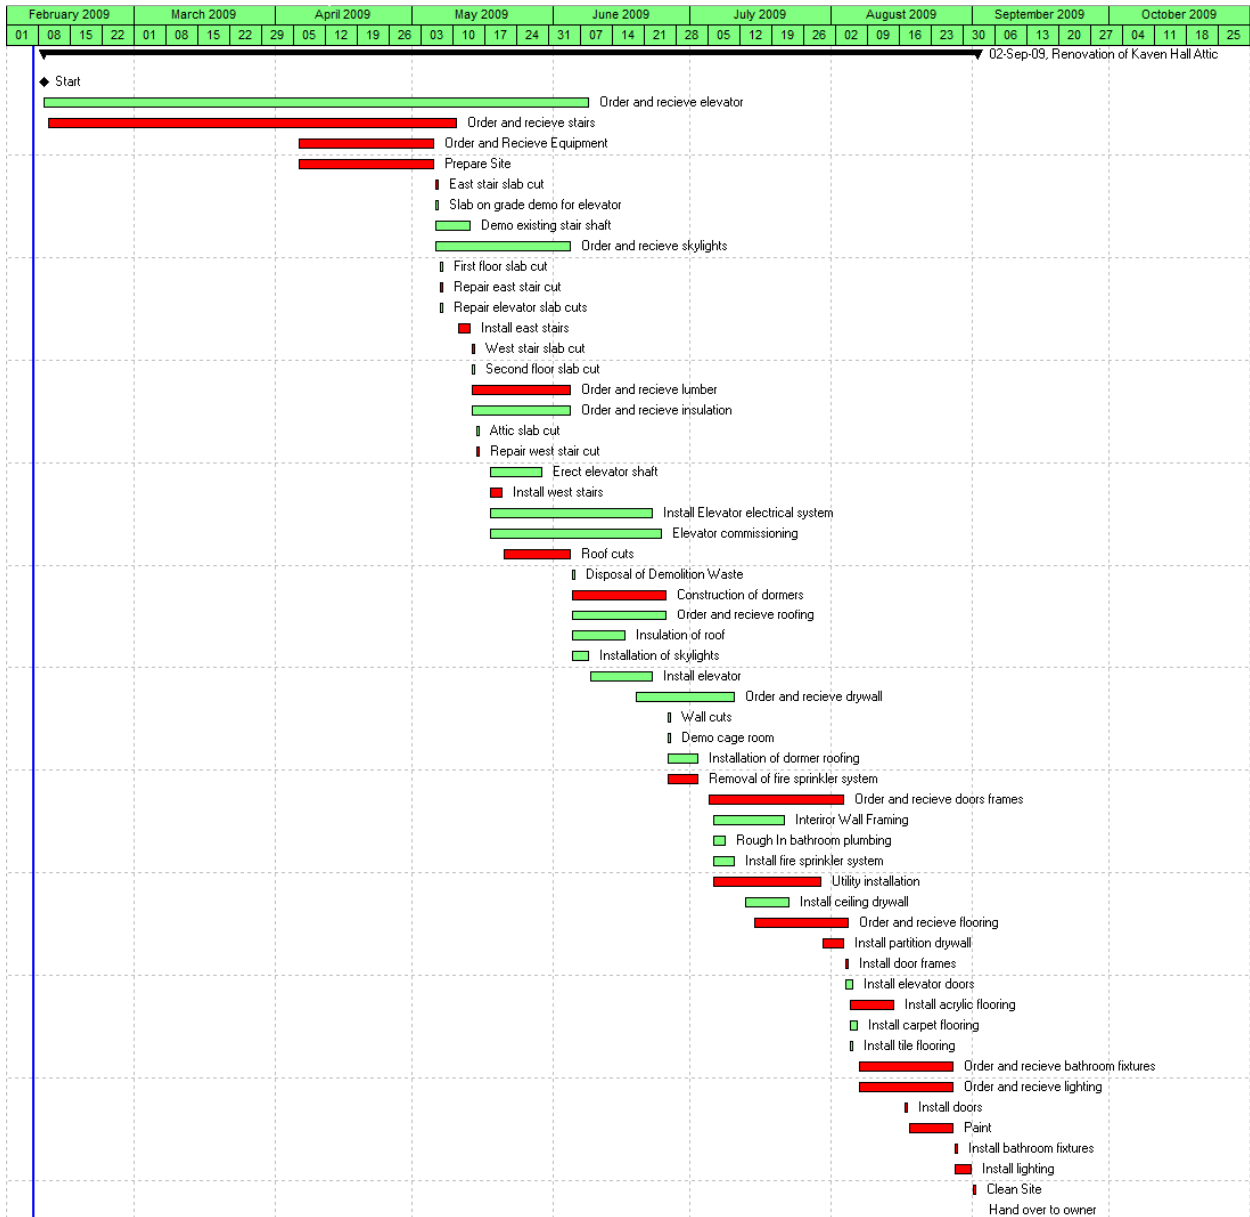
Figure 6.1 Schedule Developed Using Primavera

Through Primavera, the amount of time the renovation will take from start to finish was found to be 150 days. Since demolition and construction would be highly disruptive to the classes which take place in Kaven Hall, it was decided that demolition would begin on May 6<sup>th</sup>, the day after classes end. Given that start date for the demolition portion of the renovation, the majority of the renovation would be completed by the start of the fall semester (the last week of August). The only renovation activities which would overlap the start of the fall semester would be painting, the installation of bathroom fixtures and lighting, and the cleaning of the site. None of these activities would be disruptive to any classes being held within Kaven Hall at that time.

After the list of activities was completed, each activity, along with its duration and relationships to other activities, was inputted into Primavera construction scheduling software. Once all the information was inputted, the software created a schedule of all the activities and displayed the schedule in bar-chart form. This schedule can be seen in Figure 6.1. The activities which are represented by red bars are critical activities, meaning that any delay or acceleration in their progress will cause an equal delay or acceleration in the amount of time the renovation will

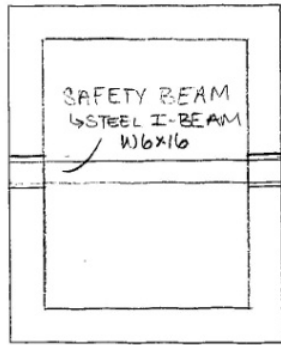
TOTAL WEIGHT OF ELEVATOR CAR WITH MAX OCCUPANCY: 4000 lbs

TWO STEEL BEARING PADS TO BE PLACED ON TOP OF SHAFT TO DISPERSE THE LOAD FROM SAFETY BEAM PLUS ELEVATOR CAR WITH MAX OCCUPANCY IN CASE OF FAILURE.

STEEL BEARING PADS  
8" x 8"  
 $A_T = 64 \text{ in}^2$

W6x16 STEEL I-BEAMS
