Control of Total Suspended Solids and Phosphorous from Stormwater in Lake Wickaboag

A Major Qualifying Project

WORCESTER POLYTECHNIC INSTITUTE

Date: March 1, 2011

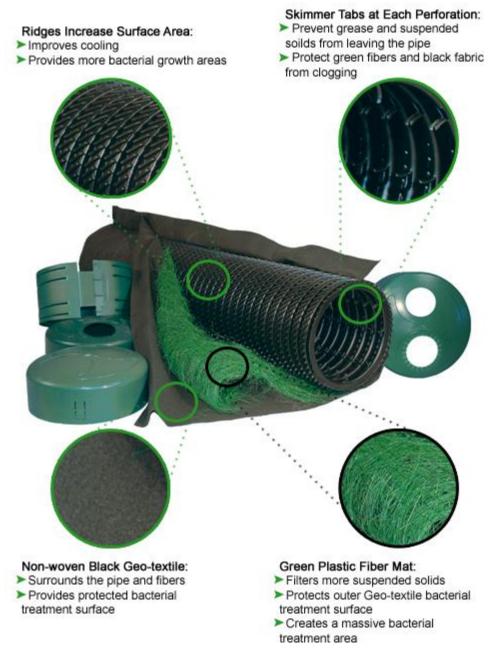
The Enviro-Septic was designed by Presby Systems in Whitefield, New Hampshire. This system is a infiltration trench leach field system. The leach field consists of a ten inch corrugated perforated pipe that is wrapped in a green plastic fiber mat and a non-woven black geo-textile. The pipes in the Enviro-Septic are all installed level as long as they are below the equalization tank outflow and can be offset from each other in series. In many applications including drainage or septic systems the pipes are set on top of six inches to one foot of gravel. Figure 5 shows the components of the Presby Enviro-Septic pipe system (Presby Environmental, 2009). Appendix D shows a detailed diagram of how the Enviro-Septic system works.

Figure 5: Enviro-Septic Pipe System

Corrugated perforated pipe offer more surface area for bacterial growth along the pipe and block greases and large suspended solids from exiting the pipe. The green plastic fiber mat filters out suspended solids and creates a bacterial treatment area that helps to break down the suspended solids and other organic compounds. The non-woven black geo-textile surrounds the green plastic fiber mat and provides an additional protected bacterial treatment surface. This multi-bacterial layer system helps to provide oxygen for the aerobic digestion necessary to provide a high quality effluent from the system to the groundwater. The gravel part of the system provides an area of filtration and is an area where pathogens will get slowed down and inactivated prior to entering the groundwater. It was discovered by Presby Systems in 2009 that the addition of a
