*Portali e Lunette:
A Multimedia Catalog for the Preservation of Venice's
Artistic Entrances*

An Interactive Qualifying Project Submitted to the faculty of
Worcester Polytechnic Institute

30 July 2002

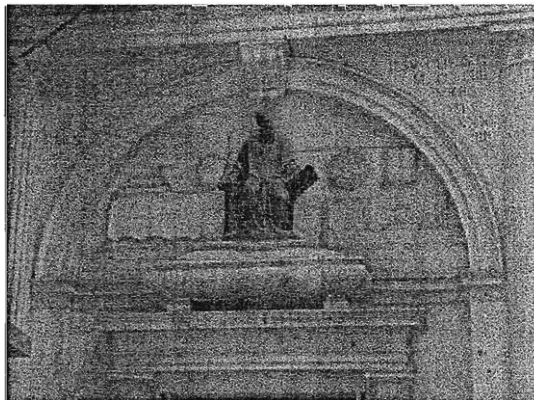
Figure 7 Italian Renaissance Lunetta on San Zulian Church

The Renaissance era occurred between the 15th and 16th centuries⁴; it was a time of rebirth and enlightenment. Renaissance lunette emanate a delicate elegance that is unlike any other style. The lunette are not elaborate and instead carry subtle subject matters that are not gaudy.

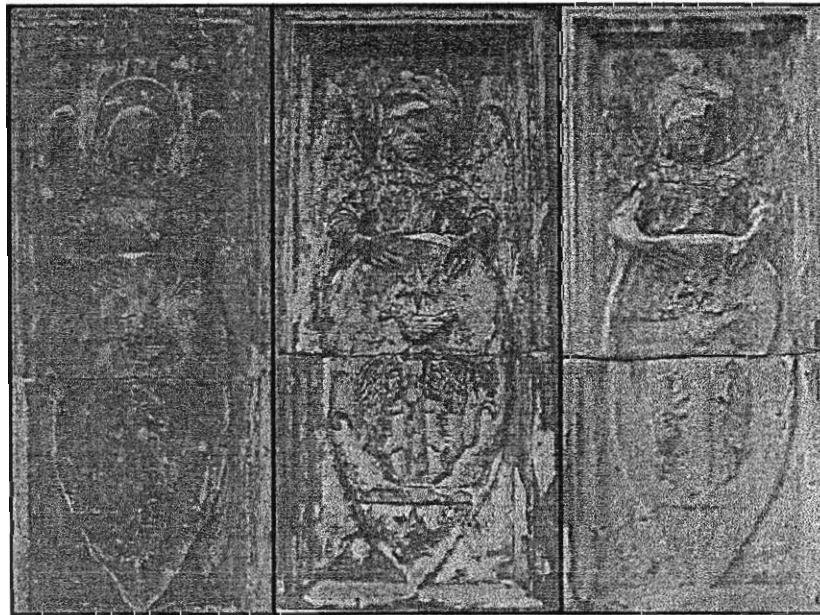
Figure 8: Example of Deterioration

The photos in Figure 8 were taken in Venice in the years 1930, 1979, and 2000 respectively. These photos are a good example of the decay that happens over time to some of these precious pieces of art work.

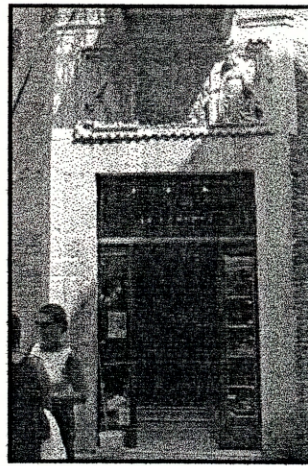
Figure 10: Artwork Not Attached to a Door

In order to eliminate confusion as to whether a piece of architecture is really a portale or a lunetta that should be included in the Public Art Database, we have created some precise definitions. The definition we created for a portale is an entrance way to a building or courtyard where artwork has been incorporated around the doorway, as well as on top of it. This definition does not include artwork above a door but not attached to the doorway in any way. The definition of a lunetta is an artistic element located inside an arch above an outside door of a building. A lunetta also must utilize the entire arch. This definition does not include metalwork and sculptures that do not utilize the entire space of the arch, as seen in Figure 9 and Figure 10.

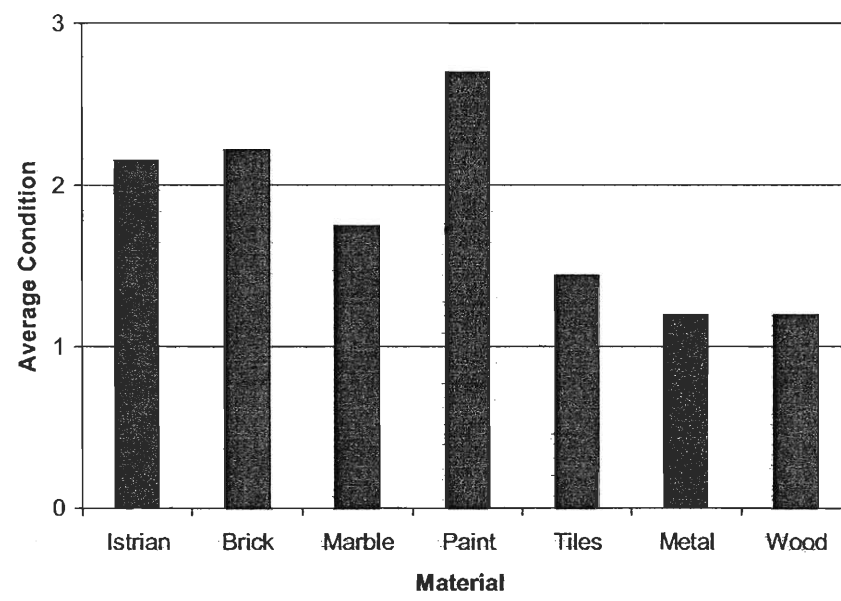
Figure 22: Average Surface Condition by Material

Istrian stone is the most abundant material for lunette and portali. It is a very robust material and does not wear easily. However, many pieces utilizing this material are in need of restoration or care. Marble is a material that tends to resist wear, while brick wears quickly because of its porous composition. From **Figure 22**, we can clearly see that painted pieces, which are found on frescos, are in the worst condition. This is because plaster and paint cannot hold up against the elements as well as stone. Tiles are in the best condition, according to **Figure 22**. This is attributed to the recent restoration of the tiled mosaics on the Basilica di San Marco, however not all mosaics receive the extensive care that these do. The following graph shows the surface conditions versus materials.

Paint is a more delicate material, so these pieces require more attention than ones made of stone. It must be noted that missing sections of the paint and tile pieces were not included in the calculation of the surface condition because it is impossible to restore the missing areas, due to Italian laws.

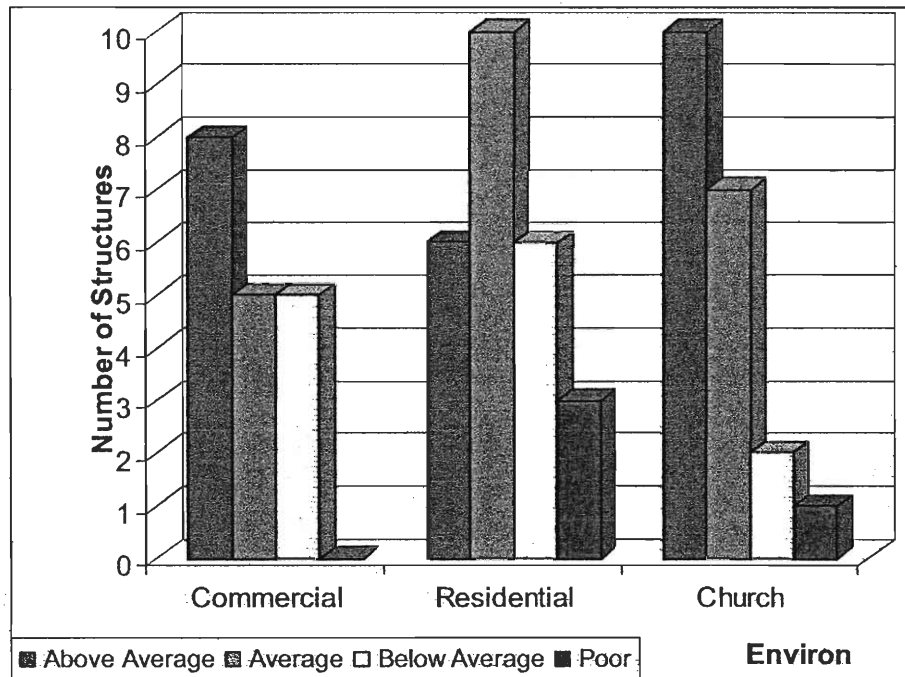
Figure 23: Percent of Structures per Surface Condition by Environ

The purpose of this section is to show the relationship between the environ of the piece and the current surface condition. According to our data, pieces on churches are in better condition than those in the commercial and residential environs. This could be attributed to the higher amount of visibility that the pieces on churches receive, along with a church's independent funding source for repairs. The structures found in the residential environ are more likely to be in low exposure areas, such as back alleyways, possibly contributing to the slightly worse conditions of the pieces.

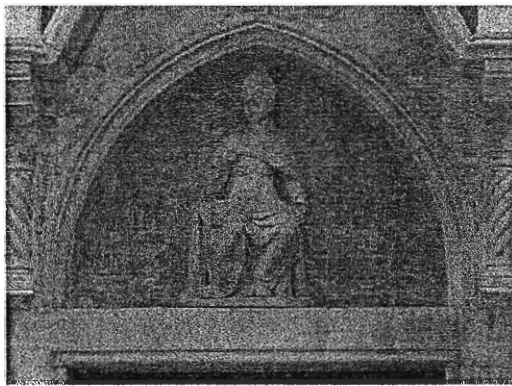
Figure 25 Lunetta on Chiesa di S. Alvise

As seen in **Figure 25**, these historically important lunette are in need of attention. It is evident that the background material is decaying, as well as the statue. In this case, the statue is missing its right hand.
