Coastal Erosion Mitigation on Nantucket

An Interactive Qualifying Project submitted to the Faculty of
WORCESTER POLYTECHNIC INSTITUTE
in partial fulfillment of the requirements for the
Degree of Bachelor of Science

December 14th, 2023

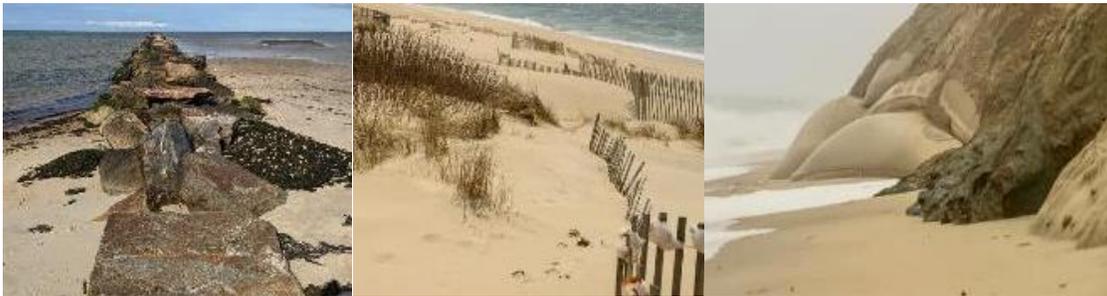
Figure 1. Erosion Control Structures: **L:** Jetty at Jetties Beach
C: Sand fencing and vegetation at Madaket Beach **R:** Geotubes at Sconset Beach
<https://www.savenantucketbeaches.org/>

This increased threat posed by erosion has led to erosion mitigation becoming an important topic for the Nantucket community. As shown in Figure 1, coastal erosion mitigation structures, such as jetties, groynes, sand fencing, vegetation, and geotubes have been built to help protect the Nantucket shoreline. These structures are designed to help with sand accretion, reduce the damage caused by waves, or both.

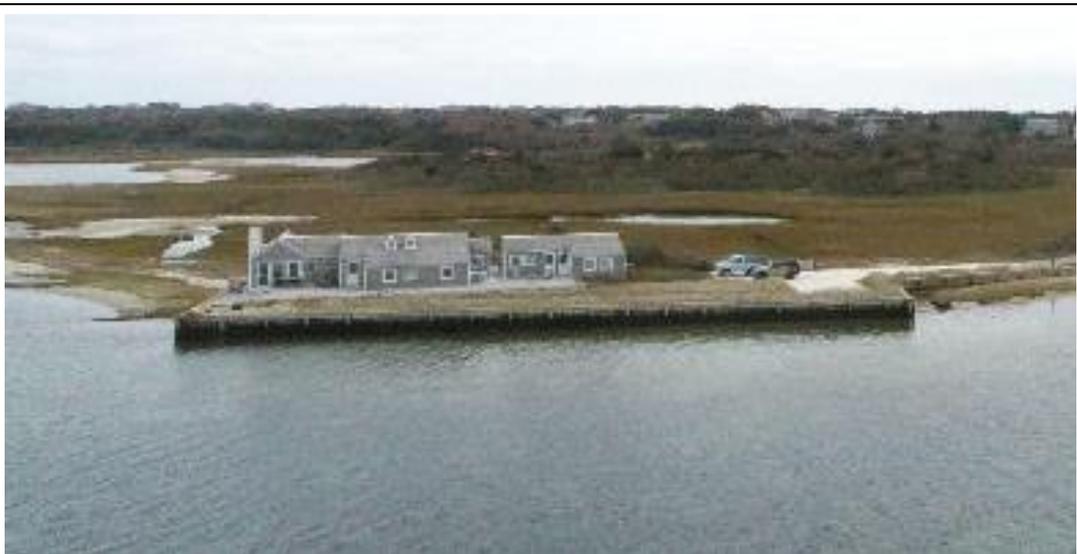
Figure 6. The picture above shows an example of drone photography, courtesy of Burton Balkind. The picture displays a wooden bulkhead installed at a house near Pimney's Point.

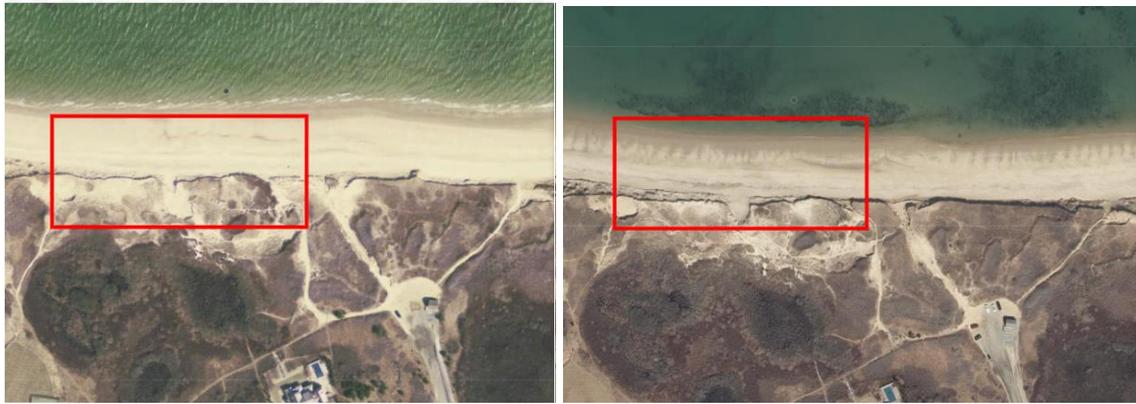
Dionis Beach has changed over time due to erosion and accretion. As seen in [Tables 1, 2, and 3](#) the amount of erosion has changed over time for Dionis Beach but has consistently only had moderate amounts of erosion. This erosion can be seen in Figure 15 (following page) in the red boxes. When comparing the two photographs the bluff has receded since the picture in 2014. Dionis Beach has not experienced as much erosion as other beaches because it does not experience as many strong, high-energy waves.

Figure 15. Dionis Beach erosion from MORIS:
L: Dionis Beach in 2014 **R:** Dionis Beach in 2021
<https://czm-moris-mass-eoeea.hub.arcgis.com/#DataViewer>

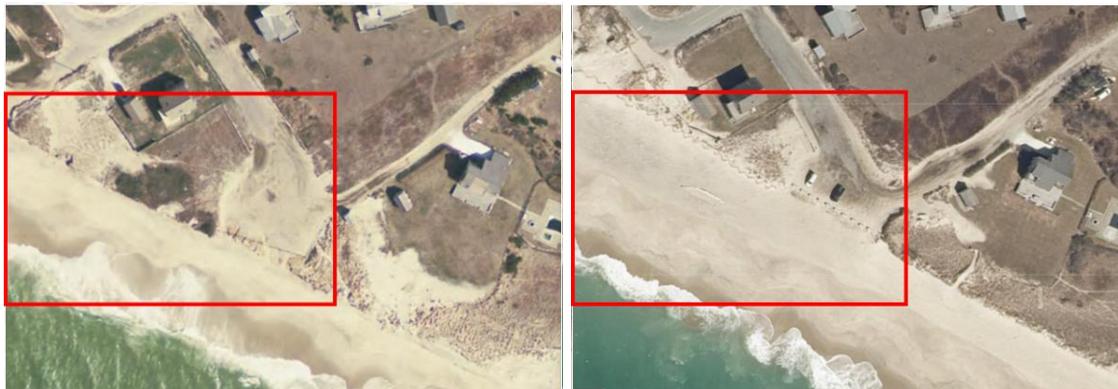
The Madaket Beach Parking Lot has experienced large amounts of erosion over time. This can be seen in [Tables 1, 2, and 3](#) where it has consistently had one of the highest erosion rates of the four locations. This erosion can also be seen in Figure 16 where the parking lot in the red box has visibly eroded over that period. The parking lot has been about cut in half in size in the last 7 years. The house to the left of the parking lot has had its backyard significantly eroded away and is almost on the beach. The Madaket Beach Parking Lot has experienced a large amount of erosion due to the strong waves that the beach consistently has.

Figure 16. Madaket Beach Parking Lot erosion from MORIS:
L: Madaket Beach Parking Lot in 2014 **R:** Madaket Beach Parking Lot in 2021
<https://czm-moris-mass-eoeea.hub.arcgis.com/#DataViewer>

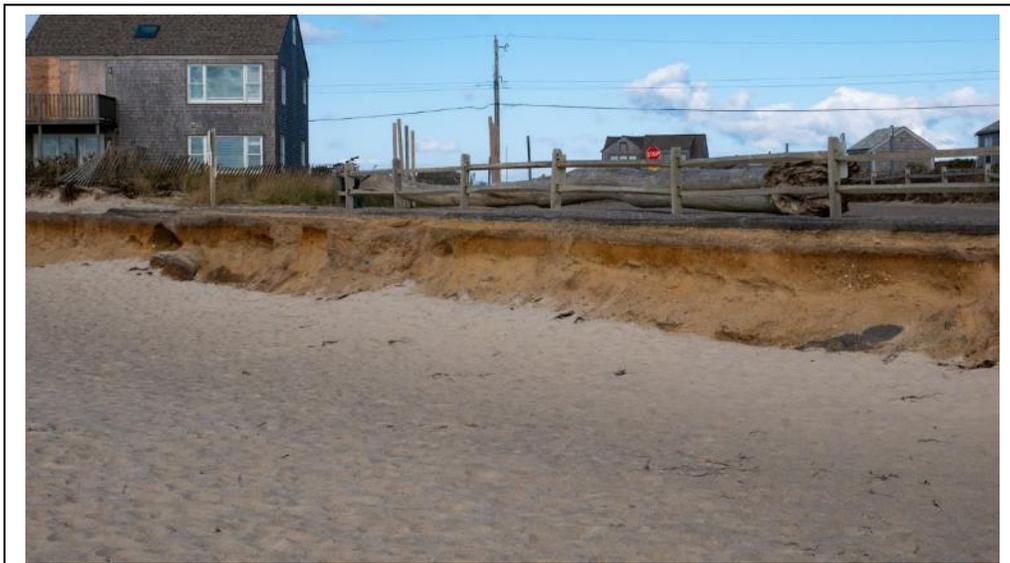
Figure 20 shows an example of the erosion occurring at the Madaket Beach Parking Lot.

Figure 20: An example of the erosion at the Madaket Beach parking plot. The photo was captured during high tide.

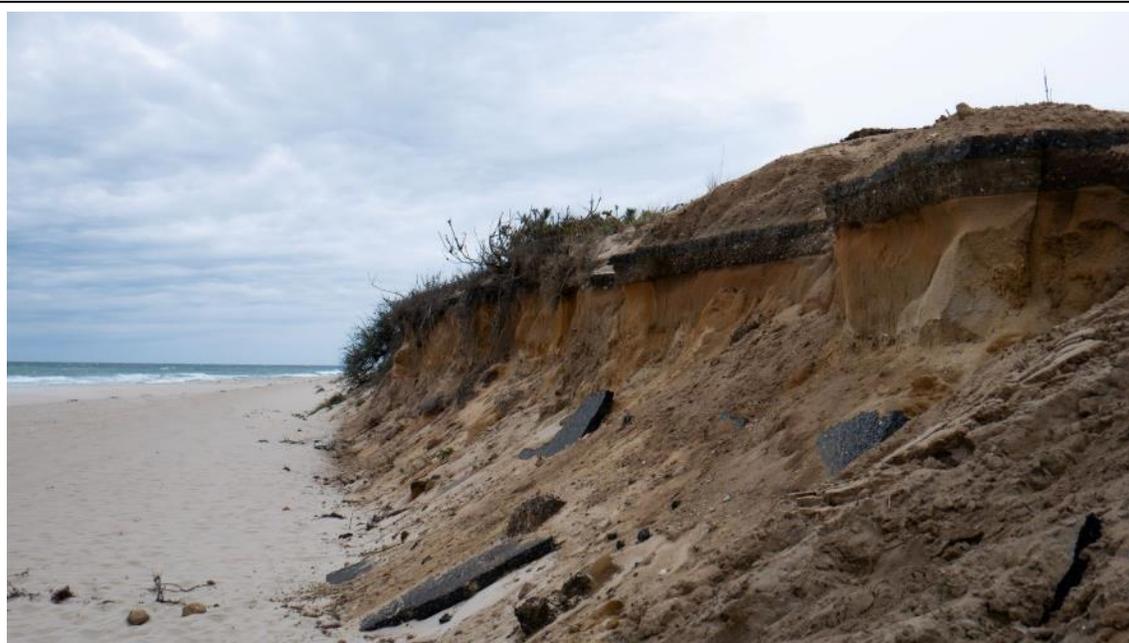
Figure 22 shows an example of the erosion occurring on Cisco Beach.

Figure 22. An example of the erosion on Cisco Beach. The photo was captured at low tide.

- a. Fencing helps to catch sand blown by the wind and builds dunes around the areas. Sand Fencing would be effective on Cisco Beach as the area is not regularly reached by high tide or minor storms (Massachusetts Office of Coastal Zone Management, 2018). Sand Fencing would help to capture sand moved by the wind. This would help to build up the dunes which in turn would help protect the shore from waves caused by storms.
