Promoting Universal Accessibility of the East Kowloon Harbor Front

An Interactive Qualifying Project Report submitted to the faculty of
Worcester Polytechnic Institute in partial fulfillment of the requirements for
the Degree of Bachelor of Science

Date: March 6, 2015

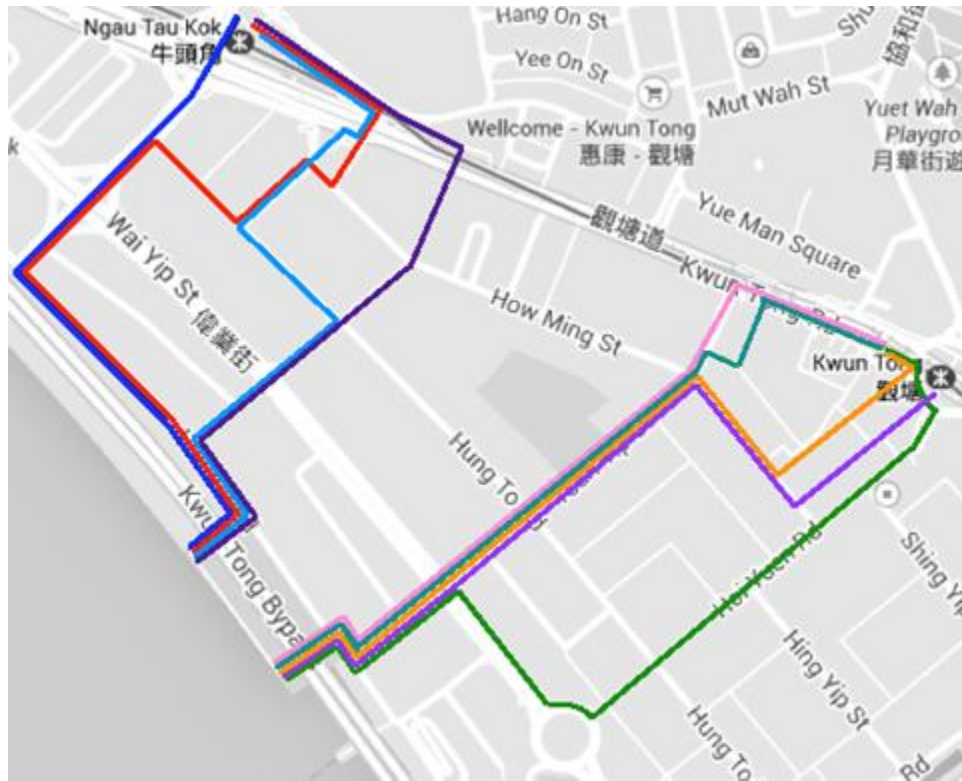
Figure 4.1: Viable Pedestrian Routes though Kwun Tong (adapted from Google, 2015)

from Kwun Tong MTR Station (refer to Figure 4.1). Please refer to Appendix F for a detailed description of each route.

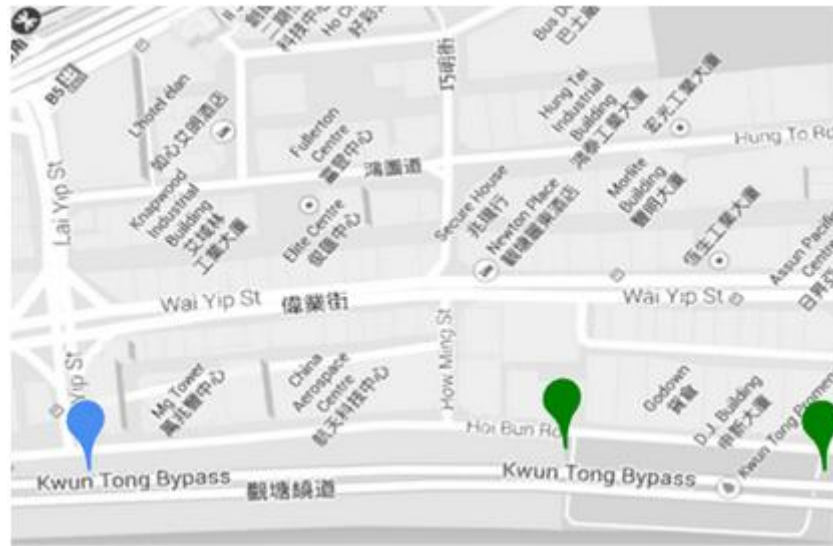
Figure 4.2: Existing (green) and Projected (blue) Entrances to the Kwun Tong Promenade (adapted from Google, 2015)

in Figure 4.2), which will make the red route more of a direct option. The completion of the promenade may also create more possible pedestrian pathways from Ngau Tau Kok north of Lai Yip Street, however our analysis was limited to exploring the routes reaching the promenade via the two current entrances (shown in Figure 4.2 by the green drop pins).

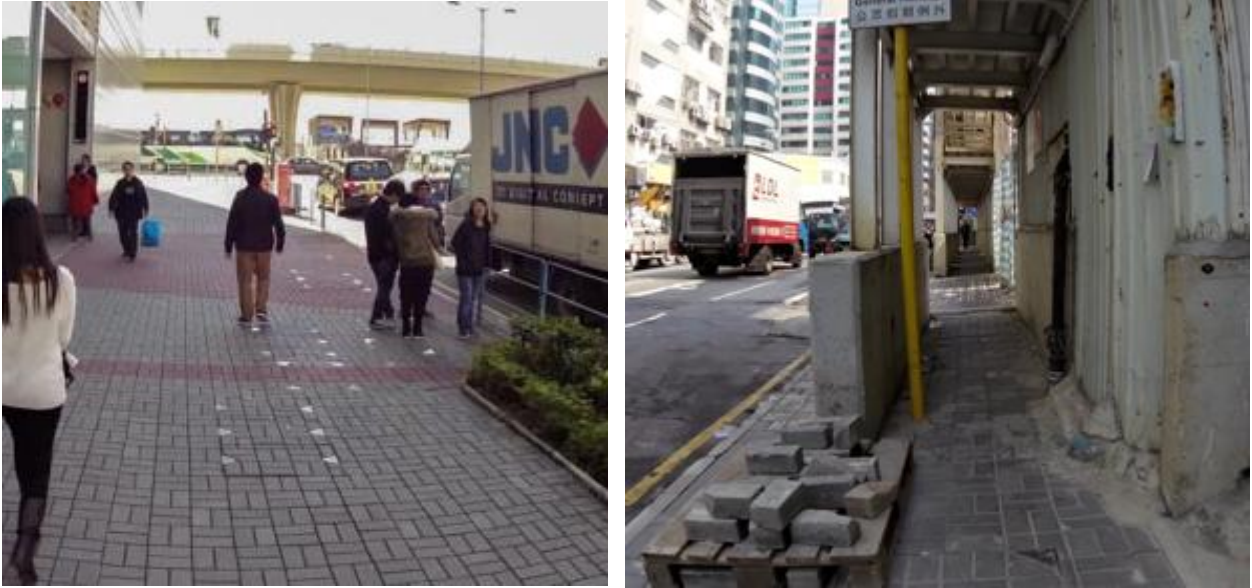
Figure 4.3: Sidewalk Condition Comparison of Lai Yip Street (left) and Tsun Yip Street (right)

Route 1 achieved a rating of gold for sidewalks and walkways since the sidewalks along the entire route were at least 4 meters wide and clear from any obstacles or obstructions. The sidewalk along Lai Yip Street, the left image in Figure 4.3, is approximately 4 meters wide and is even and level. By comparison, the right image is of the sidewalk along Tsun Yip Street, which contributed to the low silver rating of Routes 5-8. The sidewalk is uneven, and in some places damaged, and the narrow width is not ideal. In addition, using the limited sidewalk space for storage further minimizes the walkable area and creates unsafe tripping hazards.

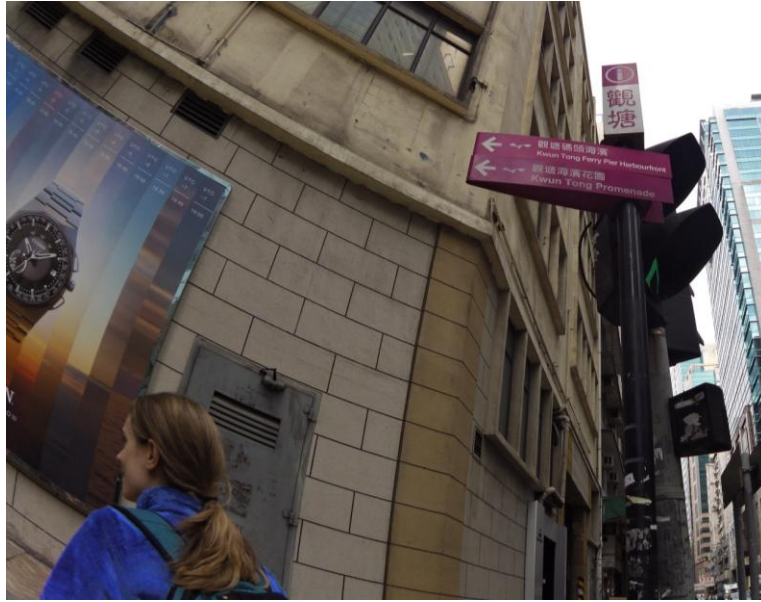
Figure 4.4: Signage for the Kwun Tong Promenade

The highest rating achieved for connectivity was Route 1, since all crosswalks along the route were zebra crossings. The routes awarded a gold rating had all but one zebra crossing across Hoi Bun Road. The remaining routes that achieved a silver rating had few zebra crossings, rather crossings marked with directional arrows or were completely unmarked (Figure 4.5).

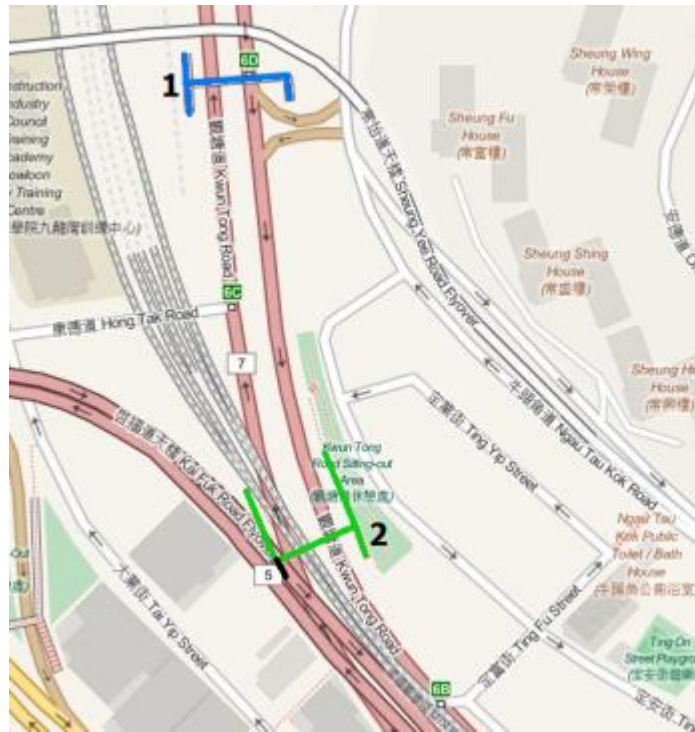
Figure 4.7: Routes 1 & 2 to Cross Kwun Tong Road

Routes 1 & 2 were north of the Ngau Tau Kok MTR Station (see Figure 4.7). Routes 3-5 were either at Ngau Tau Kok MTR Station or south of the station (see Figure 4.8). Routes 6-9 were around Kwun Tong MTR Station, while Routes 10 & 11 were south of that station (see Figure 4.9).

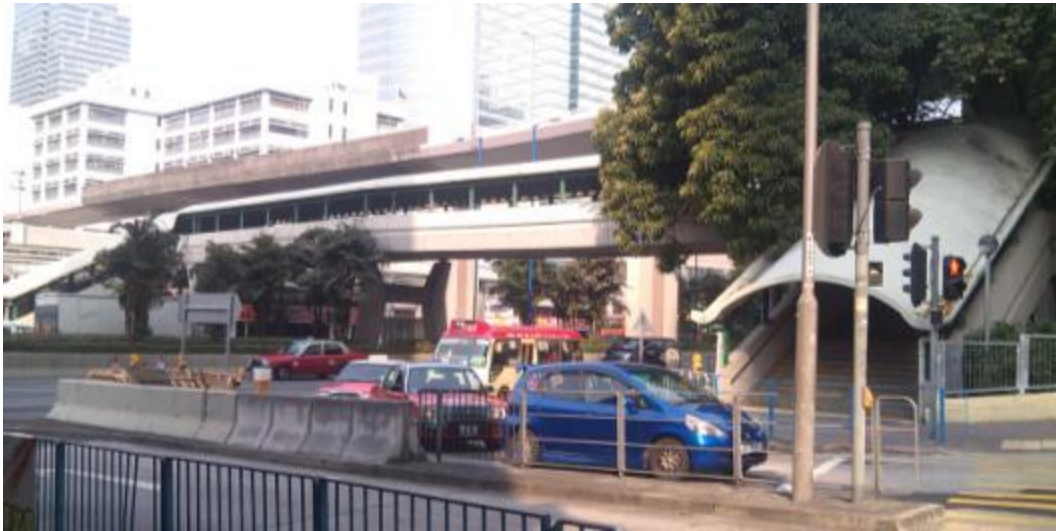
Figure 4.11: Route 1, A Challenging Pedestrian Overpass

The worst route that we found was Route 1 (see Figure 4.11). There was no handicapped access, few tactile surfaces and no signage. The sidewalks around the entrances were narrow at some points, and there were many obstacles such as vehicular red lights and fire hydrants. Also, to enter the footbridge, pedestrians must walk along side a road with high vehicular traffic levels and few barriers between the pedestrians on the sidewalk and the vehicles on Kwun Tong Road.

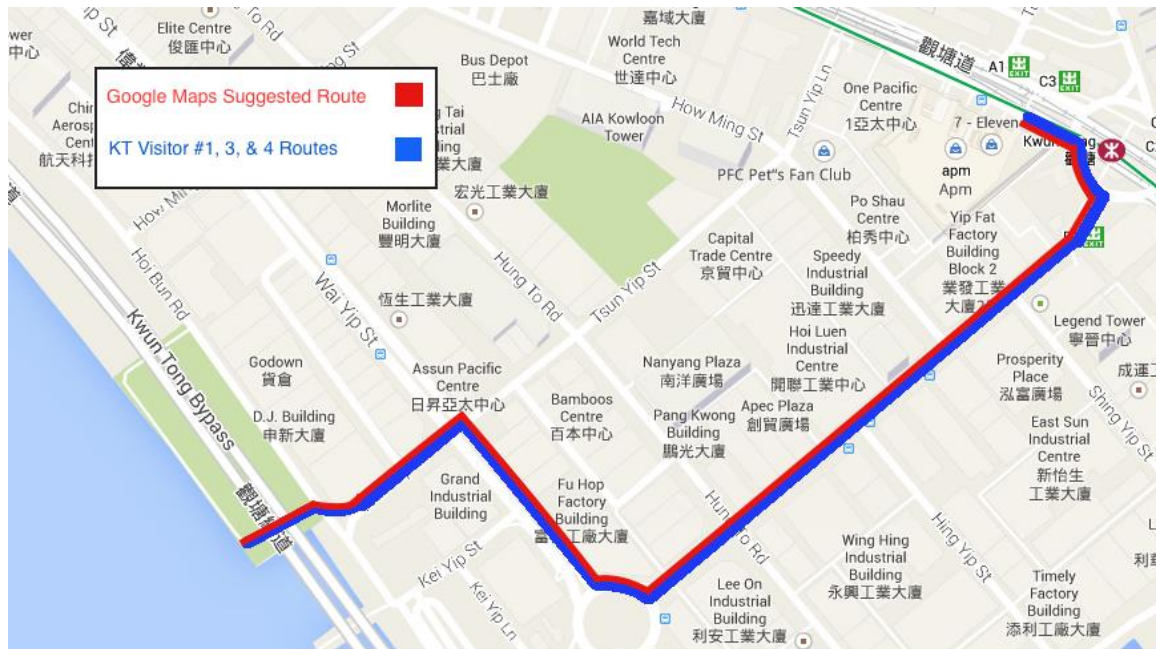
Figure 4.17: KT Visitor #1, #3, and #4 vs. Google Maps, originating from Kwun Tong MTR Station

After compiling the video footage recorded by six visitors traveling from the Kwun Tong MTR station to the Kwun Tong Promenade, we determined that it is not as difficult as we had assumed it would be to navigate to the waterfront. According to the data, on average, it took each visitor approximately 16 minutes and to reach the promenade. Upon further analysis, and comparison with Google maps, we determined that the average detour from the most direct route was approximately 3 minutes. At first glance this detour does not seem to be meaningful in terms of time spent. However, if you look at this information in terms of the total time it takes to reach the waterfront, this average detour accounts for approximately 25% of the entire trip to the waterfront. Figure 4.16 below overlays the route of KT visitors #s 1, 3, and 4 against one of the most direct routes according to Google Maps. This figure shows that although the visitors traveled the same route as suggested by Google, the duration of their trip was longer than the approximated time from Google Maps. This is most likely due to the fact that someone unfamiliar to an area would travel slower and spend time searching for signs. According to further analysis provided in Appendix H, these three visitors took the fastest route compared to the other visitor routes.

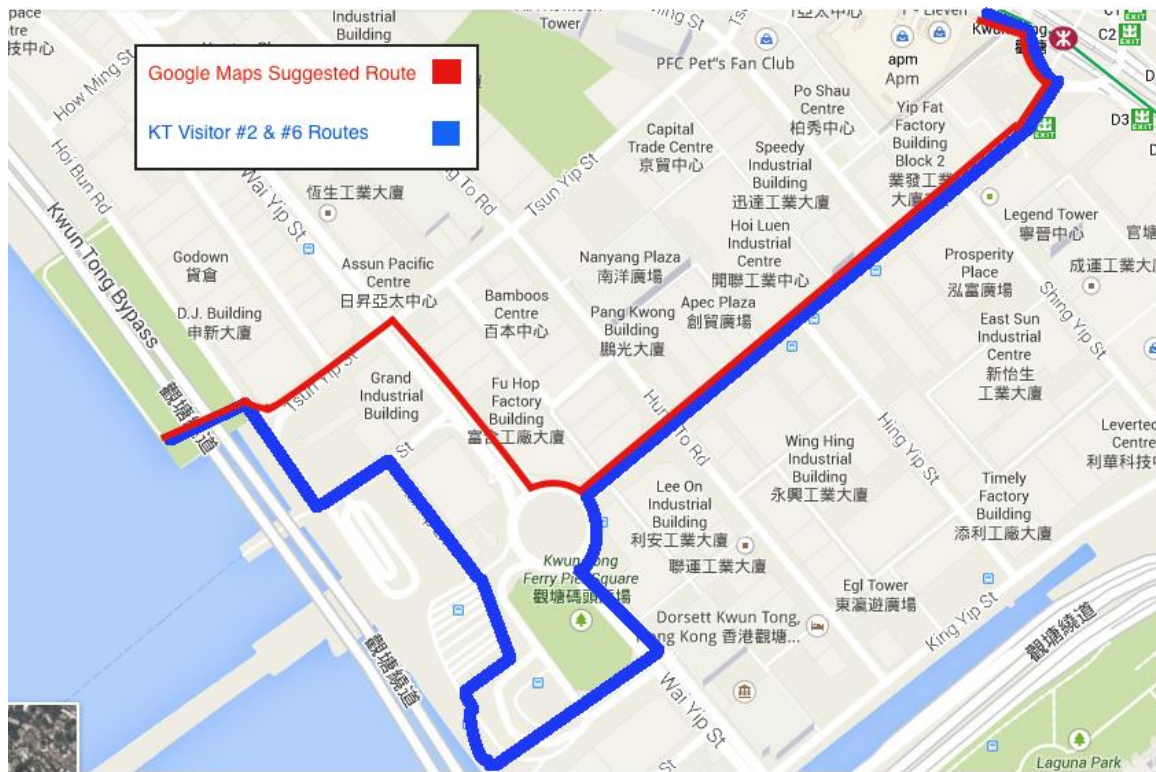
Figure 4.18: KT Visitor #2 and #6 vs. Google Maps, originating from Kwun Tong MTR Station

To build off of this, in terms of distance traveled, according to Google Maps the most direct route from the Kwun Tong MTR station to the Kwun Tong Promenade via Tsun Yip Street or Hoi Bun Road, is approximately 1 km or 0.62 miles. Upon evaluation of the visitor video footage and related data, we determined that the average distance traveled by each of the six visitors was 1.54 km or 0.97 miles. Looking at it from this perspective, we feel that this more accurately represents the size of the detour taken by the visitors because it leaves out factors, such as walking speed or time spent waiting at a cross walk. Therefore, it seems that on average, there was a substantial detour taken by visitors while walking a route to the waterfront, amounting to about 1/2 km or about three tenths of a mile. Examining the average distance of the detours more closely, it was determined that the detour of 1/2km is close to 50% of the total trip from the MTR station to the waterfront, a significant distance to add to the trip. In Figure 4.18 below, the route with the longest detour, taken by both KT visitor #2 and #6, is overlaid against one of the most direct routes according to Google maps.

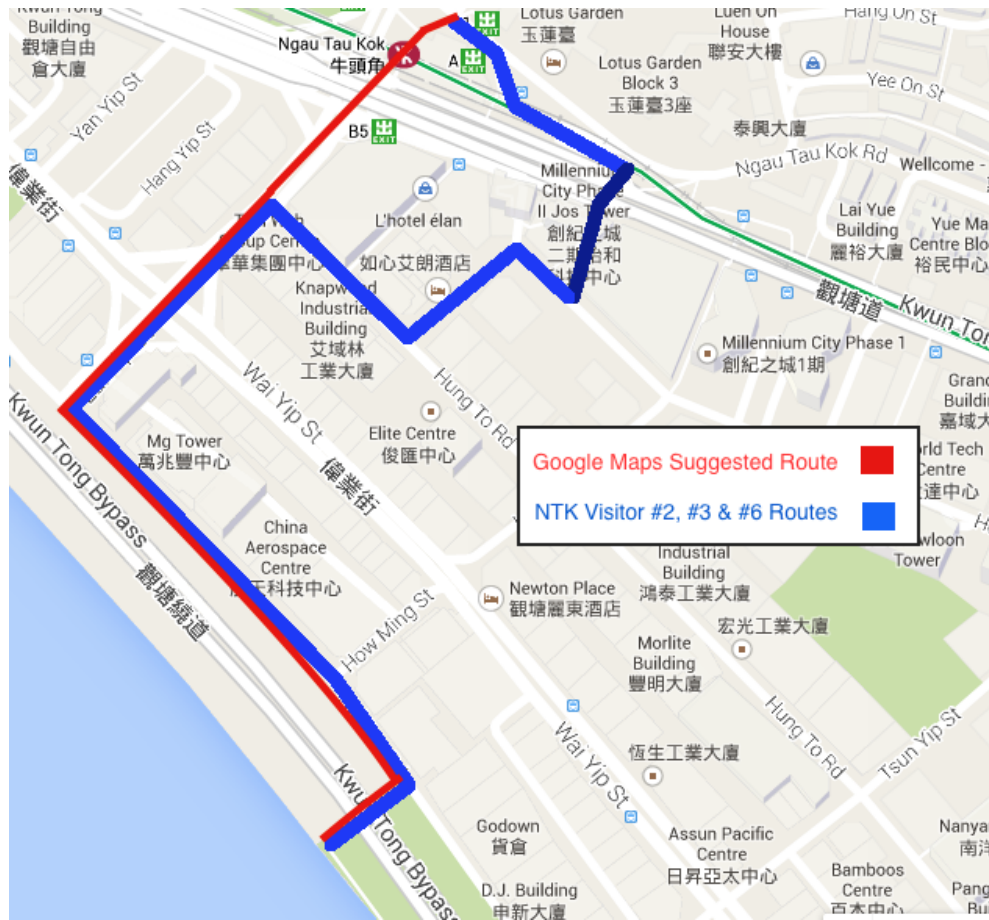
Figure 4.19: NTK Visitor #2, #3, & #6 vs. Google Maps, originating from Kwun Tong MTR Station

A similar experiment was conducted from the Ngau Tau Kok MTR Station to the Kwun Tong Promenade. Data and video footage were collected from six individuals who were first-time visitors to the area. After analyzing the video footage, our team determined that on average, the visitors walked about 1.7 km or 1.1 miles to reach the waterfront. Comparing this data with the most direct route according to Google Maps, the trip to the waterfront is approximately 1km or 0.62 miles. Therefore, the distance of the detour walked by the six visitors averaged about 0.7 km or 0.48 miles more than the shortest route. Displayed below in Figure 4.19, the route with longest detour in terms of distance is compared to that of the suggested route that Google maps offered. The route in question was taken from the journeys of NTK Visitors #2, #3, and #6.

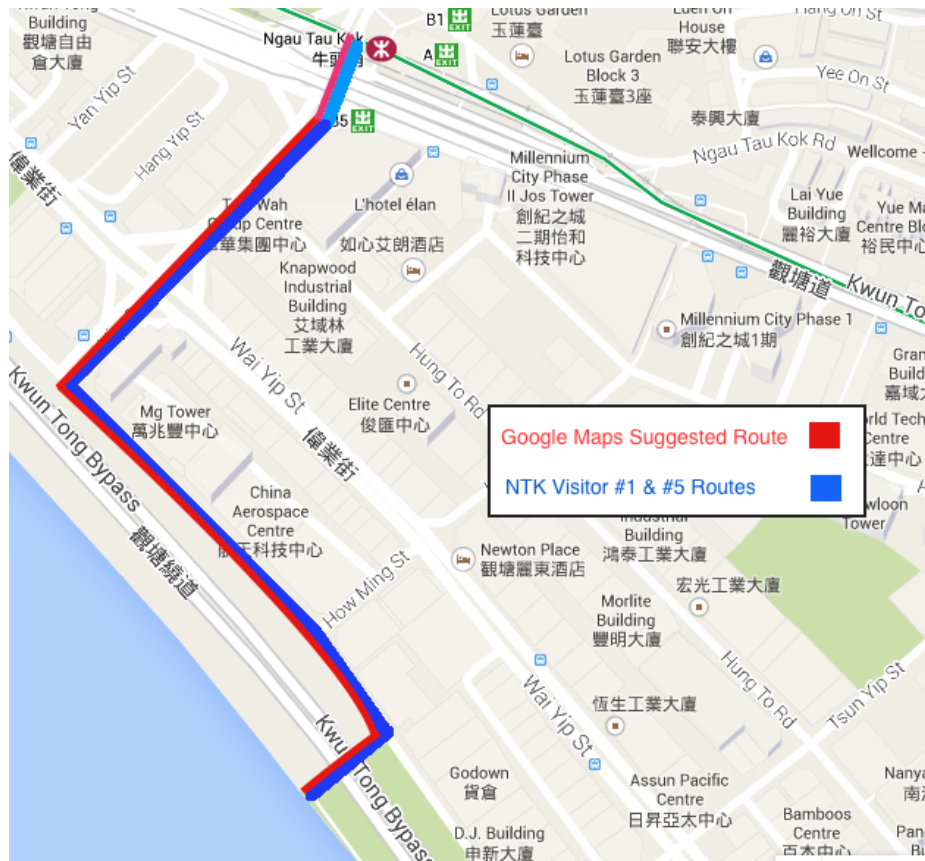
Figure 4.20: NKT Visitor #1 and #5 vs. Google Maps, originating from Ngau Tau Kok MTR Station

As far as time goes, according to Google Maps, the journey from Ngau Tau Kok station to the promenade should be approximately 11 minutes. After analyzing the video footage from the different visitors, our team determined that the average time spent by the visitors to reach the waterfront was approximately 17 minutes. Therefore, we determined the average time detour to be close to 6 minutes longer than the ideal time of the most direct route. This average detour of 6 minutes is substantial because it consists of about 55% of the total time that it should take for an individual to reach the waterfront. In Figure 4.20, the routes of NKT visitors #1 and #5 are overlaid against the suggested route according to Google maps. As you can see, these visitors took the suggested route to the waterfront and thus the most direct route.

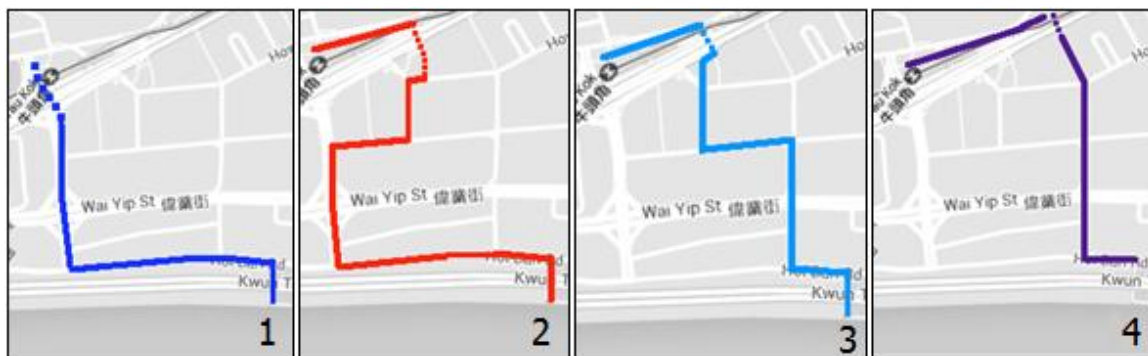
Figure F. 1 Routes 1, 2, 3 and 4, originating from Ngau Tau Kok MTR Station

The following nine routes were identified as possible pedestrian paths to reach the East Kowloon harbor front from the Ngau Tau Kok and Kwun Tong MTR Stations (Figures F.1 and F.2)

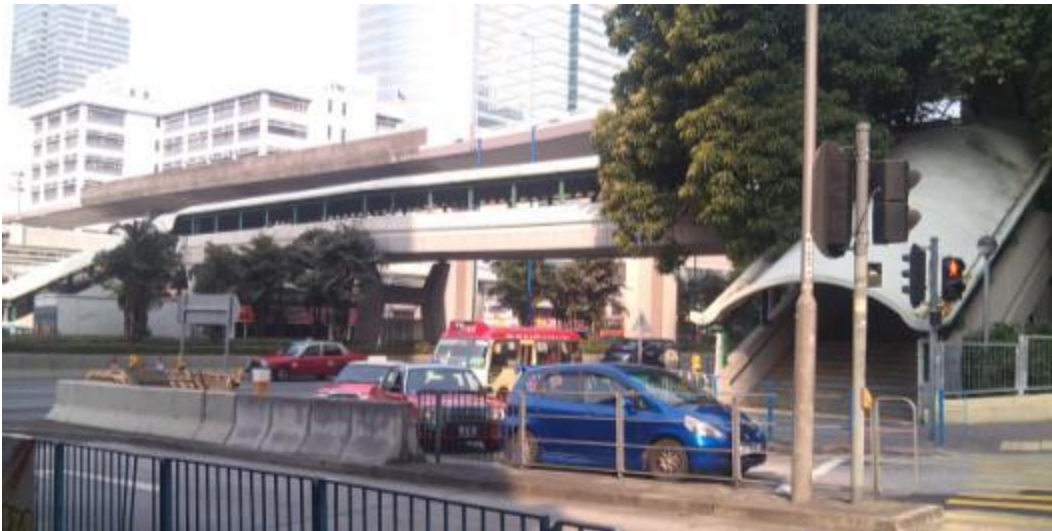
Figure G. 1: Route 1, a pedestrian overpass

The first route (see Figure G.1) only had stairs, so it was not handicapped accessible. There were only tactile surfaces where the steps began and ended, none across the bridge nor on the ground around the bridge. The sidewalks around the entrances were narrow at some points and there were many obstacles such as vehicular red lights and fire hydrants. Also to enter the bridge, pedestrians must walk along aside a road with high vehicular traffic levels, with little barriers between the pedestrians on the sidewalk and the vehicles on Kwun Tong road. There is no signage on either side of the bridge for the waterfront.

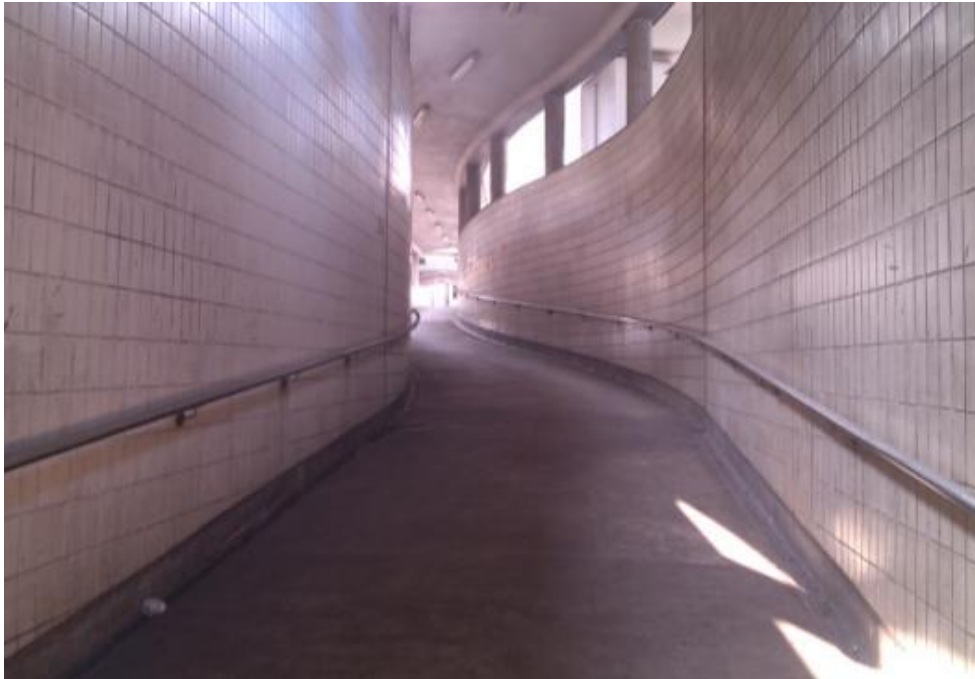
Figure G. 2: Route 2, ramp for handicapped access

subway as it cross under Kwun Tong Road, and there were none leading up to the subway entrances, along Kwun Tong Road. There was no signage on either side of the subway for the waterfront. The sidewalks around the entrances to the subway were not that wide, but there were few obstacles such as trashcans and light posts that narrowed the sidewalk.

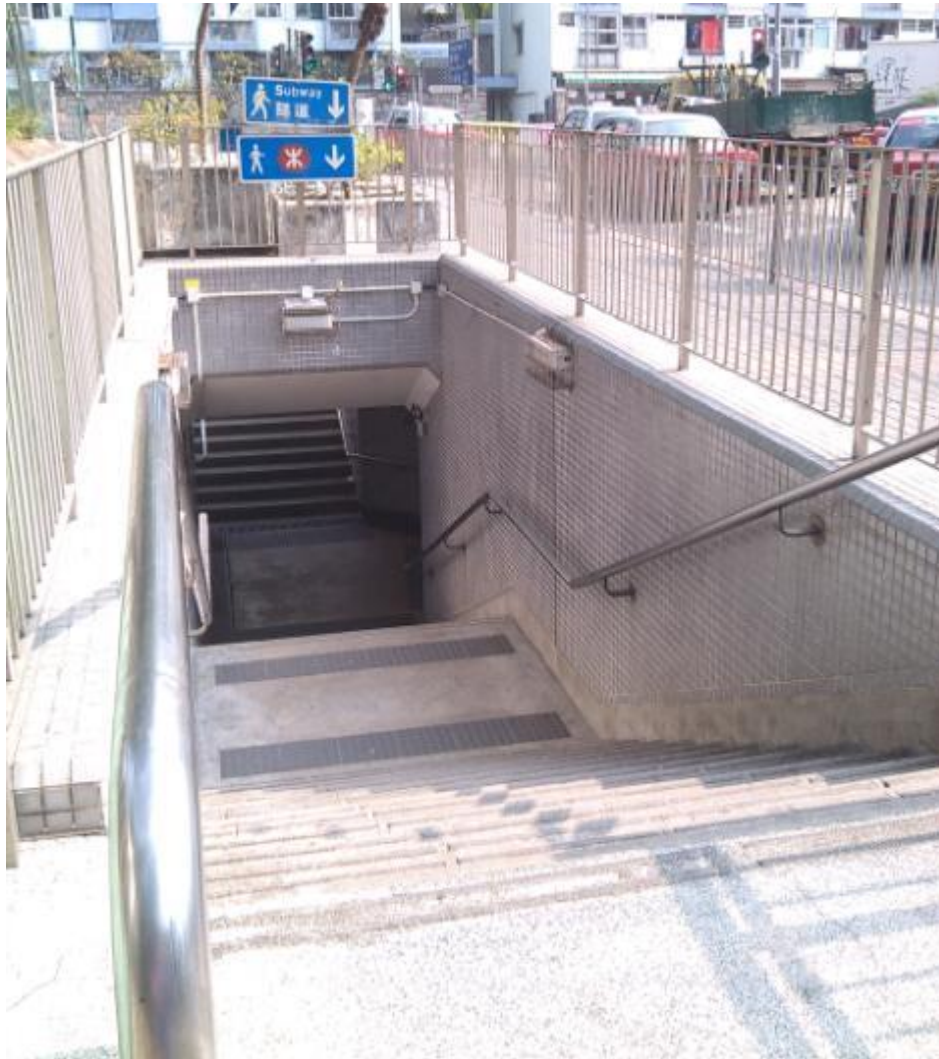
Figure G. 4: Route 3, steps leading to the subway

The third route was for the Ngau Tau Kok MTR station. The subway can only be accessed by stairs, so there was no access for those with wheelchairs or strollers (see Figure G.4). Like Route 2, there were only tactile surfaces where the steps began and ended. There was no signage on either side of the subway for the waterfront. The sidewalks around the entrances were wide and there were no obstacles around the entrances.

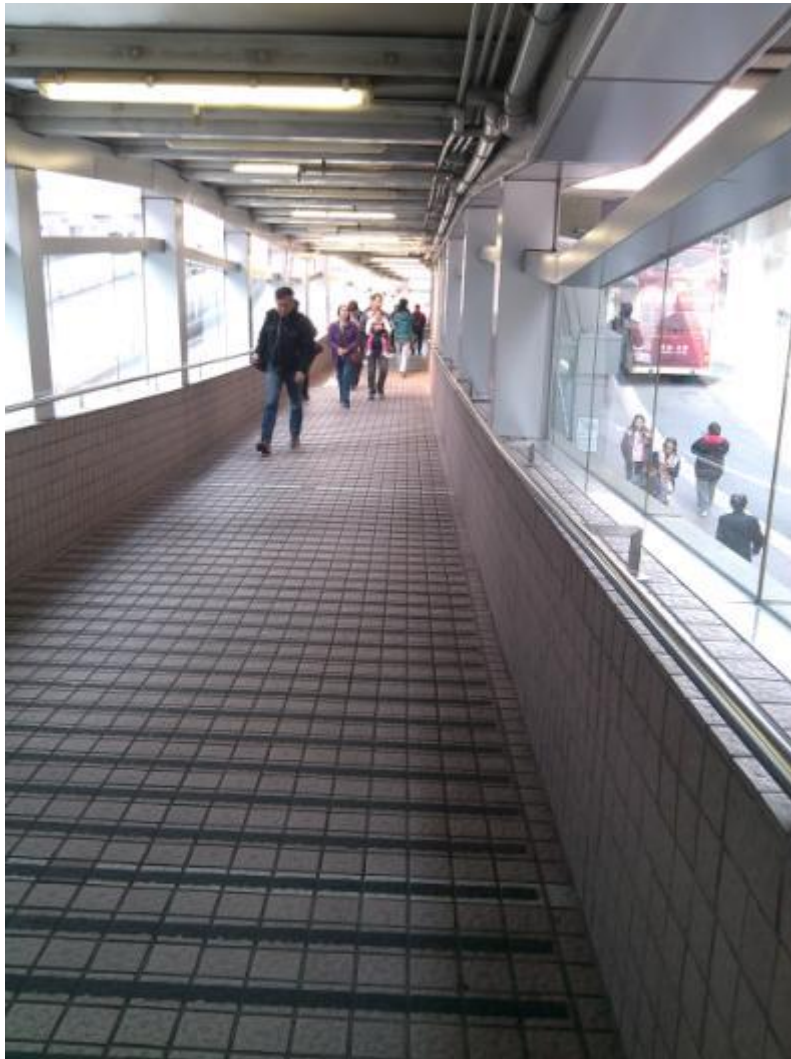
Figure G. 5: Route 4, ramp for handicapped access

The fourth route was a pedestrian footbridge that went into Millennium Shopping Mall. It was handicapped accessible via a ramp (see Figure G.5). However the ramp was rather steep, having an angle of 18.9° , and there were warning signs on the ramp, warning it was slippery when wet. There were no tactile surfaces around the entrances or on the stairs, ramp or bridge. There was no signage around the entrances or on the bridge for the waterfront. To get to ground level with a wheelchair or stroller, one has to take the elevators down. Once on ground level, a mall employee must come to remove bollards before one can exit the building.

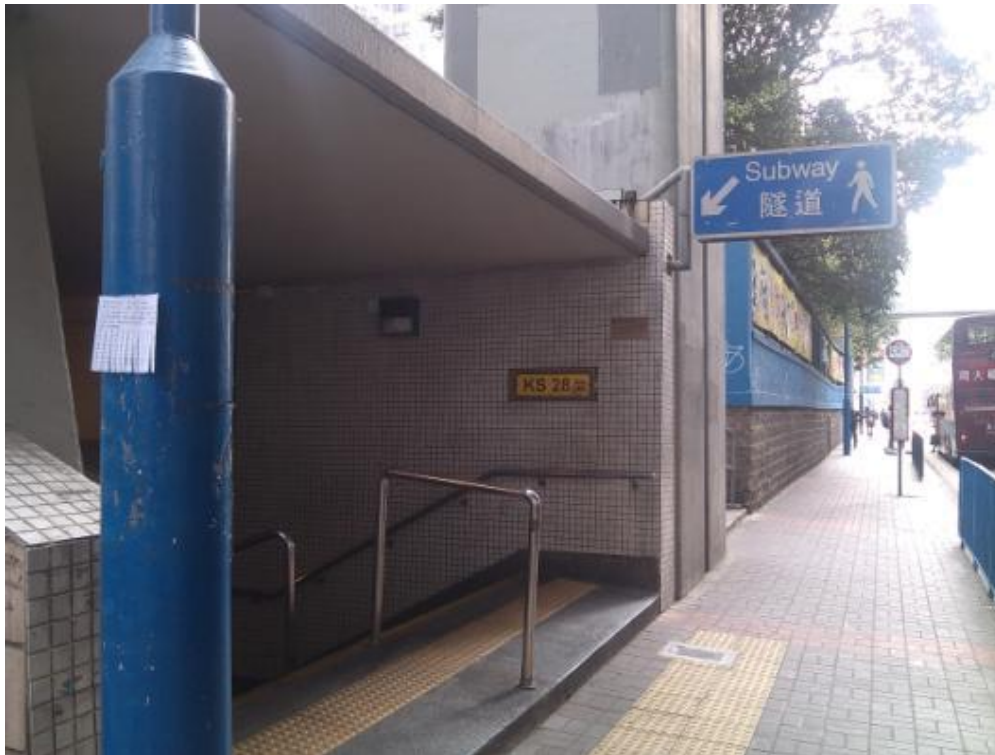
The fifth route was a subway which, like Route 3, there were only tactile surfaces where the stairs began and ended. There was no ramp or lift, so there was no access for those with wheelchairs or strollers. There was no signage on either side of the subway for the waterfront. The sidewalks around the entrances on the residential side of Kwun Tong Road, were fairly wide (see Figure G.6). However around the entrance on the left (see Figure G.7) there are several bus stops. These bus stops cause frequent, sudden, increases in pedestrian traffic on the sidewalk, when passengers are let off. It can be very difficult to get around the passengers that just got off a bus and into the subway.

Figure G. 6: Route 5, north entrance on residential side of Kwun Tong Road

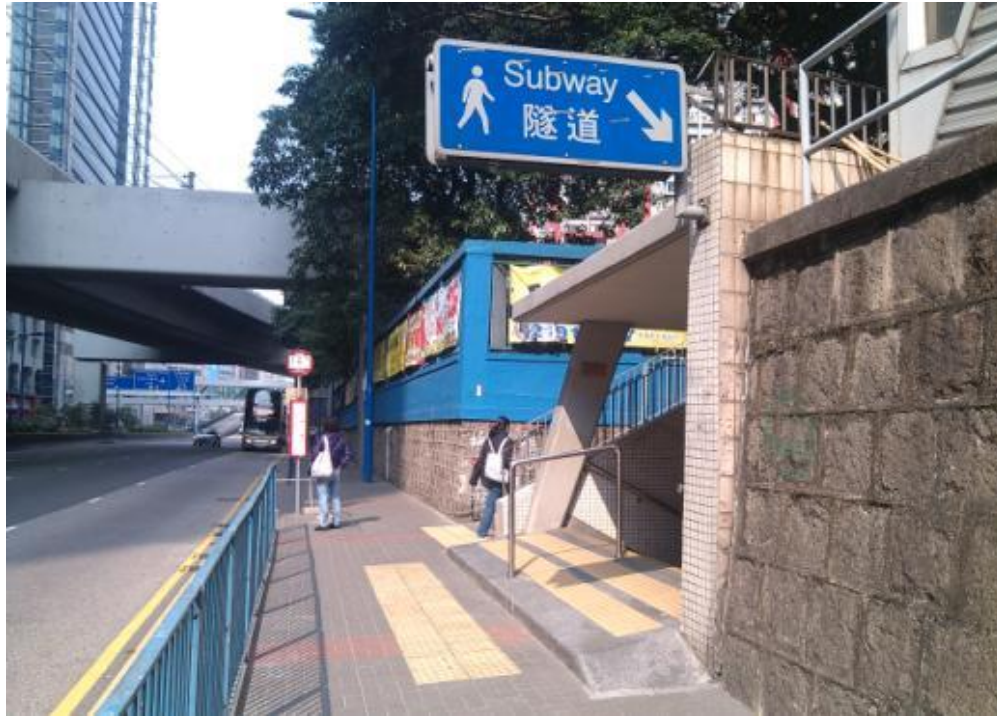
Figure G. 7: Route 5, south entrance on residential side of Kwun Tong Road

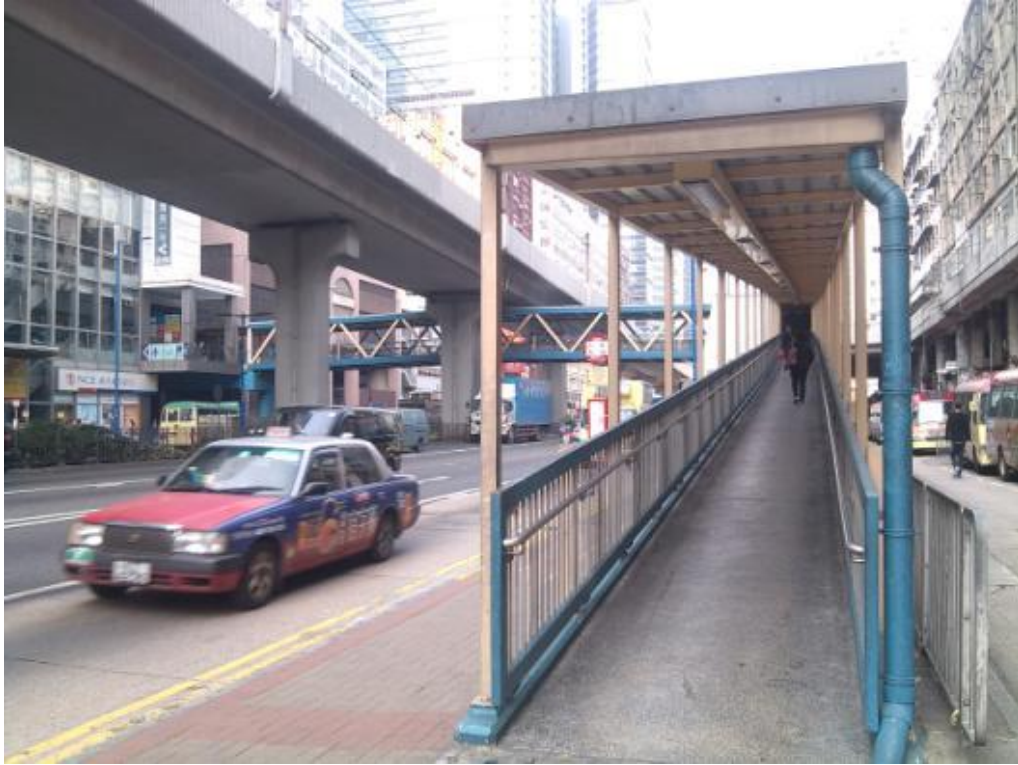
The sixth route was a pedestrian footbridge that was handicapped accessible via a ramp (see Figure G.8). However the ramp was rather steep, having an angle of 18.2° . There was no signage around the entrances or on the bridge for the waterfront. Like Route 1, there were only tactile surfaces where the steps and ramp began and ended. The sidewalk on the residential side was narrow and crowded due to the bus stops along it.

Figure G. 8: Route 6, ramp for handicapped access

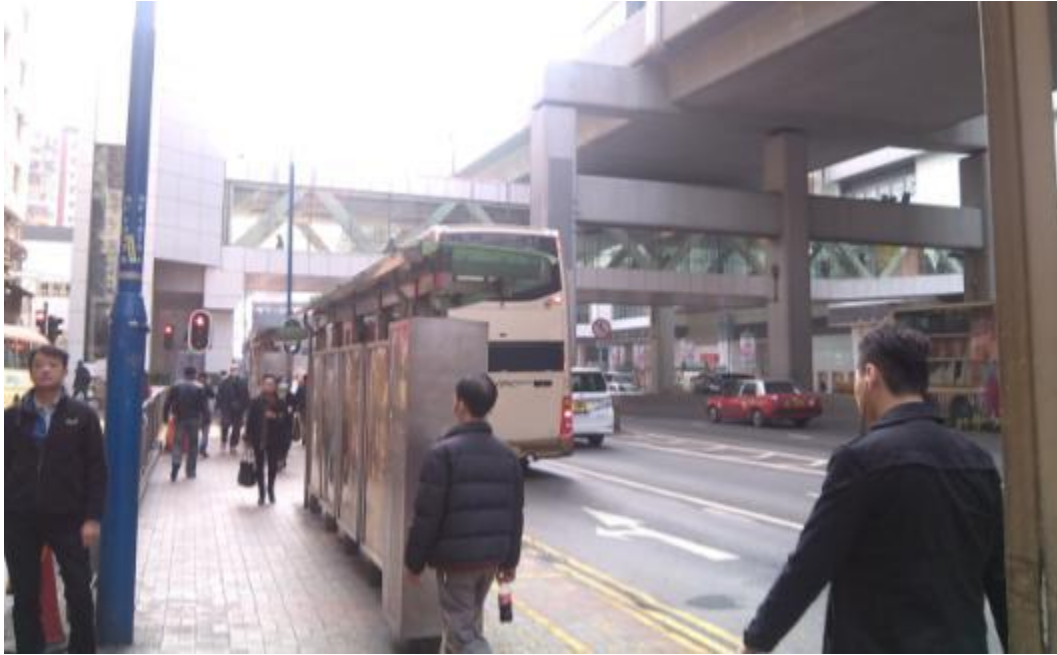
The seventh route was a pedestrian footbridge that exited into the APM mall(see Figure F-9). There was a lift for those with strollers or wheelchairs on the residential side of Kwun Tong Road. However, to get to ground level on the waterfront side of Kwun Tong Road, a mall employee must assist in operation of the lifts and to remove bollards, if you have a wheelchair or stroller. There were only tactile surfaces where the steps began and ended, like Route 1. There was a sign for the Kwun Tong Promenade; however it was outside the steps only, so if you took the lift you would not see the sign (see Figure G.10).

Figure G. 9: Route 7, pedestrian overpass to APM mall

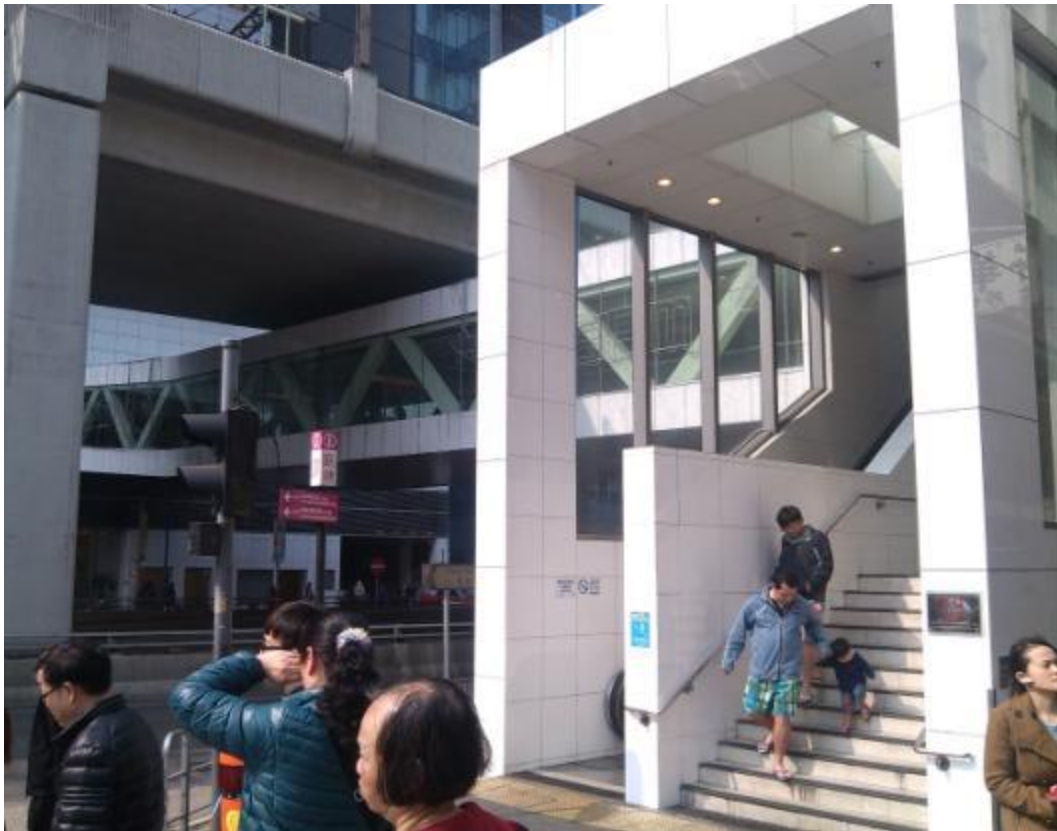
Figure G. 10: Route 7, signage outside the steps for the waterfront

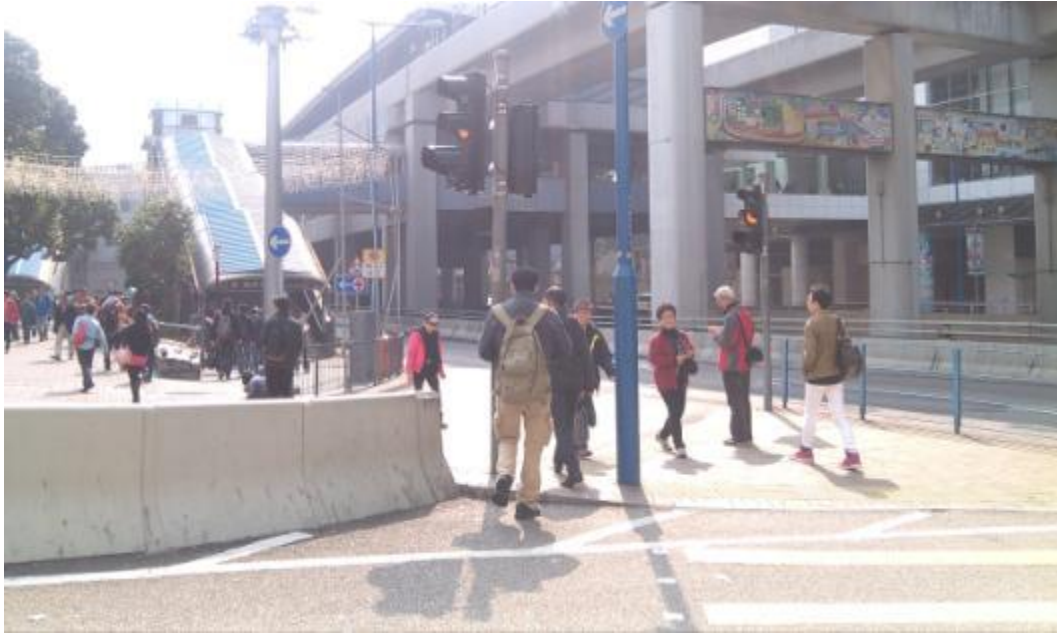
The eighth, ninth and tenth routes are all pedestrian overpasses for the Kwun Tong MTR Station. Route 8 exited into APM mall, Route 9 exited onto Hoi Yuan Road and Route 10 exited along the waterfront side of Kwun Tong Road. Route 8 has a lift on the residential side of Kwun Tong Road for handicapped access (see Figure G.13). However, the handicapped access is only for the users MTR station and those going to APM mall. The only handicapped access down to the ground level on the waterfront side of Kwun Tong Road is through APM mall. Route 9 (see Figure G.14) and Route 10 (see Figure G.15) are not handicapped accessible on either side of Kwun Tong Road. There was signage for the Kwun Tong Promenade only outside the stairs of the Route 8 (see Figure G.11, G.12), on the residential side of Kwun Tong road. Otherwise there was no signage for the waterfront. For Routes 8 & 9, there were only tactile surfaces where the steps began and ended. There were no tactile surfaces on Route 10. On the residential side of Kwun Tong road, the south side exit for Route 10 has tactile surfaces on the sidewalk (see Figure G.16). Otherwise there are no tactile surfaces on the bridges or on the sidewalks surrounding the entrances on the residential side of Kwun Tong Road. Between these three bridges, there are also obstacles all along the sidewalks on the residential side of Kwun Tong Road, such as stalls, store fronts, trashcans and light posts. At some points the sidewalk became very narrow and uneven.

Figure G. 11: Route 8, a pedestrian footbridge that goes to Kwun Tong MTR Station

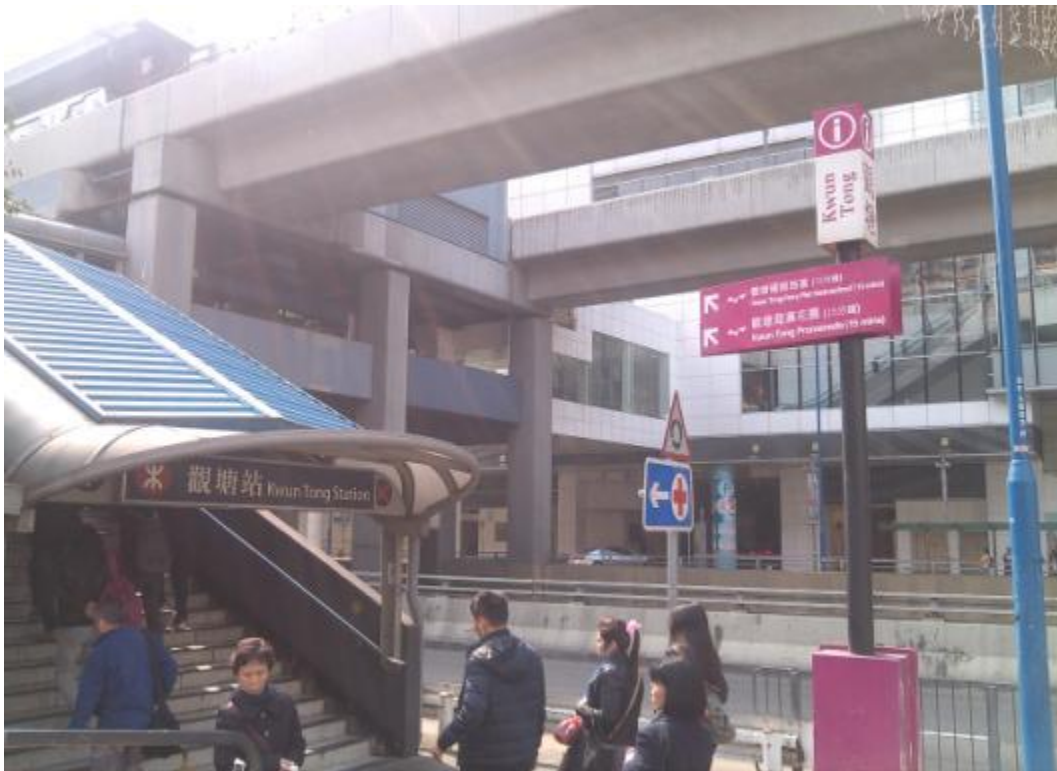
Figure G. 12: Route 8, signage outside the steps for the waterfront

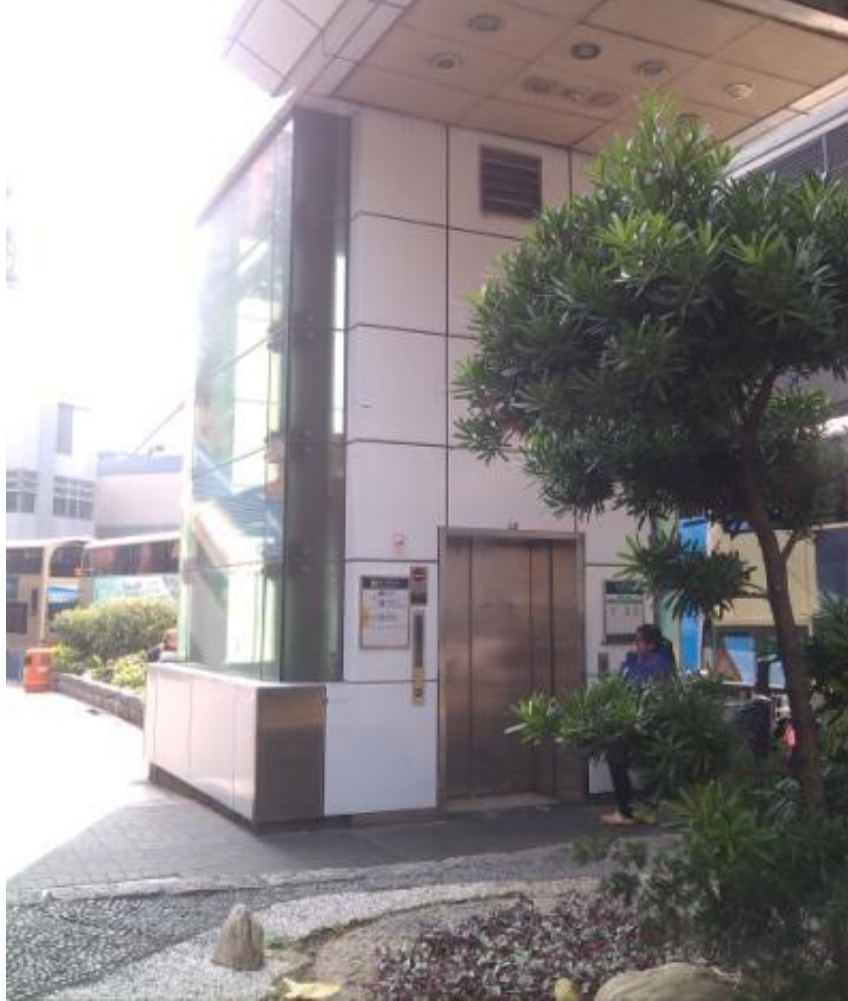
Figure G. 13: Route 8, lift for handicapped access, hidden under the stairs

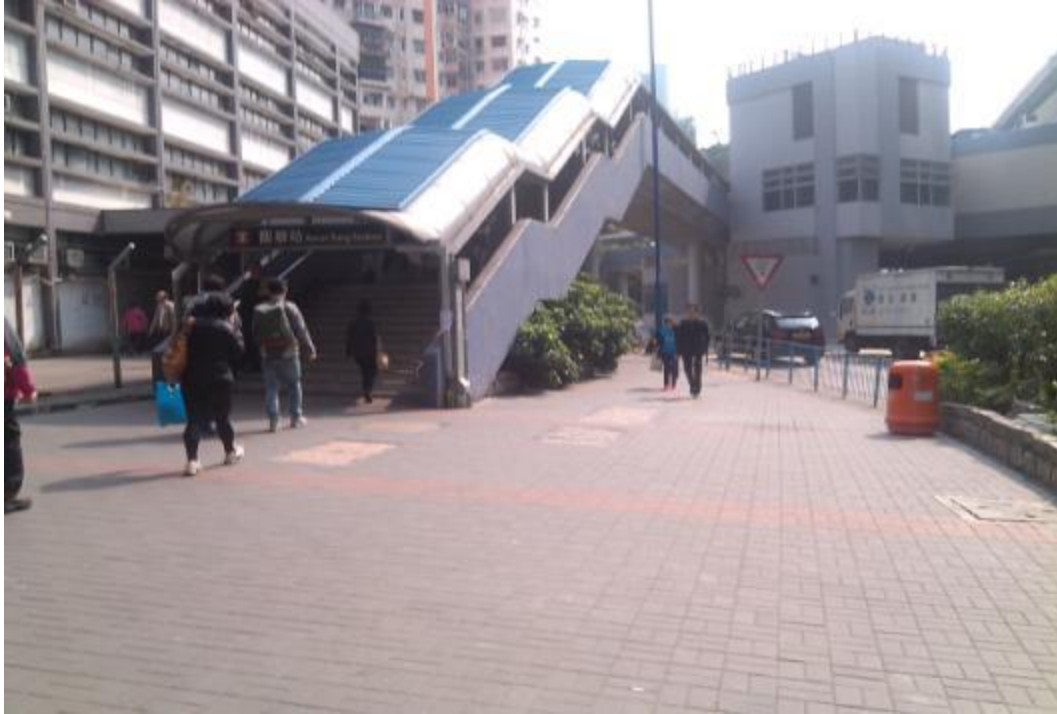
Figure G. 14: Route 9, a pedestrian footbridge that goes to Kwun Tong MTR Station

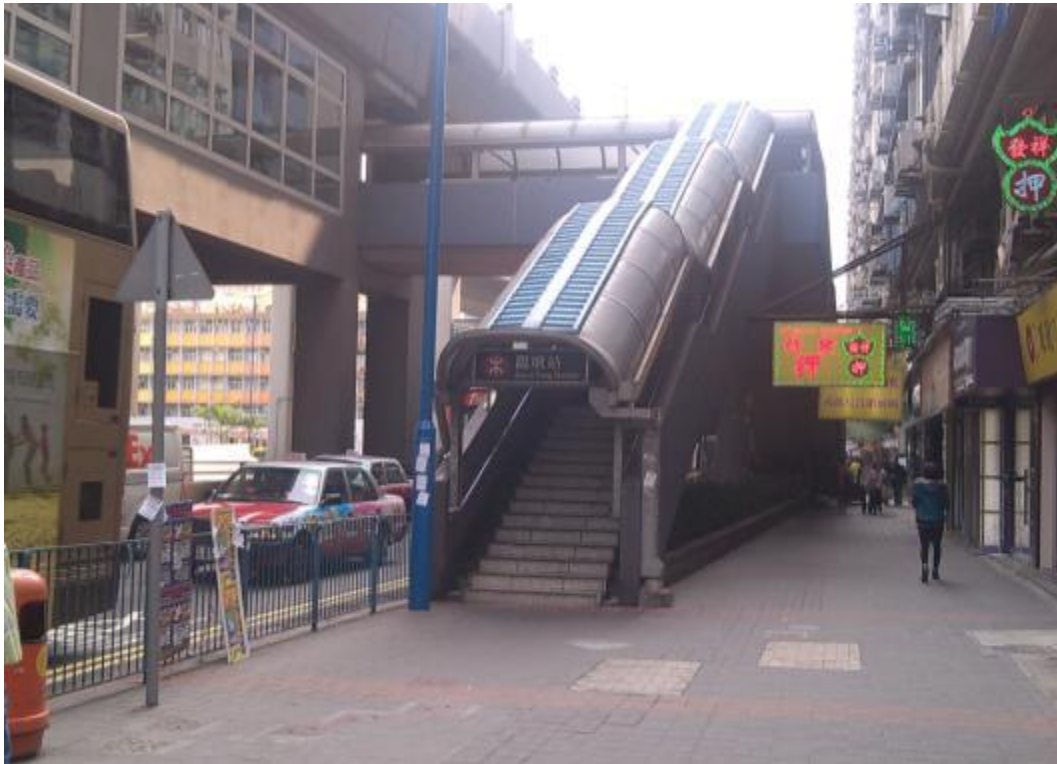
Figure G. 15: Route 10, a pedestrian footbridge that goes to the Kwun Tong MTR Station

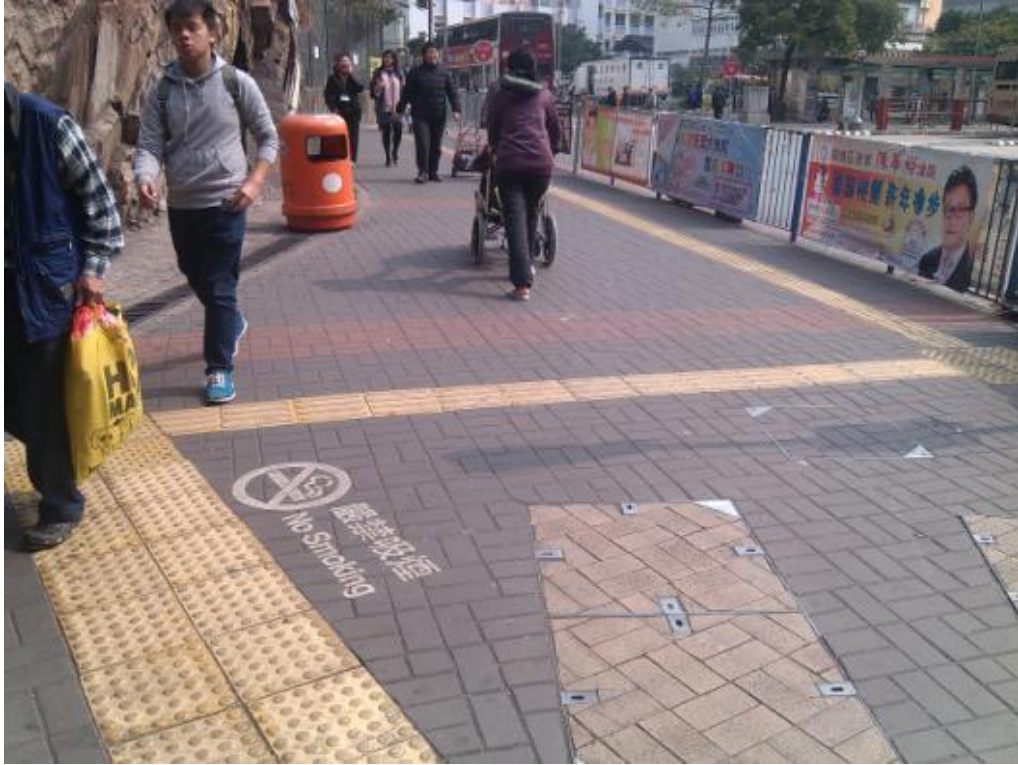
Figure G. 16: Route 10, only tactile surfaces found on sidewalks along Kwun Tong Road
