Promoting Universal Accessibility of the East Kowloon Harbor Front

An Interactive Qualifying Project Report submitted to the faculty of
Worcester Polytechnic Institute in partial fulfillment of the requirements for
the Degree of Bachelor of Science

Date: March 6, 2015

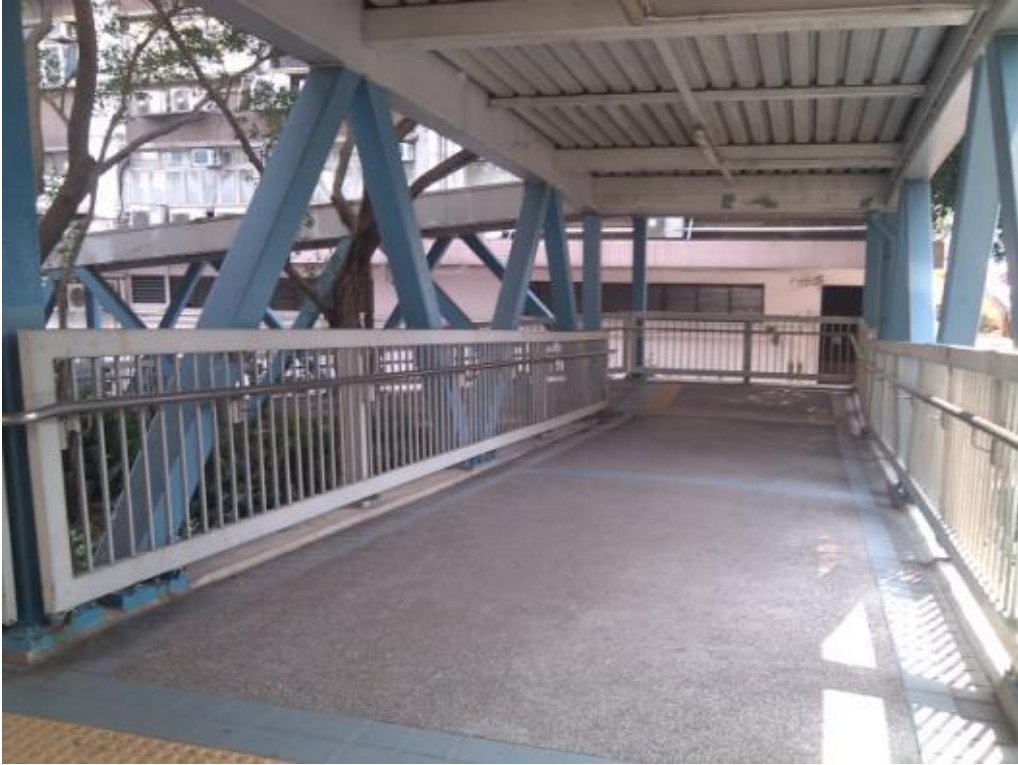
The eleventh route was a pedestrian overpass with a ramp for wheelchair and stroller access (see Figure G.17). The ramp wasn't as steep as the others, with an angle of 12°. There was no signage for the waterfront, and there were only tactile surfaces where the stairs and ramp began and ended. The sidewalks around the entrances to the footbridge were not obstructed and fairly wide.

Figure G. 17: Route 11, ramp for handicapped access

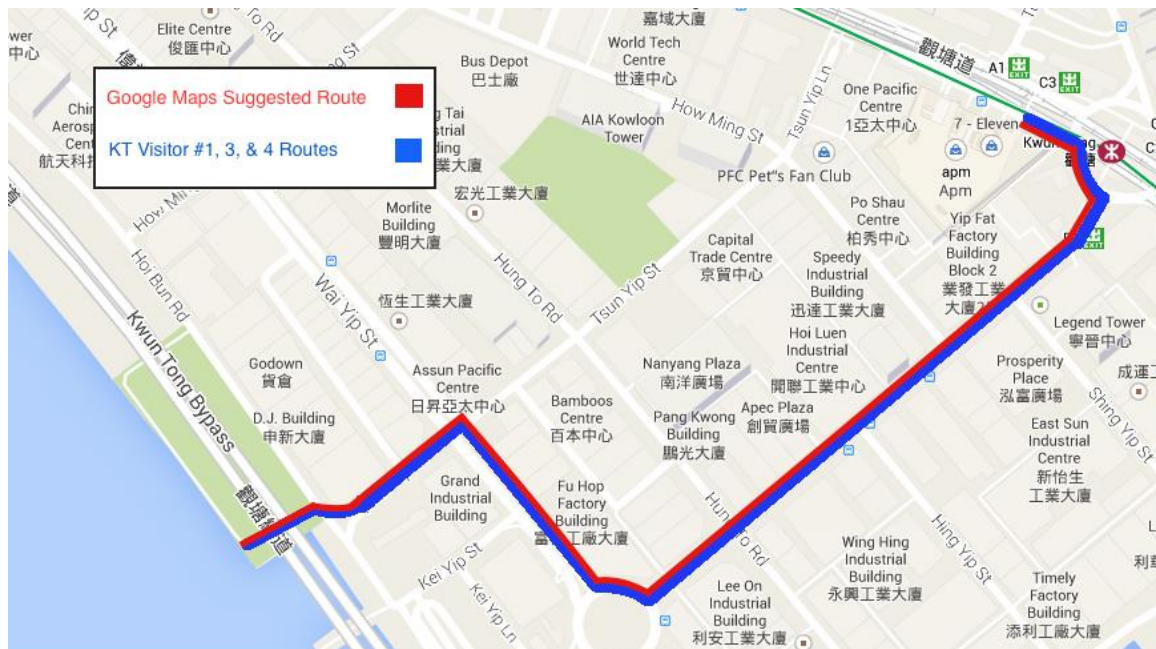
Figure H. 1: KT Visitor #1, #3, & #4 vs. Google Maps, originating from Kwun Tong MTR Station

The routes of six visitors were recorded from Kwun Tong MTR station to the waterfront promenade in Kwun Tong. Visitors 1,3, and 4 all took very similar routes to the waterfront. These three visitors exited the MTR station at Exit A2 and headed southeast towards Hoi Yuen Road. From there, the visitors took a right on Hoi Yuen Road and traveled southwest for approximately 550 meters. The visitors then took another right at the roundabout and began traveling northwest on Wai Yip Street for approximately 250 meters. They then took a left at Tsun Yip Street and traveled southwest the remaining distance to the promenade. This route was one of three routes recommended by Google maps. These three visitors averaged a distance traveled of about 0.83 miles or 1.33 km. As you can see in Table G-2, the expected distance for the most direct route to the waterfront is approximately 0.62 miles or 1 km. From this, our team determined that the visitors that traveled this route took a detour of about 0.21 miles or 0.33 km. This distance accounts for about 34% of the total trip distance. In terms of time spent, these visitors averaged a travel time of approximately 13 minutes and 40 seconds. Again, according to the most direct route provided by Google maps, the journey should take around 13 minutes. In this sense, the detour was less than a minute, 40 seconds to be exact. A forty-second detour only accounts for about 5% of the total trip time. The visitors who took this route had the best results in reaching

the waterfront compared to the others who traveled from Kwun Tong MTR station to the waterfront. Figure H.1 displays the route that KT visitors 1, 3, and 4 used to travel to the waterfront and Table H.1 displays the detour information for all of the routes from Kwun Tong MTR Station.

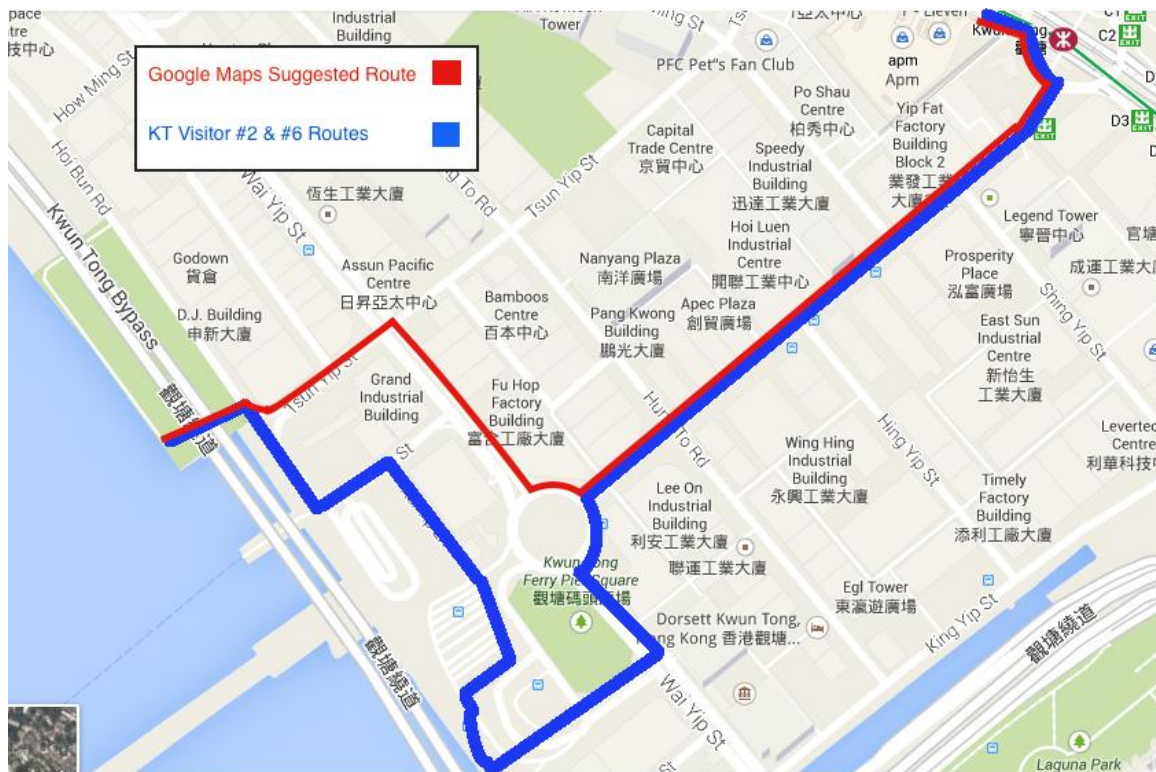
Figure H. 2: KT Visitor #2 & #6 vs. Google Maps, originating from Kwun Tong MTR Station

Kwun Tong visitors #2 and #6 also took a similar route to the waterfront. Visitor #2 exited from Exit A2 of the MTR station and proceeded as the previous visitors did to Hoi Yuen Road. Visitor #6 took Exit B1 which feeds directly onto Hoi Yuen Road. From there both visitors traveled southwest for approximately 550 meters. However, once they reached the roundabout, the visitors took a left on Wai Yip Street and began traveling southeast until they reached a pedestrian footpath that provides passage over Wai Yip Street. Once over the street, the visitors took a right and began walking along the waterfront near the ferry pier in the direction of northwest. After navigating around the ferry pier the visitors reached the Kwun Tong Promenade. These two visitors averaged a route distance of about 1.1 miles or 1.75km. According to the most direct route on Google maps that was mentioned earlier, the visitors took a detour of approximately 0.48 miles or 0.75 km. This accounts for roughly 77% of the total trip distance.

The two visitors that traveled this route averaged close to 18.5 minutes in travel time. In terms of the time detour, these visitors took a detour of close to 5 minutes and 30 seconds. This time detour accounts for about 42% of the total trip time. The visitors that took this route to the waterfront took the least efficient route of the routes recorded. Figure H.2 displays the route that KT visitors 2 and 6 used to travel to the waterfront overlaid against the Google Maps suggested route and Table G-1 displays the detour information.

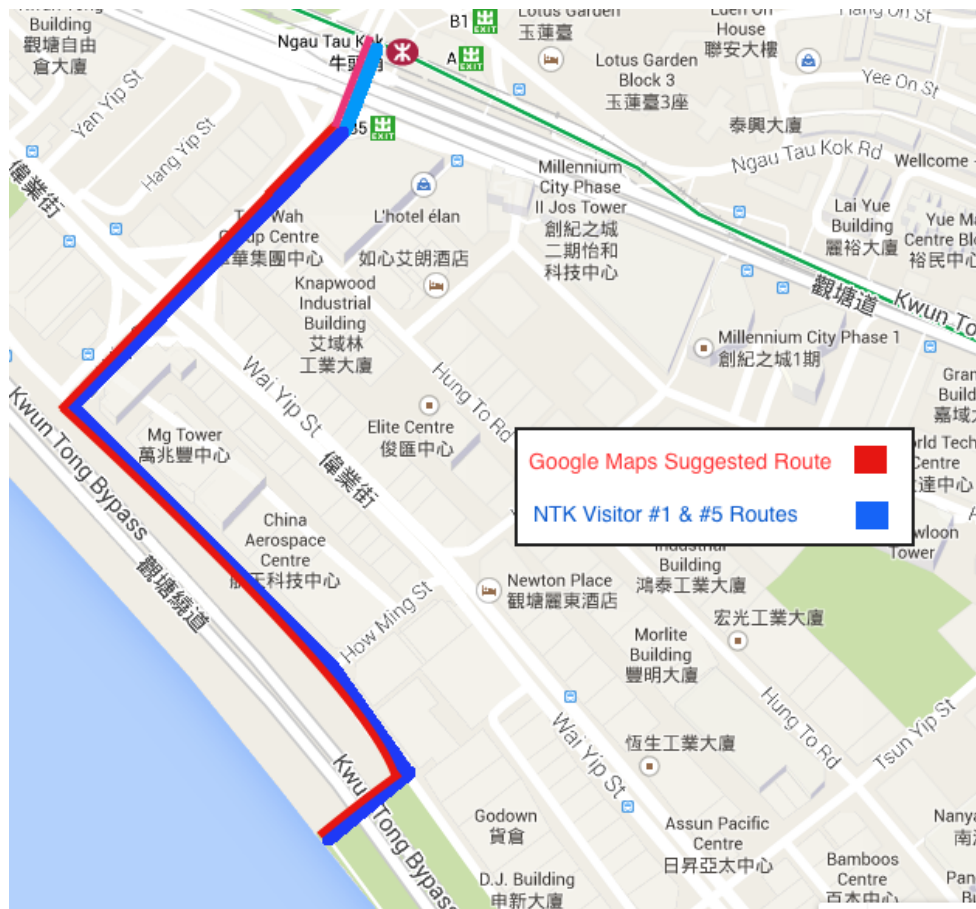
Figure H. 4: NTK Visitor #1 & #5 vs. Google Maps, originating from Ngau Tau Kok MTR Station

Similar to the previous section, the routes of six visitors from Ngau Tau Kok station were recorded as they attempted to reach the waterfront. NKT visitor #1 and #5 Traveled to the waterfront through the most direct route of all the visitors. Both visitors took exit B6 from the station and headed southwest towards on Lai Yip Street for approximately 350 meters. The visitors then took a left onto Hoi Bun Road and headed southeast for close to 450 meters until they reached the entrance to the Kwun Tong Promenade. This route was one of two recommended by Google maps. According to the aforementioned, this route was to take approximately 11 minutes and cover about 1 km in distance. These two visitors averaged a trip time of 12 minutes and 30 seconds and a distance of about 0.71 miles or 1.136 km. According to this information, the two visitors averaged a detour of roughly one tenth of a mile or 0.16 km. In terms of time, the detour by visitors #1 and #5 was close to 1 minute and 30 seconds. You can see in the table below that the distance of this detour only accounts for about 16% total trip, while in time, it only accounts for approximately 14% of the trip. Figure H.4 displays the route taken by these two visitors and compares it to the most direct route suggested by Google Maps and Table H.2 displays the route detour information.

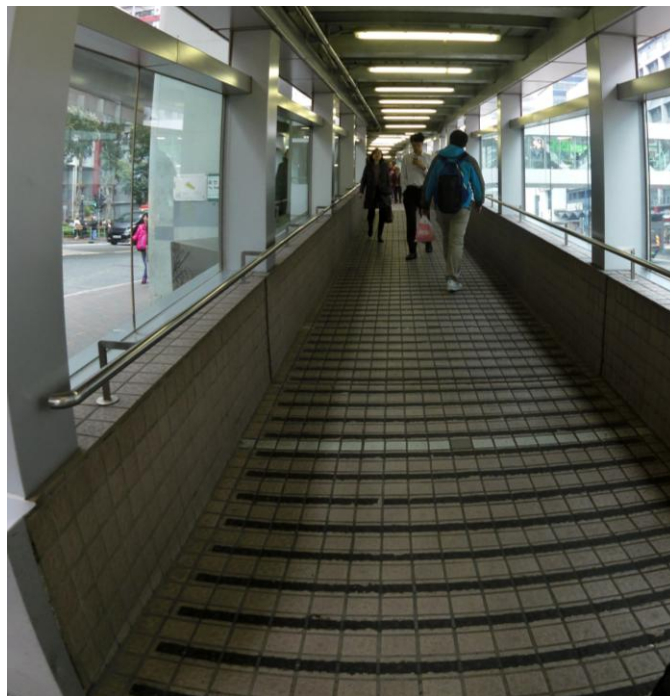
Figure I. 1: Pedestrian Footbridge Ramp

The remaining two routes from Ngau Tau Kok MTR Station could be navigated in a wheelchair, with assistance from someone pushing the wheelchair. The pedestrian overpass leading into the Millennium Phase II Tower had a slope of about 19° with two landings, making it possible to wheel a wheelchair up and down (Figure I.1, taken from first landing at ramp entrance). Additionally, there were textured strips to provide traction and slip resistance, however, they were in poor condition and degrading.

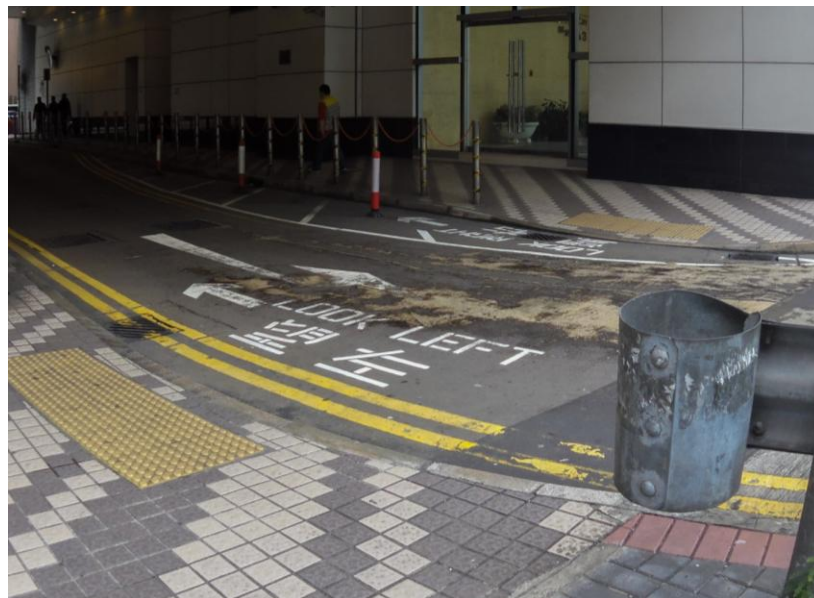
Figure I. 2: Crossing Between Millennium Towers II and III

Once inside Millennium Tower, the Fireman's lift was labeled as handicapped accessible, with all controls within reach from a wheelchair. The lift exited onto Kwun Tong Road and followed the sidewalk left, crossing between the Millennium Towers II and III. The sidewalk along Kwun Tong Road was wide and level, and it is possible for the person in the wheelchair to push him or herself. However, at the crossing between the two towers, assistance is required since the sidewalk is very sloped and there is a significant change in vertical height at the curb without a curb ramp (Figure I.2).

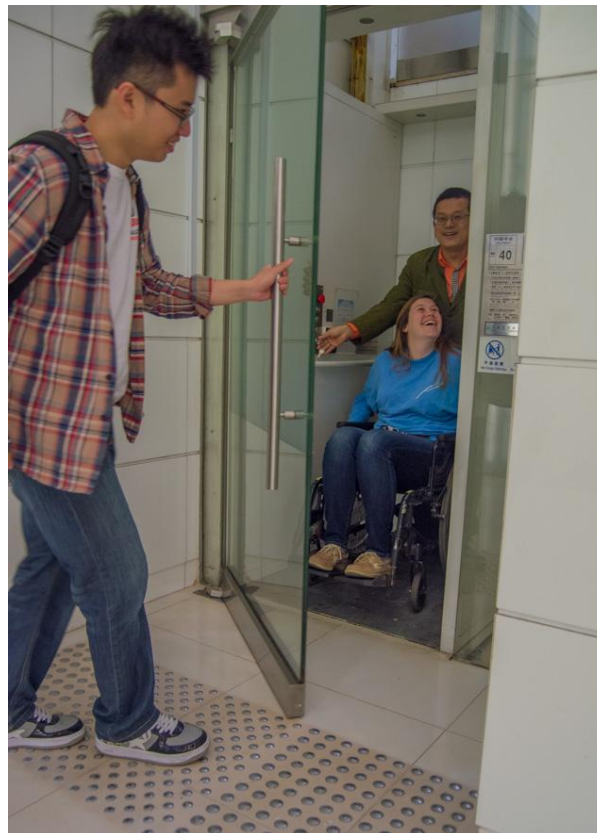
Figure I. 3: Lift Requiring Staff Assistance

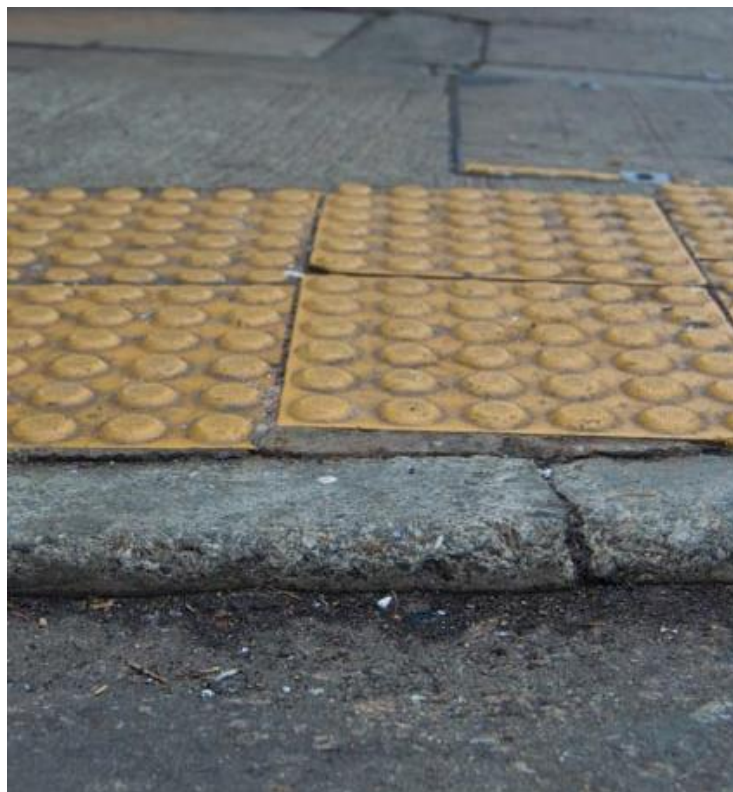
Figure J.1: Image of Lack of Cub Ramp
