MHR-TREE-47

TREES IN HIGHWAY MEDIANS

An Interactive Qualifying Project Report

WORCESTER POLYTECHNIC INSTITUTE

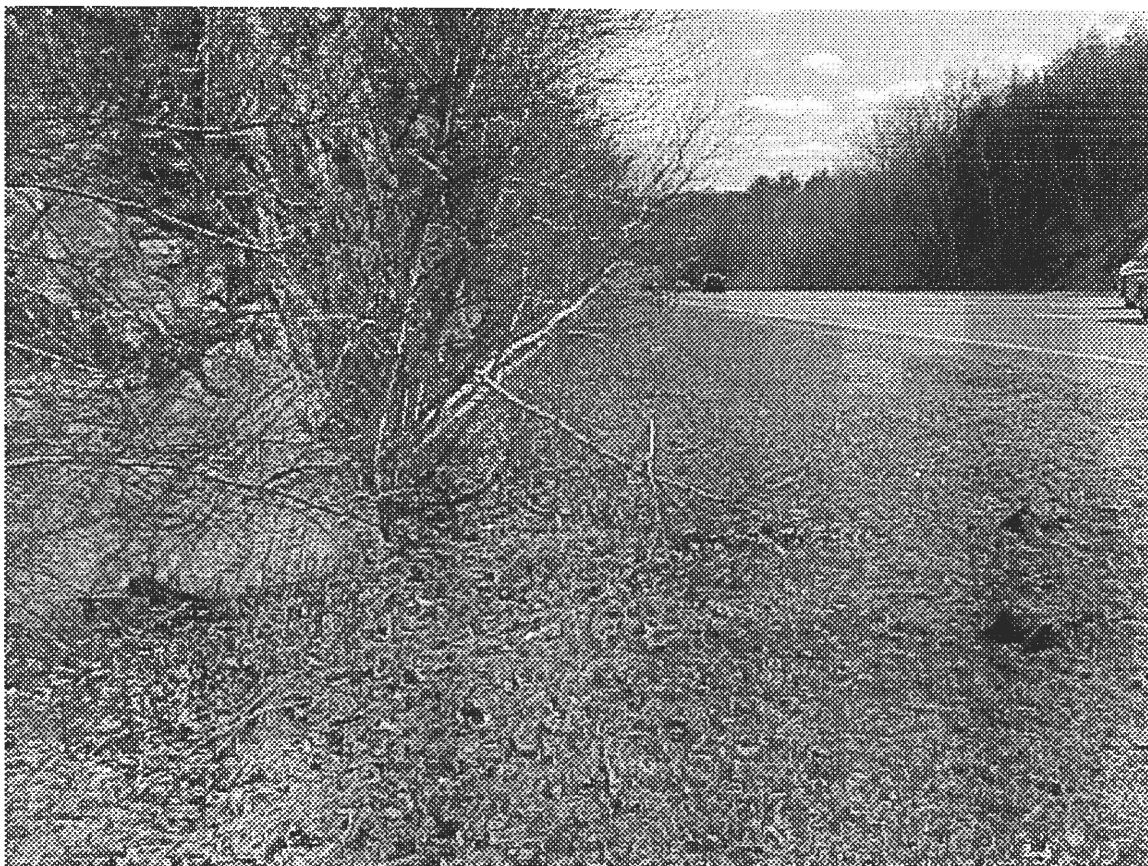
Figure 1. Trees in a highway median

Determining whether trees in interstate highway medians, like those shown in Figure 1, are a net benefit or hazard to society is the objective of this project. Safety issues, such as the probability of an automobile striking a tree off the road and the consequences of the collision are a major concern among highway engineers when dealing with trees in the median. In addition to the possible hazardous characteristics of trees, potential benefits (i.e., safety advantages, environmental and aesthetic values, and economic values) must also be considered when placing a societal value on trees.

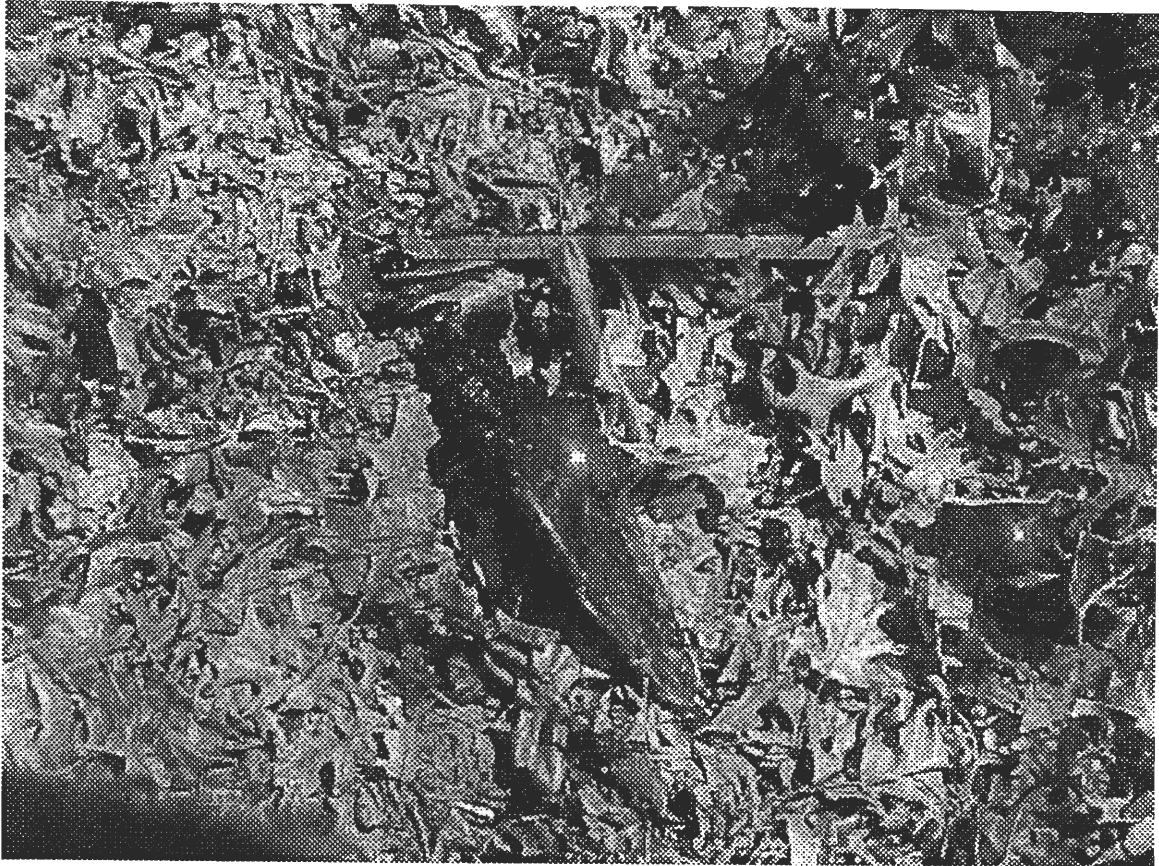
Figure 6. Fender fragment at a possible accident site (site 1).

The “Number and physical properties of the trees” and “Indicating accident sites” sections of the survey were conducted in the median. Starting at mile zero and walking down the length of the median as far as possible, sites of previous accidents were examined. Upon discovering an accident site, several pieces of information were recorded including the condition of the trees (e.g., bark on the trees, broken trees, etc.), skid marks in the median, automobile fragments in the median, etc. Most accident sites were identified because of automobile fragments in the area. Pictures were taken to illustrate typical tree damage, broken trees in the accident site, automobile fragments, etc.

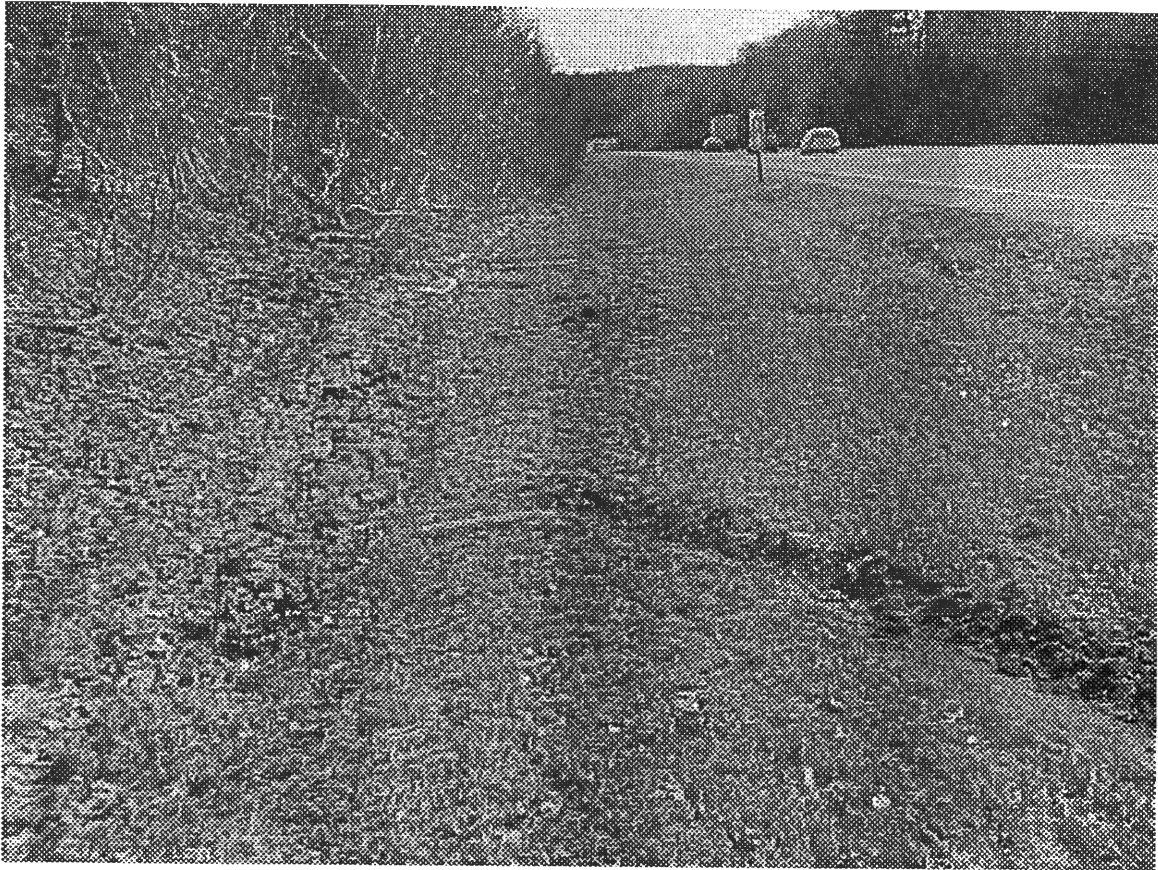
Figure 7. Skid marks leading into median (site 13).

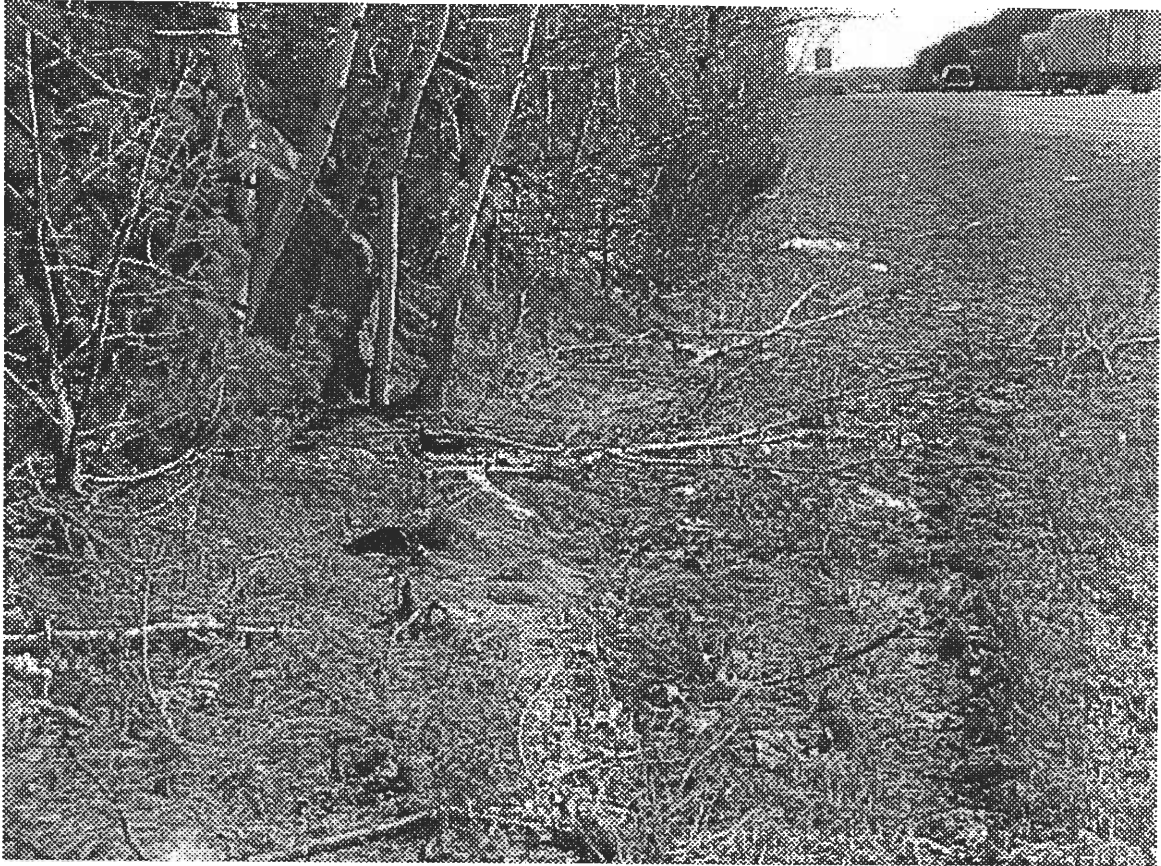
Figure 8. Skid marks and broken trees in median (site 10).

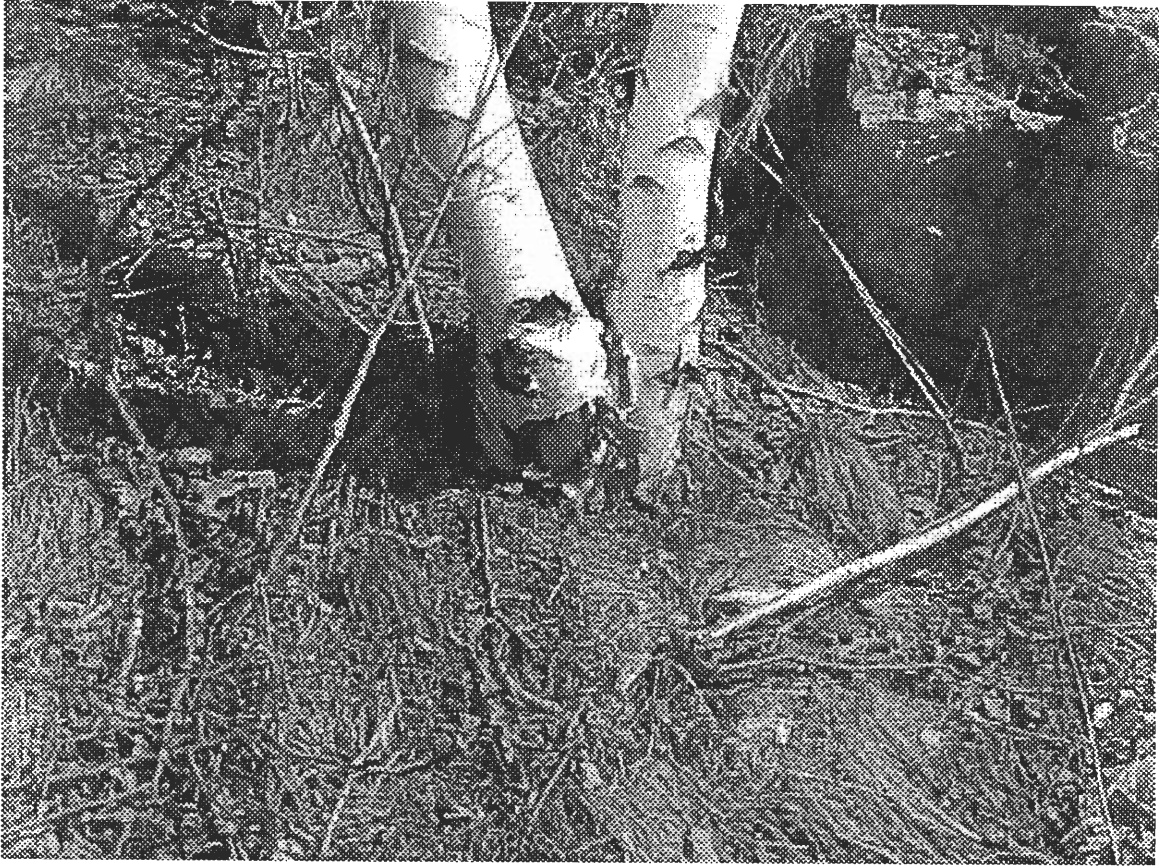
Figure 9. Signs of bark disruption due to accident (site 10).

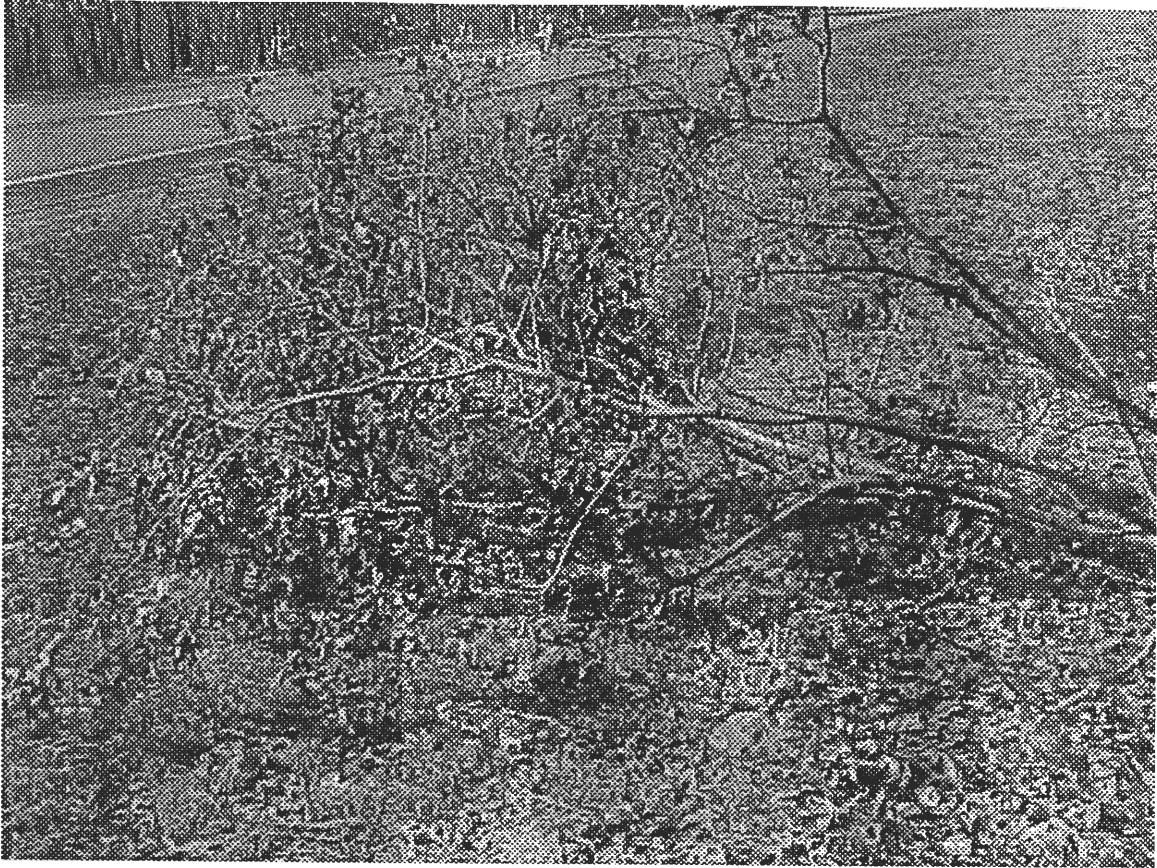
Figure 11. Broken tree (site 1).
