# The Panama Canal Expansion Impacts: Connecting Us to the Future

A Major Qualifying Project Report:

Worcester Polytechnic Institute

Submitted on October 28, 2015

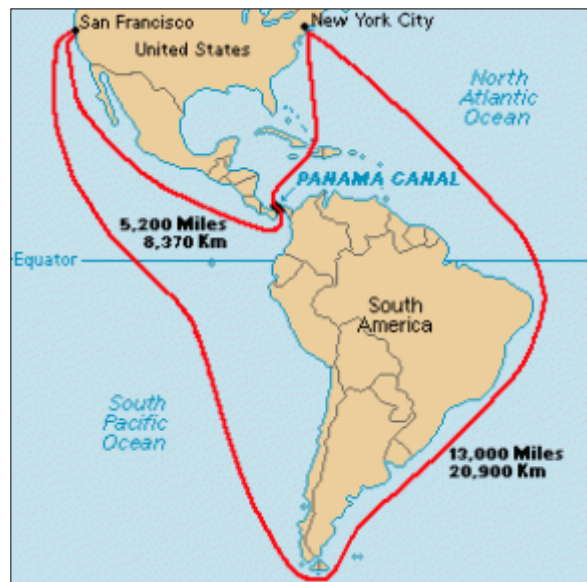
Figure 3: Panama Canal Route and Cape Horn Route (Mohit, 2010)

In 1513, Spanish explorer Vasco Núñez de Balboa traveled from the Atlantic Ocean across the Isthmus of Panama to the Pacific Ocean. At this time, the shortest route between the Atlantic to Pacific Oceans was traveling around Cape Horn, the southernmost point of South America (Figure 3). After Balboa's discovery, the Spanish, Dutch, French, British, and eventually the Americans became interested in creating a path to shorten this common route (Longley, 2003).

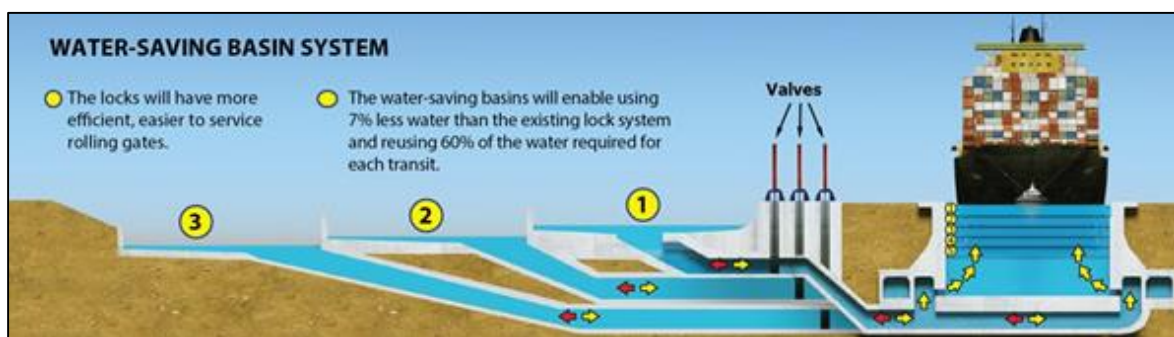
Figure 7: Water Saving Basin System (ACP, 2015f)

The expansion project focuses around the accommodation of Post-Panamax ships and mainly the new installation of the locks on the Atlantic and Pacific sides, known as the Third Set of Locks. The contract for these locks was awarded to Grupo Unidos por el Canal, S.A. for \$3.20 billion, and work on the new lock systems began on August 25, 2009. The Third Set of Locks has three water chambers, each with new features. These include a lateral filling and emptying system, saving water by using 7% less than the existing locks and reusing 60%, thereby decreasing fill and empty time (Figure 7). Other new features of these locks are the perpendicular gates, made in Italy and weighing 3,000 tons (2,720 tonnes) each. The new gates are a variation of the original gates, which swing open against the locks. Instead, the new gates slide in and out on wheeled tracks into recesses perpendicular to the direction of passage (ACP, 2015f).

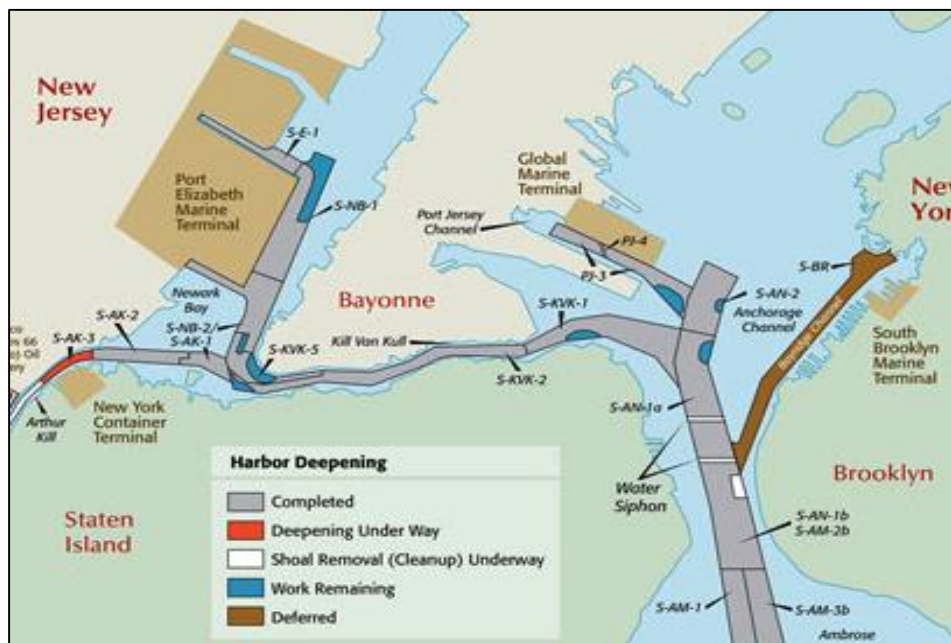
Figure 10: New York Harbor Dredging Plan (PANYNJ, 2015)

The only ports currently equipped to harbor these larger vessels are in Baltimore, Maryland, and Norfolk, Virginia (Allianz, 2013). Many of the East Coast and Gulf Coast port authorities have realized the need for extensive dredging by 45 ft (13.7 m) or more in order to accommodate the larger ships to stay competitive with the Pacific Coast ports (Allianz, 2013; Hricko, 2012). Currently the Port Authority of New York and New Jersey is undergoing a \$6 billion construction effort to receive the Post-Panamax ships and their cargo, which is expected to be completed in 2016, in time for the opening of the widened locks in Panama. As part of this construction, the Bayonne Bridge is being raised 64 ft (19.5 m) to a total height of 215 ft (65.5 m) (Jervis, 2015; PANYNJ, 2015). Additionally, the Port Authority of New York and New Jersey is partnering with the U.S. Army Corps of Engineers to dredge New York Harbor (Figure 10).

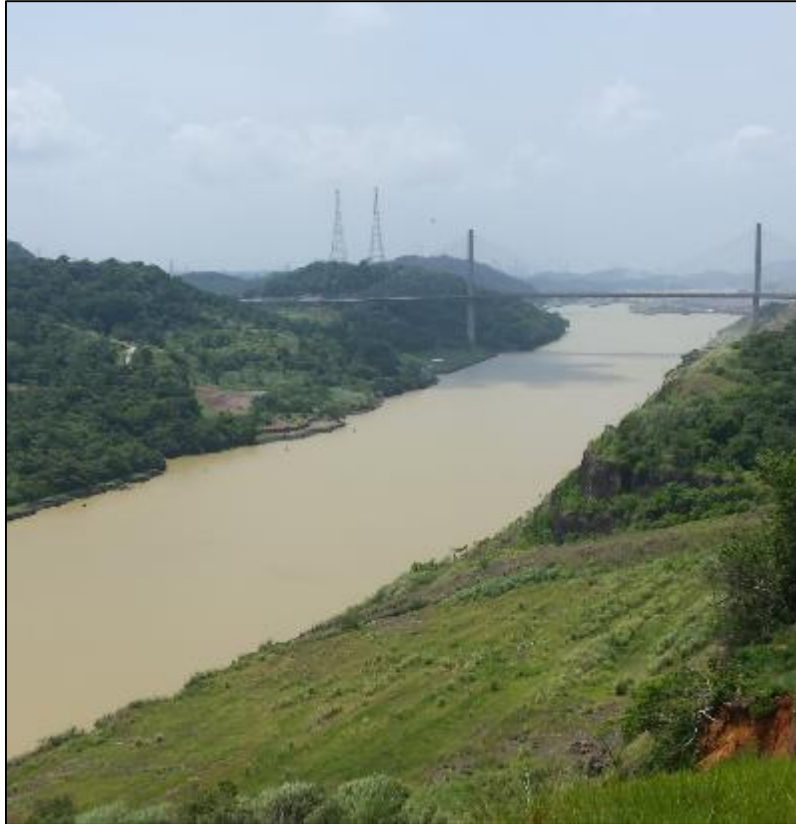
Figure 16: Gaillard Cut near the Centennial Bridge<sup>7</sup>

The series of 15 Reaches, numbered 2-15 on Figure 15 are narrow areas of the Canal that are difficult to maneuver. They span from the Atlantic Ocean over Lake Gatun to the Pedro Miguel Locks. Bas Obispo Reach to Paraiso Reach (numbers 9-14 on the map) are the narrowest reaches of the Canal known as the Gaillard Cut. Figure 16 is an image of the Gaillard Cut near the Centennial Bridge. In full length, the Gaillard Cut is 8.01 miles (13 km) long with 730 ft (222 m) width at its curves (ACP, 2008a; ACP, 2014a). The land surrounding some areas of the Canal is unstable and susceptible to landslides. During initial excavations of the Canal in the early 20<sup>th</sup> century, landslides poured millions of cubic yards of mud and dirt into the cut, which delayed further excavations and the opening of the Canal (ACP, 2008a; Gaillard Cut, 2015). Currently, hillsides have been terraced with smaller slopes to decrease the chance of these threatening landslides, but with the expansion underway, it is a constant threat to navigation through the Canal (Gaillard Cut, 2015).

The narrow Reaches like those at Gaillard Cut make navigation challenging through the Canal, but there are additional risks mariners must be aware of. The Panama Canal is constantly changing. Seasonal rains may reduce visibility and increase the risk of erosion and landslides. These risks and other environmental changes make the Canal difficult to navigate. In addition, mariners must be cautious of hydrodynamic effects like currents, suction, and surges throughout the Canal (Pilot's Handbook, 1996). The rivers that feed Lake Gatun and the Panama Canal originate in the rainforest. Erosion from deforestation of the rainforest carries sedimentation into the Canal during the rainy season (ACP, 2007). The sedimentation settles and builds up in the Canal, reducing the water depth.

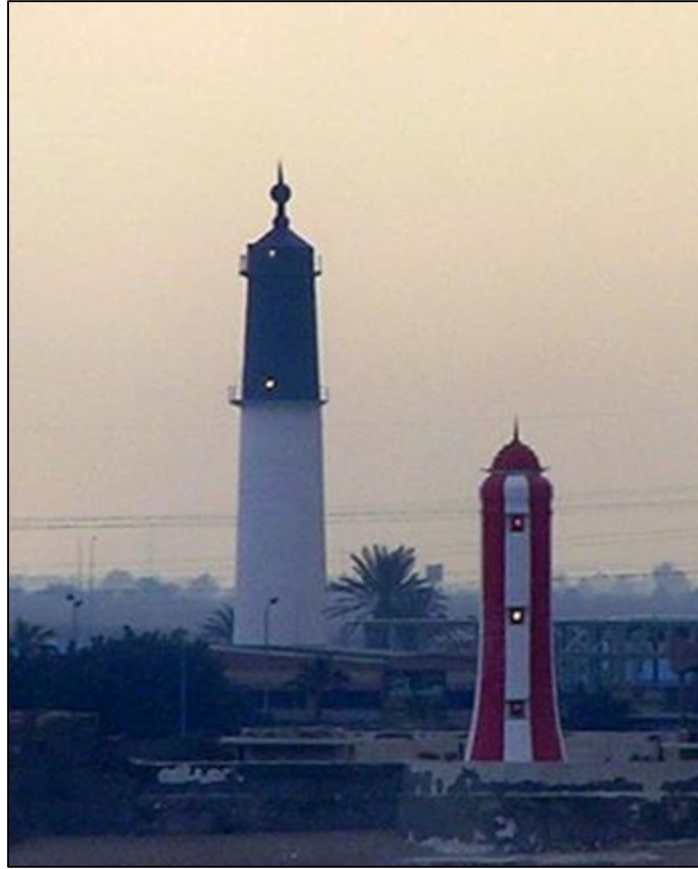
Figure 22: Great Pass Range Lighthouses in Alexandria, Egypt (Rowlett, 2015a)

Lighthouses have been used in ranges for over a century. The Bremerhaven Lighthouse along the North Sea in Germany, is the rear tower to a pair of range lights marking the northern side of the harbor's lock. The front tower is a small red and white lighthouse on the southern pier of the lock. This range pair helps ships leaving the Weser River navigate a turn into the adjacent estuary (Rowlett, 2014a). The El-Boughaz el Kebir and Al Maks Upper are the two lighthouses of the Great Pass Range located in Alexandria, Egypt. The El-Boughaz el-Kebir is the front tower and has guided ships into the Alexandria Harbor since 1908. It replaced the Al Maks Lower tower in 1908 after a change in the line of approach to the harbor. The Al Maks Upper rear tower has been in service since 1894 (Rowlett, 2015a). Figure 22 shows the two lighthouses of the Great Pass Range.

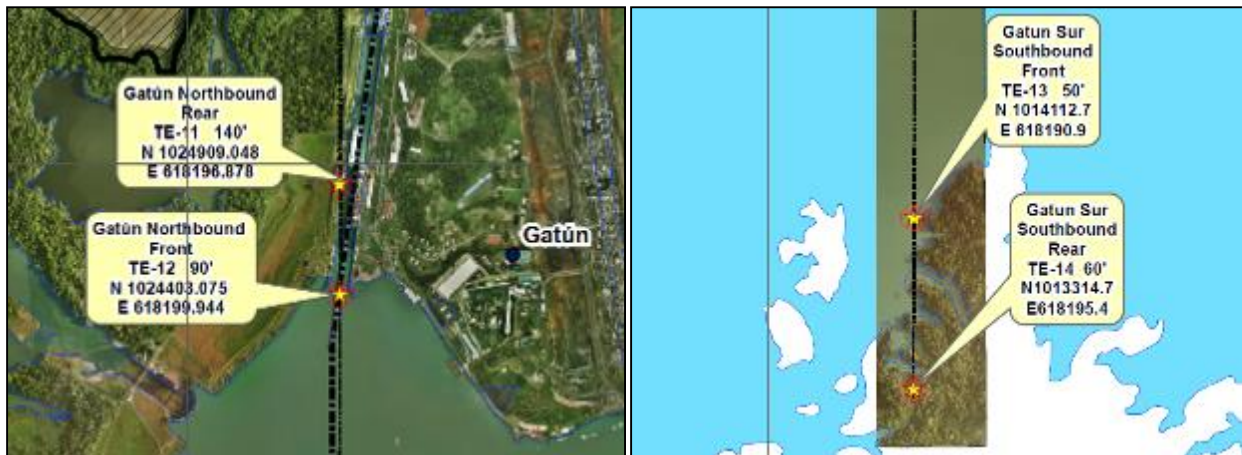
Figure 24: Map of Gatun Reach Range Towers (Canal de Panamá, 2014)

One example of range spacing is the Gatun Reach which is 3.22 nautical miles in length. The Northbound towers are 90 and 140 ft (27.4 and 42.7 m) while the Southbound towers are 50 and 60 ft (15.2 and 18.3 m). Although they seem similarly spaced (see Figure 24), both towers of the Northbound range are significantly higher than the Southbound range. Another difficult location to design for is near or inside the locks. With the required heights for towers to reach their intended geographic range, placement of a tower on the locks may obstruct visibility for mariners.

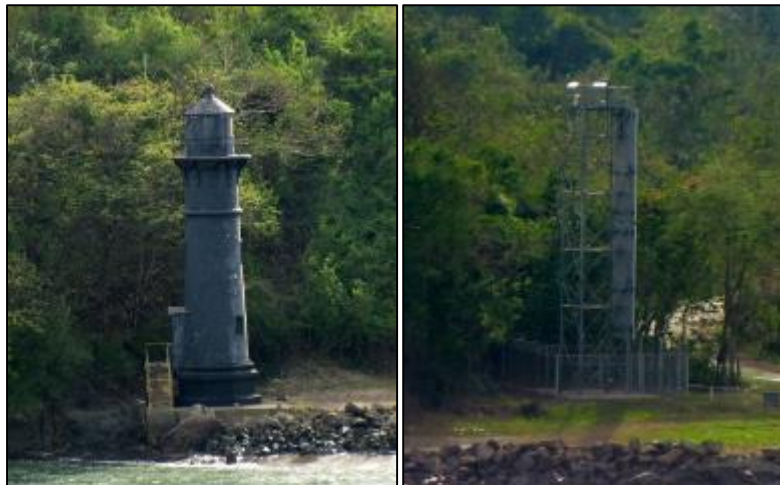
Figure 26: Balboa Southbound Rear Range Tower (Rowlett, 2014b)

Pairs of lighthouses still exist in the Canal, and can be seen by vessels as they are transiting. The ACP has retrofitted some of these double lighthouse ranges with latticed steel structures as one or both of the towers. In Figure 26, the Balboa Southbound Rear range tower was originally a lighthouse (left), but has recently been replaced by a latticed steel structure (right). Figure 27 is an example of a range front tower with the lighthouse still existing near the newly erected latticed steel structure.

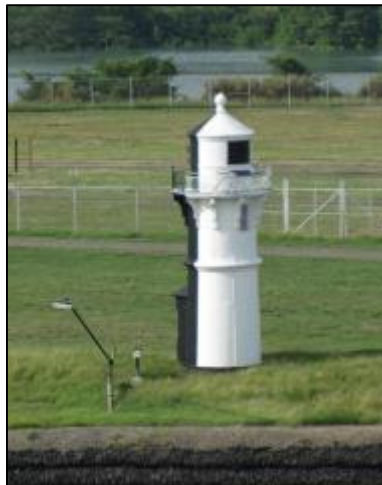
Figure 28: Miraflores Northbound Front Range Tower (Rowlett, 2014b)

A lighthouse can be constructed from many materials depending on its geographic location or environment. The inland lighthouses at the Panama Canal used for navigation are mostly white-painted concrete towers. Black-painted concrete lighthouses in the Canal are inactive, like the Pacific Entrance Rear range tower near the Pacific Entrance of the Canal or the Gamboa Southbound Front range tower in Gamboa. The ACP will also paint portions of lighthouses black if they are used for single directional traffic. Figure 28 is an example of the Miraflores Northbound Front range tower that is painted white on the south-facing side for navigation, and black on the other half.

The lighthouses in the Panama Canal have been constructed with cast-in-place reinforced concrete as their main structural material. Like many other lighthouses erected along the coast and near fault lines, reinforced concrete was chosen because of its ability to withstand high winds, harsh climate, and seismic activity (Browning, 2014; NPS, 1997). Not only was it stronger than the previous iron and steel lighthouses, but also cheaper and required less maintenance.

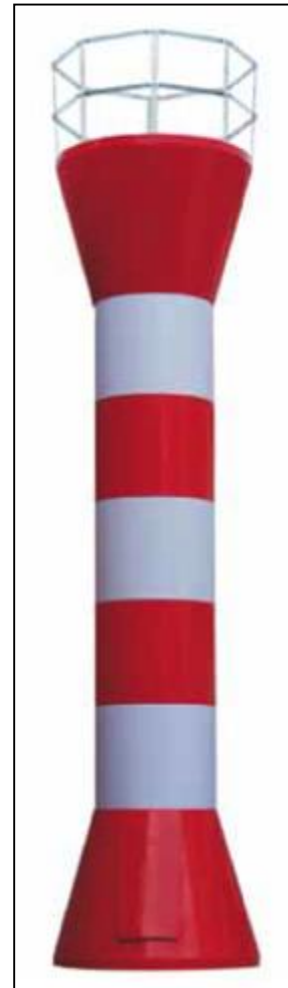
Figure 29: GRP Tower  
(Tideland Signal  
Corporation, 2010)

GRP towers are manufactured for heights ranging from 16.4 to 65.6 ft (5 to 20 m) with a minimum wall thickness of about 0.3 in (8 mm) (ANST, 2012; Tideland Signal Corporation, 2010). Towers can withstand gale wind forces of up to 125 mph (56 m/s) and some are wave resistant for up to 6.56 ft (2 m) (Floatex, 2015). The added modules, as seen in Figure 29 with the red and white stripes in the middle, are typically 3.3 ft (1 m) in height. These structures and

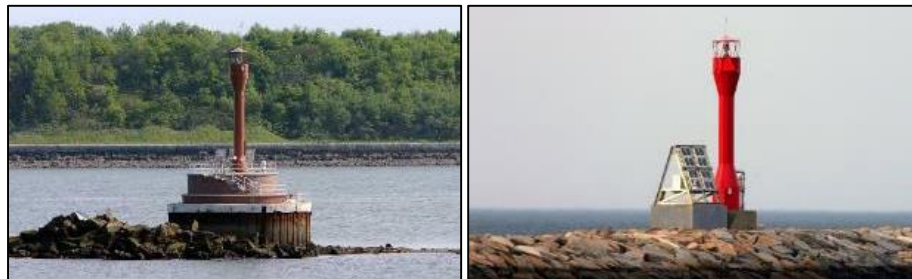
Figure 30: Deer Island Light and Cape Cod Canal Breakwater Light (Rowlett, 2015d)

Glass reinforced plastic beacon towers are used globally to mark waterways. Deer Island Light, for example, is a GRP tower that marks the entrance of the Boston Harbor. After replacing the original lighthouse in 1982, this GRP tower was the first GRP lighthouse constructed in the United States. It was chosen because it occupies minimal space, withstands high winds, and was inexpensive (Browning, 2014). Deer Island does not have a daymark on the brown structure (Figure 30, left). The Cape Cod Canal Breakwater Light located along the Cape Cod Canal in Massachusetts is also a GRP tower, but it marks the entrance of the Cape Cod Canal (Figure 30, right). It has a red triangular daymark.

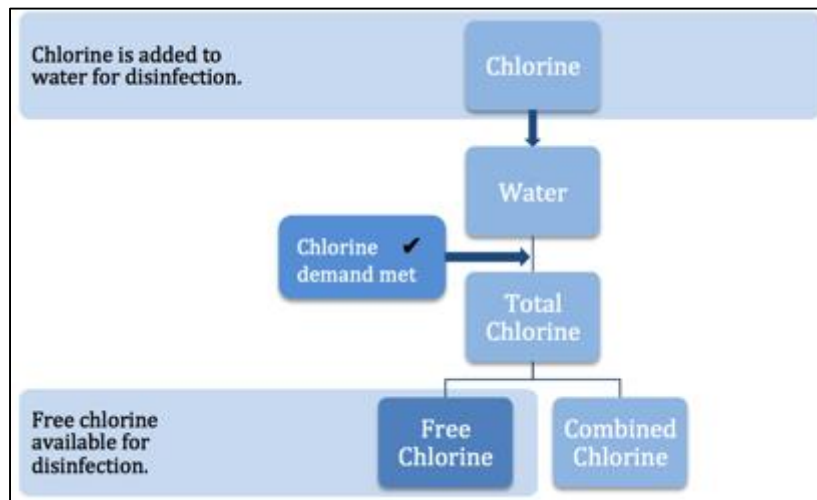
Figure 36: Process of Chlorine Batching

Chlorine disinfectants are added to drinking water during the treatment process to kill microorganisms that can cause typhoid, cholera, hepatitis A, and other diarrheal diseases (Reed, 2011). Upon initial application to water during treatment, chlorine reacts with organic material and other compounds present in the water. Once the chlorine demand of the water has been reached, the remaining chlorine concentration is considered the total chlorine. The total chlorine consists of combined chlorine and free chlorine. Combined chlorine is the chlorine that joined with nitrogen in the water and is unavailable for disinfection purposes. Free chlorine is the concentration of chlorine that is still available for disinfection and is also known as residual chlorine (WHO, 2008). Figure 36 outlines the chlorine batching, or disinfection, process.

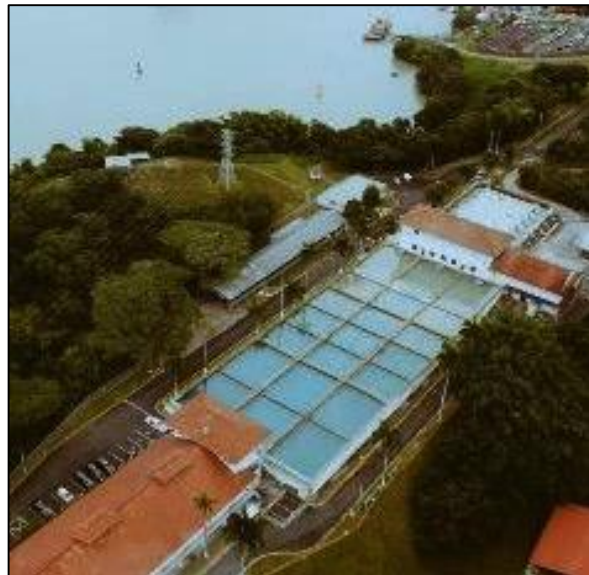
Figure 37: Miraflores Water Treatment Plant (Canal de Panamá, 2015)

The Panama Canal Authority has three water treatment plants that yield 100 million gallons (379 million liters) of water daily; the Miraflores Water Treatment Plant produces nearly half of this treated water (Vásquez, 2010). Constructed in 1913, the Plant opened for operation in 1915 (Figure 37) (Canal de Panamá, 2015). At the Miraflores Water Treatment Plant, the ACP is responsible for treating raw water from Lake Gatun and producing drinking water. This Plant has a maximum capacity of 50 million gallons (189 million liters) per day, 90% of which is sold to the Institute of Aqueducts and Sewer Systems by the ACP for distribution to the city (Vásquez, 2010). There are two pumping stations at the Miraflores Water Treatment Plant: one for the East and one for the West parts of the city (Figure 49) (Vásquez, 2010). The ACP stores 10% of treated water to service the Canal zone (Vásquez, 2010).

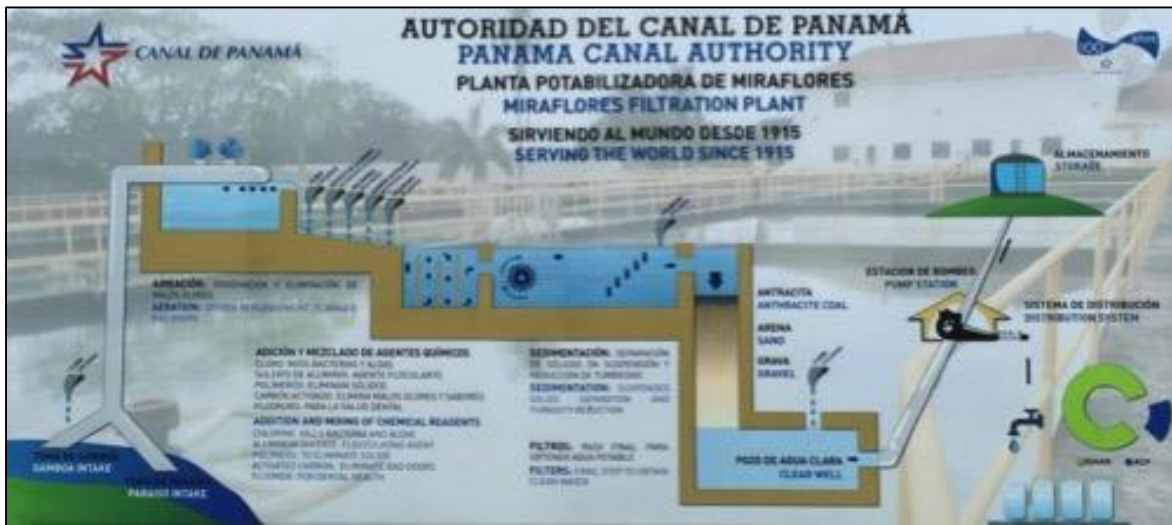
Figure 38: Water Treatment Process at the Miraflores Water Treatment Plant (Miraflores Water Treatment Plant, 2015)

Aeration removes odor-causing gases and replenishes oxygen in the water. Next, the aerated water travels through three channels (Figure 42), at which time batching of chlorine, aluminum sulfate, polymers, activated carbon, and fluoride are added to the water. Chlorine is added to kill bacteria and algae, aluminum sulfate aids the flocculation process, polymers remove solids, activated carbon eliminates bad odor, and fluoride improves dental health. After chemical batching, the water continues to travel through the three channels to chambers that rapidly mix the water and the added chemical reagents through a hydraulic system (Figure 43) (Vásquez, 2010). At the end of the hydraulic chambers, the water moves to three series of seven basins (Figure 44). The first basin is for flocculation (Figure 45). Large propellers slowly stir the water and the ionic charge of the water brings the chemicals together to create flocs (Figure 46). The flocs move through the other basins and as they increase in size and weight, the particles sink to the bottom of the basins where workers remove it as sludge (Figure 47). This process is called sedimentation. Sedimentation separates suspended solids and reduces turbidity. When the water reaches the end of the seven basins it merges and travels into one of 20 water filtration basins (Figure 48). The filtration process moves the water through media consisting of anthracite coal, sand, and gravel into a recollection chamber (Vásquez, 2010). At this point in the treatment process, the water is now potable. Another batch of chlorine is added to the water as it moves to the pumping stations to disinfect and create a safeguard against further contamination.

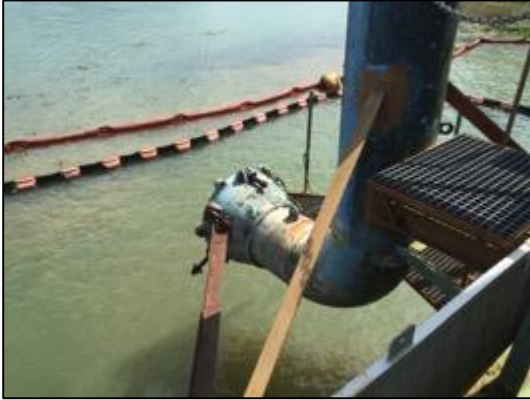
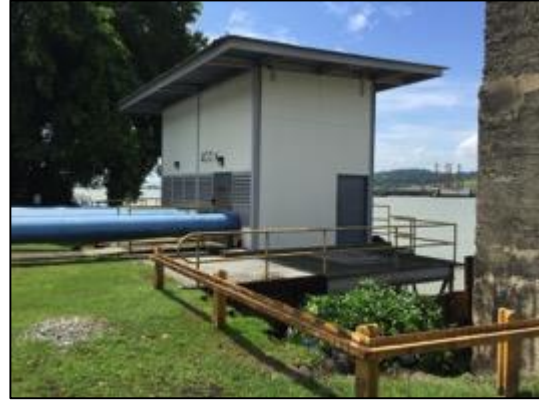
Figure 38 outlines the water treatment process at the Miraflores Water Treatment Plant. The treatment process begins with the extraction of raw water at the Gamboa and Paraiso intakes in Lake Gatun (Figure 39 and Figure 40, respectively). Then, the water is transported to the Miraflores Water Treatment Plant through a series of underground pipelines. Upon arrival at the Miraflores Plant, the water undergoes several stages of treatment. First, the raw water travels through an aeration process (Figure 41) (Vásquez, 2010).

Figure 39: Water Intake at Gamboa

Figure 40: Water Intake at Paraiso

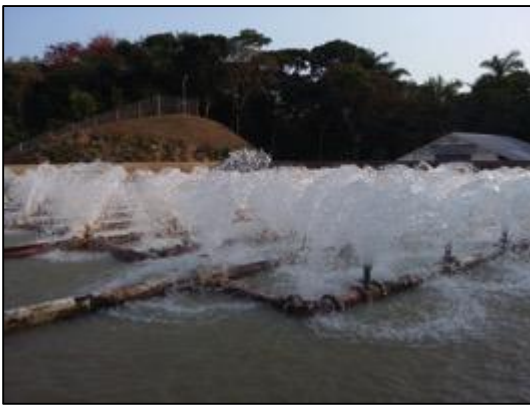
Figure 41: Water Aeration Process

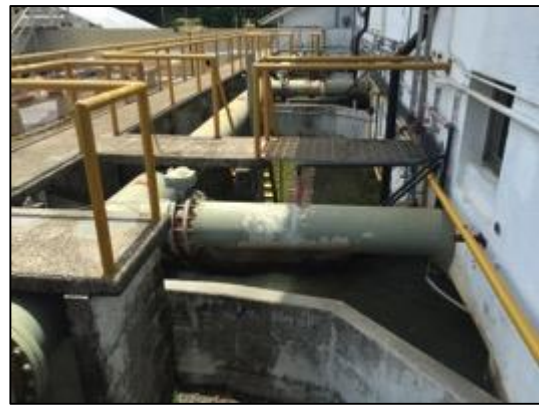
Figure 42: Chemical Batching in Channels

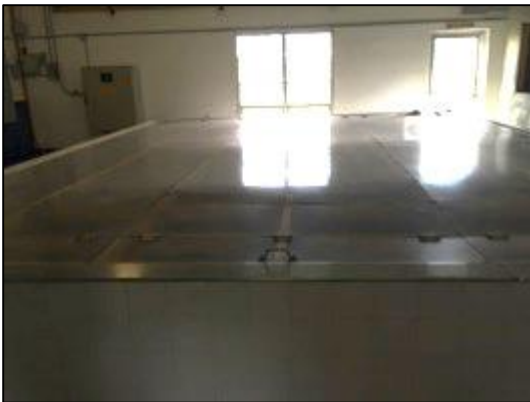
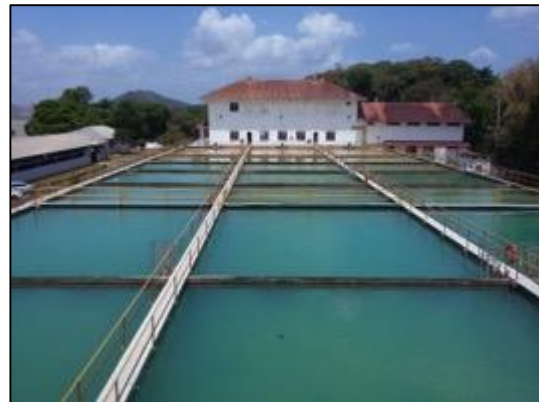
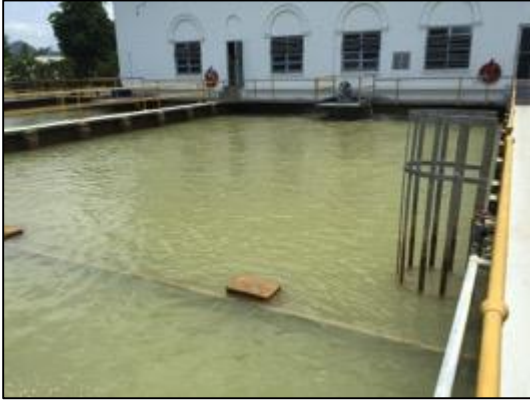
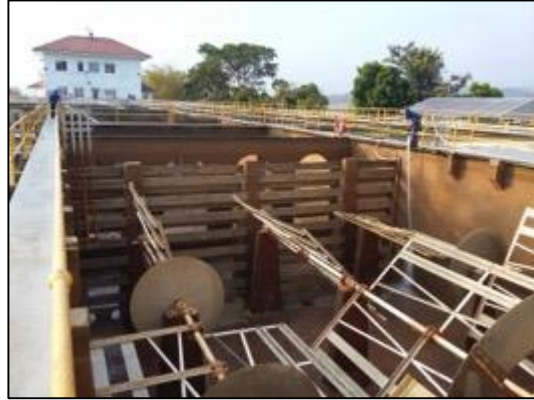
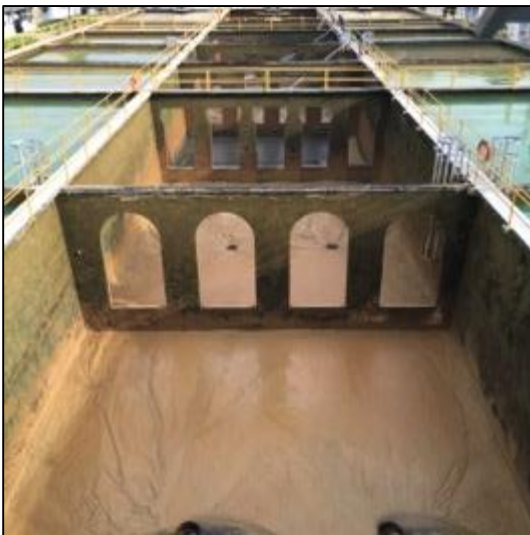
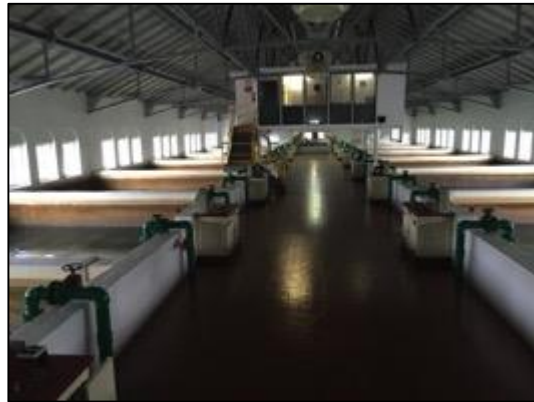
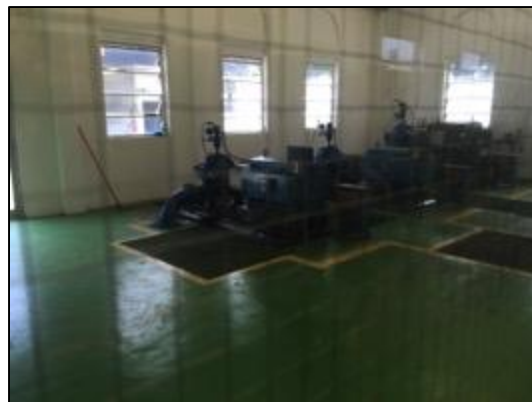
Figure 43: Hydraulic Mixing Chamber

Figure 44: Water Treatment Basins

Figure 45: Flocculation Basin

Figure 46: Flocculation Propellers

Figure 47: Sedimentation Sludge at Bottom of Basin

Figure 48: Water Filtration Chambers

Figure 49: Water Pumping Station

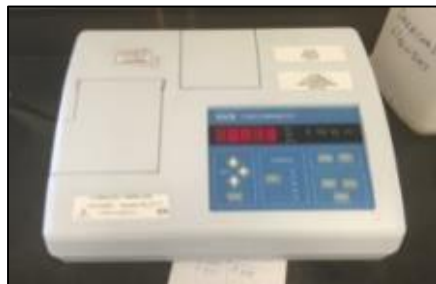
Figure 54: HACH 2100N Turbidimeter

The team tested water samples against turbidity health targets using a HACH 2100N Turbidimeter (Figure 54). This device utilizes a stable halogen-filled tungsten filament lamp that is capable of analyzing samples up to 4,000 NTU. The HACH 2100N Turbidimeter meets the reporting requirements of the United States Environmental Protection Agency (EPA) Method 180.1 (Appendix C) (Hatch, 2015). To determine the turbidity of a water sample, a team member filled the sample cell provided with the Turbidimeter to the line etched on the outside

of the cell and replaced the cap. After, the conductor of the test wiped the outside of the sample cell to remove any water residue or fingerprints. Then, the conductor placed the sample cell into the instrument cell compartment of the Turbidimeter and closed the cover. The Turbidimeter displayed a reading of the turbidity of the sample.

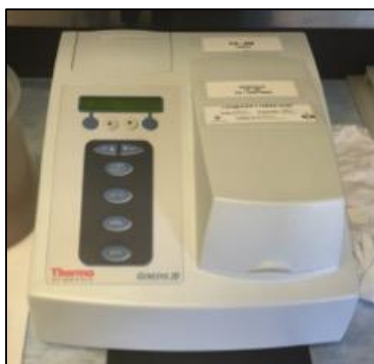
Figure 55: GENESYS 20

Water testing to determine residual chlorine in the samples involved the use of a GENESYS 20 (Figure 55). The GENESYS 20 is a visible spectrophotometer that uses a tungsten-halogen light source and a single beam optical design (Thermo Scientific, 2012). To determine the residual chlorine, a team member rinsed a syringe three times with water from the 100 mL sample, then collected 10 mL and emptied the contents of the syringe into a 50 mL plastic beaker. The conductor of the test added 0.50 mL of phosphate buffer and 0.50 mL N,N-diethyl-p-phenylenediamine to the 10 mL sample of water. The water, depending on the amount of residual chlorine, began to change to a red color. A deeper red corresponded to a higher residual chlorine concentration. The team member swirled the sample for 10-15 seconds and then poured the solution into a 1 cm sample cuvette. After, the conductor of the test wiped the outside of the cuvette to remove any water residue or fingerprints and inserted the cuvette into the vacuum sealed compartment of the spectrophotometer. The GENESYS 20 printed a reading of the residual chlorine of the water sample. Testing for residual chlorine followed guidelines of ISO Standard 7393-2: 1985, *Water quality -- Determination of free chlorine and total chlorine -- Part 2: Colorimetric method using N,N-diethyl-1,4-phenylenediamine, for routine control purposes* (Appendix C) (International Organization of Standardization, 1985).

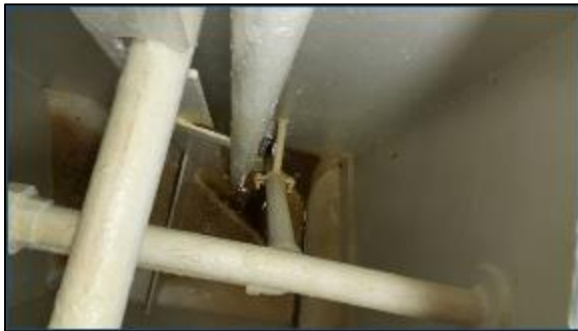
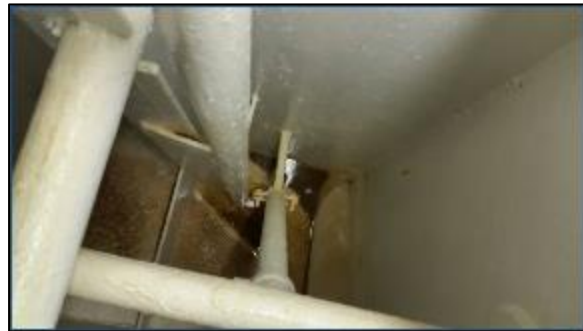
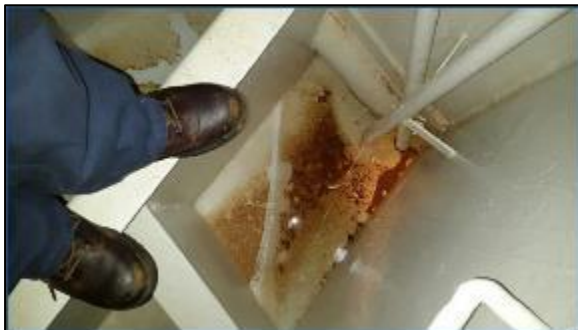
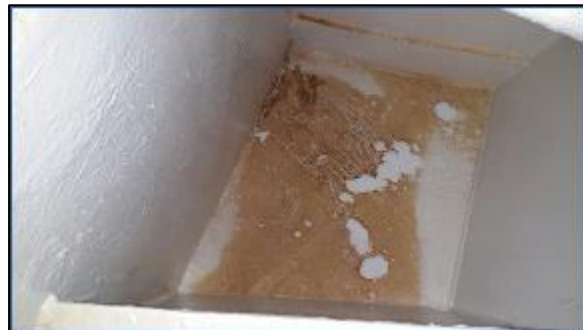
Prior to the inspection of the potable water storage tanks, tugboat crewmen and engineers drained the tanks and opened the access doors. Figure 56 to Figure 62 are photographs of the inside of the potable water storage tanks aboard R-GUÍA. Inspection of the tanks confirmed the presence of rust in the potable water storage tanks.

Figure 56: R-GUÍA tank inspection 1-7

Figure 57: R-GUÍA tank inspection 2-7

Figure 58: R-GUÍA tank inspection 3-7

Figure 59: R-GUÍA tank inspection 4-7

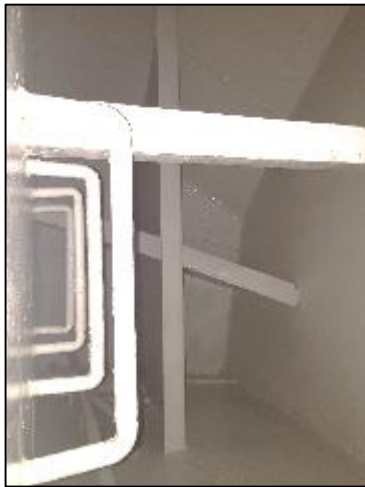
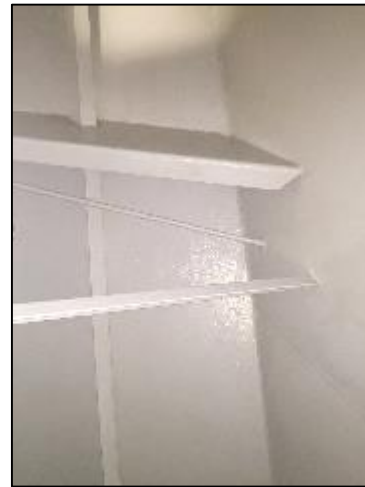
Figure 63: R-GUÍA Potable Water Tank Post Cleaning and Epoxy Painting 1-2

Figure 64: R-GUÍA Potable Water Tank Post Cleaning and Epoxy Painting 2-2

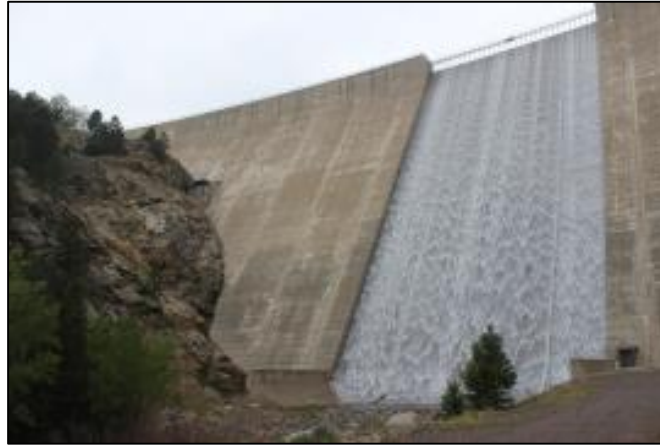
Figure 66: Free falling spillway at Gross Reservoir, CO (Baker, 2013)

One type of spillway is a free overfall spillway (Figure 66). In these spillways, water flows over the crest of the dam into a plunge pool. Occasionally, crests will have a lip, used to propel the falling water away from the foot of the dam. These spillways can be gated or ungated (Hydraulic Structures for Flow Diversion and Storage, 2012).

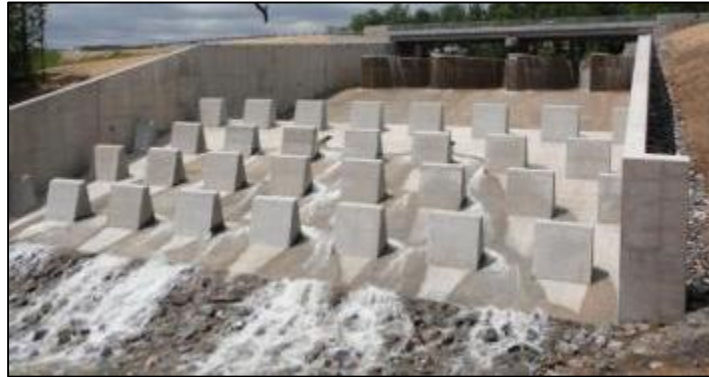
Figure 68: Open chute spillway with large baffle blocks (C. William Hetzer, Inc., 2012)

variations of this spillway where the chute is placed below or on the side of the dam, typically called a side-channel spillway. In chute spillways, energy dissipation is crucial. Baffle blocks or stepped channels are a means of energy dissipation for this spillway design (Figure 68) (Hydraulic Structures for Flow Diversion and Storage, 2012).

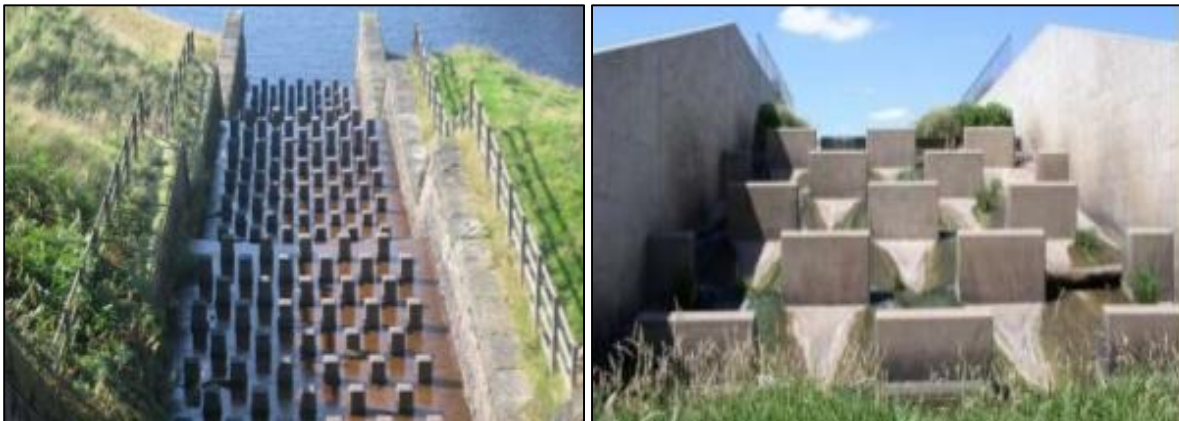
Figure 70: Energy dissipation technique using rock lined spillway channels (Tandon, 2014)

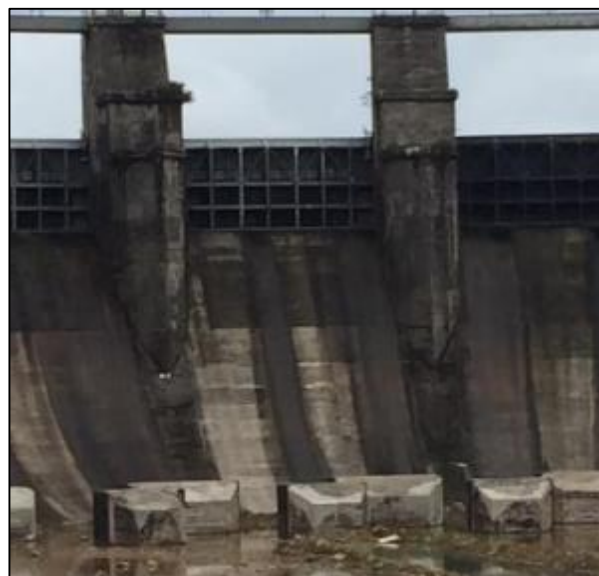
Figure 74: Baffle blocks of the Gatun Spillway and basin

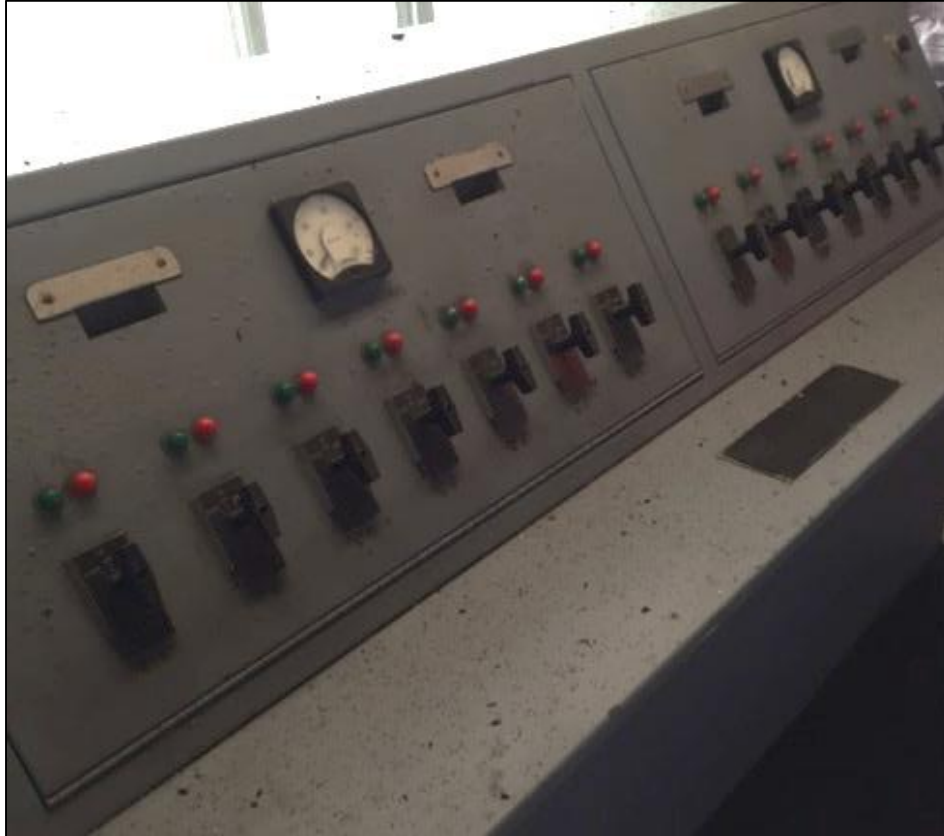
Figure 76: Control desk where the spillway gates are opened and closed

If the spillway gates are required to open, an operator will do so from the control desk that overlooks the spillway (Figure 76). The desk is located on a mezzanine in the Gatun Hydroelectric Plant to the left of the spillway. The mezzanine has small windows that are opened to view the spillway while operation is in progress. Each gate has a number (1-14) posted on the footbridge in the center of the gate so the operator knows which gates are which. Additionally, the spillway gates must be opened in a specific sequence to minimize the powerful impact of currents and flow on the gates, spillway, and power station (Figure 77) (O. Fontalvo, personal communication, August 21, 2015). In Figure 76, the controlling knobs are switched to the off position. The spillway will be opened if approved by the hydrology staff, in the case of flooding, who will establish a time duration for the gates to be opened. When the gates are fully open, the flow rate of the water is 13,400 ft<sup>3</sup>/s (379 m<sup>3</sup>/s) (O. Fontalvo, personal communication, August 21, 2015). The velocity of the water being released is approximately 58.1 ft/s (17.7 m/s) (Re, 2012).

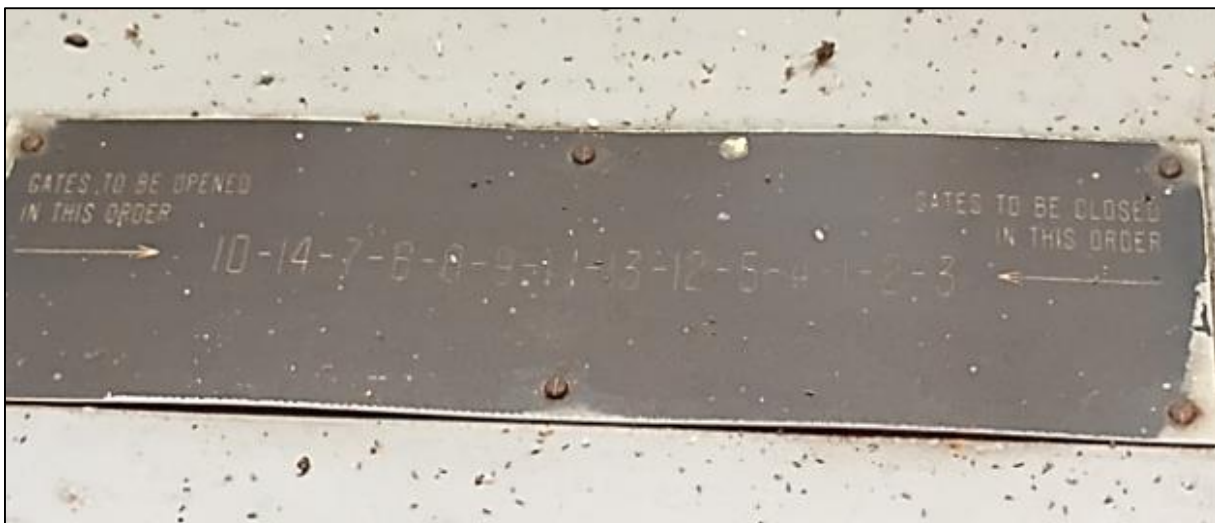
Figure 77: Order of opening Gatun Spillway gates: 10-14-7-6-8-9-11-13-12-5-4-1-2-3. The order is reversed for closing the gates.

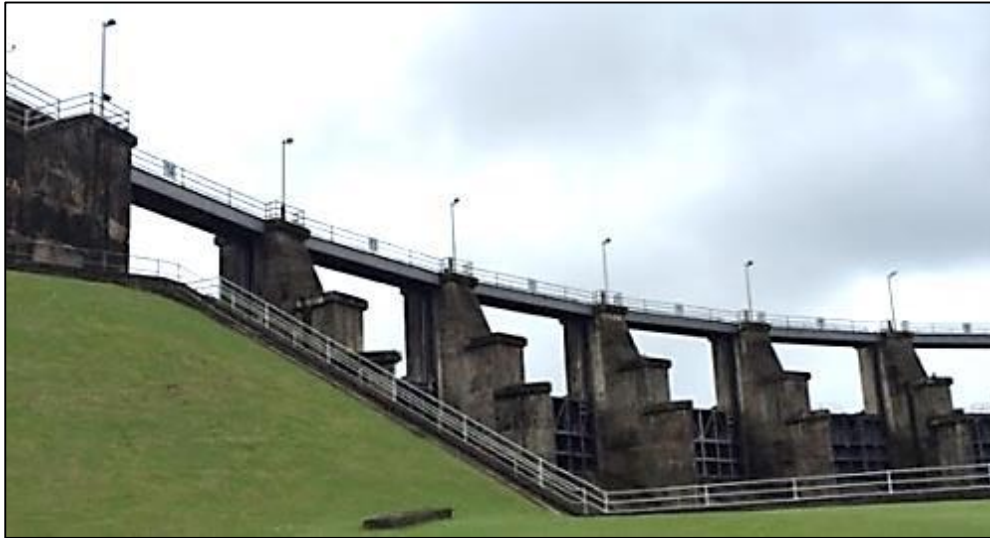
Figure 78: Piers of the Gatun Spillway

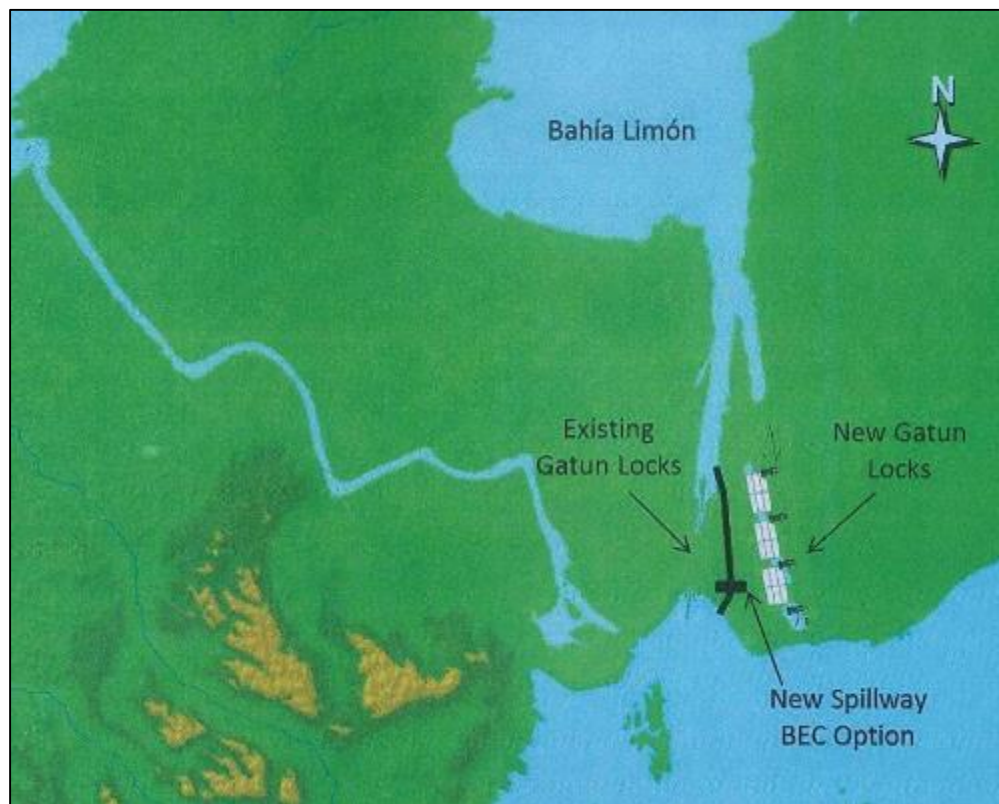
Figure 79: Proposed location for new BEC Spillway (ACP, 2015e)

Currently, the proposed site to build the new spillway is between the existing and Third Set of Locks (Figure 79). As shown in Figure 79, the existing Gatun Locks are to the left of the spillway and the new locks to the right. The spillway will have a downstream flow and empty into Limon Bay, or the start of the Canal on the Atlantic side. In this area, no residential communities are present. The only buildings affected by the new spillway are owned by the ACP and the people who work in these buildings would be relocated. Since the ACP used this location for equipment storage and as excavation grounds for the Third Set of Locks, there are already facilities available to house equipment and other construction related needs. Some concerns about the area involve the hazards of hitting electrical, water, and power lines. All the lines that supply the locks with power will have to be moved eventually during construction.

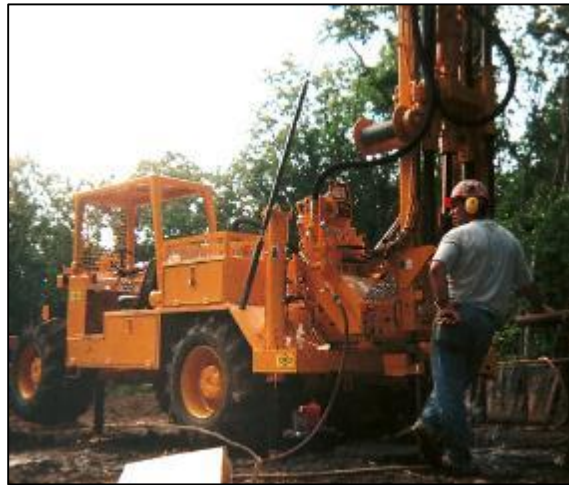
Figure 80: Machinery used for borehole drilling (Raimonde Drilling Corporation, 2015)

The ACP and INGETEC are currently conducting geological assessments, including site visits and sampling within the proposed location of the new spillway. This sampling is done through extracting boreholes. Boreholes are a type of exploration tactic geologists use to determine what type of soils and rock are found in an area. Although boreholes are drilled in many locations on a site, samples are not taken from every hole. In order to extract the cores from the ground, a large machine with a powerful hydraulic drill attached to the rear is needed,

called a drilling rig (Figure 80). Samples, called drilling cores, are taken and placed into a “core box” for testing (Figure 81). Core samples vary in size depending on the specifications indicated by the contracting company. In this project, the ACP specifies HQ3 cores, a 2.41 in (61.1 mm) diameter core (Major Drilling, 2015). From these samples, geologists analyze aspects such as what type of soil or sediment is contained within the sample and the age of the rock. After soil testing is complete, geologists conclude what types of materials should be used in an area in order to ensure safety in the designs for a structure (Learning Development Institute, 2015). While new boreholes and testing are being performed on the project site, the ACP geologists have geological data for the existing and new set of locks for comparison.

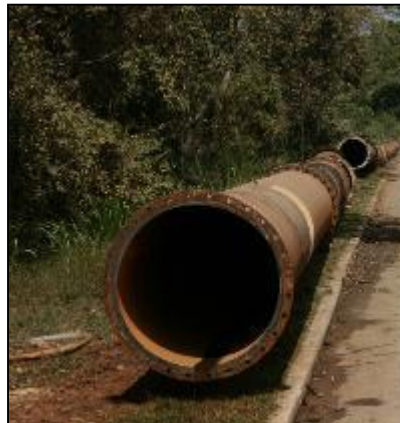
Figure 86: Excavation pipe size (ACP, 2015c)

Because trucks cannot be utilized for excavation, the ACP is investigating transporting excavated material through steel dredging pipes, as shown in Figure 86. Approximately 2.95 ft (0.90 m) in diameter, the pipes would have to be run under the new locks or sunk in either Lake Gatun or Limon Bay (Figure 86). In order to move the excavated material through the pipes, slurry, a combination of soil and water, is made and then pumped through the length of the pipe. Typically, there is one large pump at the beginning of the connected pipe length, then a few smaller pumps along the remaining pipe route. These pumps provide the necessary pressure to move the slurry to its destination. Pumps vary depending on the total distance and how many angles are present in the pipelines throughout the route.

The ACP is particularly interested in running the steel pipes through one of the new crossunders of the new locks. These crossunders are tunnels around and under the locks that house telecommunication and electrical lines, as well as other equipment to operate the locks. They are equipped with stairs and an elevator to allow for maintenance. Running pipe through a crossunder offers a shortcut to the Monte Lirio site without having to sink the pipes in Lake Gatun. The feasibility study of this method involved looking at the crossunder plans for each lock and noting the features to determine if any obstacles were present. Additionally, routes for excavation were examined.

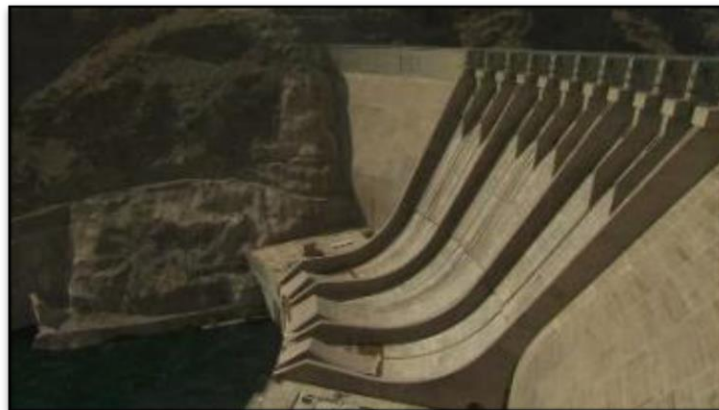
Figure 87: Karakaya Spillway, Turkey (Karakaya Dam, 2015)

Ski jumps are very effective and economical when trying to decide what type of energy dissipater to use in the case of a spillway (Najafzadeh, Barani, & Hessami-Kermani, 2014). When the velocity of the released water exceeds 65.6 ft/s (20 m/s), this type of spillway is typically used. A ski jump spillway consists of a large chute with a flip bucket at the end, causing the water to shoot up into the air, adding air entrainment into the water and thus slowing down its velocity (Figure 87). This decline in velocity reduces the risk of a scour hole forming upon impact into the plunge pool (Heller, 2013). Aside from decreasing erosion, the goal of a ski jump spillway is to discharge the water as far away from the foot of the spillway as possible. By releasing the water away from the base of the dam, the probability of scour affecting the structural stability of the dam is significantly reduced.

In order to improve these spillways, dentate splitters are generally added to further aid in energy dissipation, as seen in Figure 87 above. Dentate splitters, or teeth, are part of the spillway structure and divide the one jet flow of water into many flows, reducing the kinetic energy and overall impact the water will have on the plunge pool. The jet becomes weak when this method is utilized, allowing the water to hit the plunge pool with decreased speed. A longer trajectory is better for this ski jump method (Rahatabad, 2004). Physical modeling is important to use to test different situations and determine the number of dentate teeth to effectively reduce scour. Studies done on this type of energy dissipater have concluded that the plunge pool erodes nearly half as much when dentate splitters are used (Rahatabad, 2004).

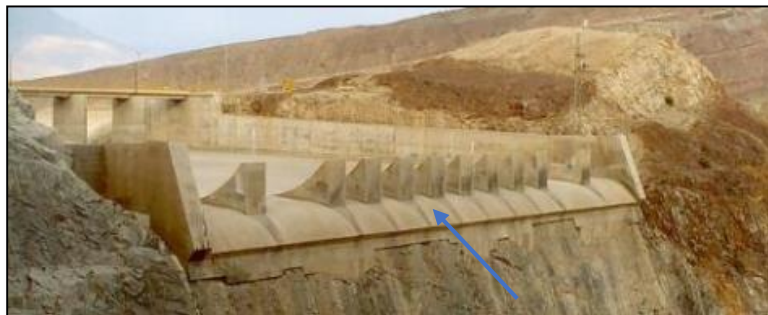
Figure 88: Circular shaped buckets (Roberson, 2015)

Another variation of ski jump spillways is the shape of the flip bucket. The bucket can be either circular or triangular (Figure 88, Figure 89). Triangular ski jumps are appealing because they are easier to construct and yield larger throwing distances of the water, as seen in Figure 89, which is better for reducing the possibility of scour holes. More choking, or holding back of water, is present in triangular ski jumps because the water shoots from the spillway at an inclined angle. This also moderates the velocity (Hager, Heller, Minor, & Steiner, 2008). Circular flip buckets do not incorporate a large take off angle.

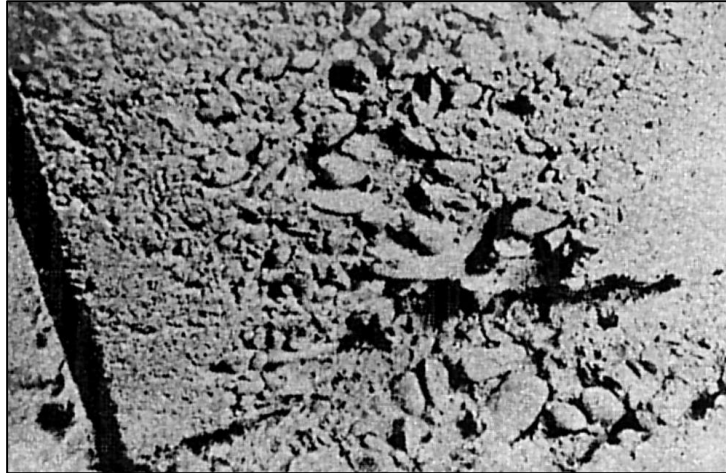
Figure 90: Cavitation in concrete (ACI Committee 210, 1998)
