Energy Efficiency of Historic Meetinghouse on Pleasant Street

Interactive Qualifying Project Report submitted to the Faculty of
Worcester Polytechnic Institute in partial fulfillment of
requirements for the Degree of Bachelor of Science Submitted by:

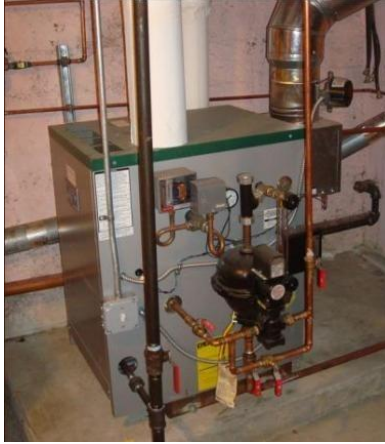
(Figure 1) Steam boiler

A steam boiler (Figure 1) consists of steam valves, gauge glass, low-water cutoff, automatic water feeder, pressure relief valve and steam limit control. In the boiler, the intake water is heated to be steam and the steam is distributed through the pipes and radiators in the space.

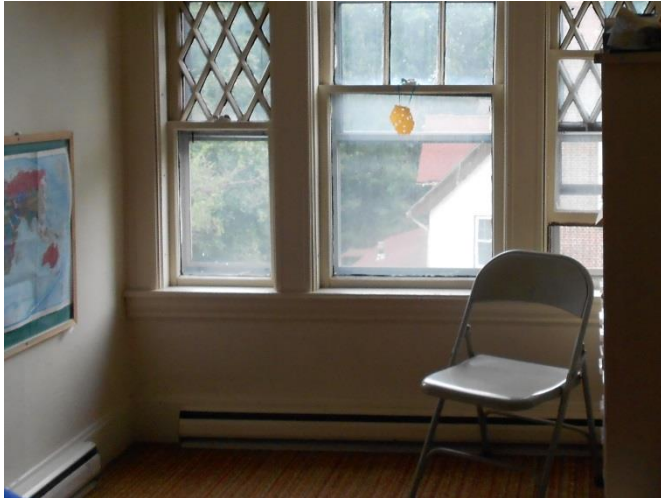
In the current heating system, the meetinghouse has two heating zones. One is the first day school classroom on the third floor. The other one is the rest of the house from the first floor to the third floor. In the First-day School Classroom on the third floor, electrical baseboards are installed on the window side and it is controlled by a switch near the door (Figure 4). The other rooms in the meetinghouse are heated by steam radiators (Figure 5) and the temperatures are controlled by a thermostat on the first floor. The gas-fired steam boiler is located in the basement, installed with a no. RVGP-KS 8-BKF gas vent damper which is operated at 24VAC, 60/50 Hz. and 80mA. The steam is circulated in a loop through boiler, pipes, and radiators located in different rooms.

(Figure 3) Electric resistance heaters in the classroom on the third floor

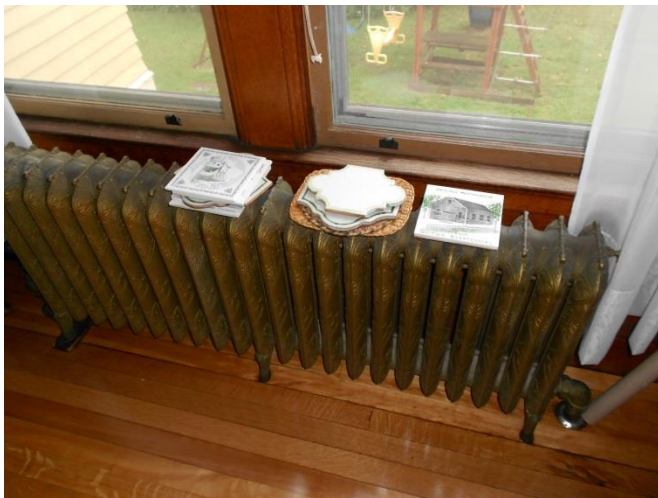
(Figure 4) Radiator on the first floor in Worcester Friends Meetinghouse

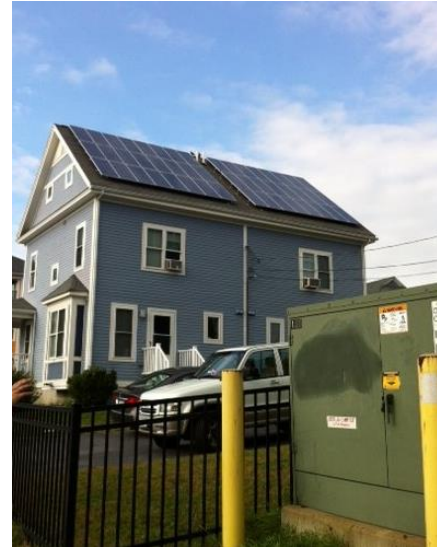
(Figure 5) a residential house with solar panels on the roof, Worcester

A Photovoltaic (PV) system includes PV panels, one or more batteries, an inverter, a charger regulator and wirings. Solar cells on the PV panels absorb photons from the Sun and convert solar energy to direct current (DC). Then DC goes through the inverter in which it is converted to alternating current (AC). If the produced electricity cannot be used up immediately, the part that isn't used can either be stored in the batteries or go into the electrical grid through a net energy meter. The normal batteries used for storage are Lead Acid Batteries. The net energy meter records how much electricity goes into the electrical grid and how much electricity from the grid is consumed. The family only need to pay for the net electricity consumption from the electrical grid. (State of California, California Energy Commission & California Public Utilities Commission) As this indicates, installing PV system on residential houses becomes more economically practicable.

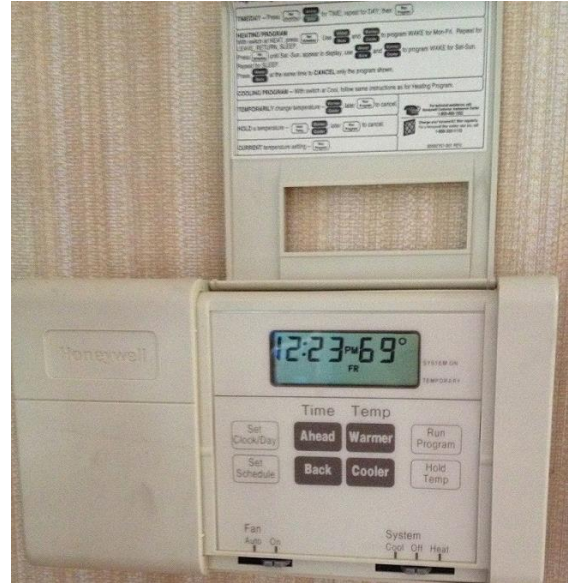
Programmable thermostats are becoming more and more popular as they allow users control over the temperature of their home or work environment. This brings both options of comfort and energy efficiency to a consumer. Most residential thermostats have four setpoints per day. These setpoints are scheduled temperatures throughout the day. They are usually programmable for morning (wake up), day (when at work or out of the house), evening (returning home), and night (sleep) (Jackson 8). The current thermostat in the meetinghouse is a Honeywell programmable thermostat with four setpoints that are in essence set at the same temperature. They are labeled heat, leave, return, and sleep and correspond to the four setpoint described above. The thermostat in the meetinghouse (Figure 6 on next page) is visibly broken as it displays 69 degrees

Fahrenheit but when touring the house, it was significantly warmer. It is partially programmable but ineffective, as it is broken. Rather than cooling or heating the building to the programmed temperature, the heating system attempts to keep the house at a constant high temperature. Additionally, the house is controlled by single zone heating. This is inefficient as the thermostat in the first

floor atrium determines whether the boiler is on or off. The problem with single zone heating is that the boiler may shut off when the first floor is warm but other areas in the house are still cold. Replacing this thermostat may have a significant effect on the energy efficiency of the house.

(Figure 6) The Current programmable thermostat in the meetinghouse

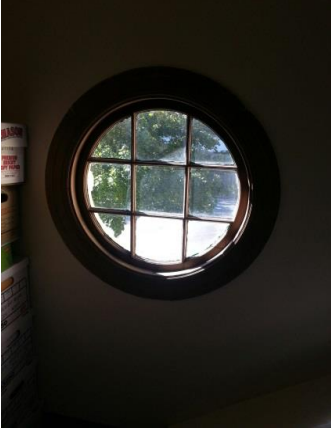
(Table 3) Examples of different windows in the meetinghouse

The most common type of window throughout the house are double hung windows. This is a design featuring two vertically sliding sashes. There are 29 double windows in the meetinghouse and they are all made of softwood. This softwood design requires regular maintenance to prevent wear.

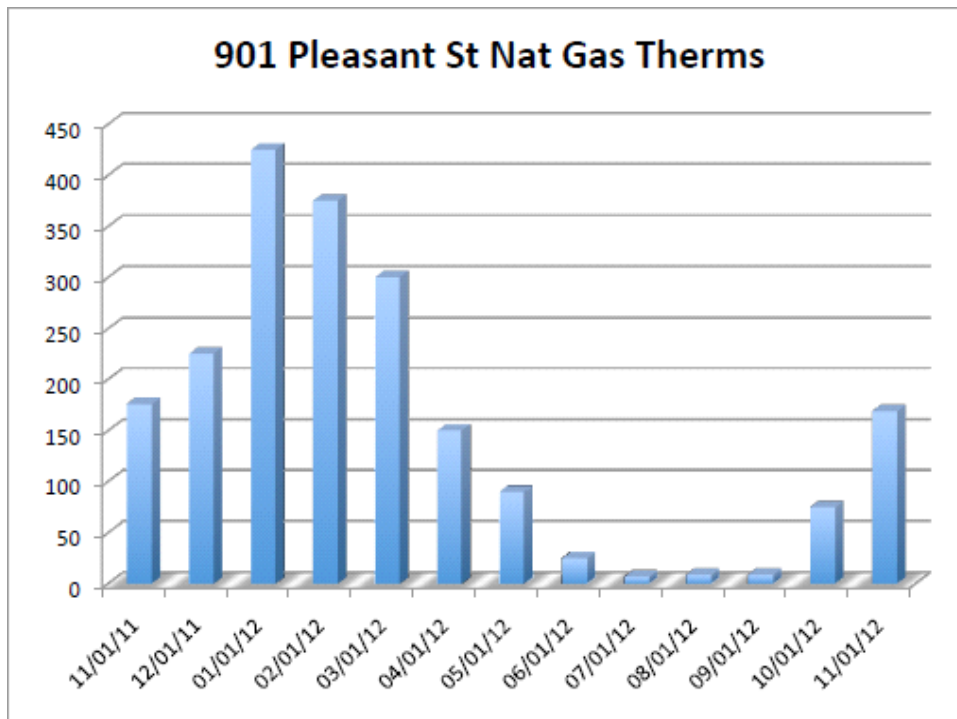
(Figure 13) Pleasant Street Natural Gas Usage Chart (Source: David Legg)

The above figure is a graphical display of the number of Therms of natural gas used during the same time period detailed in the table. Here it is easy to see the trend of energy usage where the amount of heat peaks in the winter months and is almost negligible in the summer months. This collected data from the gas bill acted as a control group or a baseline measurement before energy retrofitting changes took place. Because the cost of heat alone was calculated (\$1778.48) for the year, the gas bills in future years will help determine the heat and money saved. However it is possible that if the wrong thermostat is chosen, the building occupants do not know how to properly use the thermostat, or comfort (heat constantly cranked up) is a concern savings may not be seen.

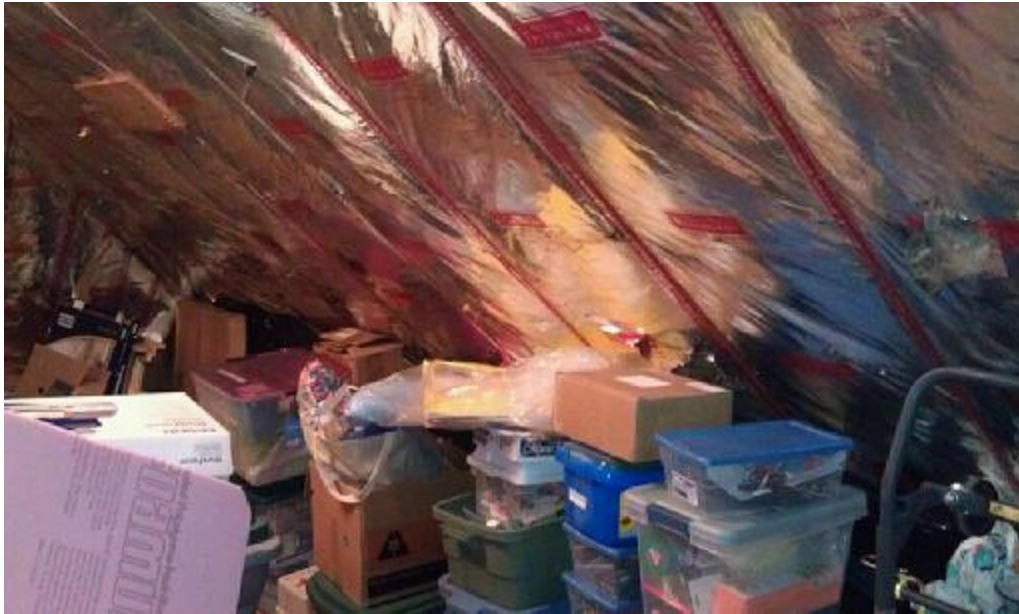
(Figure 14) Current insulation in the meetinghouse attic

The house includes a large amount of attic space that currently lacks the proper up-to-date insulation. The existing insulation is an Owen's Corning fiberglass insulation with an aluminum reflective wrapper, which is insulation from the 70's. This poses a problem with regards to heat loss in the existing attic areas. In the winter, large amounts of heat will escape through these poorly insulated sections of the roof, which is where all the heat rises. This will increase the use of natural gas, thus increasing the cost of heating. With a simple change to the attic space, the upstairs could maintain a better heat controlled space and additionally create two-three closets that could store anything from office supplies to children's toys.

The square footage per bay is 12.8 square feet and for the entire eave, 192 square feet. Based on the research, a feasible replacement for the eave would be using a polyisocyanurate board and fiberglass batt insulation combination. The fiberglass insulation is R-38, Owen's Corning EcoTouch Kraft Batts in Bag Insulation offered from Home Depot. For the 192 square feet, 5 bags need to be purchased at a total of \$238.90. The insulation along has an R-value double that of the previous insulation which is only R-19. The R-value of the new insulation would be is 3.20 per inch vs. the damaged insulation with an R-value of 3.04 when in brand new.

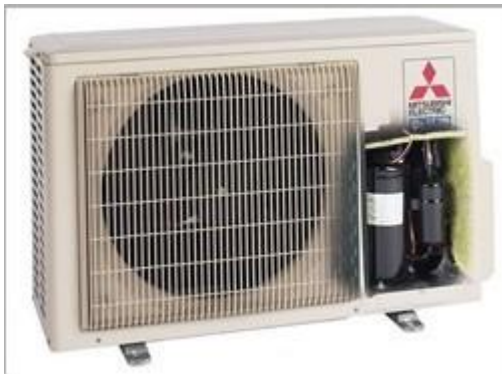
(Figure 15) Mitsubishi Heat Pump (outdoor unit)

Heat pump system offers an acceptable alternative option for residential heating (K.J. Chua, 2010). Its Coefficient of Performance (COP) is high and its performance has been improved a lot recently due to the use of heat-driven ejector and better compressor technology.

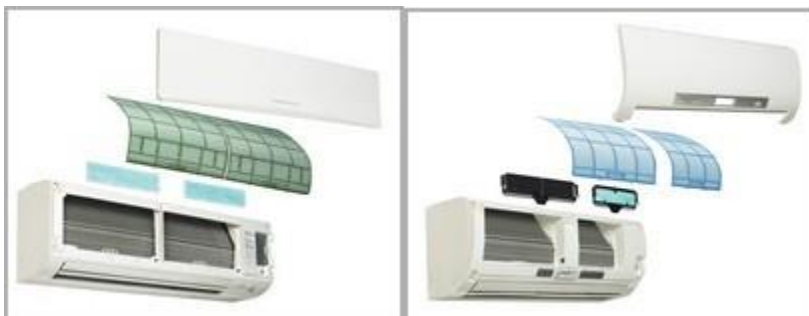
(Figure 16) Mitsubishi air handler (indoor unit)

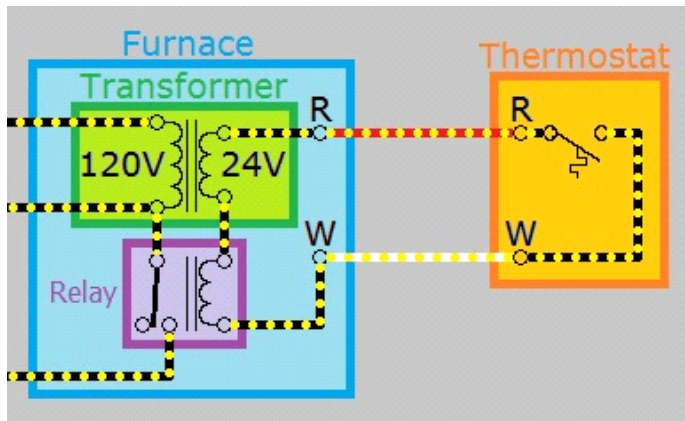
After analyzing several options, a thermostat that would be a good fit was selected for the meetinghouse. This original thermostat choice was the Honeywell VisionPRO (~\$300 list price). This is a high end model and is expensive as it is compatible for up to three heating and two cooling zones. The major obstacle with implementing the thermostat in the building dealt with the outdated heating system. The boiler in the house was configured to only use R and W wires. The R wire is the 24V AC input that is stepped down from the 120V AC wall power through a transformer. This provides power to the thermostat while the W wire goes to the relay switch to control heat. When the relay closes the circuit completes and the boiler turns on. Conversely, when the relay switch is open the boiler is off and not being called. (Fig 15) below visually demonstrates this concept.

(Figure 17) Wiring Setup for 2 Wire Heating System

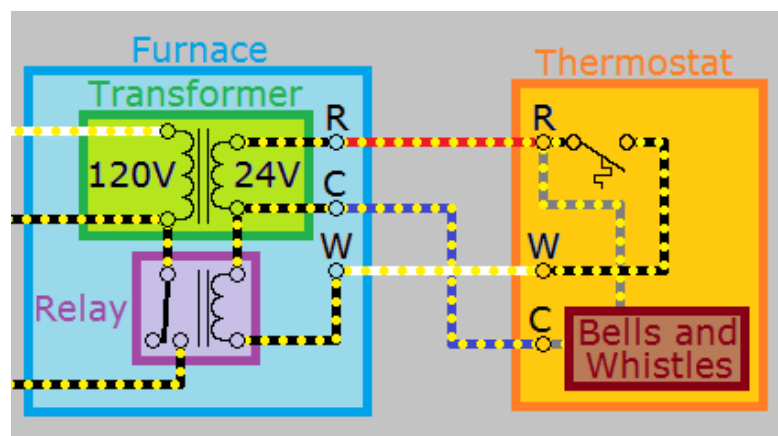
However for the WiFi thermostat to be operational, it needed a C wire, or a 24V AC ground to constantly provide power to the thermostat (completing the 24V loop from the transformer). This C wire needed to run from the 24V AC ground of the transformer to the C terminal on the back of the thermostat. (Figure 18) below visually shows the placement of this wire.

(Figure 18) Wiring Setup for 3 Wire Heating System

Adding this C wire involved purchasing a new electrical wire pairing for a few dollars. It was decided that buying a wire pair was preemptive as if an additional wire is needed in the future it will be readily available. The C wire was not easy to implement as the boiler is outdated and does not have a printed circuit board with labeled terminals. In an attempt to get this AC common voltage, one end of the C wire was connected to the back of the thermostat and the other to the 24V AC ground from the ignition circuit. This was done using a two to one wire connector to add this new wire into the terminal already containing the ground wire from the ignition stage. The picture below (Figure 19) shows terminals of the ignition circuit including 5 the 24V AC ground.

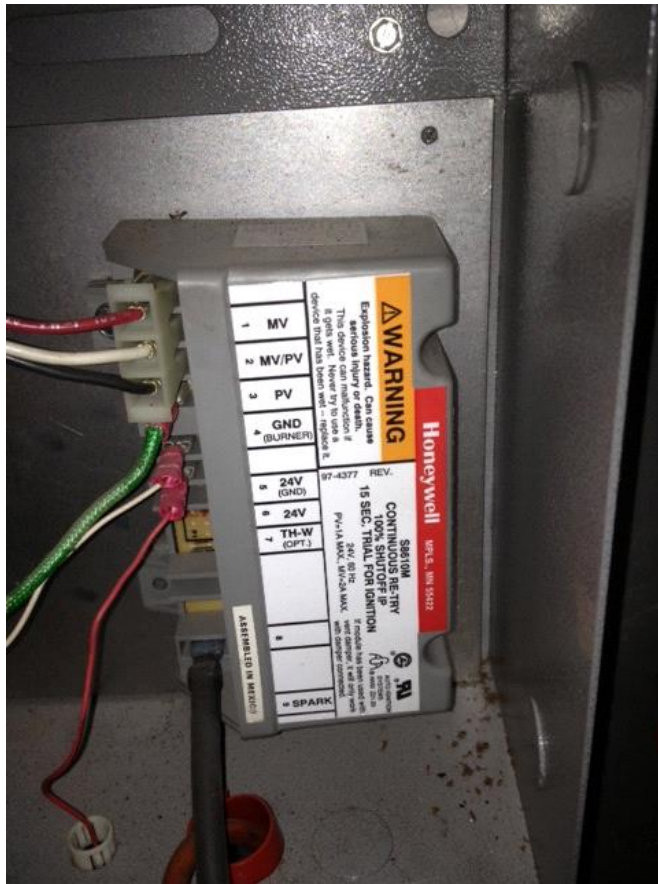
(Figure 19) Ignition Stage Terminals

Running the C wire to the ignition stage seemed feasible from an electrical standpoint as the two wires were terminating at the same node. However when installation of the VisionPRO was attempted, it was unsuccessful. The thermostat was returned to the store as its connections were flimsy and possibly broken. A new thermostat, the Honeywell RTH8580WF, was purchased and successfully installed on December 16, 2013. It was about a hundred dollars cheaper as it is less versatile and cannot control multiple heat pumps. The thermostat can only provide conventional heat as currently in the meetinghouse or heat from a single heat pump. This does not cause a problem with the current setup of the house and still met the requirements set by Dave.

The installation of the RTH8580WF required some troubleshooting to come up with a new method. The proposed idea of wiring the C wire to the ignition stage 24V ground was not effective as the thermostat failed to turn on. After going through various manuals and guide videos with Dave, it was found that it may be possible to get this ground directly off of the transformer (120V to 24V step down). Dave had initially tried this and demonstrated how he connected the R, W, and C wires. The reason the thermostat was not receiving power was because he had the R wire and W wires connected to the transformer on the boiler controlling the relay switch. He connected a wire to the wall transformer common in an attempt to make a C wire. This did not work because the R and C wire loop was never complete and the two transformers were never interacting. To fix this the R and C wire were moved to the 24V AC hot and 24V AC common sides of the wall transformer. These efforts proved valid and when the power was turned back on, the thermostat display lit up. The current schedule for the meetinghouse thermostat is listed in the table below. Note that the wake, leave, and return times are slightly different on Sundays due to hours of worship and more activity.

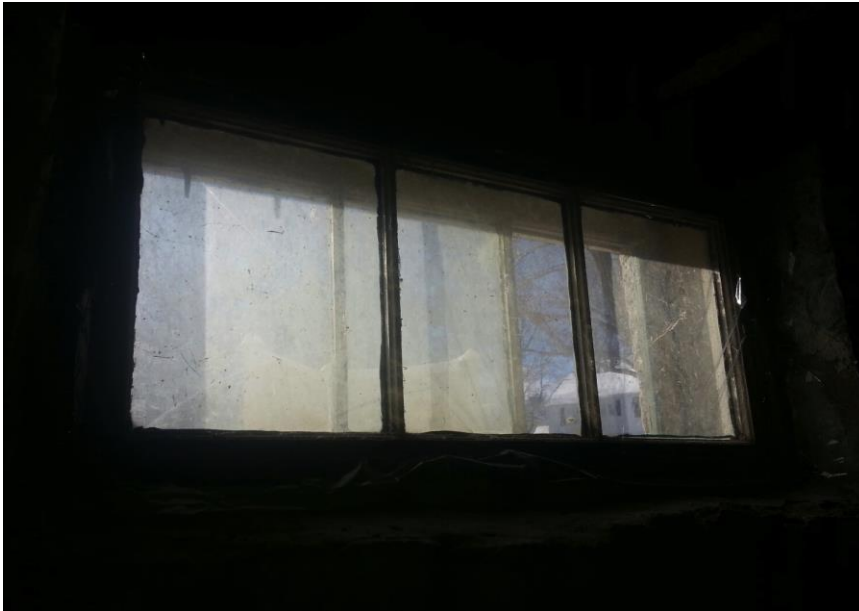
(Figure 22) Window B-11

To window B-11, the 3-M home solution was applied. After applying double-sided tape to the window frame, a thin plastic film was used to cover the entire window. Afterwards we used a hair dryer to tighten the film.
