FAILURE ANALYSIS OF THE WORLD TRADE CENTER 5 BUILDING

A Thesis

This project involves a failure analysis of the internal structural collapse that occurred in World Trade Center 5 (WTC 5) due to fire exposure alone on September 11, 2001. It is hypothesized that the steel column-tree assembly failed during the heating phase of the fire. The results of this research have serious and far-reaching implications, for this method of construction is utilized in approximately 20,000 existing buildings and continues to be very popular. Catastrophic failure during the heating phase of a fire would endanger the lives of firefighters and building occupants undergoing extended egress times (e.g., high-rise buildings), or relying upon defend-in-place strategies (e.g., hospitals). Computer software was used to reconstruct the fire event and predict the structural performance of the assembly when exposed to the fire. Results from a finite element, thermal-stress model confirms this hypothesis, for it is concluded that the catastrophic, progressive structural collapse occurred approximately 2 hours into the fire exposure.

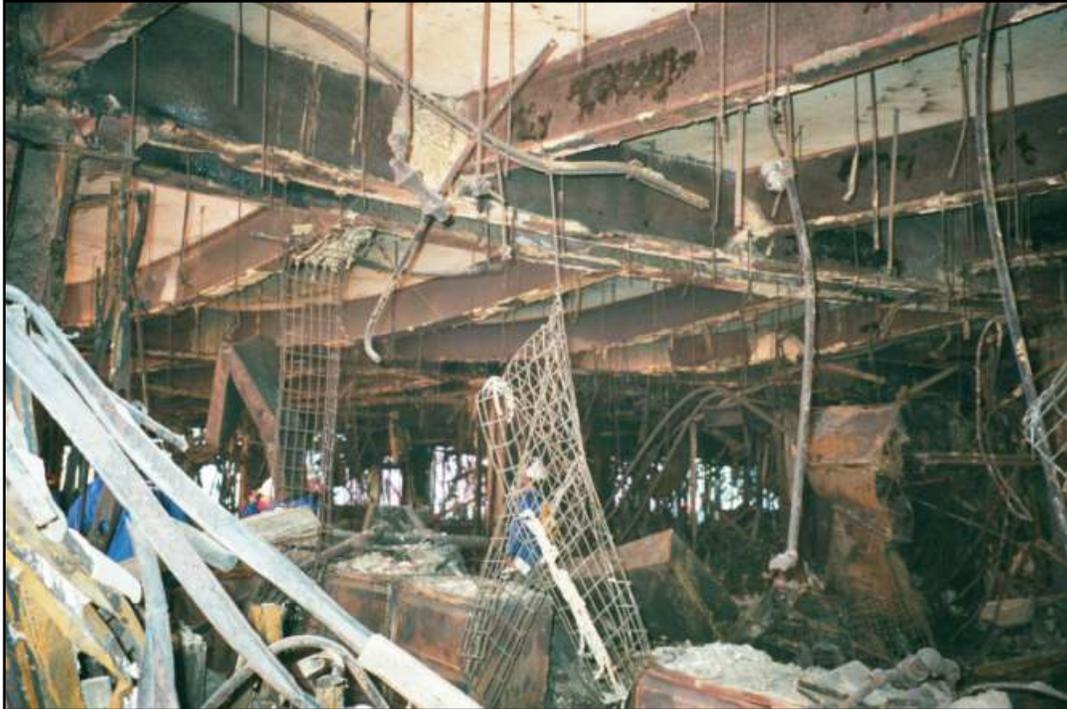
Figure 5: 9th Floor of WTC 5 After Fire Burnout

Generally in a fire the beam and the underside of the concrete slab are heated, causing thermal bowing. As the beam deflects downward, it also undergoes thermal expansion, causing compressive axial restraint forces to develop in the surrounding structure. In time, the yield strength and modulus of elasticity of the steel decreases steadily and the deflection increases, alleviating these restraint forces. The beam then becomes a catenary and tensile forces develop in the beam to resist the dead load on the structure. As the fire reaches its decay stage, the temperature of the compartment decreases and the beam undergoes thermal contraction, which increases the tensile forces within the beam and on the bolted connections. Therefore, steel beam failure can be expected during the cooling phase of a fire if it were to happen. There were instances in WTC 5 which followed this expected mechanism: Figure 5 below shows the 9th floor after the fire had burned out. The exception is the internal structural collapse under an intact portion of the roof from the 8th floor down to through the 5th floor.

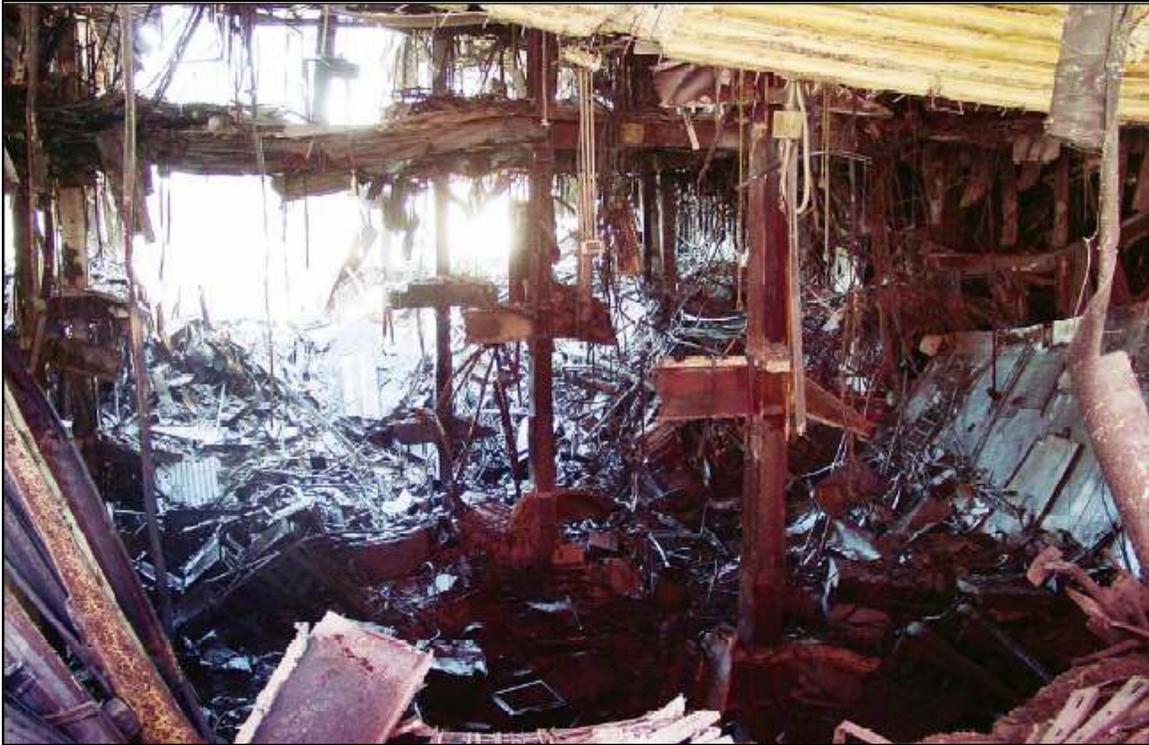
Figure 6: Internal Collapse Area in WTC 5

The fire-induced failure that led to the progressive collapse of WTC 5 was atypical for steel buildings in general. As observed on the ninth floor, the steel beams were expected to deflect significantly, yet carry the load (see Figure 5 above). It is hypothesized that the failure occurred during the heating phase of the fire because the columns remained straight and freestanding after the collapse. Furthermore, the shear connections were located a significant distance away from the columns, thereby weakening their ability to transfer heat energy to a cooler sink (i.e., the columns). If the expected failure mechanism had occurred during the cooling phase, the columns most likely would have been deformed to some extent due to the tensile forces that would have developed in the beams.

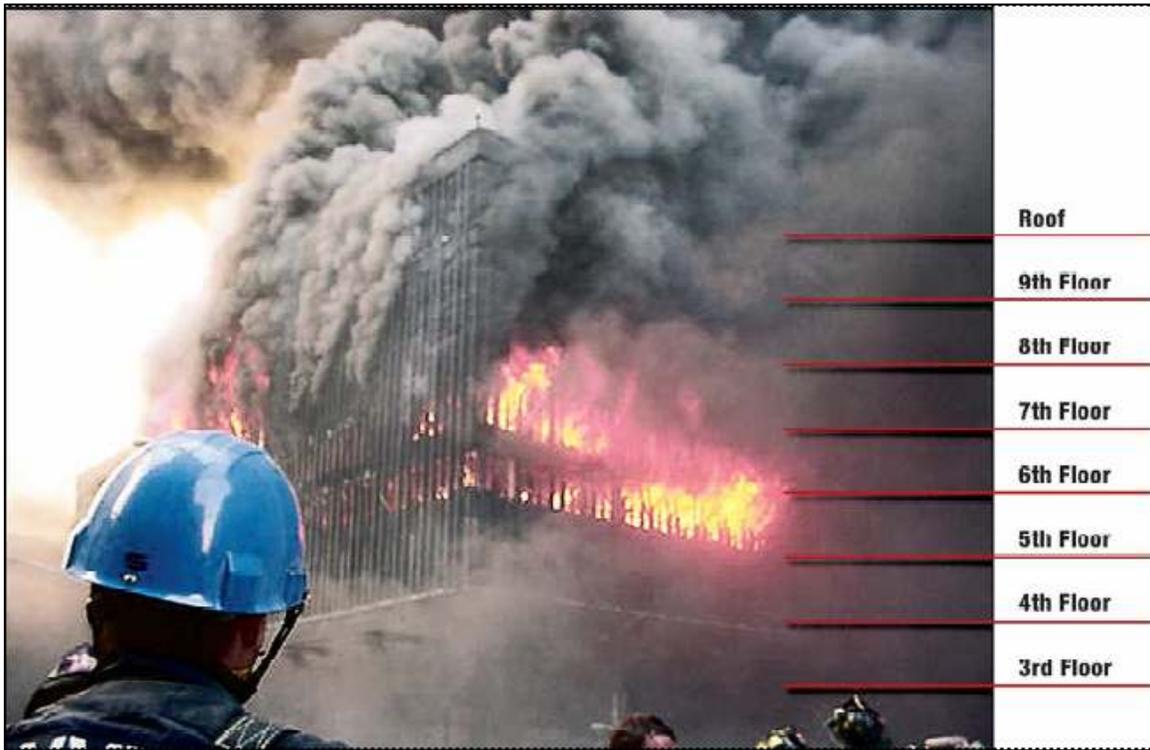
Figure 8: WTC 5 Involved in Fire

There was a complete burnout of all combustibles above the 5th floor of WTC 5, and the sprinkler system did not operate at all due to a drained water supply (see Figure 8 below). The computer model CFAST can predict the effect of a specified fire on gas temperatures, various gas concentrations, and smoke layer heights within a compartment. This software is used to approximate the temperature history of a typical compartment in WTC 5.

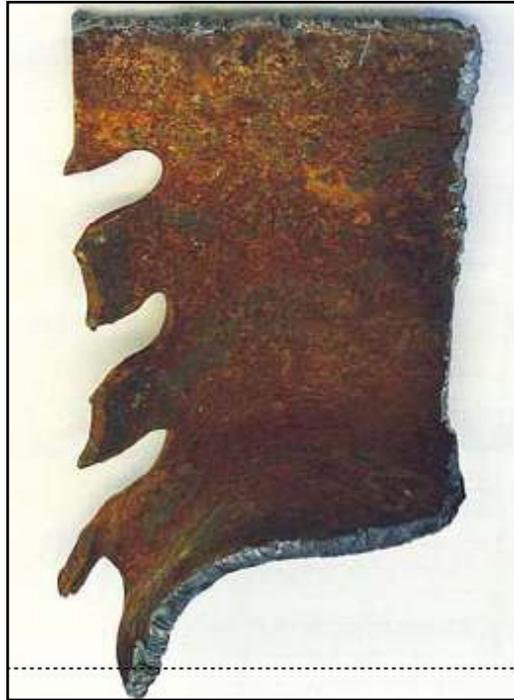
Figure 9: Recovered Beam Stem Sample from WTC 5

permanently as a result. It is hypothesized that the column-tree assembly from WTC 5 never reached this mechanism prior to its failure. The web tear out failure of a collected WTC 5 beam stem specimen is shown in Figure 9 below.

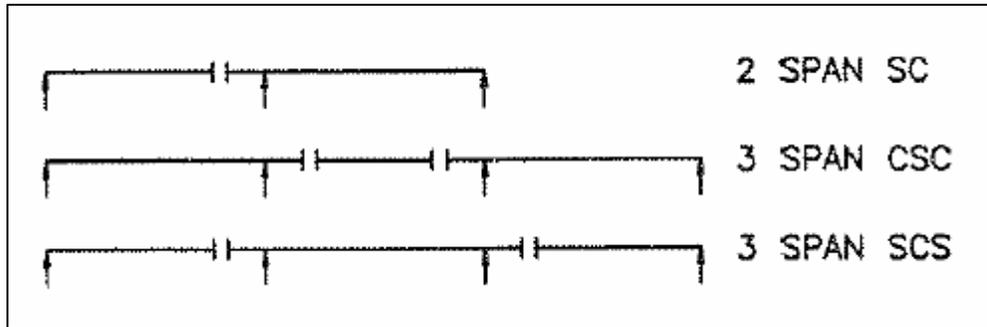
Figure 15: Common Gerber Beam Design Configurations

The Gerber beam design method (also known as the cantilever-splice construction method), which was extensively used in the construction of WTC 5, was invented in the 19th Century by Professor Gerber in Germany. Gerber's design was in response to railroad bridge failures caused by uneven support settlements during this time. The Gerber beam design locates hinges at inflection points to allow settlement without an increase in the maximum bending stress (Schierle). Figure 15 below shows common configurations for the Gerber beam design applied to railroad construction.

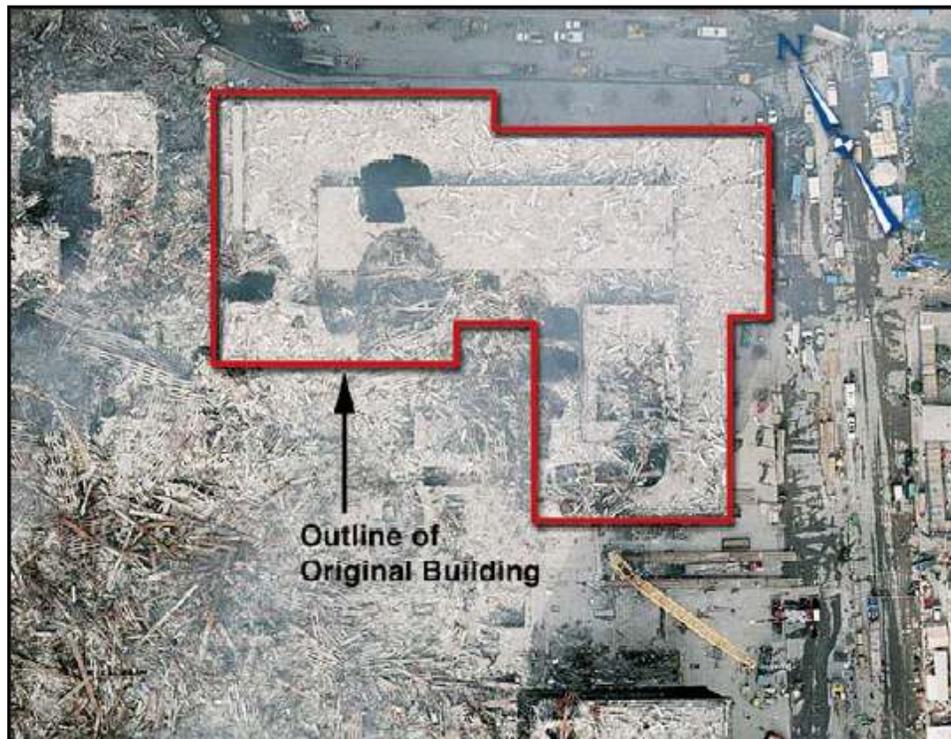
Figure 16: Aerial View of WTC 5 Damage

WTC 5 was damaged by impact of flaming debris from WTC 1 and the subsequent fires. The impact damage areas in western section of WTC 5 are shown in Figure 16 below. Ensuing fires that burned unchecked in the building caused a localized collapse from the 8th through the 5th floors in the eastern section of the building. Figure 17, Figure 18, Figure 19, and Figure 20 below show diagrammatically the collapsed areas of WTC 5 due to impact, as well as due to fire alone.

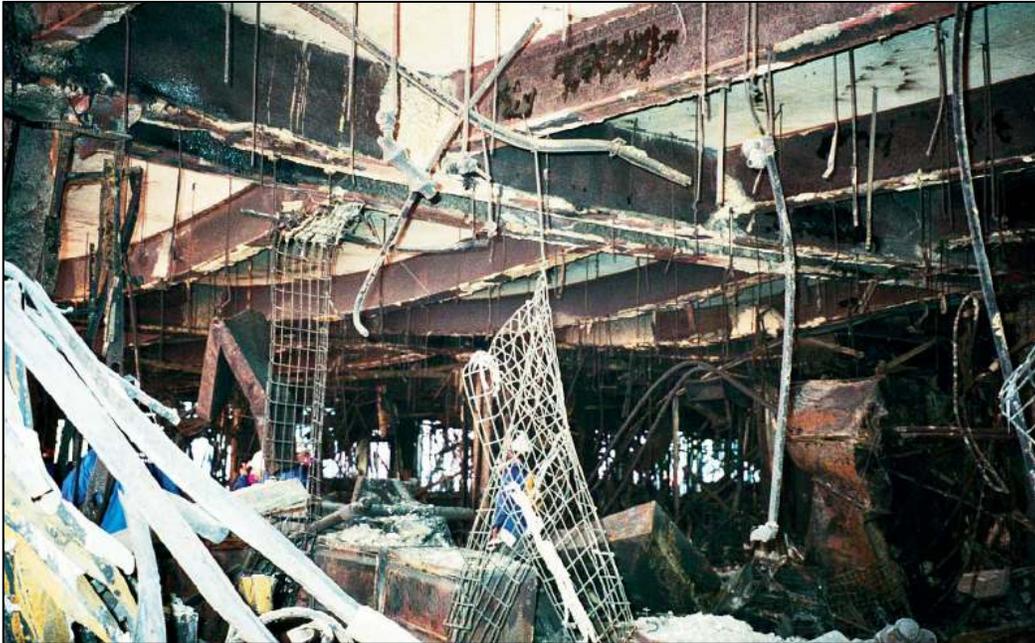
Figure 21: Deformed Beams in WTC 5 (9th Floor) (View 1)

Figure 21 and Figure 22 below show the deformed beams on the 9th floor of WTC 5. It is observed that the beams reached the catenary phase in which they no longer behave as typical beams, but more like tensile cables.

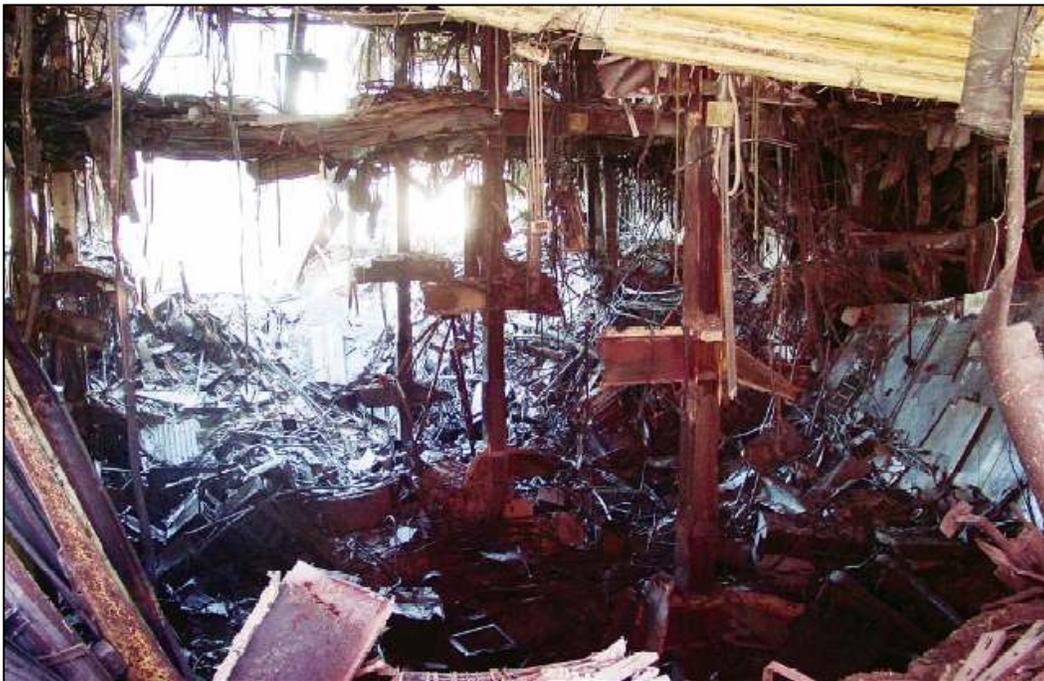
Figure 24: Localized Structural Collapse of WTC 5 (Perspective 2)

Figure 24, Figure 25, Figure 26, and Figure 27 below show different perspectives of the internal structural collapse from the 8th through the 5th floors of WTC 5. The sole focus of the project is this particular collapse, which was due to fire alone.

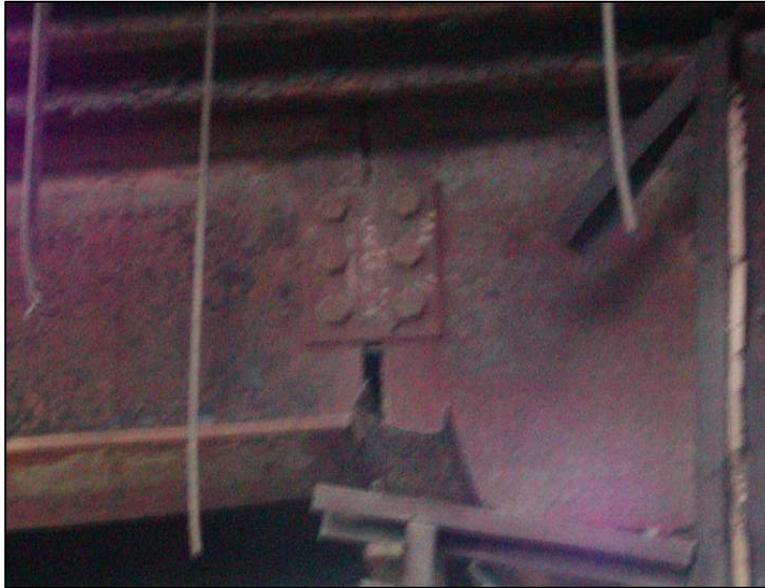
Figure 28: Typical Shear Connection in WTC 5

Figure 28 below is a photograph of a typical shear connection between a beam stem and a floor girder. The upper floors of the building used three bolts at the shear connections; the lower floors used four bolts. Figure 29 and Figure 30 below is a shear connection specimen and its associated drawing detail, respectively (Figure 31 and Figure 32 show a second shear connection specimen and its detail). It is observed that there is a nominal gap distance of $\frac{1}{2}$ in. between the beam stem and the floor girder. Figure 33 below is a web stem specimen collected from WTC 5. This specimen experienced web rupture from what appears to be a moment force. Shear connections of this type are not designed to resist moment forces.

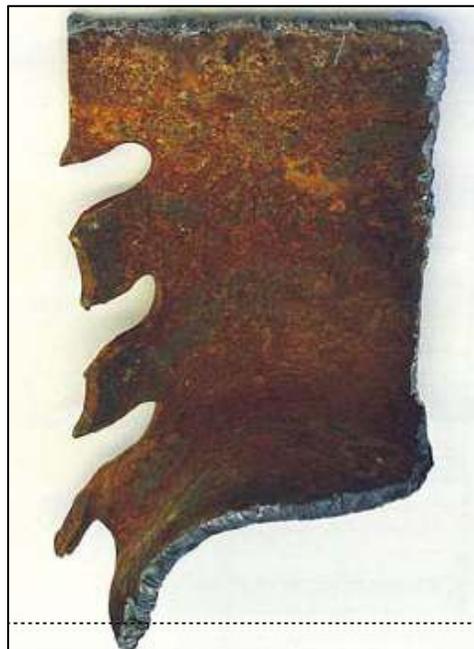
Figure 33: Failed Beam Stem Web Specimen from WTC 5

Figure 33 above is clearly part of a beam stem because Figure 27 above shows a failed beam stem still attached to a column, and the observed bolt hole failure appears very similar between the collected specimen and the beam stem still intact.

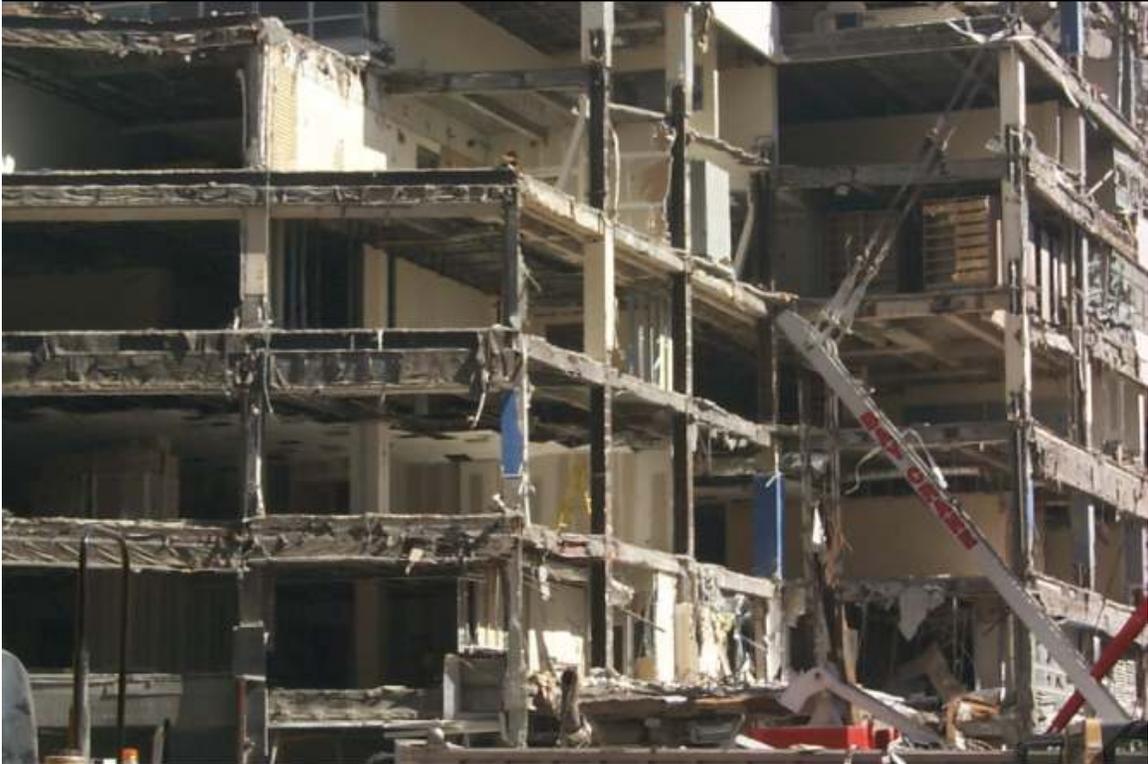
Figure 34: Exterior View of WTC 5 (Shielded Columns)

Figure 34 below shows the exterior of WTC 5 during its demolition. It is observed that in addition to their specified 1-3/8 in. (3-hour), spray-applied insulation, mostly all of the building columns were either located behind walls or fully boxed in with wall material during their service. This would suggest that mostly all of the columns were fully shielded during the fire and probably never reached very high temperatures relative to the beams and girders, which were not shielded and had 1-in. (2-hour) insulation. Therefore, the columns would have acted as heat sinks for the beams and girders to the rest of the “cooler” structure.

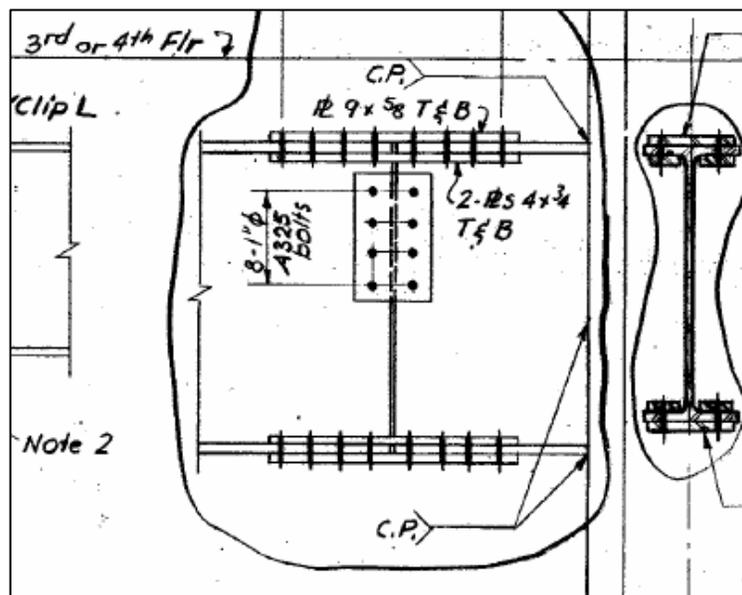
Figure 39: Typical Connection on the 4th Floor of WTC 5

The girder-to-beam stem connections on the 4th floor are different from those shown in Figure 37 above. Figure 39 below shows that these connections were moment-resisting.

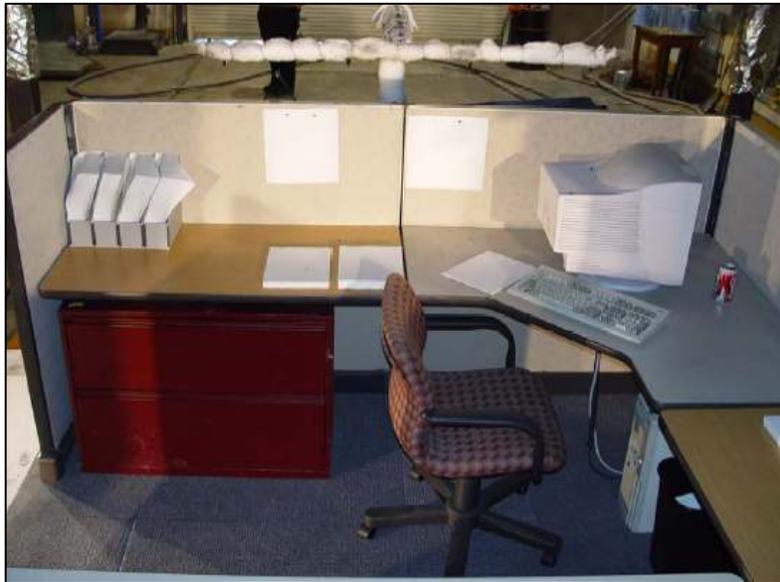
Figure 40: Office Cubicle Testing Assembly

The National Institute of Standards and Technology (NIST) released a report in 2005 (by Ohlemiller et al.) which describes a series of six fire tests of single office cubicles, the dominant combustibles in the WTC 1 building. For each test, the entire assembly was placed beneath the hood of a NIST 10 MW calorimeter and the effective heat of combustion was derived. Figure 40 and Figure 41 below show the office cubicle testing assembly prior to and during fire exposure for one of the six tests conducted.

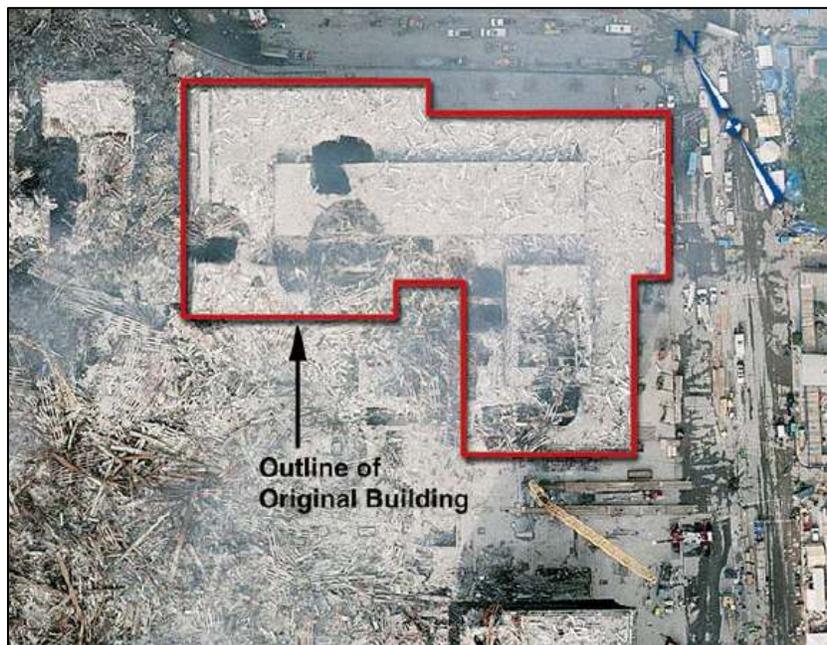
Figure 48: Roof Damage to WTC 5

In typical compartments, post-flashover fires are ventilation controlled. In the case of WTC 5, large holes in the roof of the western portion of the building were present during the fire exposure which allowed for smoke venting from the eastern portion (see Figure 48 below). Therefore, a fuel-controlled fire was simulated using CFAST by providing five flow vents from the compartment (see Figure 49 and Figure 50 below). The high ventilation conditions may provide the fire with an abundance of oxygen, but it also serves to vent heat from the upper gas layer from the compartment. Therefore, a fire that does not produce a very high peak temperature would be expected.

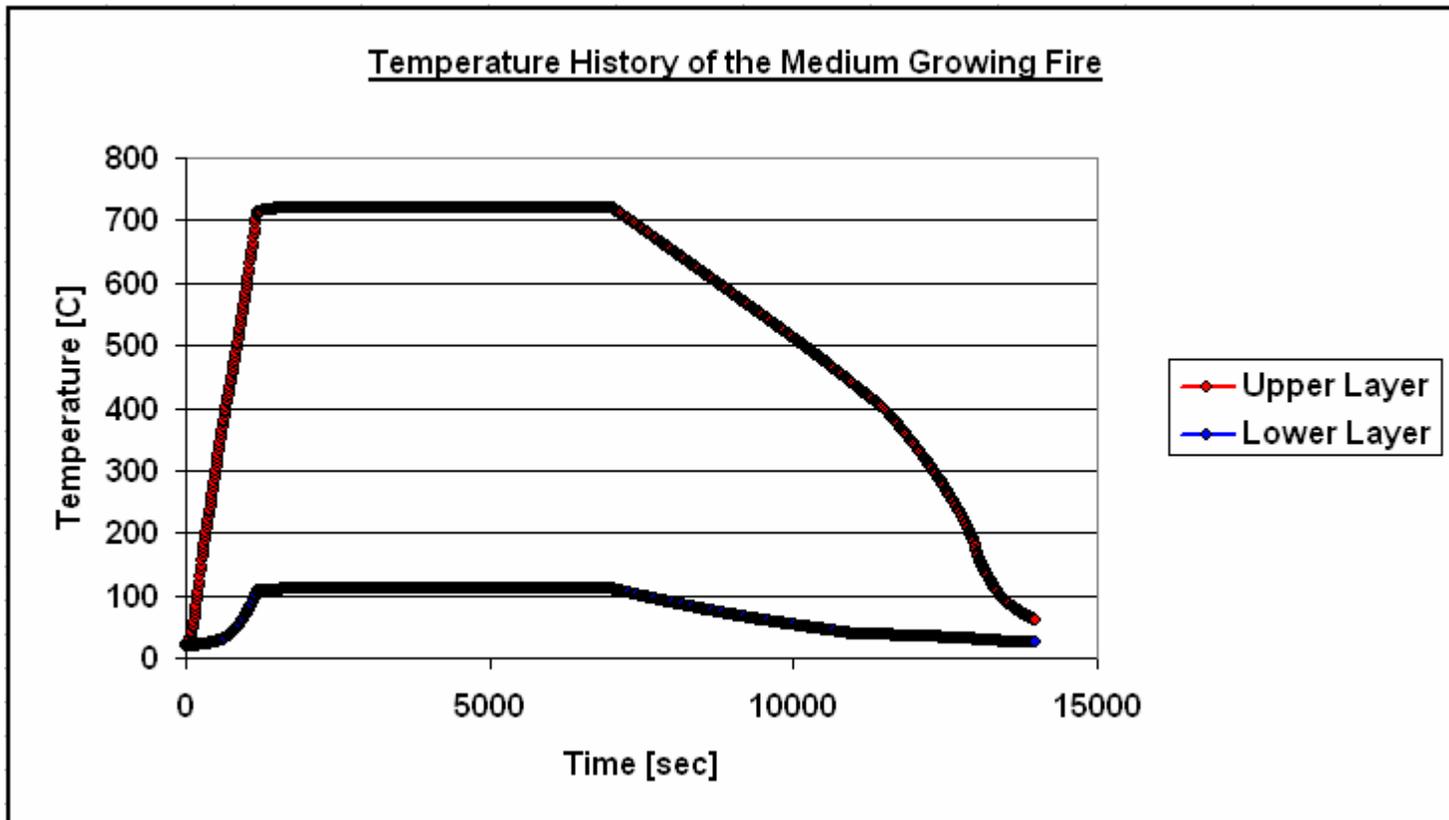
Figure 51: Temperature History of the Medium Growing Fire Scenario

The temperature histories of the medium, fast, and ultra-fast fire scenarios that were derived from CFAST are shown in Figure 51, Figure 52, and Figure 53, respectively. By comparing the heat release rate versus time plots from the results of CFAST to those manually inputted at the start of the simulation, it was confirmed that all three of the design fires are indeed fuel-controlled. More precisely, the heat release rate peaked at 16 MW for each of the design fires; the ventilation conditions did not affect the combustion process. Figure 54 below shows a comparison of the three temperature history scenarios of the reconstructed fire to that for the ASTM E-119 furnace test.

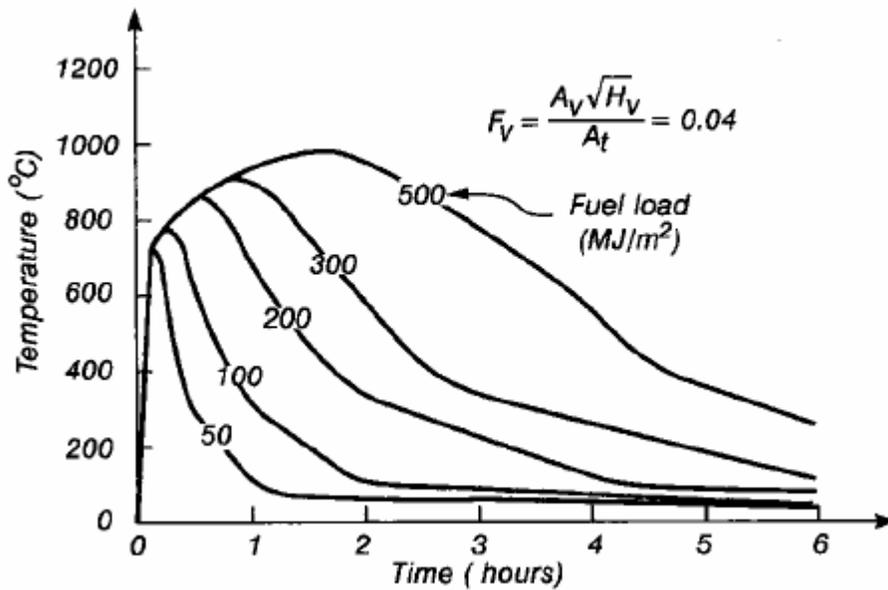
Figure 55: Time-Temperature Curves for Real Fire Exposure (EC1)

The most widely referenced time-temperature curves for real fire exposure are those of Magnusson and Thelandersson. These curves are derived from heat balance calculations for the burning rate of ventilation controlled fires. Figure 55 below shows the effect of varying the fuel load for a constant size of ventilation opening. It can be observed that these temperature history curves last about 4 hours and are relatively comparable to those derived for the reconstructed fire in WTC 5 (as shown in Figure 54 above). The fire in WTC 5 was fuel controlled, as opposed to ventilation controlled, thus the differences between the two curves is expected. It can therefore be stated that the reconstructed fire of WTC 5 is physically reasonable.

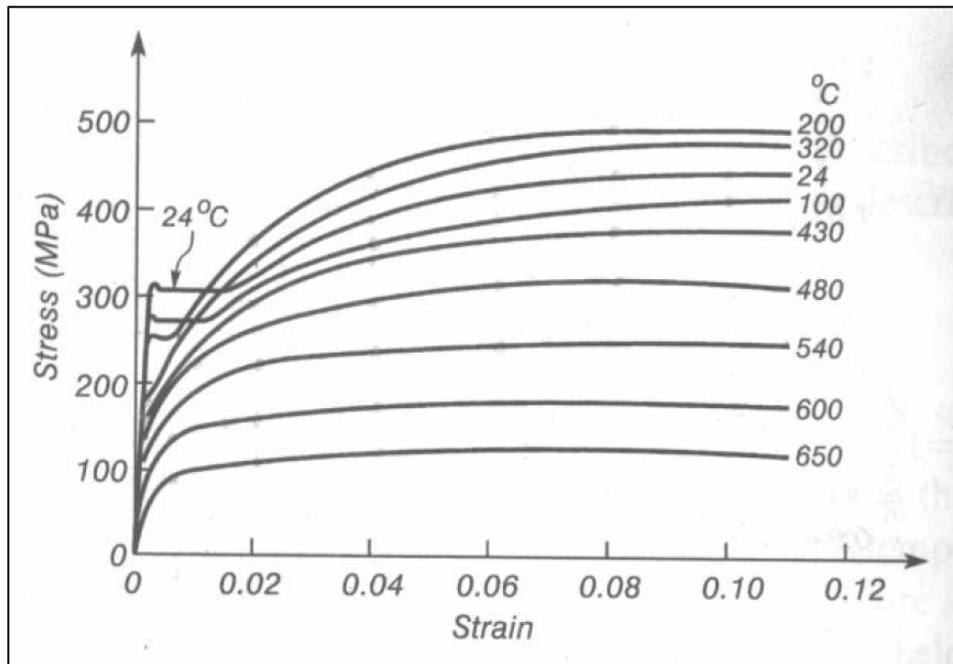
Figure 56: Stress-Strain Test Results (Harmathy)

Harmathy performed A36 steel strength tests at a wide range of elevated temperatures. The results of this work are shown in Figure 56 below. As this figure shows, most normal construction steels have very well-defined yield strength at normal temperatures, but this disappears at elevated temperatures. The 2005 NIST report concerning WTC 1 and 2 references this data from Harmathy. For added clarity, the results shown in Figure 56 are represented in Figure 57 below.

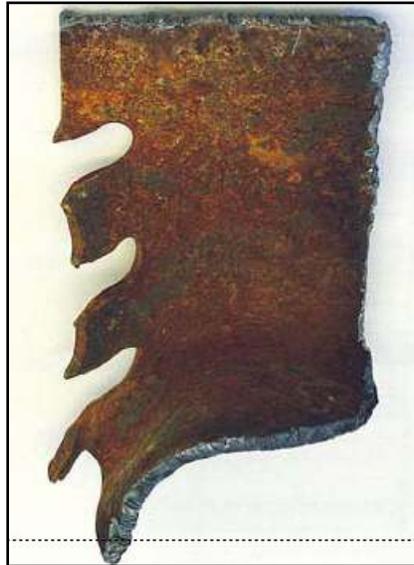
Figure 59: Web Tear Out of a Beam Stem Web from WTC 5

The WTC 5 connection failures not influenced by debris impact were due to shear rupture of the web portion of the beam stems. Figure 59 below is forensic evidence that demonstrates this shear rupture failure. This type of failure occurs when the bolts bear against the weak side (i.e., acting toward the free end of the member) of the bolt holes. Moreover, this bearing stress causes shear planes to form in the web steel. Finally, cracks along the shear planes cause catastrophic failure of the shear connection.

The connection failures as a result of fire exposure in WTC 5 were due to shear rupture of the web portion of the beam stems. This type of failure occurs when the bolts bear against the weak side (i.e., acting toward the free end of the member) of the bolt holes. Moreover, this bearing stress causes shear planes to form in the web steel. Finally, cracks along the shear planes cause catastrophic failure of the shear connection. The goal of this project is to predict when the shear connections of WTC 5 experienced catastrophic failure as described above. In order to accomplish this goal, the time at which cracks along the shear planes begin to form must be derived. ABAQUS does not have the capabilities to predict the formation of cracks within a deformable body explicitly. Therefore, an indirect technique was derived to predict the time at which connection failure occurred.

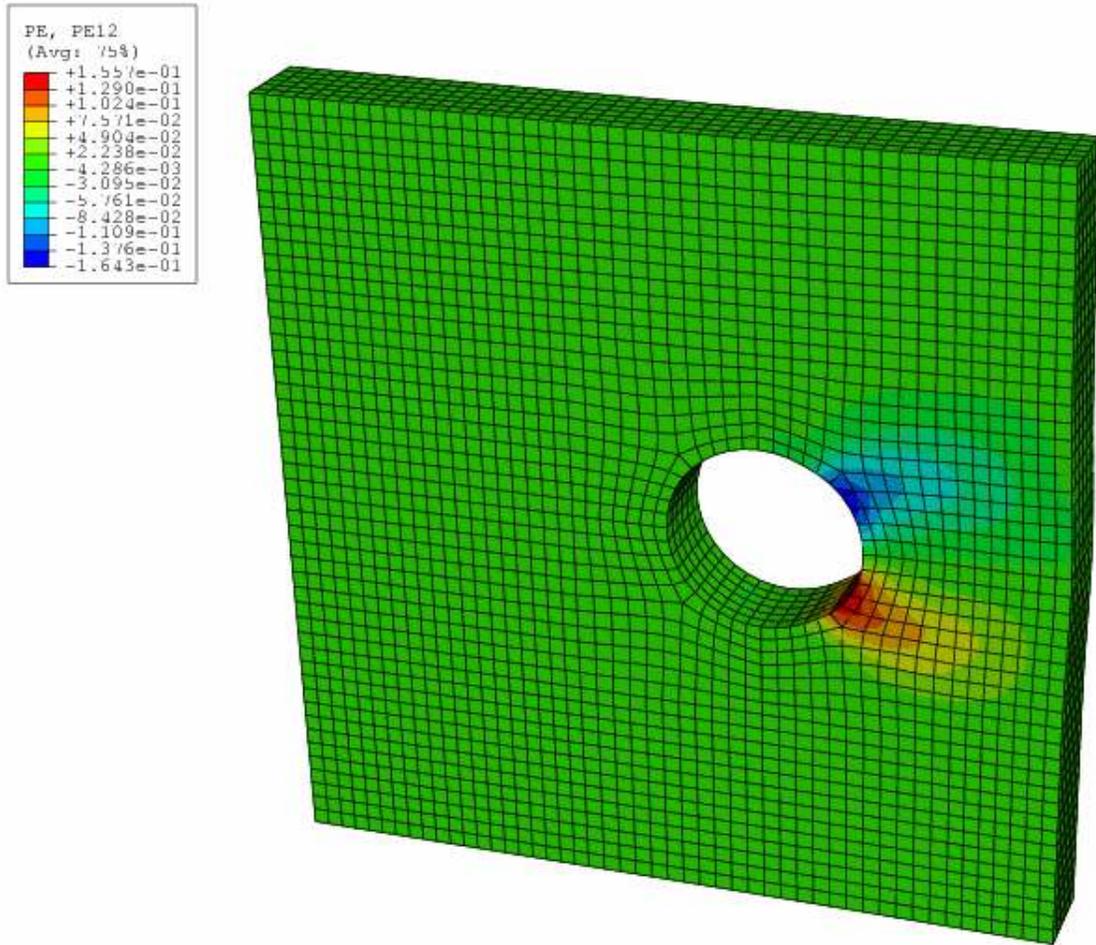
Figure 67: Shear Strain Distribution (Failure Load Application)

The shear strain of the steel in the vicinity of the bolt hole was observed under the failure loading (see Figure 67 below). Furthermore, a mesh refinement analysis was conducted in order to ensure that the result is mesh-independent. Table 5 below summarizes the mesh refinement analysis and shows that the failure criterion for the WTC 5 thermal-stress model is a shear strain of approximately 0.16 (or 16%) at the weak side of a bolt hole.

A failure criterion determination model created in ABAQUS includes a single bolt and hole. Using the AISC Steel Manual (LRFD), a failure load was derived and applied to this model. The plastic shear strain at failure was then derived to serve as the failure criterion for shear rupture at a bolt hole. This failure criterion is important, for the stress distribution in the vicinity of the bolt hole has limited application at elevated temperatures in terms of predicting failure.

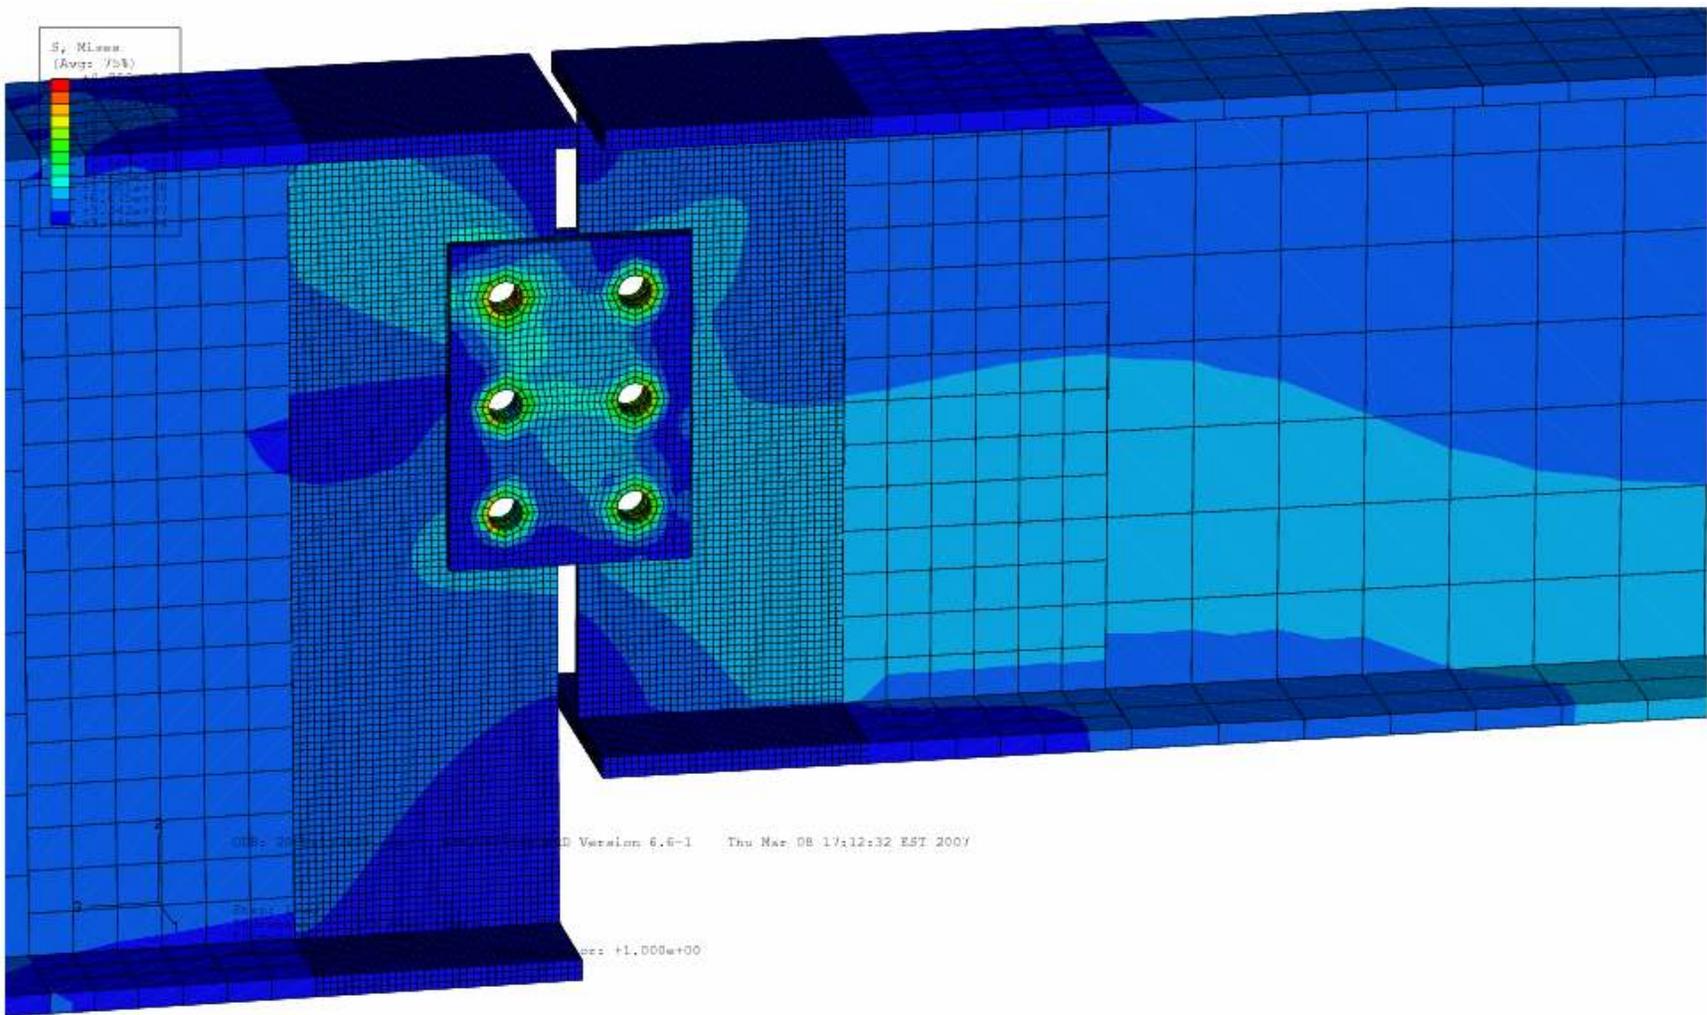
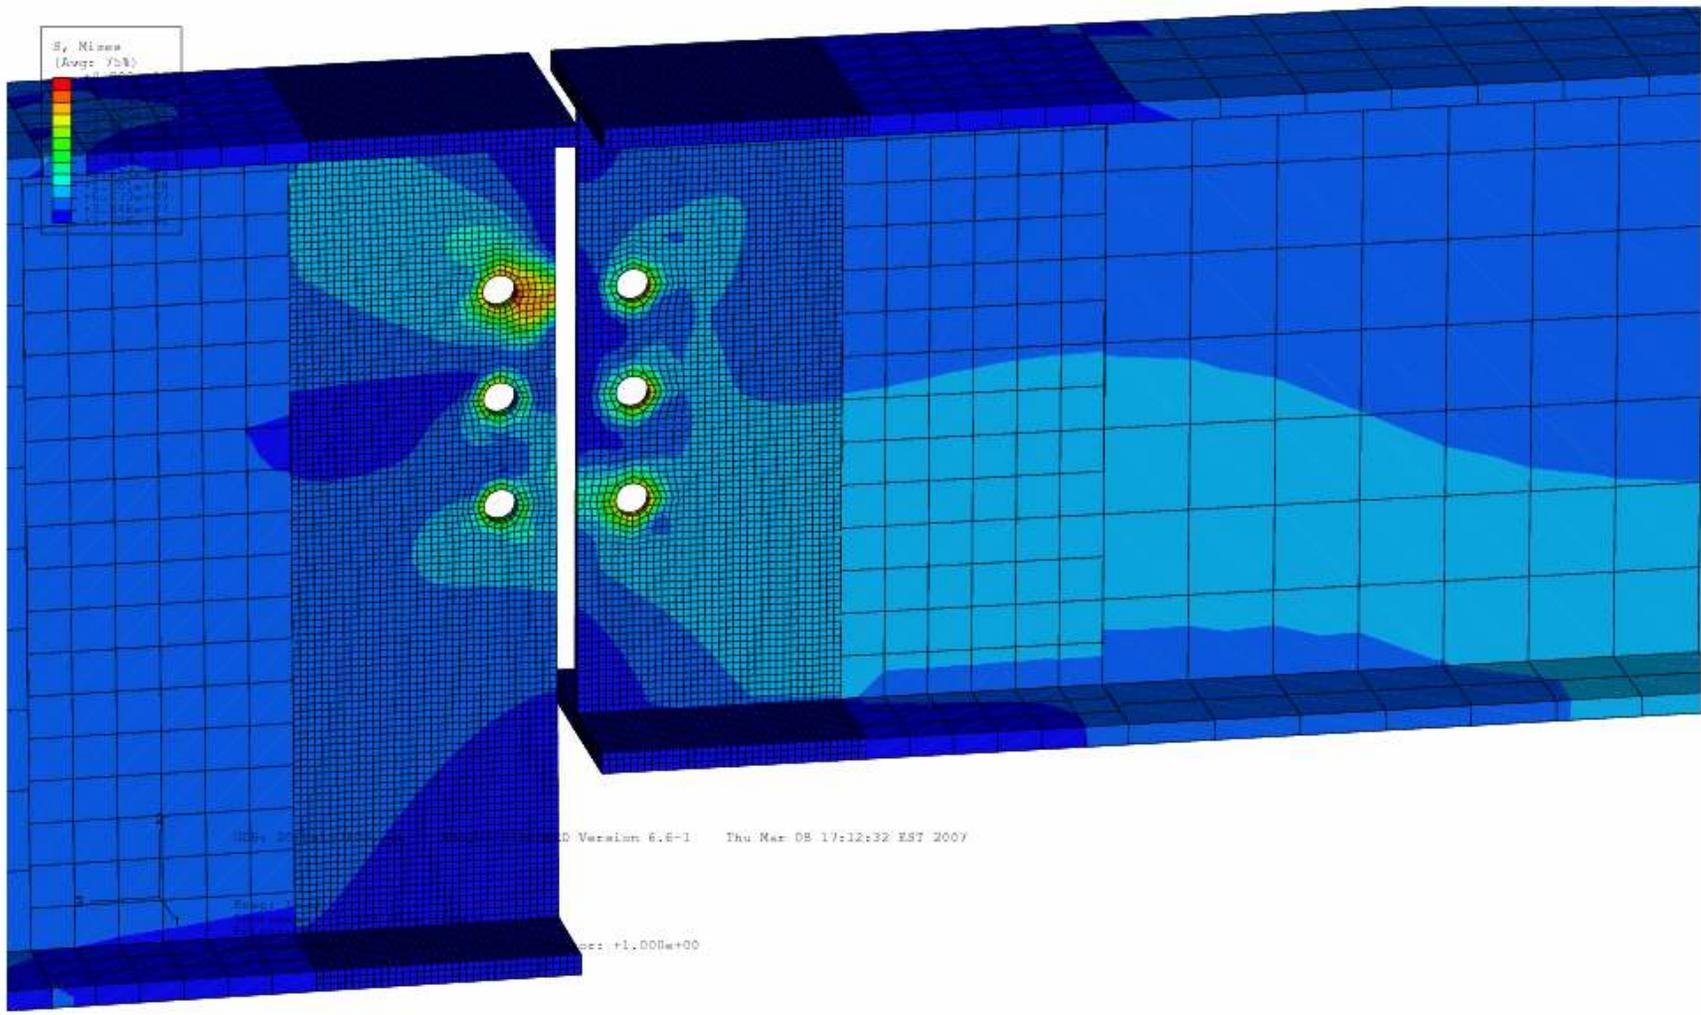
Figure 70 and Figure 71 below show the stress distribution in the vicinity of the shear connection. The upper limit (red) of the contour plot was set to the ultimate strength of the A36 steel (58 ksi). Figure 72 below shows a plot of the equivalent strain; no permanent deformation is observed. This makes physical sense, for permanent deformation would not be expected under ambient conditions. It can be concluded that the mechanical model represents the structural behavior of the assembly accurately under ambient conditions. Therefore, this model will serve as a proper foundation for the sequentially-coupled, thermal-stress model.

Figure 70: Von Mises Stress Distribution (Shear Tabs Included)

Figure 71: Von Mises Stress Distribution (Shear Tabs Excluded)

The mechanical model was tested at ambient conditions to ensure the results are realistic. The behavior of any steel assembly under ambient, service conditions is well understood and easily discernable from experience. The maximum deflection of the floor girder was found to be generally consistent with structural engineering standards. Thus, the behavior of the mechanical model was validated for normal ambient conditions.
