FAILURE ANALYSIS OF THE WORLD TRADE CENTER 5 BUILDING

A Thesis

This project involves a failure analysis of the internal structural collapse that occurred in World Trade Center 5 (WTC 5) due to fire exposure alone on September 11, 2001. It is hypothesized that the steel column-tree assembly failed during the heating phase of the fire. The results of this research have serious and far-reaching implications, for this method of construction is utilized in approximately 20,000 existing buildings and continues to be very popular. Catastrophic failure during the heating phase of a fire would endanger the lives of firefighters and building occupants undergoing extended egress times (e.g., high-rise buildings), or relying upon defend-in-place strategies (e.g., hospitals). Computer software was used to reconstruct the fire event and predict the structural performance of the assembly when exposed to the fire. Results from a finite element, thermal-stress model confirms this hypothesis, for it is concluded that the catastrophic, progressive structural collapse occurred approximately 2 hours into the fire exposure.

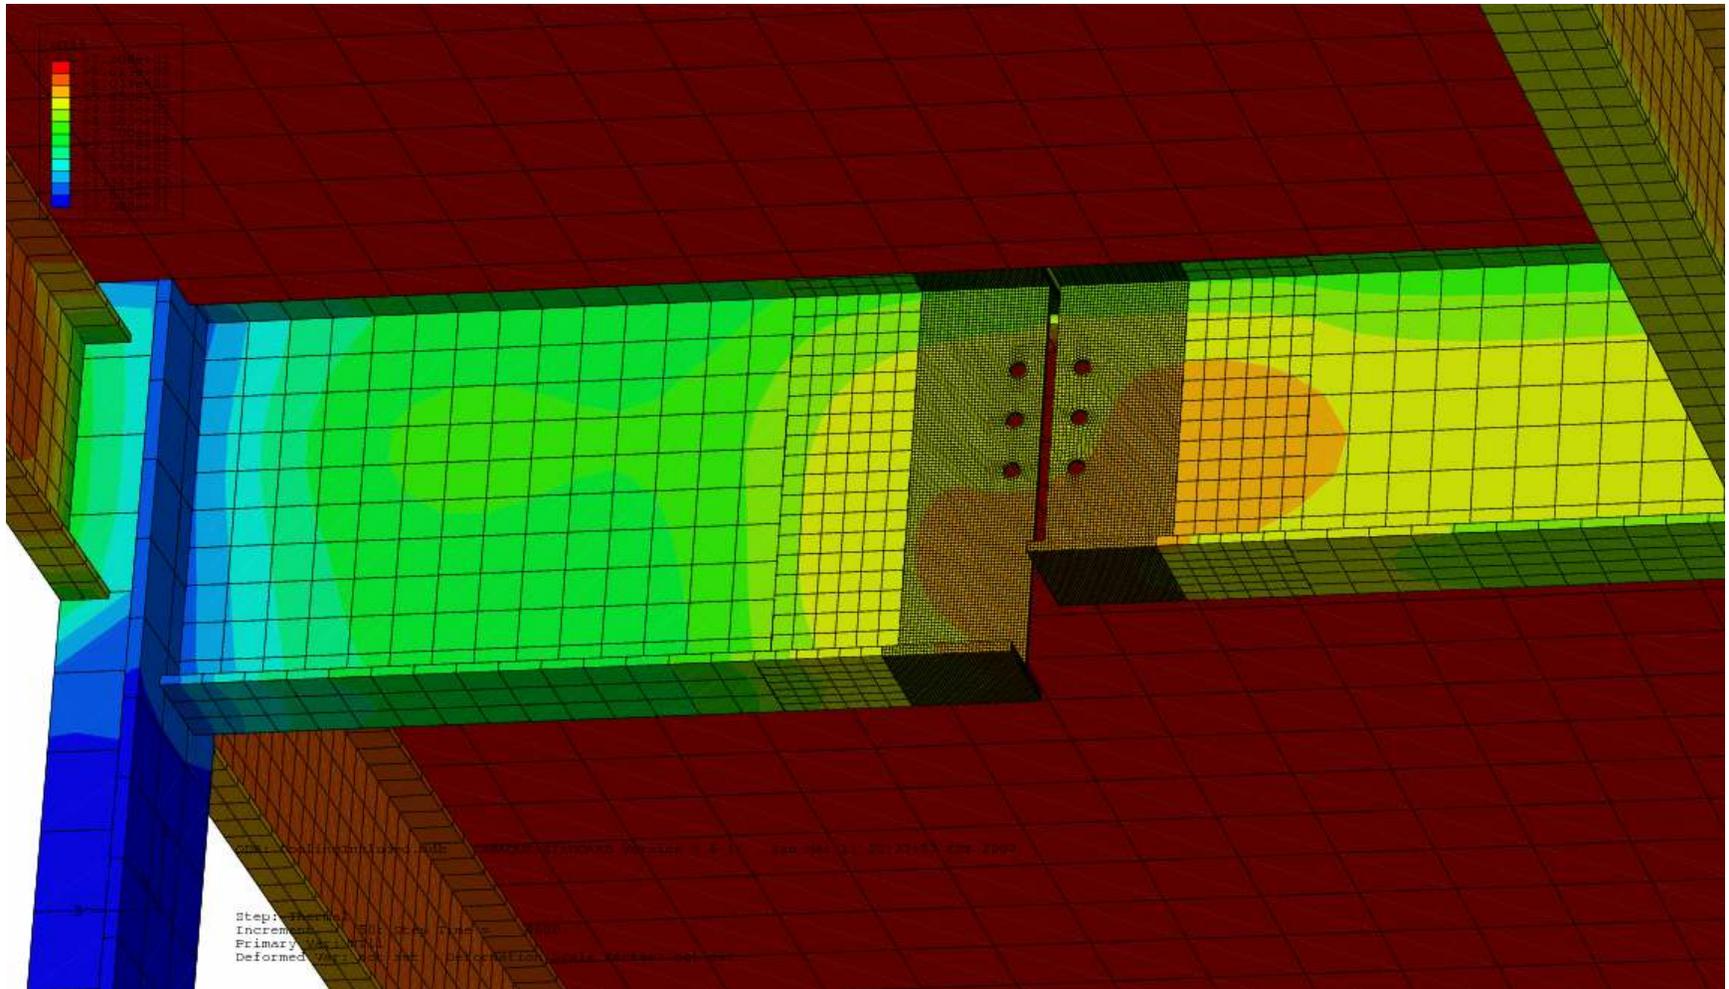
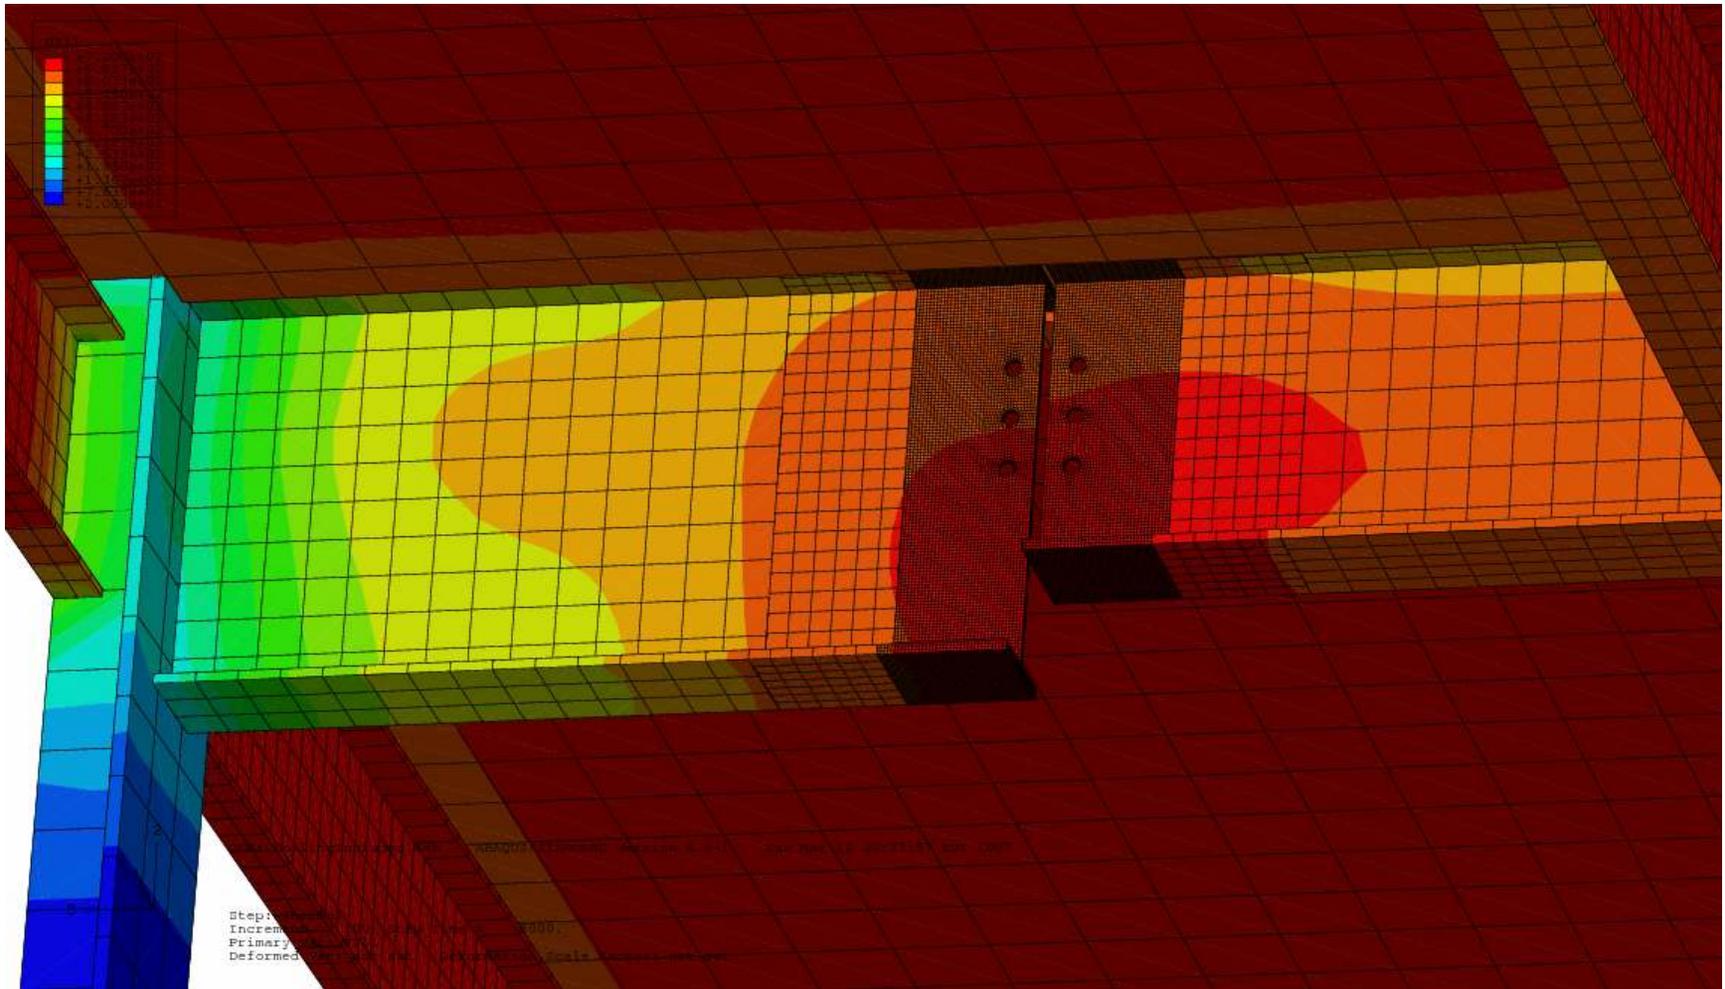
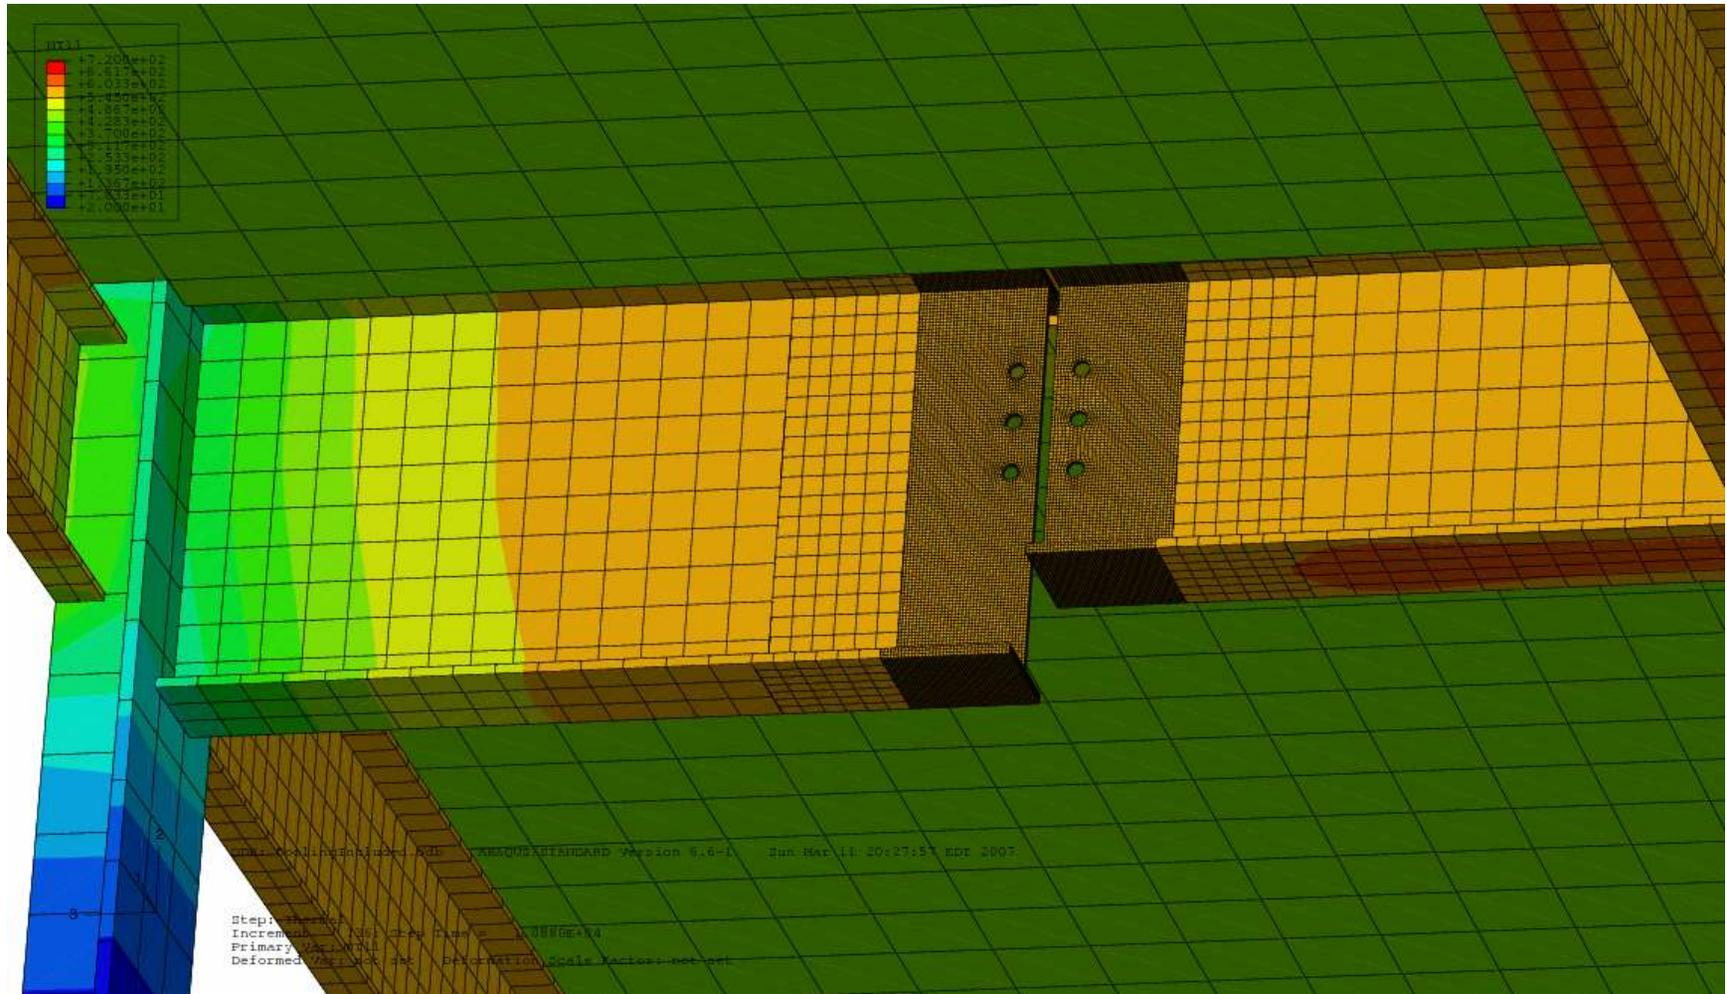
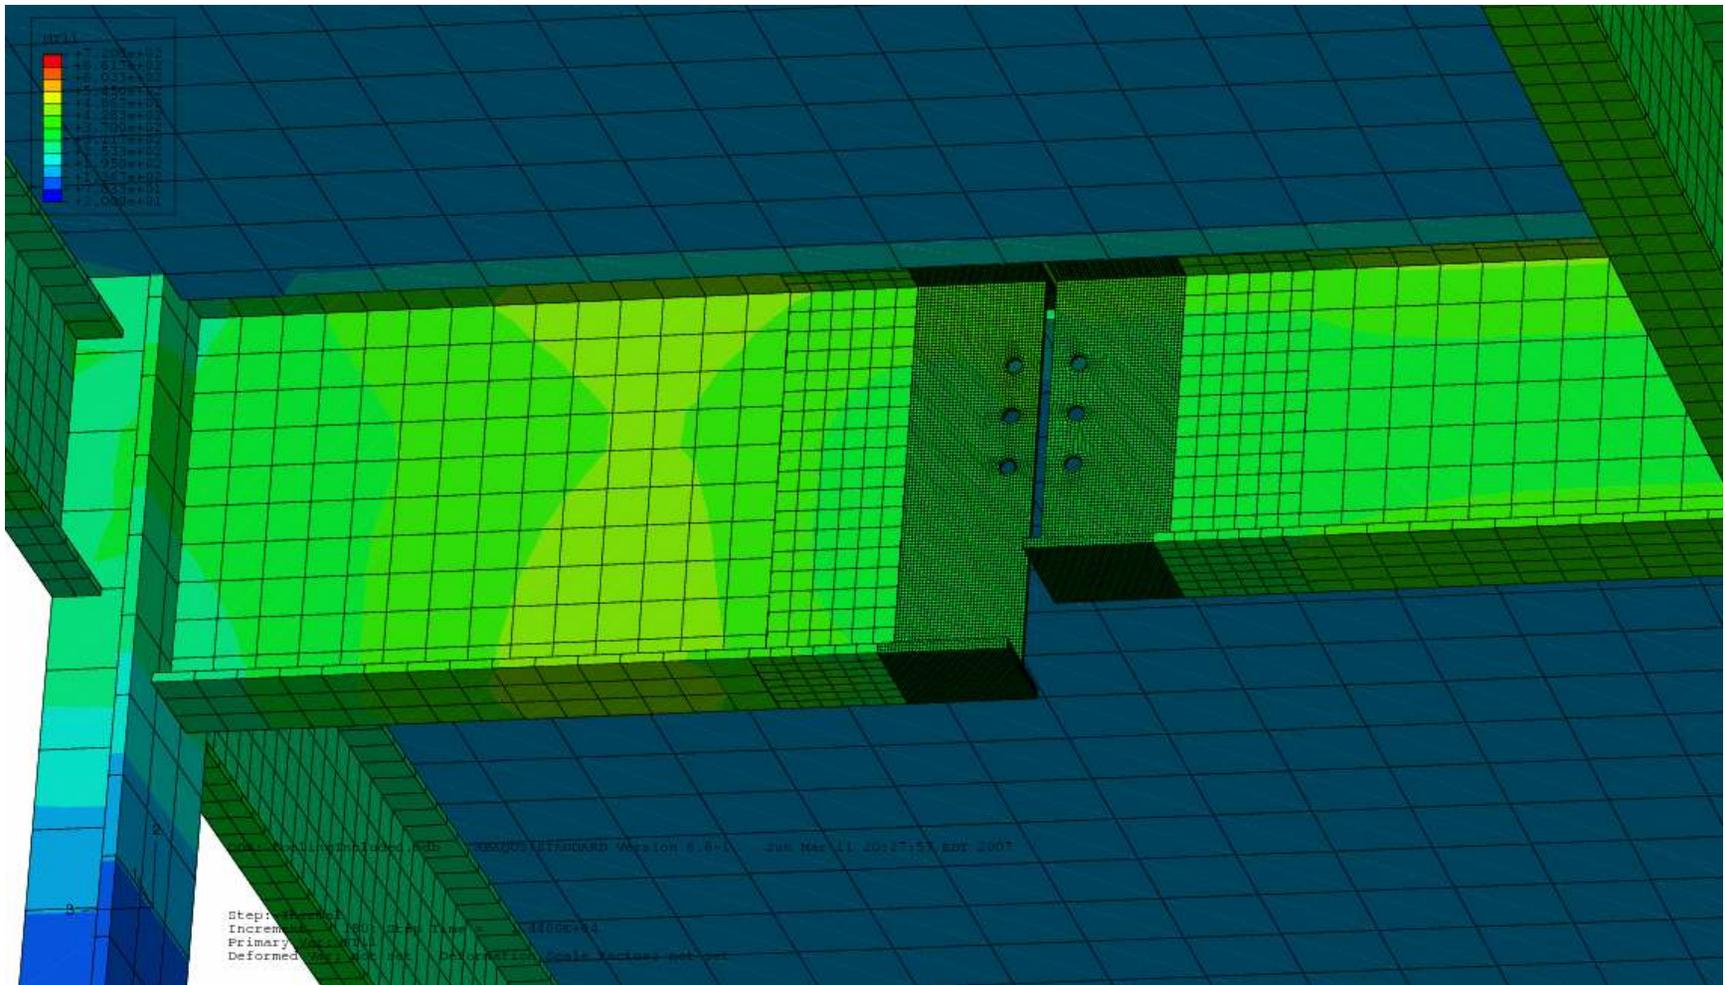
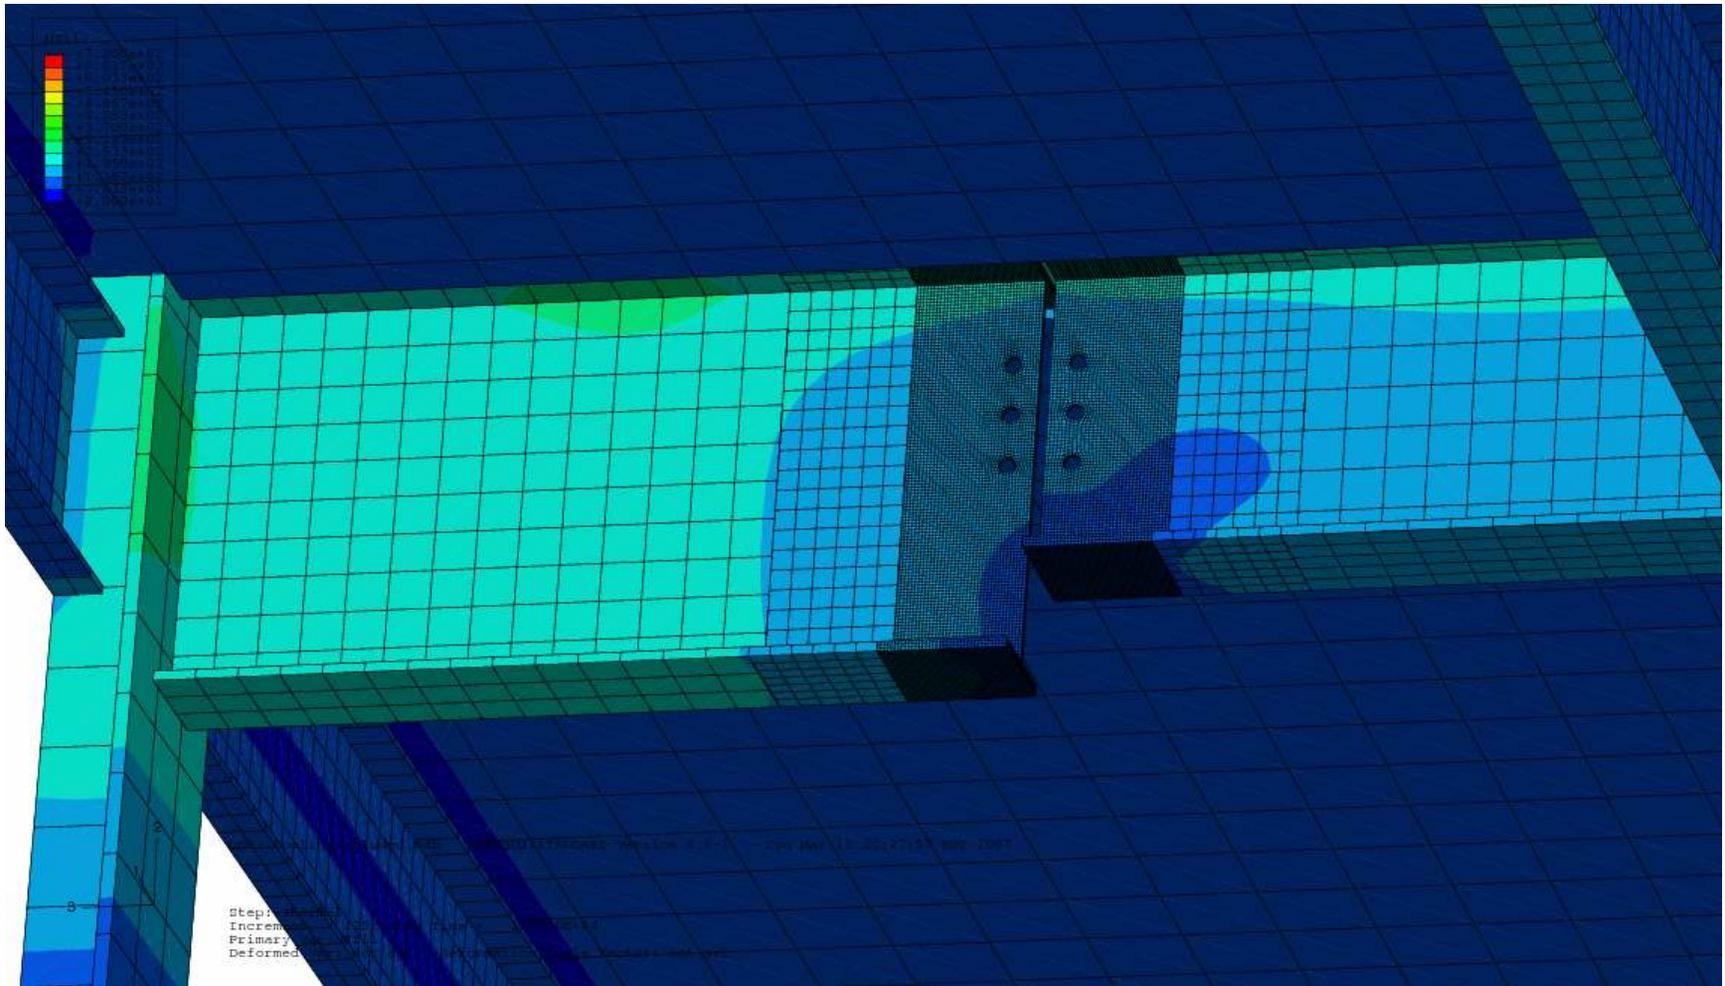
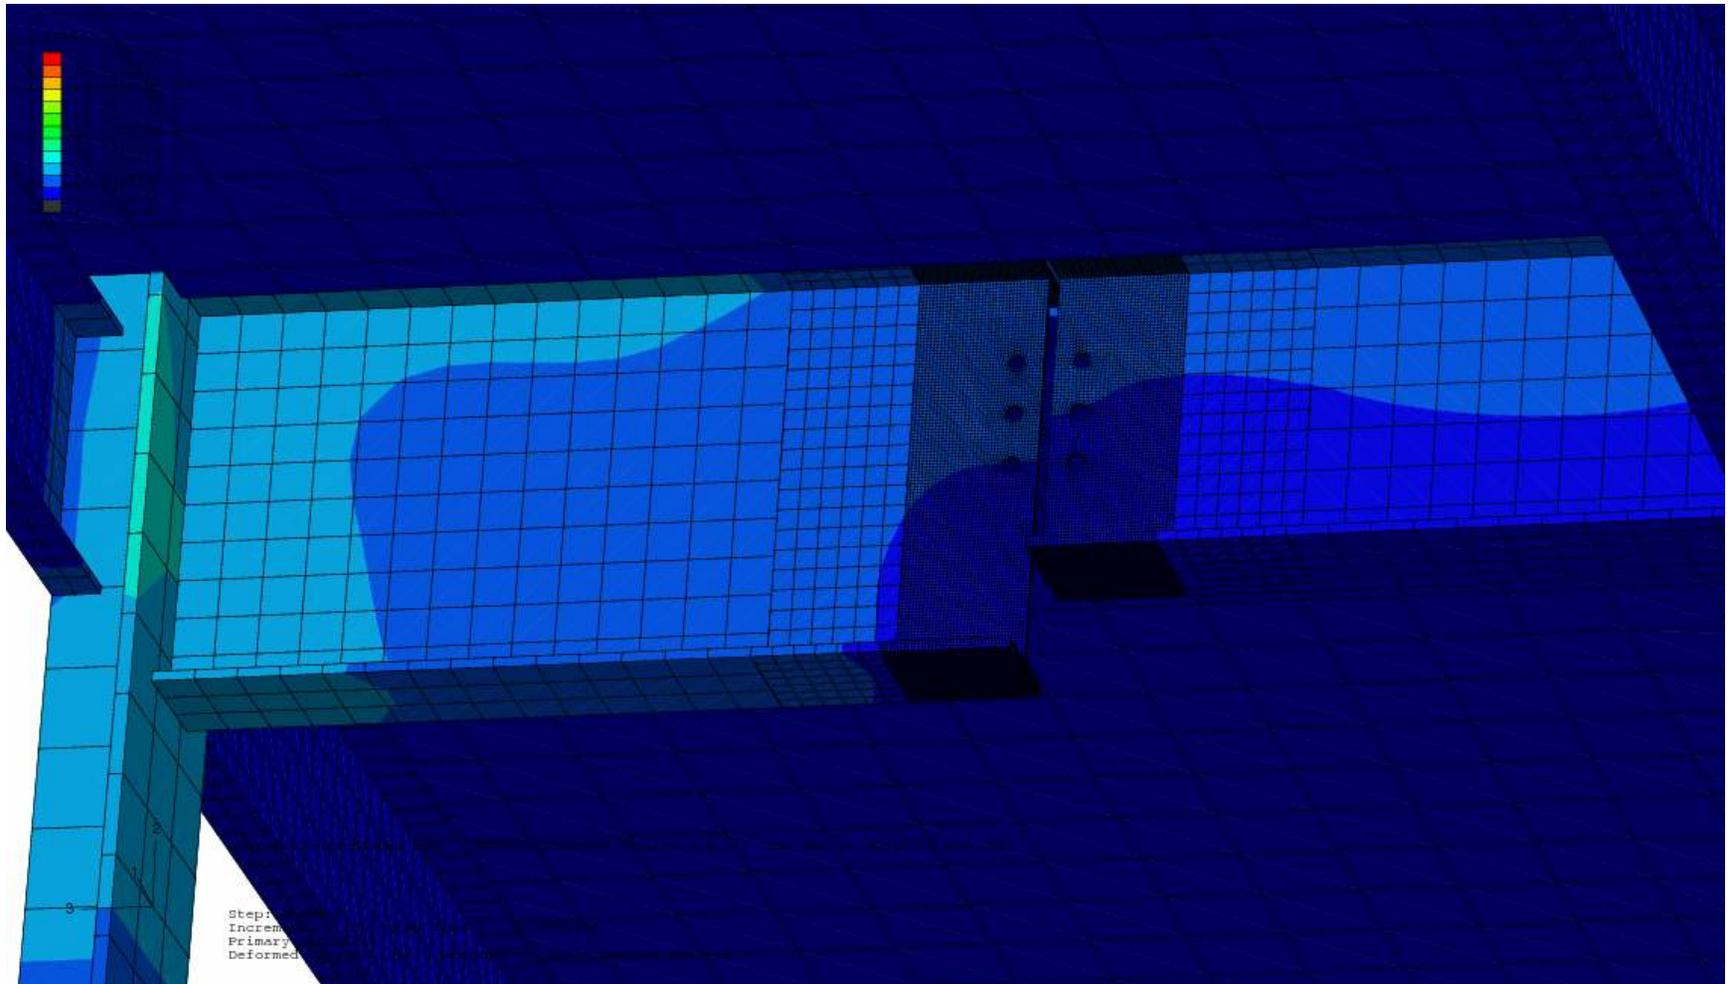
<u>Reference</u>	<u>Duration of Analysis</u> (Fire: $t < 4$ hours) (Burnout: $t > 4$ hours)	<u>Temperature Gradient</u> (Across Beam Stem) (Left-to-Right)
Figure 75	1 hour	450 °C
Figure 76	2 hours	400 °C
Figure 77	3 hours	250 °C
Figure 78	4 hours	Negligible
Figure 79	5 hours	-150 °C
Figure 80	6 hours	-150 °C
Figure 81	7 hours	-150 °C
Figure 82	8 hours	-50 °C

It is observed that the insulation functions as predicted: it delays the transmission of heat to the steel during the fire exposure. Moreover, it can be observed that the top of the assembly remains relatively cool due to the heat sink effect of the concrete slab above it. Lastly, the average temperature of the steel agrees with estimates from hand calculations.

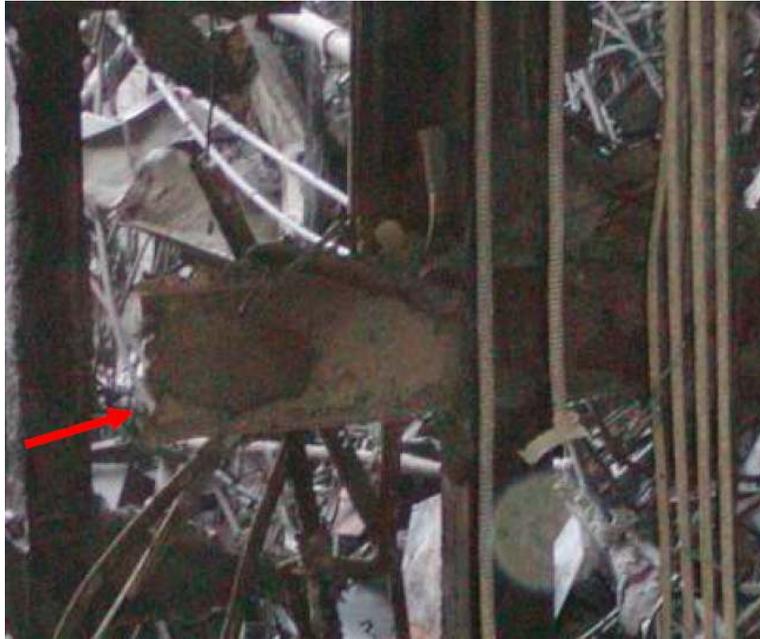
Figure 93: Evidence of the Formation of a Fulcrum Point (1 of 2)

Figure 93 and Figure 94 below present photographic evidence that a fulcrum point mechanism formed prior to catastrophic failure. It is observed that penetrations were made toward the lower part of the beam stem webs. This is in the region that the thermal-stress model predicted the lower flange of the floor girder would penetrate into the beam stem web. These photographs represent more key articles of forensic evidence which help to validate the results of the thermal-stress model.

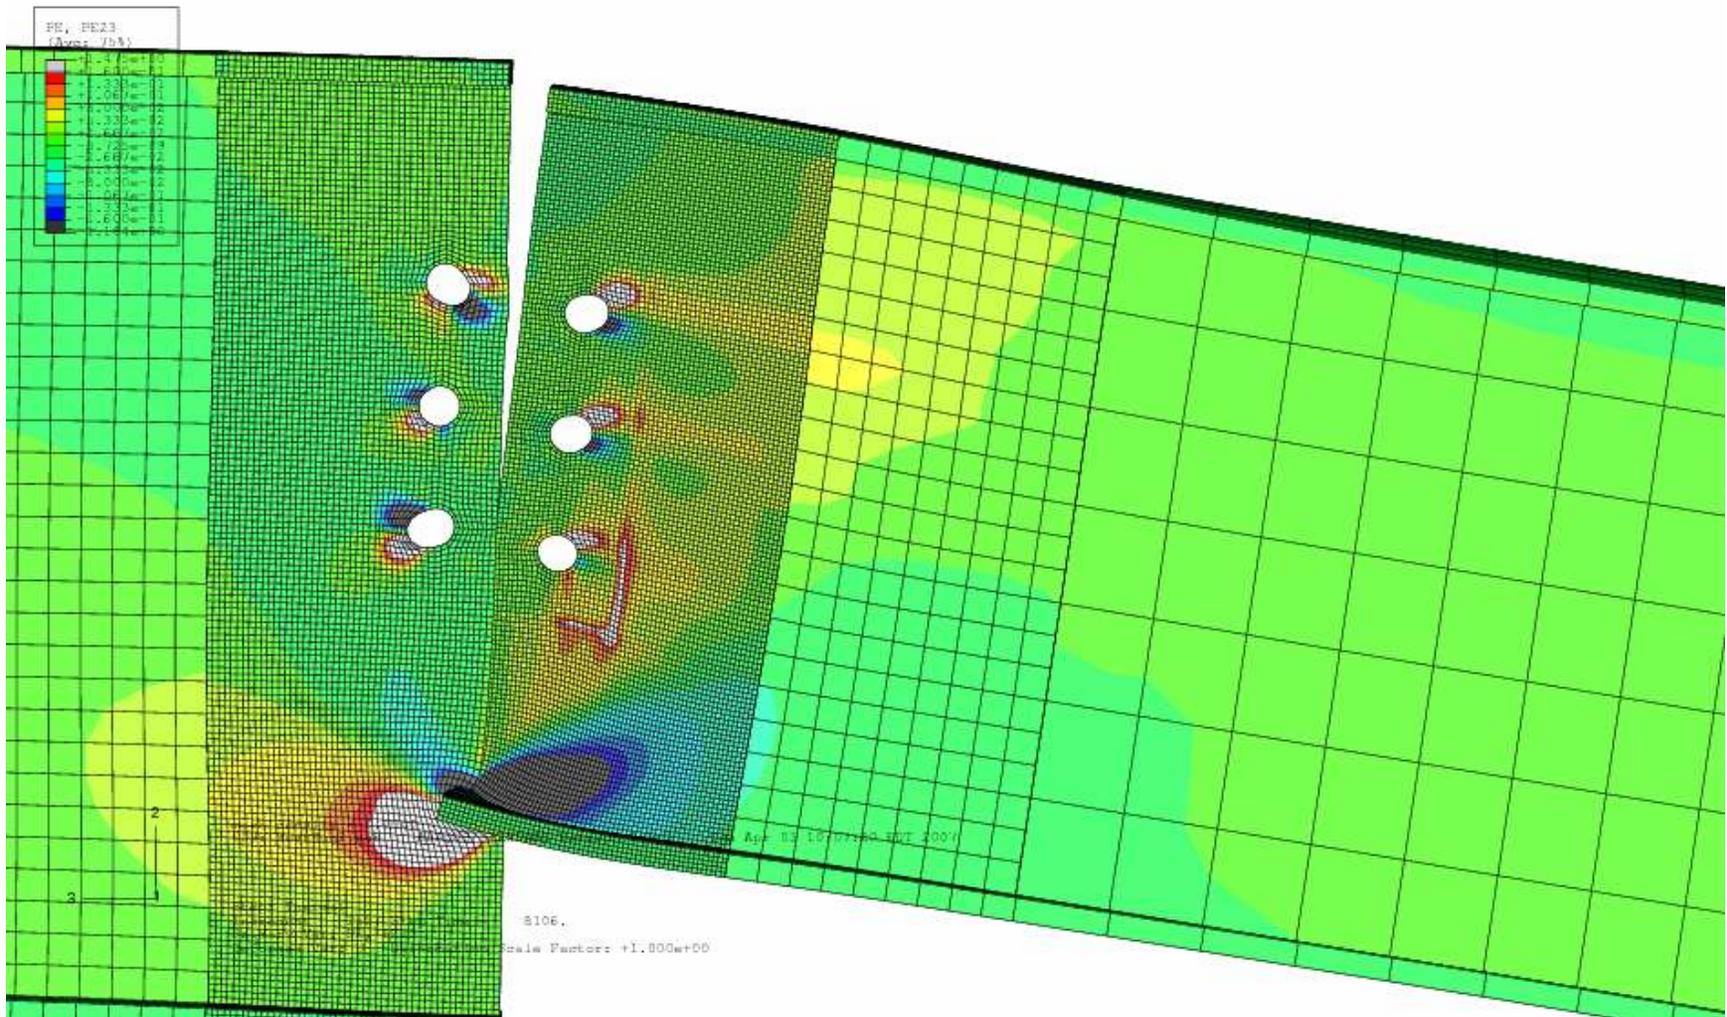
Figure 97: Plastic Shear Strain (2 Hours, 15 Minutes of Fire Exposure)

Figure 97 and Figure 98 below show the plastic shear distribution after 2 hours and 15 minutes of fire exposure. The maximum plastic shear strain at the top bolt hole is 0.47. Figure 99 shows the stress distribution in the vicinity of the shear connection. Similar to the previous thermal-stress model, an excessive stress concentration at the weak side of the top bolt hole is observed at this point in time during the fire exposure. This extended analysis has confirmed the results described in Section 6.2, for the intensive refinement of the meshes in the model did not result in any appreciable change in the observed results.

It is observed that the failure identified in the finite element model is very similar to that observed in a collected WTC 5 structural specimen that underwent failure. More precisely, the angles at which the bolts pried against the bolt holes are similar in the model and the specimen. Moreover, photographs of failed beam stems show evidence of fulcrum point penetrations. The sequentially-coupled, thermal-stress model has estimated the time (i.e., 2 hours) in which catastrophic structural collapse occurred within WTC 5.

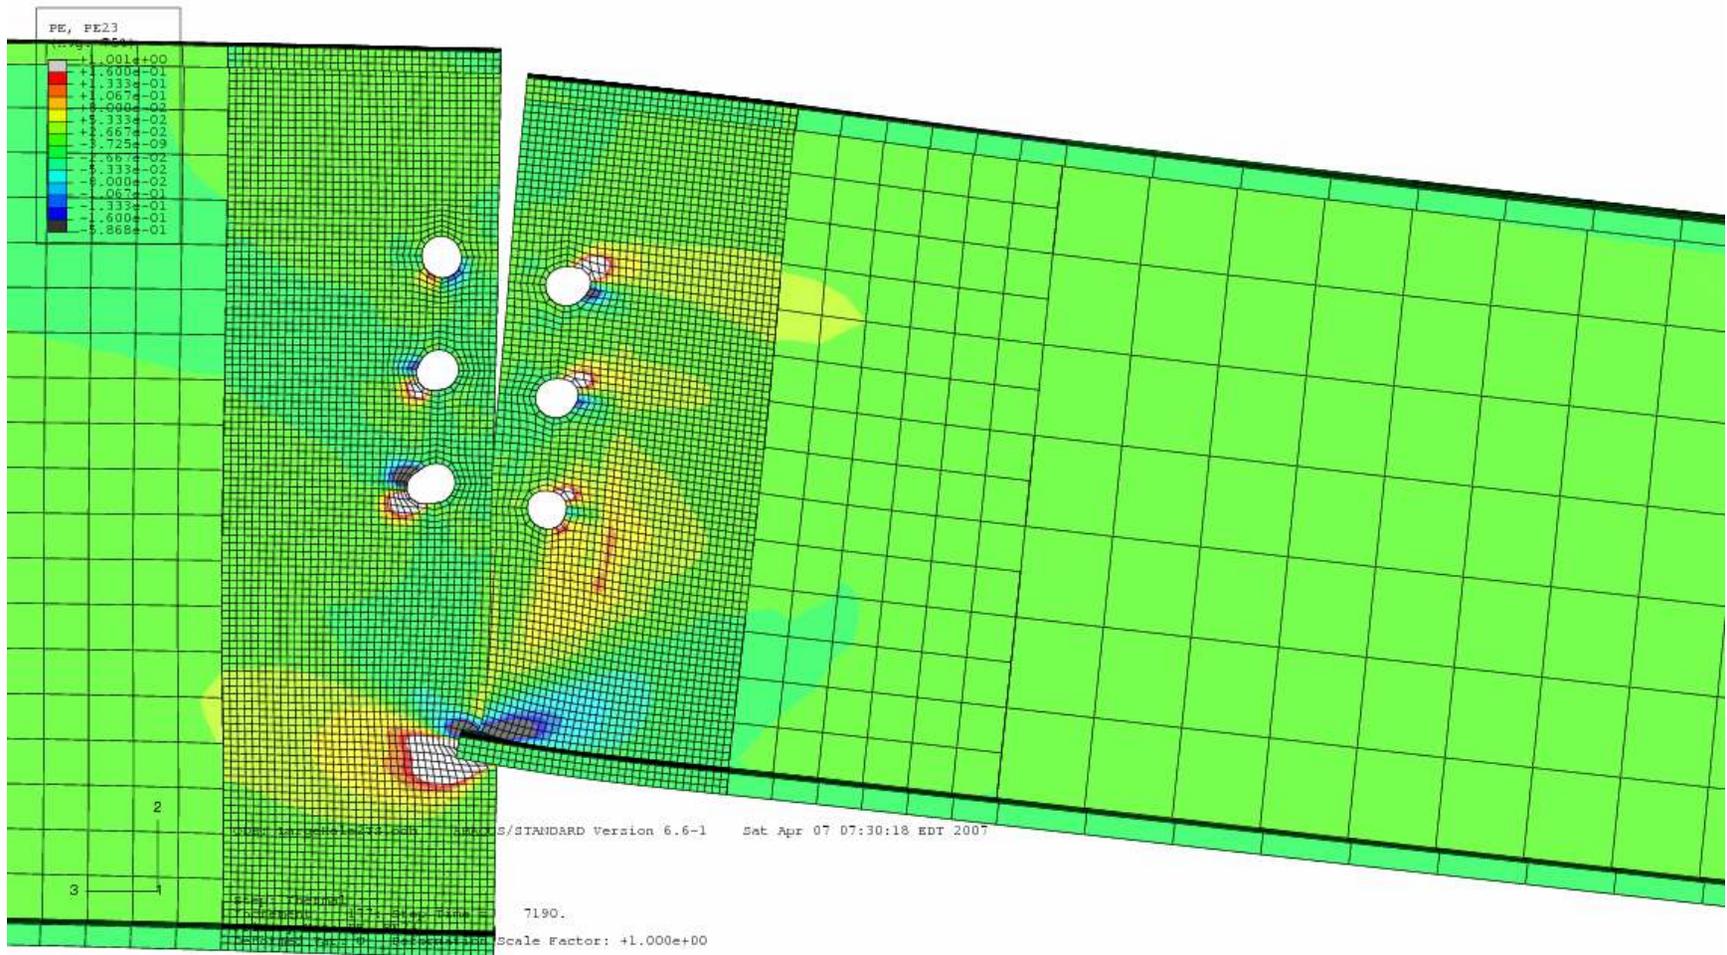
Figure 104: Plastic Shear Strain (2 Hours of Fire Exposure)

It was hoped that using oversized bolt holes would arrest, or at least significantly delay, the formation of a fulcrum point mechanism by allowing for more translational freedom of the bolt shanks within their respective holes. Yet, the result of the thermal-stress analysis suggests that this provision would only slightly delay the onset of catastrophic failure. In reality, the failure would probably occur at about the same time as for the smaller holes, for the clear distance is reduced when oversized holes are used. Perhaps the use of *slotted holes* may be beneficial, for they may allow for large rotation at the shear connection with limited bearing stress. The implementation of slotted holes represents the introduction of new geometry into the finite element model, as opposed to modifying existing geometry. Hence, the implementation of slotted holes into the thermal-stress model would require major modifications and is out of the scope of this research.

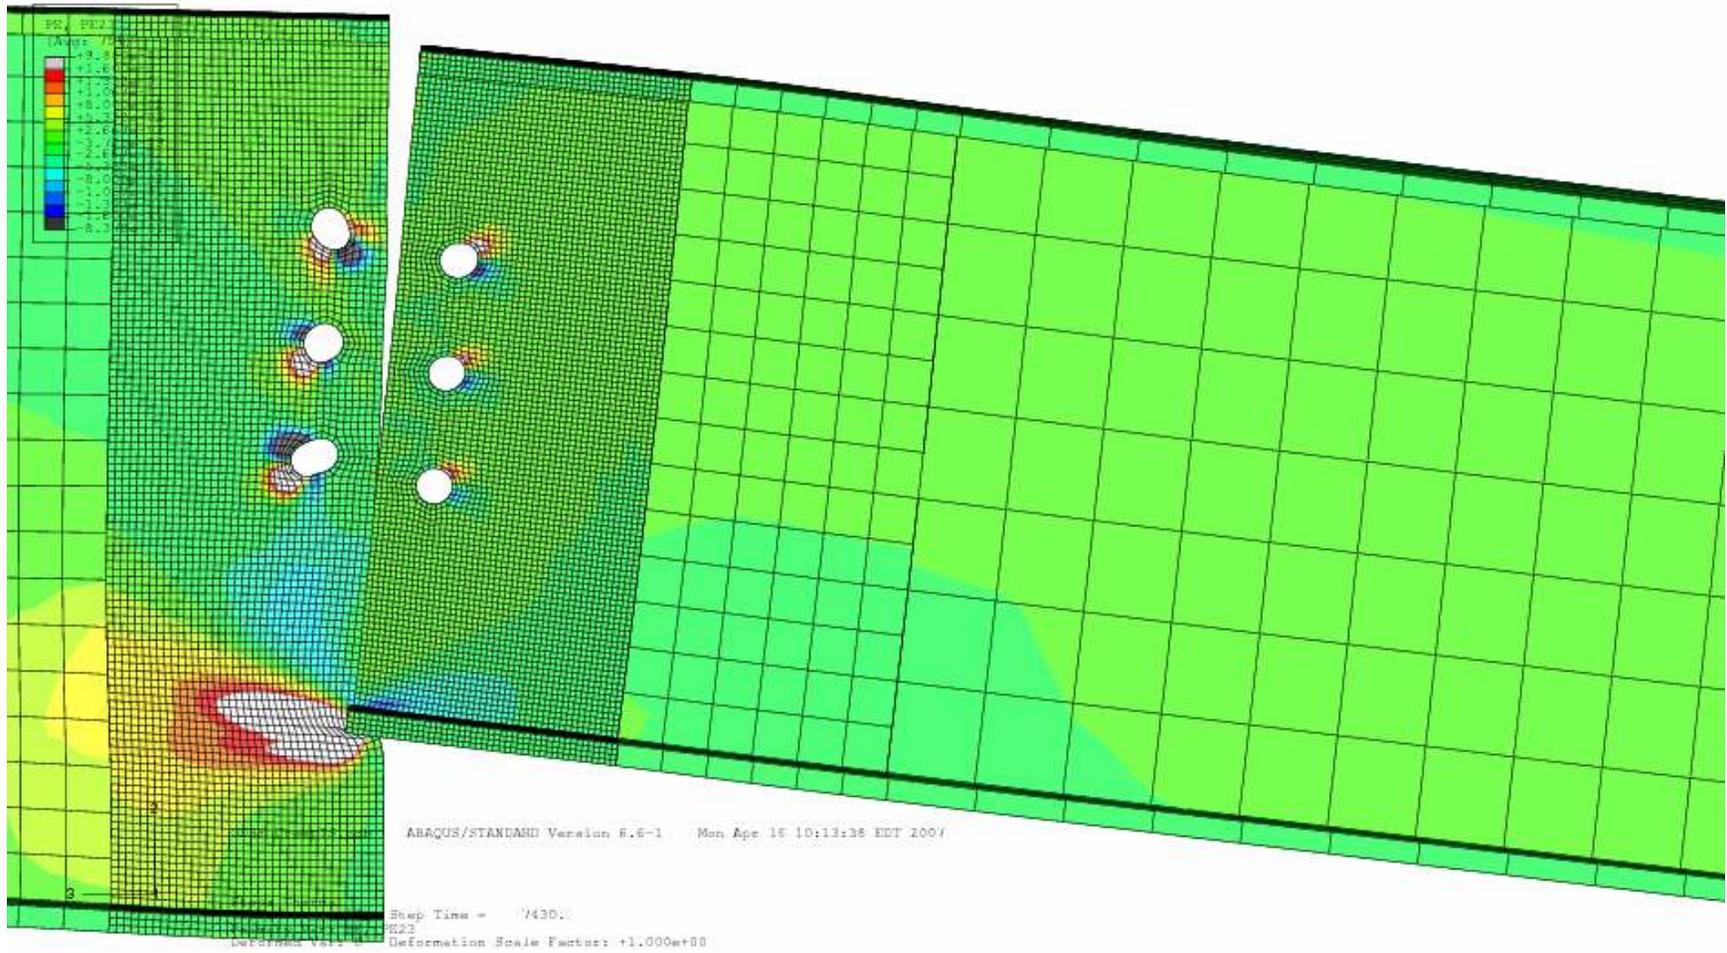
Figure 106: Plastic Shear Strain with Thermal Creep Strain Included (2 Hours of Fire Exposure)

fulcrum point mechanism occurs very rapidly and leads to rupture failure within a few minutes following. Therefore, the effects of thermal creep strain would be minimal in this case granted the limited time in which it may occur. However, the effects of thermal creep strain are observed in another -less critical- aspect of the thermal-stress behavior. It is observed that the deformation of the bolt holes in the downward direction is more extensive as compared to the results described in Section 6.2 (see Figure 106 below). This is physically reasonable considering that gravity loads act upon the assembly over a prolonged period of time when the steel temperatures are high.

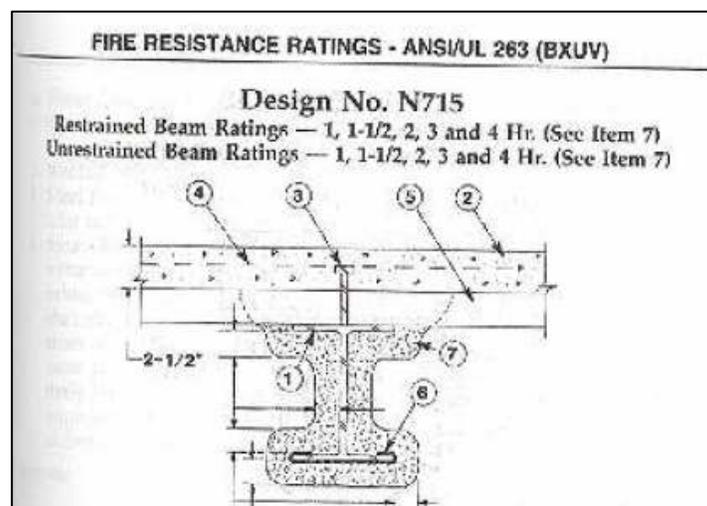
Figure 108: Design No. N715 (Spray-Applied Fire Resistance)

Figure 107 below is a schematic of the column-tree and floor girder assembly contained in WTC 5. This particular analysis shall focus on the W18X50 floor girder. The floor girders of WTC 5 had a 2-hour fire resistance rating. Design No. N715 of the 2004 UL Directory specifies that the spray-applied fire resistance must be 1-inch thick in order to achieve a 2-hour rating (see Figure 108 below).

Figure 107 above is a schematic of the column-tree and floor girder assembly contained in WTC 5. This particular analysis shall focus on the W18X50 floor girder. The floor girders of WTC 5 had a 2-hour fire resistance rating. Design No. N715 of the 2004 UL Directory specifies that the spray-applied fire resistance must be 1-inch thick in order to achieve a 2-hour rating. A schematic of the floor girder is shown in Figure 123 below.

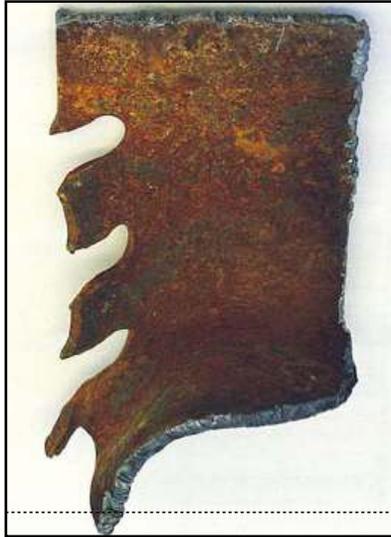
Figure 117: Recovered Beam Stem Sample from WTC 5

Figure 117 above shows a recovered beam stem sample from WTC 5. It is observed that failure was due to web shear. Therefore, other connection failure modes such as gross shear rupture may be ruled out. It is known that the beam stems are composed of A36 steel with yield and ultimate strengths of 36 and 58 ksi, respectively. Moreover, the W24X61 beam stems have a clear distance and web thickness of 1.03125 and 0.4375 inches, respectively. The nominal bolt and bolt hole diameter is 7/8 and 15/16 inches, respectively. Figure 118 below is a schematic showing the two shear tabs connected to the beam stem.

Figure 92 below presents a comparison between the model’s results and forensic evidence. The left side of Figure 92 shows the equivalent strain in the vicinity of the three bolt holes in the beam stem web after 2 hours of fire exposure. The right side of Figure 92 shows a recovered beam stem sample from WTC 5 that serves as forensic evidence of the structural failure. It is observed that the failure in the finite element model is very similar to the failed structural specimen. More precisely, the angles at which the bolts pried against the bolt holes are similar. The top bolt bears against the weak side of its bolt hole at about 15 degree below the horizontal. The bottom bolt bears against the strong side of its bolt hole initially, but as a result of the failure of the top bolt hole, pulls out from the beam stem web in the direction of the floor girder.

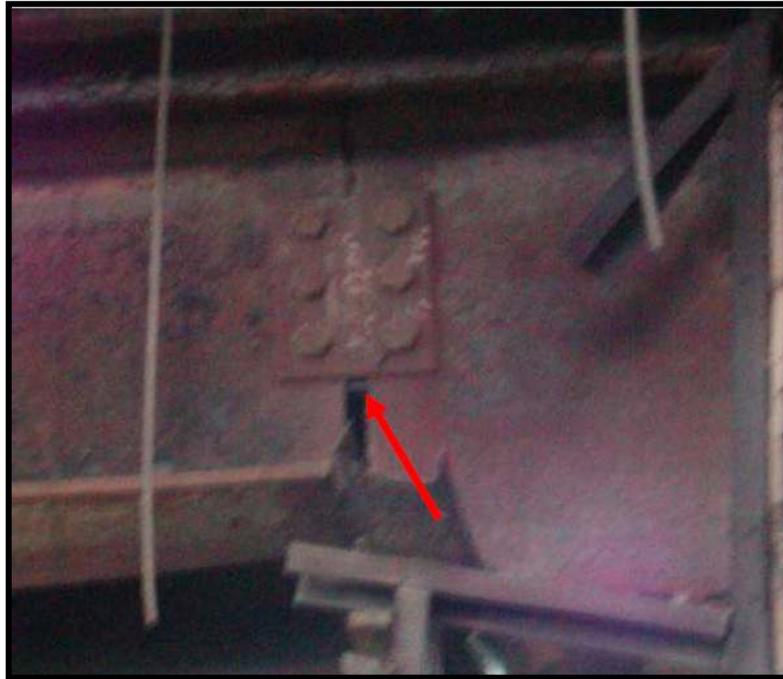
Figure 121: Photograph of the Shear Tab Connection (WTC 5) (NIST)

It must be determined if shear tabs were on both sides of the beam stem web in WTC 5. This is a requisite to an accurately model of the shear connection assembly in ABAQUS. Figure 121 below is a photograph provided by NIST that presents forensic evidence that two shear plates were used at each connection. Since the clarity of this photograph is open to interpretation, a mock structural connection design must be used to confirm this fact.

Figure 122 below shows a schematic of the beam stems and floor girder assembly. A distributed design load of 3.2 kips per foot is applicable to the assembly. The shear force at the shear tab connection is determined to equal about 35 kips. It is known that the shear tabs are composed of A36 steel. The 1970 AISC Steel Manual was referenced for the mock connection design. Table I-A3 of the manual states that a double tab assembly that is $\frac{1}{4}$ -in thick and has $\frac{7}{8}$ -in diameter bolt holes will provide about 54 kips of shear resistance. Thus, a single shear tab would only provide about 27 kips of shear resistance. Therefore, it can be concluded that the two tabs were used at each shear connection in WTC 5.
