Puerto Rico Project Center

SEISMIC VULNERABILITY OF PUBLIC STRUCTURES IN PUERTO RICO

CSA Group – San Juan, Puerto Rico

May 1, 2001

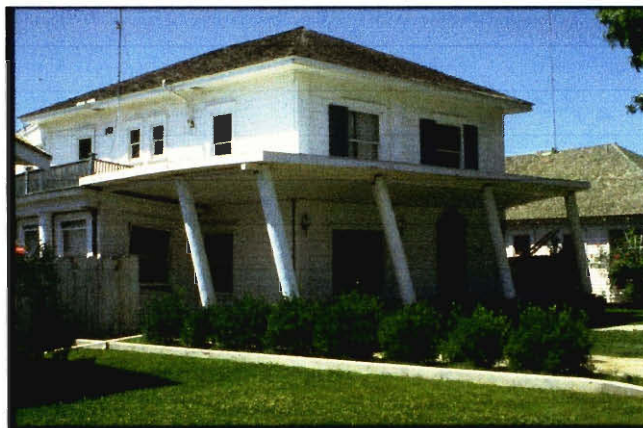
Figure 2.3: Soft Story Effects on a Structure
Source: NGDC (2001b)

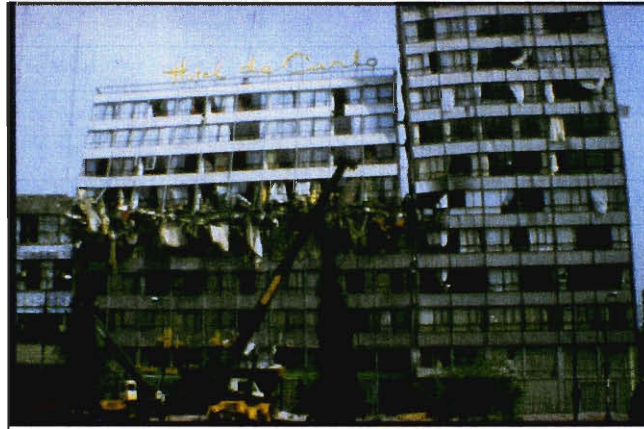
Figure 2.4: Weak Story Effects on a Structure
Source: NGDC (2001b)

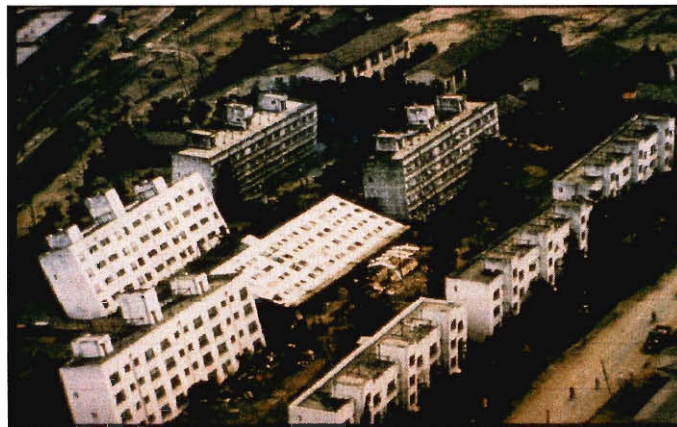
Figure 2.5: Soil Liquefaction Results in Niigata,
Japan
Source: NGDC (2001b)

into the ground or in some extreme cases, completely tip over. Figure 2.5 illustrates an extreme case of this, which occurred in 1964, in Niigata, Japan. During this earthquake, several four-story buildings in the same area tipped as much as sixty degrees (USGS, 2001).

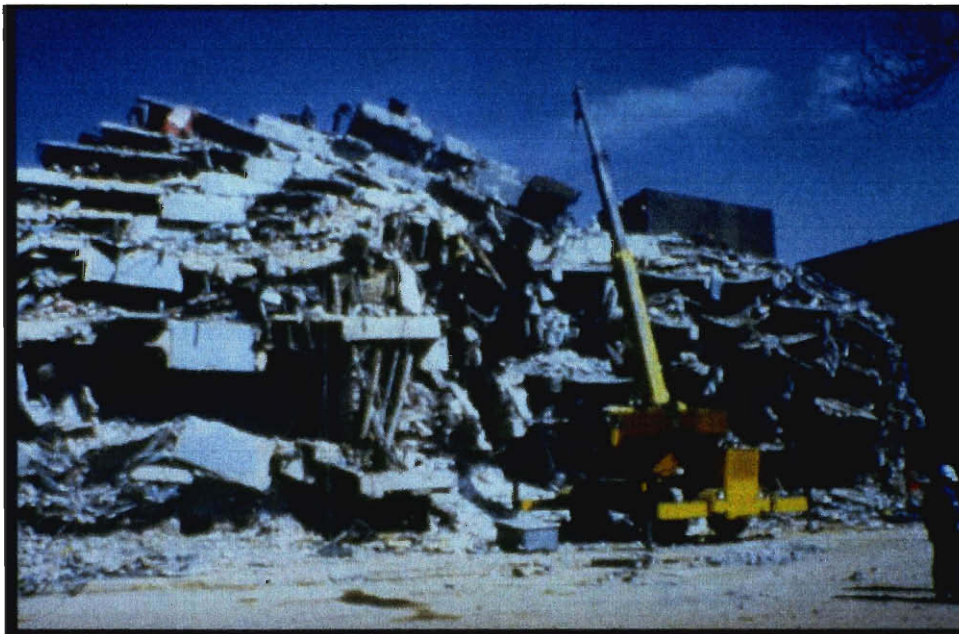
When an earthquake occurs, the ground vibrates at a certain frequency. The time it takes for one cycle this vibration is called the period. Additionally, all structures have periods associated with them. When a lateral force is applied to a building, the time it takes for it to rock back and forth once is the natural period (ACOE, 1996). According to Dr. Luis Daza, department manager of the structural engineering department at CSA Group, when this condition of resonance occurs, a building has a much larger chance of collapsing. When the two periods become very close or the same, structural soundness of the building no longer matters; the building will collapse. An example of this occurred with the Juarez Hospital in Mexico City. The hospital had a state of the art structural design and could withstand a very strong earthquake. During the earthquake in 1985, resonance occurred and the building collapsed as is shown in Figure 2.6.

Figure 2.6: Hospital Collapse in Mexico City due to Resonance (1985)
Source: NGDC (2001)

This collapse near the maternity wing of the building trapped four hundred patients and staff in the building for days. Additionally, the hospital shut down, preventing other injured patients of the earthquake from receiving care. Similar situations occurred in two other Mexico City Hospitals, trapping a total of eight hundred more people and causing the hospitals to shut down (NGDC, 2001).

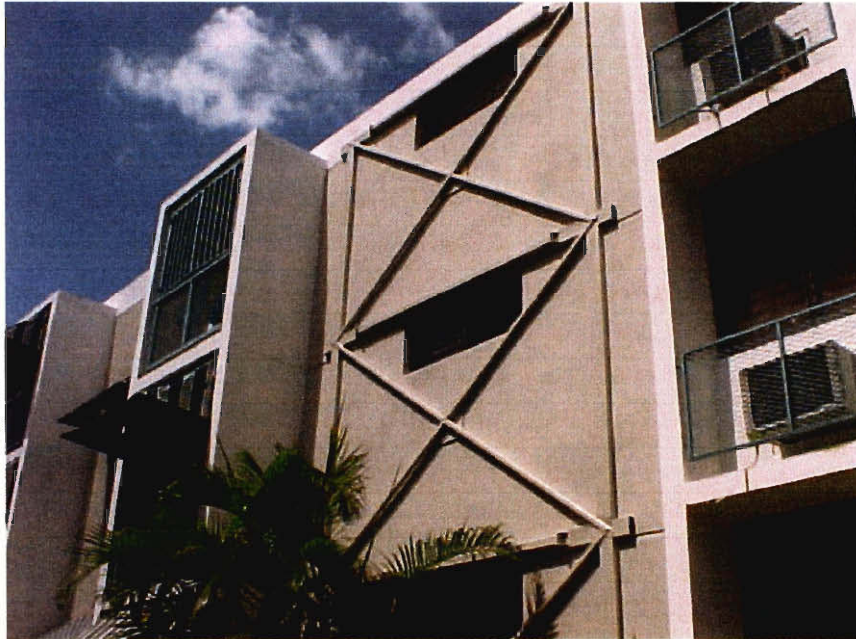
The most common major retrofit technique in Puerto Rico used to provide support for shear walls in only one direction, involves providing steel bracing on the outside of the structure. Steel bracing is commonly used because it is a cheap and effective manner. This method of retrofit consists of adding cross braces between the two shear walls on the outside of the structure. An example of this technique is illustrated in Figure 2.7. This picture was taken at an apartment complex (Balcones de Santa Maria) in Guaynabo, Puerto Rico.

Figure 2.7: Steel Bracing of Structure in Puerto Rico
Photo taken by CSA Project Team (2001)

The bonus to this retrofit technique is that the building remains in use during the retrofit process, since the construction takes place outside and the tenants can continue to use the building. The downfall to using cross bracing is that it takes away from the architect's desired design of the building. Many people feel that having steel bracing showing on the outside of a building takes away from its aesthetic appearance. However, many designers have found ways to make the building look as if the cross bracing on the outside was purposely designed by the architect for a unique appearance.

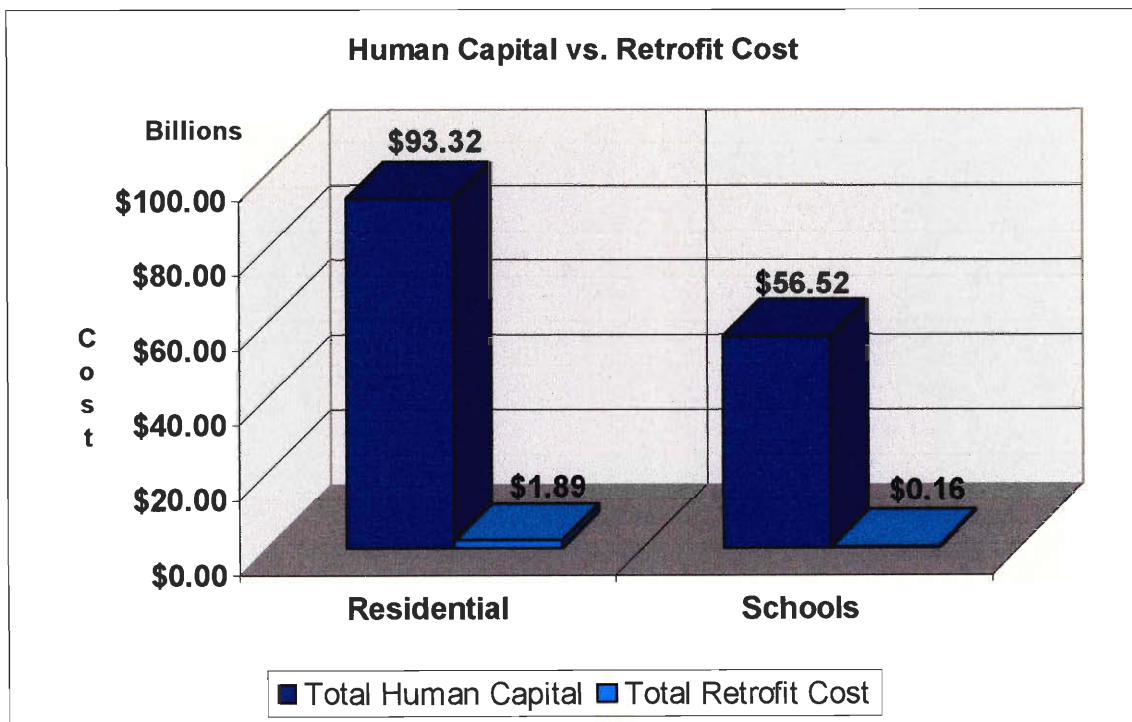
Both, the analysis of the residential structures, and school buildings, show that there is a need of retrofit here in Puerto Rico. In each case, there was a large discrepancy between the retrofit costs (RC), and the net human capital (Net HC) values, seen in Figure 4.5.

Figure 4.5: Human Capital vs. Retrofit Cost for Puerto Rico Structures

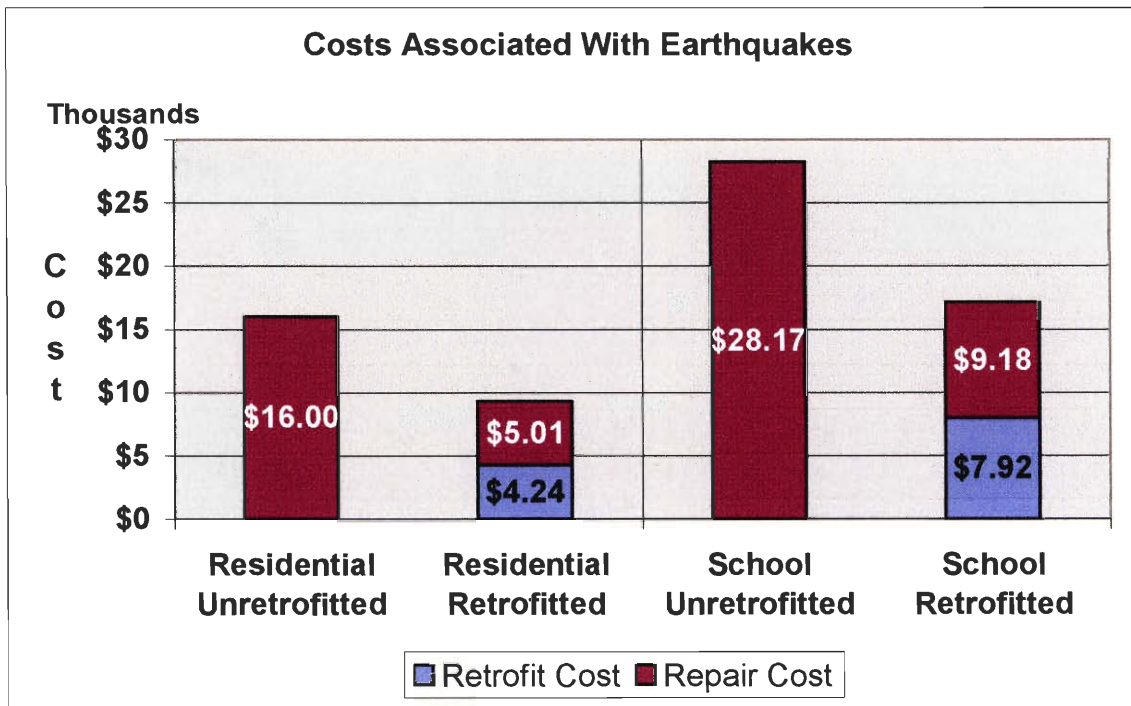
than the retrofitted damage cost plus the cost to retrofit the buildings. While money is saved in both cases, more money is saved in the retrofitting of schools. On the other hand, there are many more people at risk in residential structures. These are the two major issues to be considered if a decision were to be made on which types of structures should be retrofitted first.

Figure 4.6: Costs Associated with Earthquakes

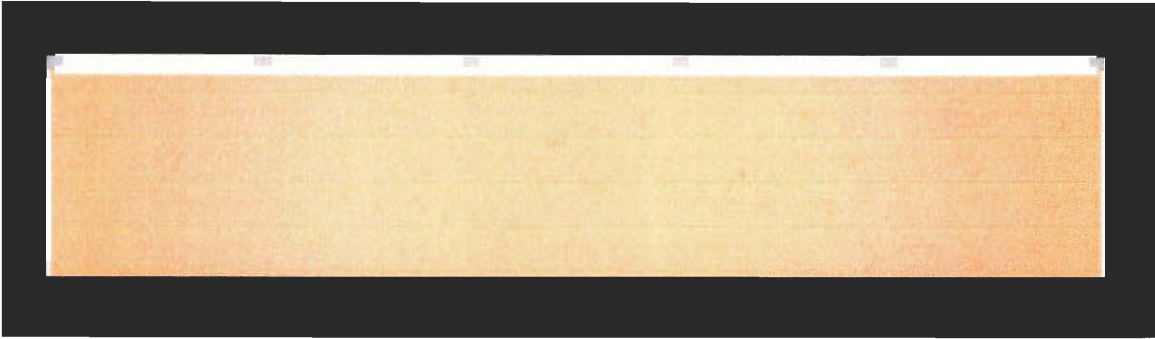
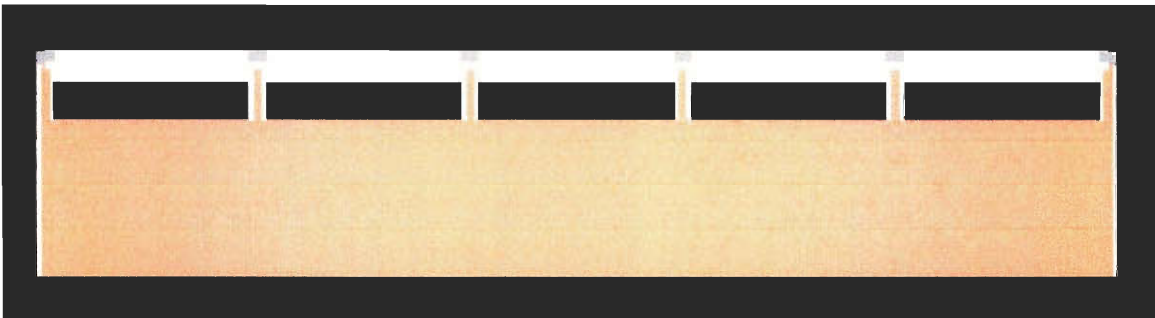
The school was reconstructed within the program with the same properties as the original building. After creating a three-dimensional model consisting of the beams, columns, and girders, the connections were imposed upon the structure. Once the frame was completed, diaphragms were inserted into the appropriate planes, modeling the masonry walls and concrete floor. However, only the structural drawings were available for the school; therefore, we modeled this school both with and without short columns.

Figure 4.7: Single Story School without Short Columns (NSC)

Figure 4.8: Single Story School with Short Columns (SC)

Creating a 3 ft space between the masonry walls and the roof in both the front and rear walls resulted in these short columns, as demonstrated in Figures 4.7 and 4.8.
