# Eel Point Road Restoration and Resilience

An interactive Qualifying Project submitted to the Faculty of  
WORCESTER POLYTECHNIC INSTITUTE  
in partial fulfillment of the requirements for the  
Degree of Bachelor of Science

*December 15, 2023*

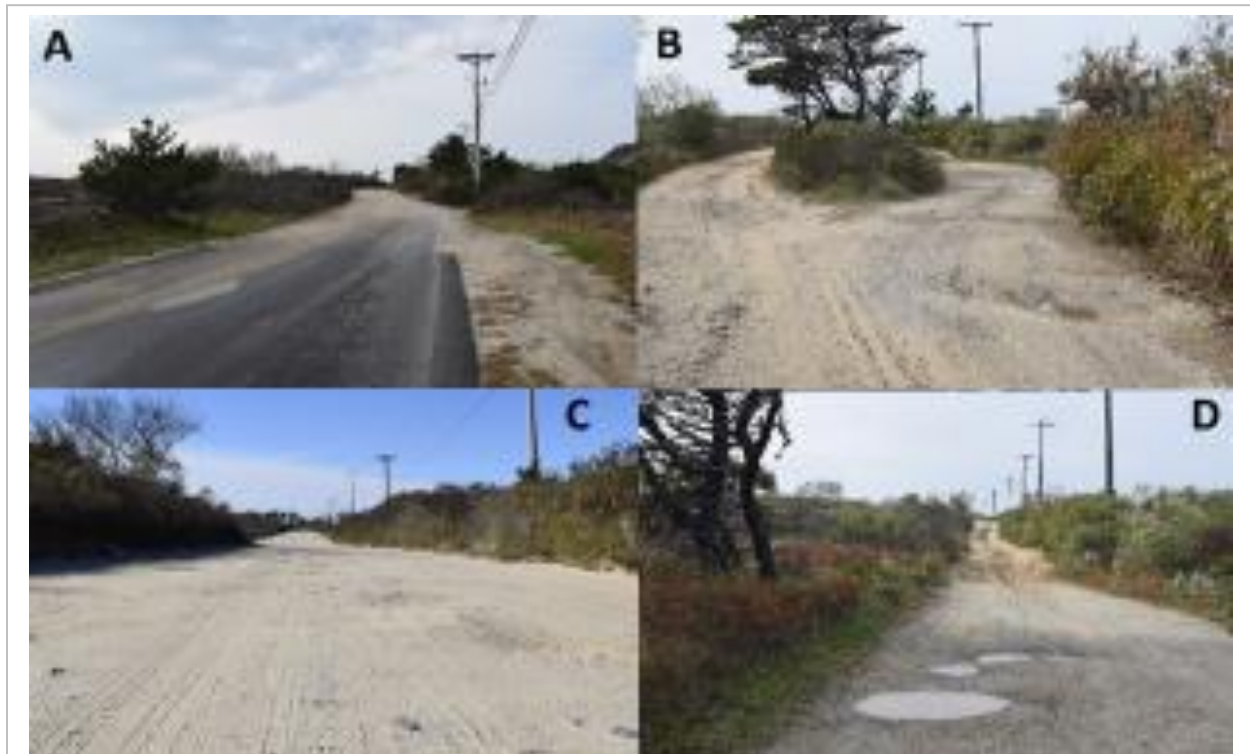
**Figure 9.** Four images of EPR.

- A.** The transition between the paved and unpaved sections of EPR.
- B.** Desire paths on EPR created by vehicle and pedestrian traffic.
- C.** The improper cross-section of EPR. The road is flat and does not slope to the sides.
- D.** Water-filled potholes and loose aggregate on EPR

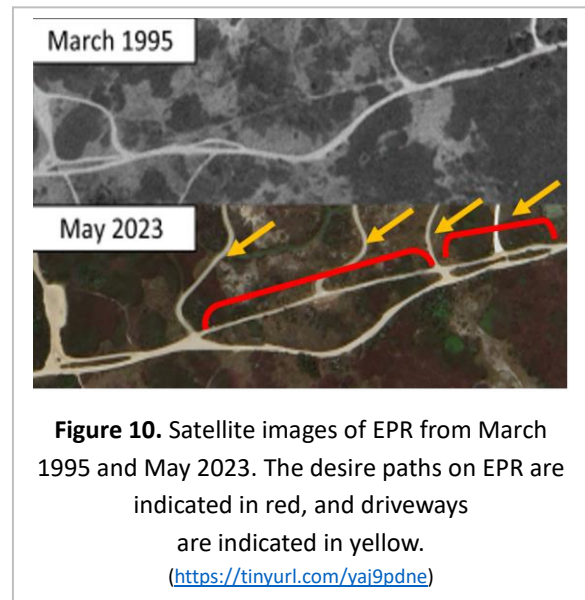
Pre-existing satellite imagery from Google Earth was collected to identify where and when desire paths and variations in the road width occurred on EPR. As shown in Figure 10, one such desire path was formed from a pre-existing walking path, and residential infrastructure has developed along the formed path.

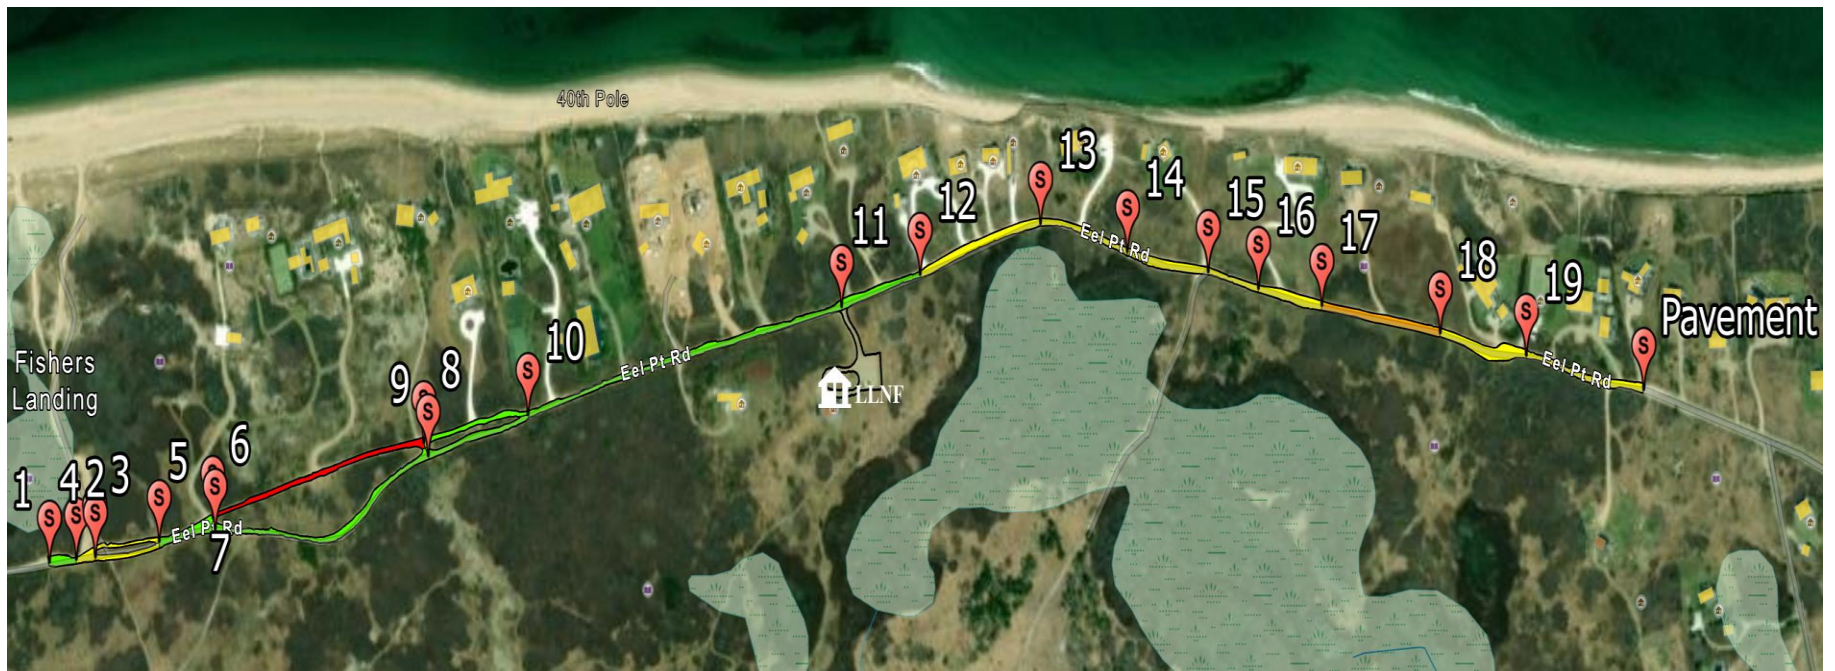
**Figure 11.** A map of the 19 segments that EPR was divided into with ratings designated as follows (Eaton 11):

After documenting the conditions affecting EPR, the [Unsurfaced Road Condition Index \(URCI\)](#) was used to measure the severity of these conditions. The surface of EPR was designated as a single branch. As shown in Figure 11 (page 18), this branch was divided into 19 additional sections according to the general structural composition and surface conditions of the road. Each section was considered as a sample unit. The distresses of each sample unit were measured for their severity as per Appendix B of [Unsurfaced Road Maintenance Management](#). A numeric rating from 0-100 was then assigned to each sample unit, and these scores were averaged to assign EPR a total URCI score of 65 with a rating of good, as per Paragraph 3-4 of [Unsurfaced Road Maintenance Management](#). The full URCI assessment for EPR is located in [Appendix H](#).

- Red:** Poor (URCI rating of 25-40)
- Orange:** Fair (URCI rating of 40-55)
- Yellow:** Good (URCI rating of 55-70)
- Green:** Very Good (URCI rating of 70-85)

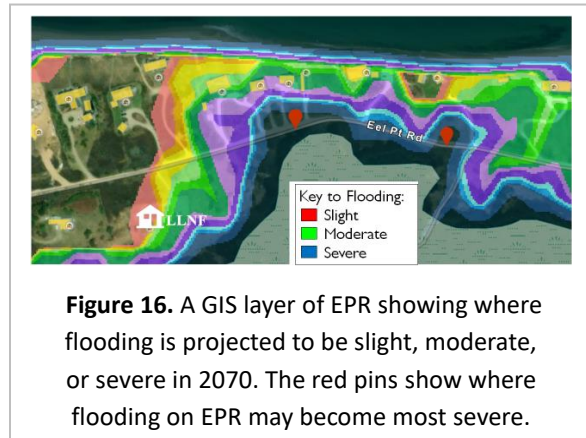
As shown in Figure 16, it was found that multiple points on EPR will be subject to severe annual flooding by 2070. Construction of the GIS map of EPR allowed the research team to identify which sections of EPR may be subject to increased levels of flooding and erosion, and to identify the causes of this flooding and erosion. By identifying these at-risk sections, recommendations were then be targeted towards specific sections of EPR to reduce the impact of flooding and erosion in those areas.
