## Urban Renewal Planning For Downtown Spencer, MA

An Interdisciplinary Qualifying Project  
Submitted to the faculty of  
Worcester Polytechnic Institute  
In partial fulfillment of the requirements for the  
Degree of Bachelor of Science

**Sponsoring Agency:**  
Town of Spencer, Massachusetts Planning Board  
Carter Terenzini - Town Administrator  
Karen M. Cullen, AICP - Director of Development & Inspectional Services

November 7, 2005

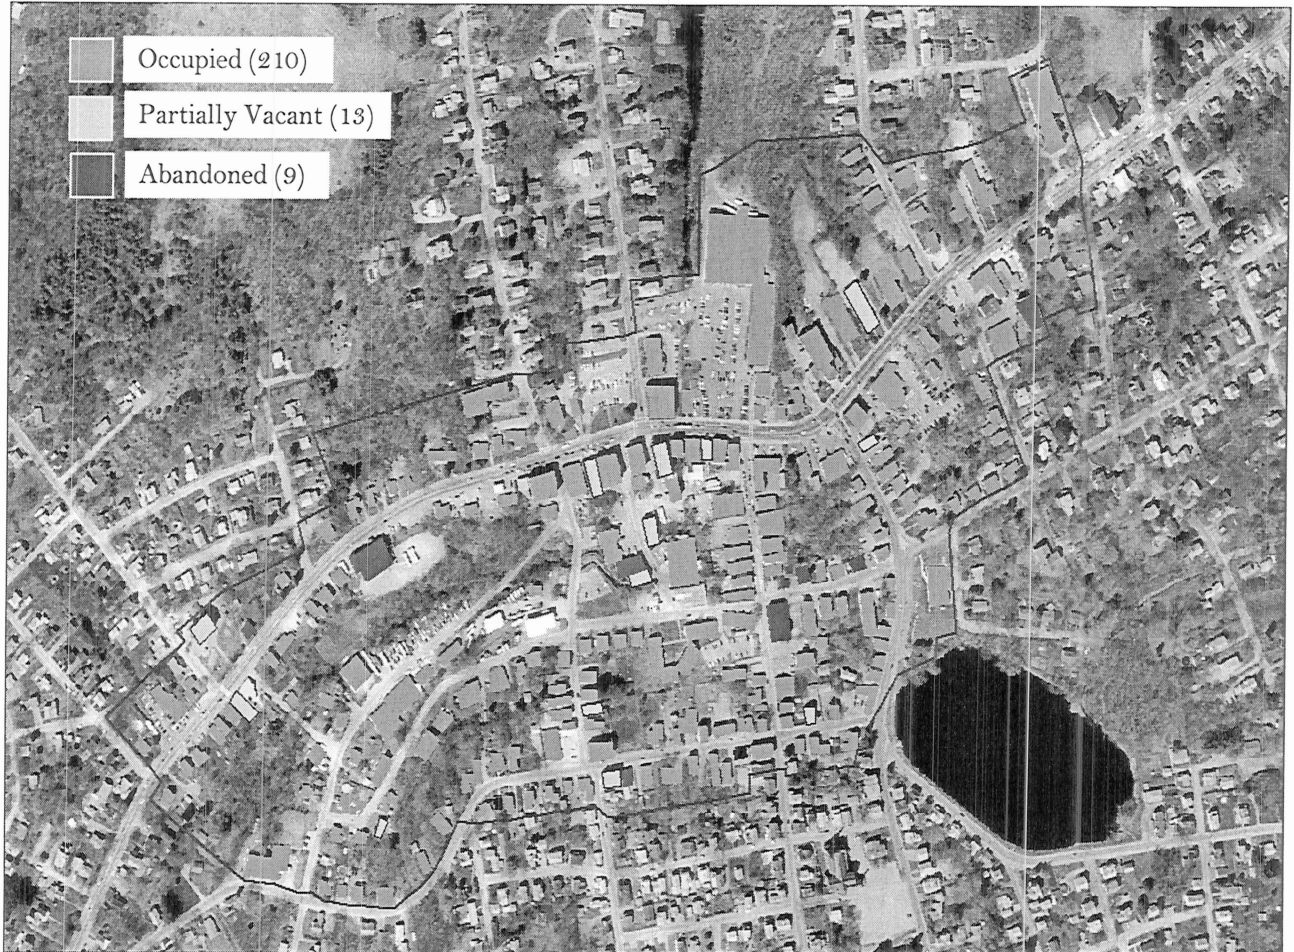
Figure 21. Structure map distinguishing between occupied, partially vacant and abandoned buildings.

Buildings that were totally unused were listed as abandoned, or a represented as a red buildings. A yellow building represents a building that had at least one floor that was vacant, but also at least one floor that was occupied. We used outside appearance, such as windows, as one of the most significant signs or vacancy.

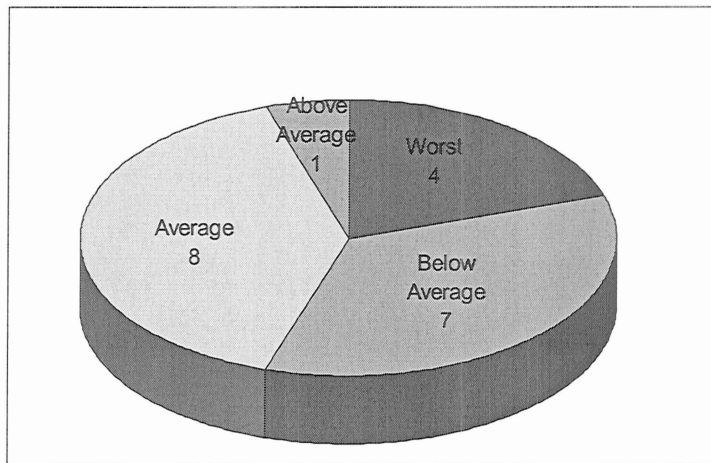
Figure 22. Aluminum Building Rating Results.

There were 20 total aluminum buildings in the study area. Their rating results are shown in Figure 22. This portion of our study shows that 55% of the aluminum structures surveyed in the study area are currently experiencing disinvestment and are in need of rehabilitation.

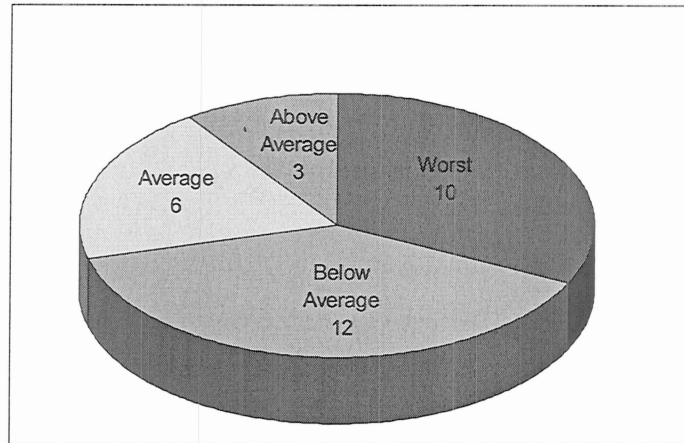
Figure 23. Brick Building Rating Results.

There were 31 total brick buildings in the study area. Their rating results are shown in Figure 23. This portion of our study shows that 71% of the brick structures surveyed in the study area are currently experiencing disinvestment and are in need of rehabilitation.

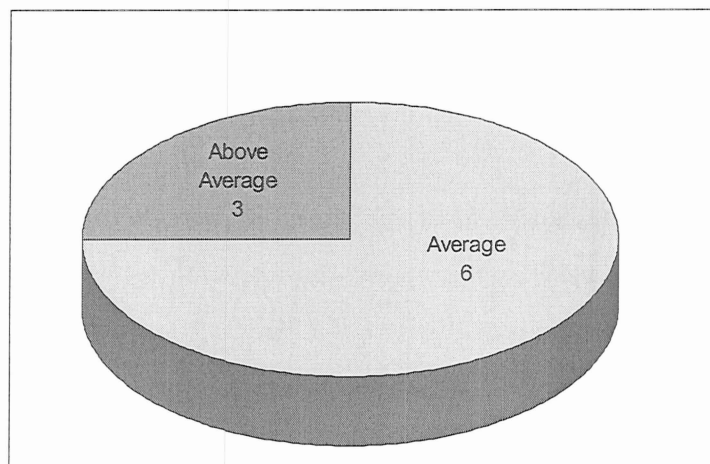
Figure 24. Cement Building Rating Results.

There were 8 total cement buildings in the study area. Their rating results are shown in Figure 24. Since there were no cement structures surveyed in the study area that were given a condition of below average, none of the cement structures are currently experiencing disinvestment.

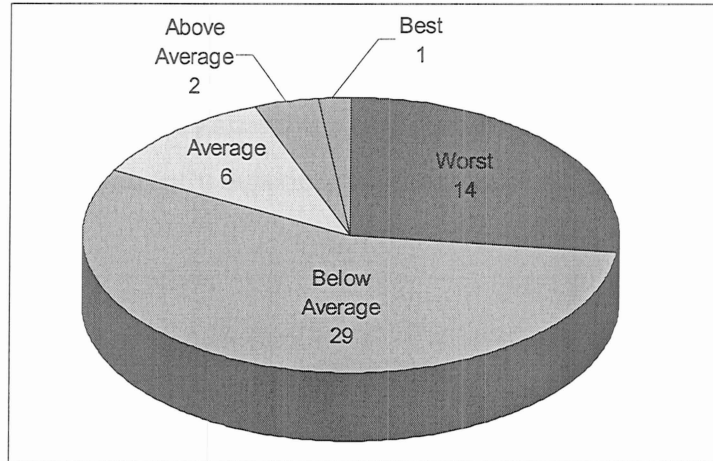
Figure 25. Wood Building Rating Results.

There were 52 total wood buildings in the study area. Their rating results are shown in Figure 25. This portion of our study shows that 83% of the wood structures surveyed in the study area are currently experiencing disinvestment and are in need of rehabilitation.

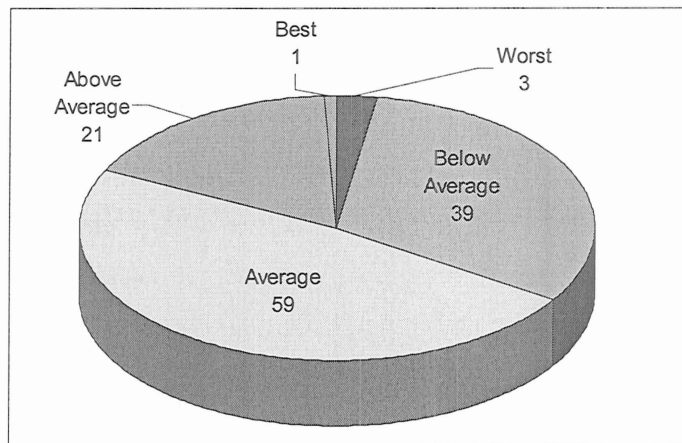
Figure 26. Vinyl Building Rating Results.

There were 123 total vinyl buildings in the study area. Their rating results are shown in Figure 26. This portion of our study shows that 26% of the vinyl structures surveyed in the study area are currently experiencing disinvestment and are in need of rehabilitation.

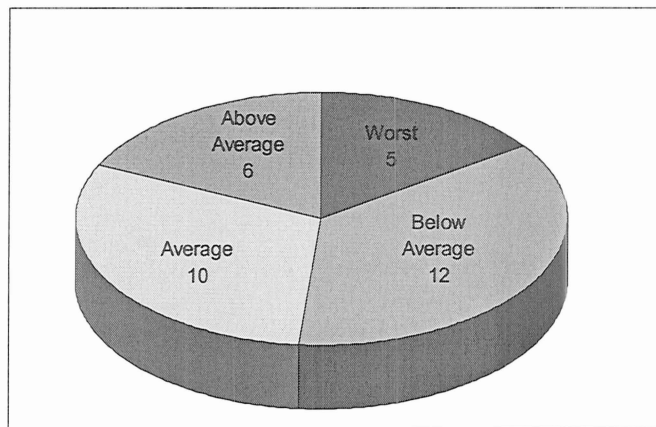
Figure 27. Commercial Building Rating Results.

There were 33 total commercial buildings in the study area. Their rating results are shown in Figure 27. This portion of our study shows that 69% of the commercial structures surveyed in the study area are currently experiencing disinvestment and are in need of rehabilitation.

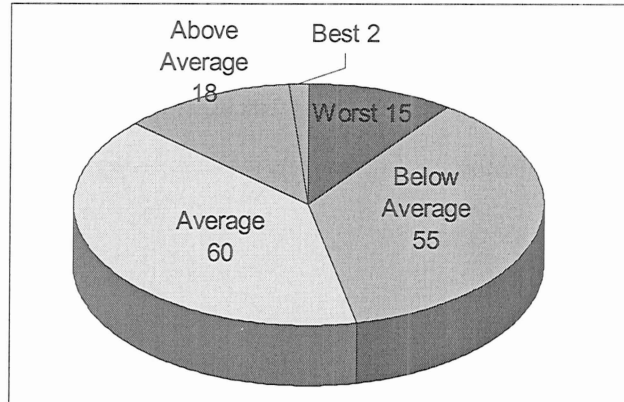
Figure 28. Residential Building Rating Results.

There were 150 total residential buildings in the study area. Their rating results are shown in Figure 28. This portion of our study shows that 86% of the residential structures surveyed in the study area are currently experiencing disinvestment and are in need of rehabilitation.

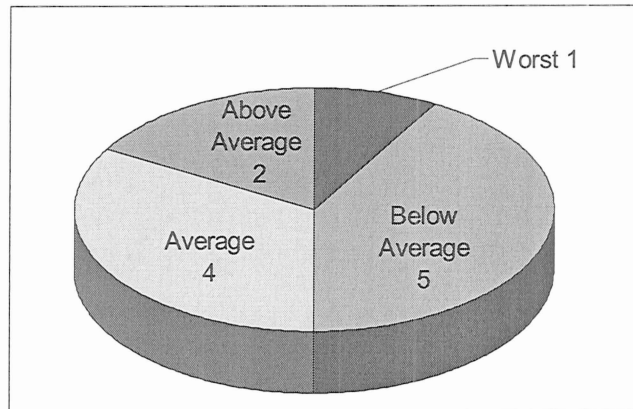
Figure 29. Retail Building Rating Results.

There were 12 total retail buildings in the study area. Their rating results are shown in Figure 29. This portion of our study shows that 75% of the retail structures surveyed in the study area are currently experiencing disinvestment and are in need of rehabilitation.

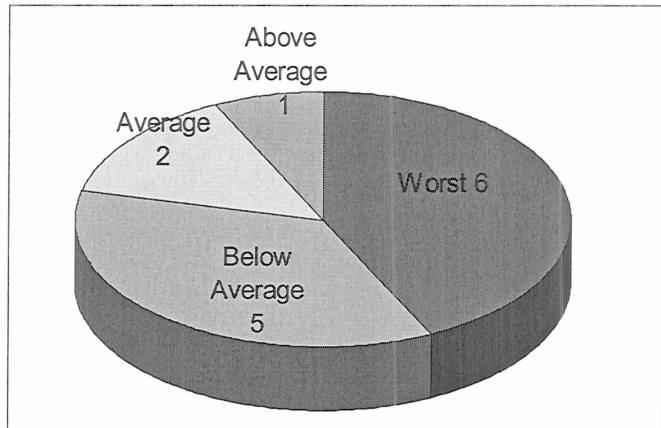
Figure 30. Industrial Building Rating Results.

There were 14 total industrial buildings in the study area. Their rating results are shown in Figure 30. This portion of our study shows that 79% of the industrial structures surveyed in the study area are currently experiencing disinvestment and are in need of rehabilitation.

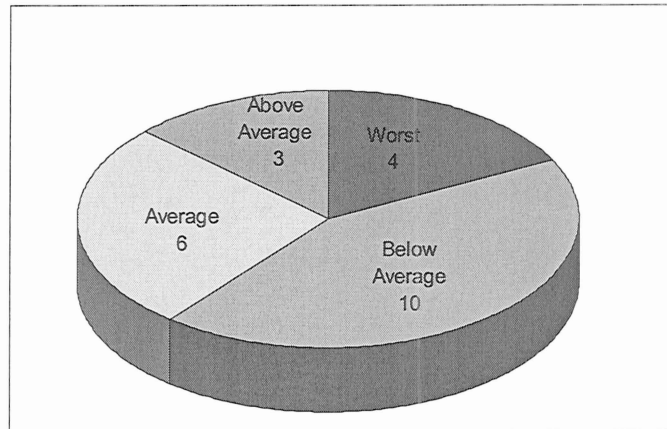
Figure 31. Mixed-Use Rating Results.

There were 23 total mixed use buildings in the study area. Their rating results are shown in Figure 31. This portion of our study shows that 87% of the mixed structures surveyed in the study area are currently experiencing disinvestment and are in need of rehabilitation.

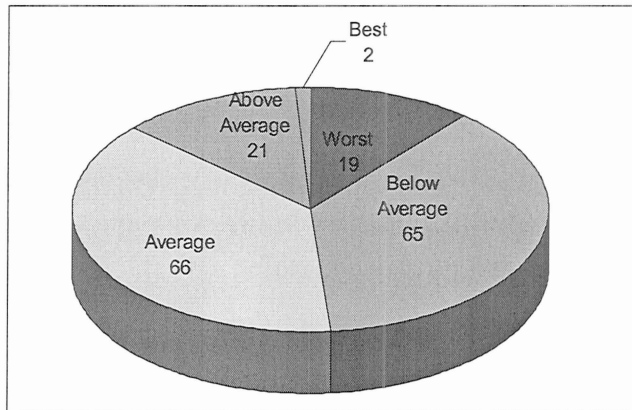
Figure 32. Residential and Mixed-Use Combined Rating Results.

This portion of our study shows that 87% of the residential and mixed structures surveyed in the study area are currently experiencing disinvestment and are in need of rehabilitation. Many towns that apply for state funded grants include a section such as this in their studies. For this reason, we have included it in ours.

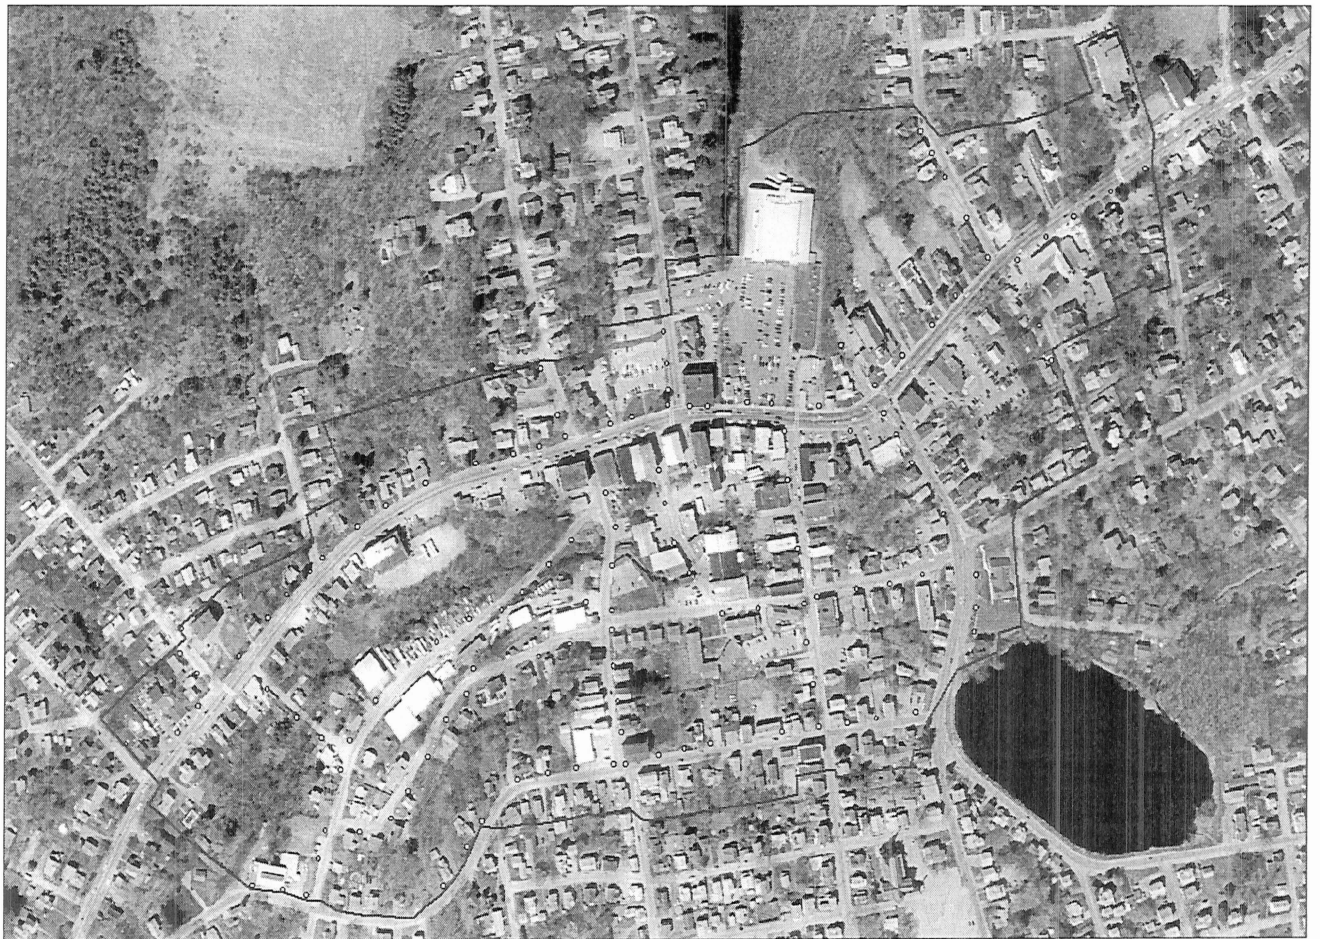
Figure 34. Map that displays light poles in the study area.

The yellow dots represent current light poles (see Figure 34). From studying the map, you can see that there are a majority of light poles along Route 9. This may be because that it is a busy street, but every street needs to be lit for safety reasons.

Pedestrians can be in danger on dark streets at night. There are a lot of corners where there is a limited sight distance so cars may not be able to spot crossing pedestrians. Especially on streets where there are below average to no sidewalks, as explained in the previous section, well lit streets would be a great improvement to the downtown study area.

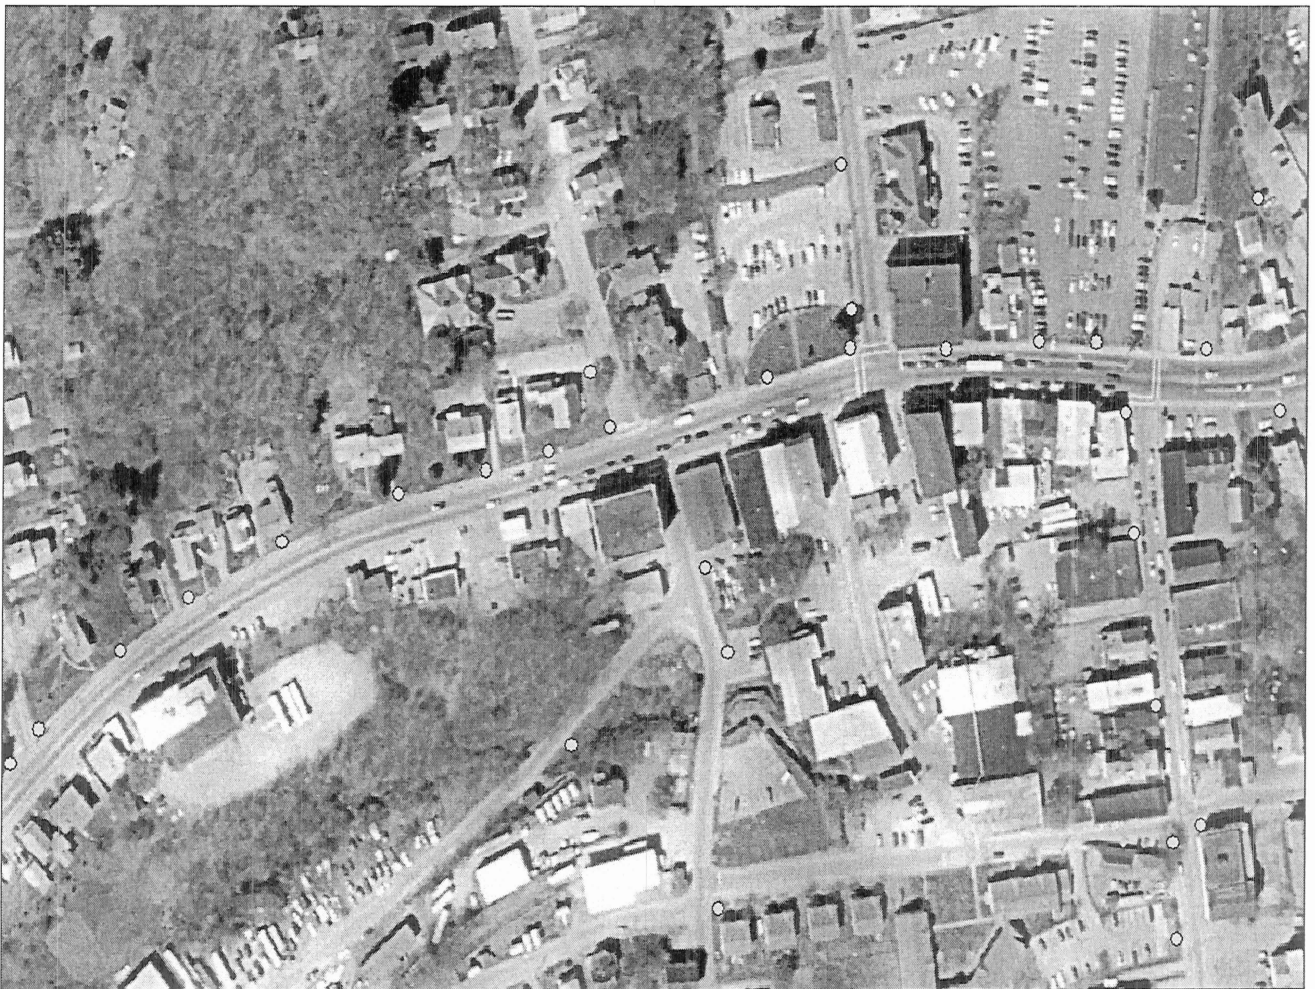
Figure 35. Close-up view of light poles along Route 9.

Shown below is a close-up of a segment of light poles (see Figure 35). It shows the ample amount of light poles along Route 9. However, in the lower half of the picture, you can see where the amount of light poles decrease and the number of buildings increase.

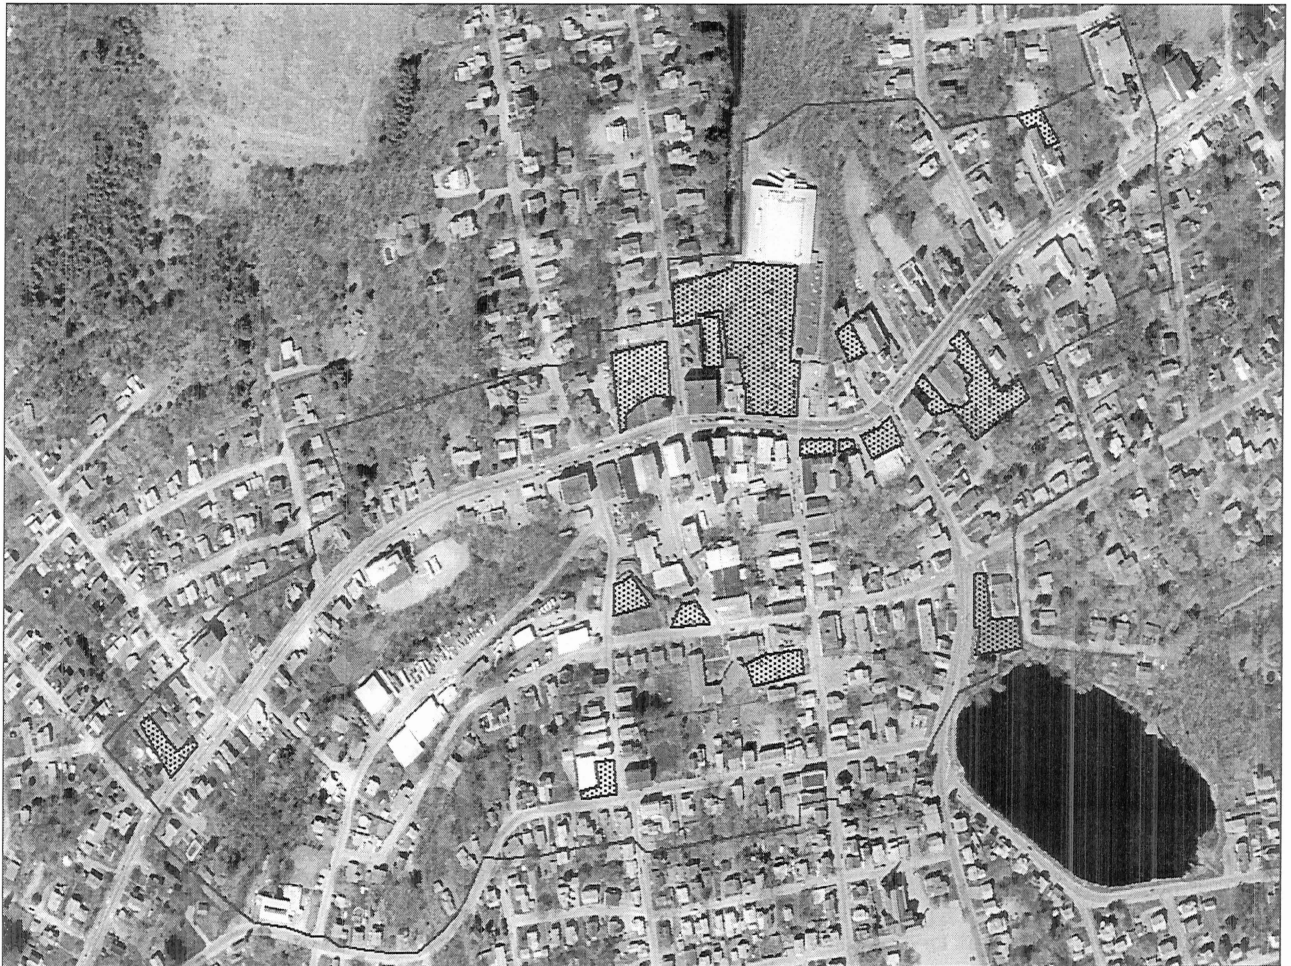
Figure 39. Parking lots in the study area.

It was necessary to survey the placement of the parking lots to estimate the total number of parking spots. These costs would be included in the total amount requested in the grant. A black shaded region represents a current parking lot (see Figure 39).

From the map, you can see that there are many parking lots in one general area. Not many public parking lots are found throughout the downtown area.

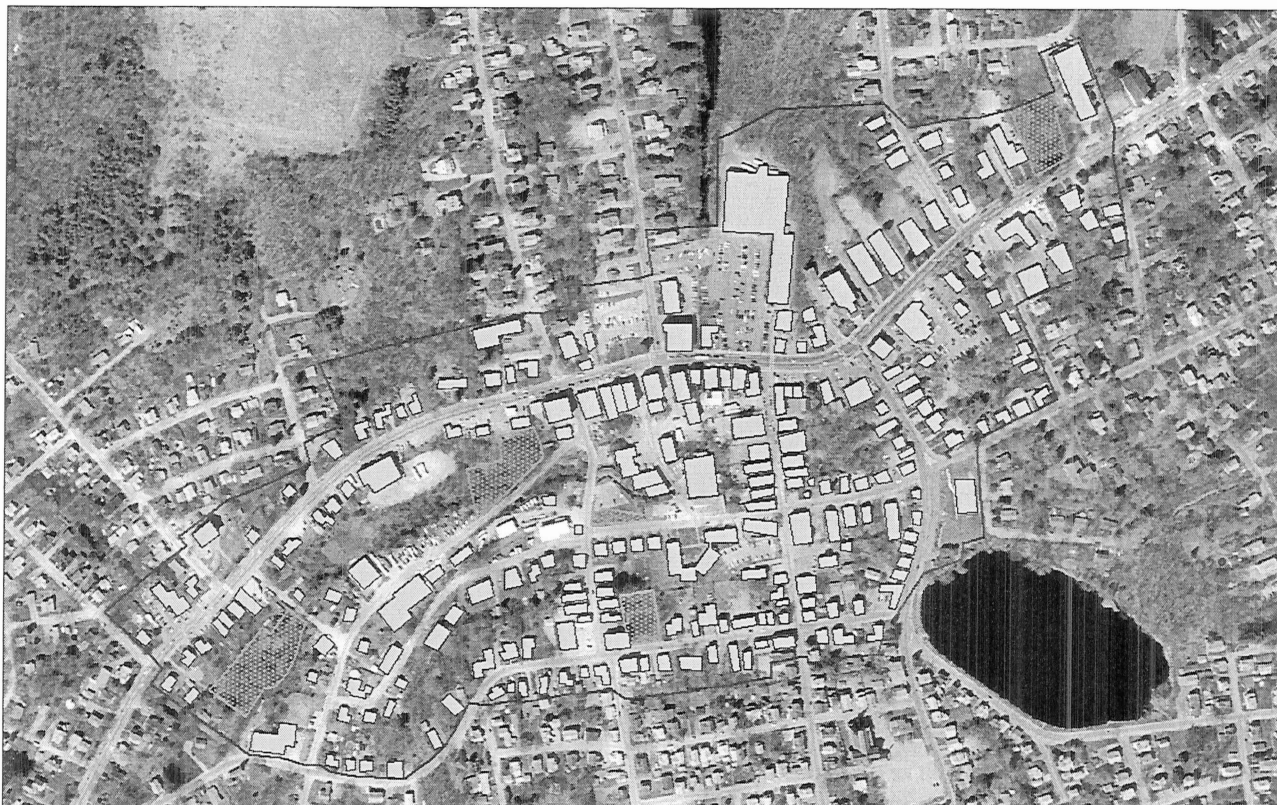
Figure 41. Recommended park locations (shown in green).

As we traveled the study area, we noticed that there are few attractions on its side roads. The map provided below shows possible park location within the downtown bounds (see Figure 41).

Pocket parks within the downtown area will provide the towns people with reason to walk the side streets and take full advantage of their celebrated town. Furthermore, these parks could possibly contain monuments marking famous Spencer events, with plaques next to them providing the park goers with a history lesson. As families walk through Spencer together, a sense of community will be restored, making towns men and women appreciate and enjoy their surroundings.

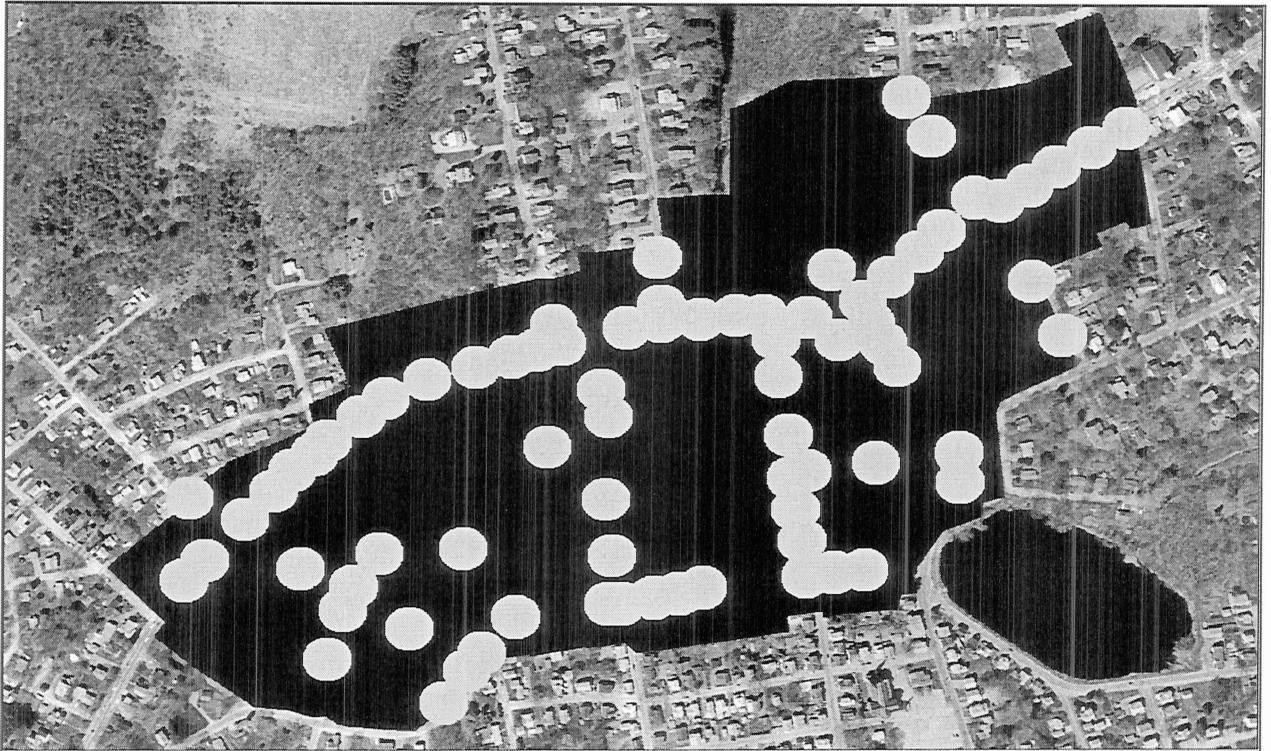
Figure 42. Light distribution in the study area.

The black area shows regions that have poor lighting. As shown, there is an abundance of dark areas south of Route 9. There still remain side streets that do not have adequate street lighting. This is highly a safety issue. Unlit areas can be dangerous to pedestrians if crossing the street at night. In order for people to feel safe in the evening and at night, walking off of the town's primary road, there needs to be sufficient lighting on all side streets. Without this addition, the thought of having attractions pull people off of Route 9, is not a reality.

In order for the citizens of Spencer to take full advantage of the downtown area, we feel that additional lighting on the side roads off of Route 9 will be necessary. The picture below (see Figure 42) shows the light distribution in Spencer's Downtown.

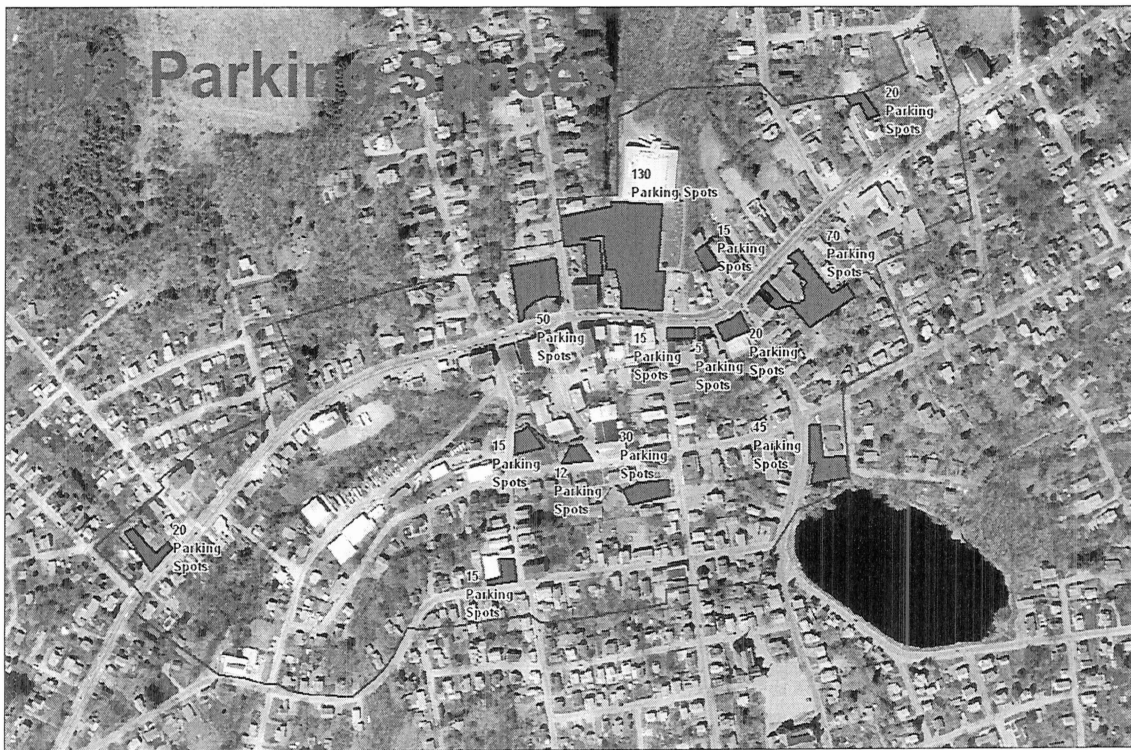
Figure 44. Available Public Parking in Downtown Spencer.

Figure 44 shows that there are currently 462 public parking spaces in Downtown Spencer. Additional parking lots through a block grant may change the environment of the area completely. In the Massachusetts Zoning Code, it is stated that, for retail buildings, there should be one parking space per 200 square feet of building floor. A quick estimate clearly shows that this is not the case in Spencer. All along Route 9, are retail buildings, and yet only 9 parking lots have any relative access to the stores and shops. If new parking lots are created, a greater amount of people can park and interact with Route 9 stores.

These new parking lots may help attract more customers to smaller shops. A problem might exist where people are not willing to stop and shop around because they are not able to find a spot along an extremely busy road. Another problem may be where they actually do find a parking spot, but it is located too far from where they want to shop. Utilizing the grant to add more parking spaces, in any form, would help build up the smaller, family run shops by attracting more business, boosting the town's economy.
