PRODUCT LIABILITY

An Interactive Qualifying Project Report

Date: May 3, 1999

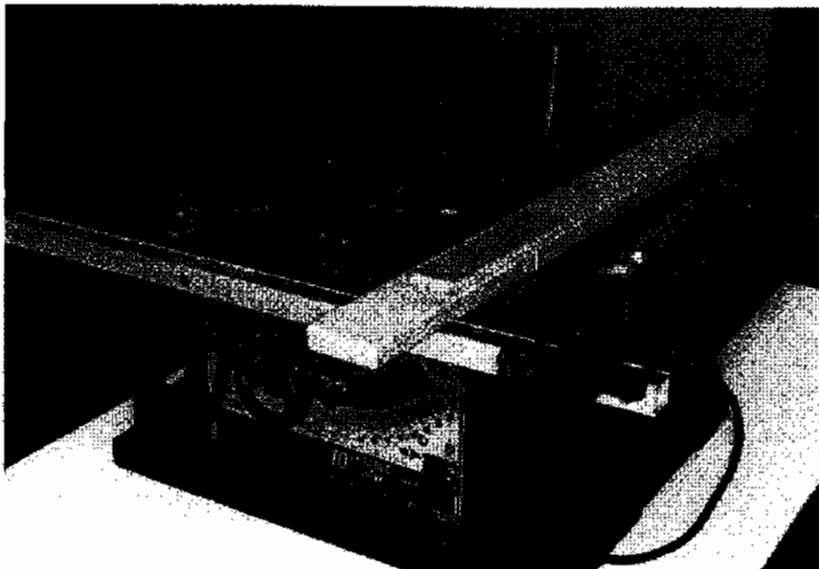
On May 14th, 1996, John Frazier (Plaintiff) severely injured his left hand and fingers when, while operating a 10" table saw model 3400-type 2 (shown in Figure 2-1), designed, manufactured, distributed by S-B Power Tool Company (Defendant). Mr. Frazier was ripping a piece of wood that was approximately 27 inches long, 2 ½ inches wide and ¾ inch thick. It is claimed that Mr. Frazier's left hand came into contact with the saw blade because of a kickback that was caused by a defective rip fence and defective anti-kickback fingers. Mr. Frazier amputated his left thumb, index finger, long finger and ring finger. Under both theories of negligence and breach of warranty, a product liability law suit is filed against S-B Power Tool Co. for it's negligence in design manufacturing and distribution of the table saw.

Figure 2-1: Skil Table Saw

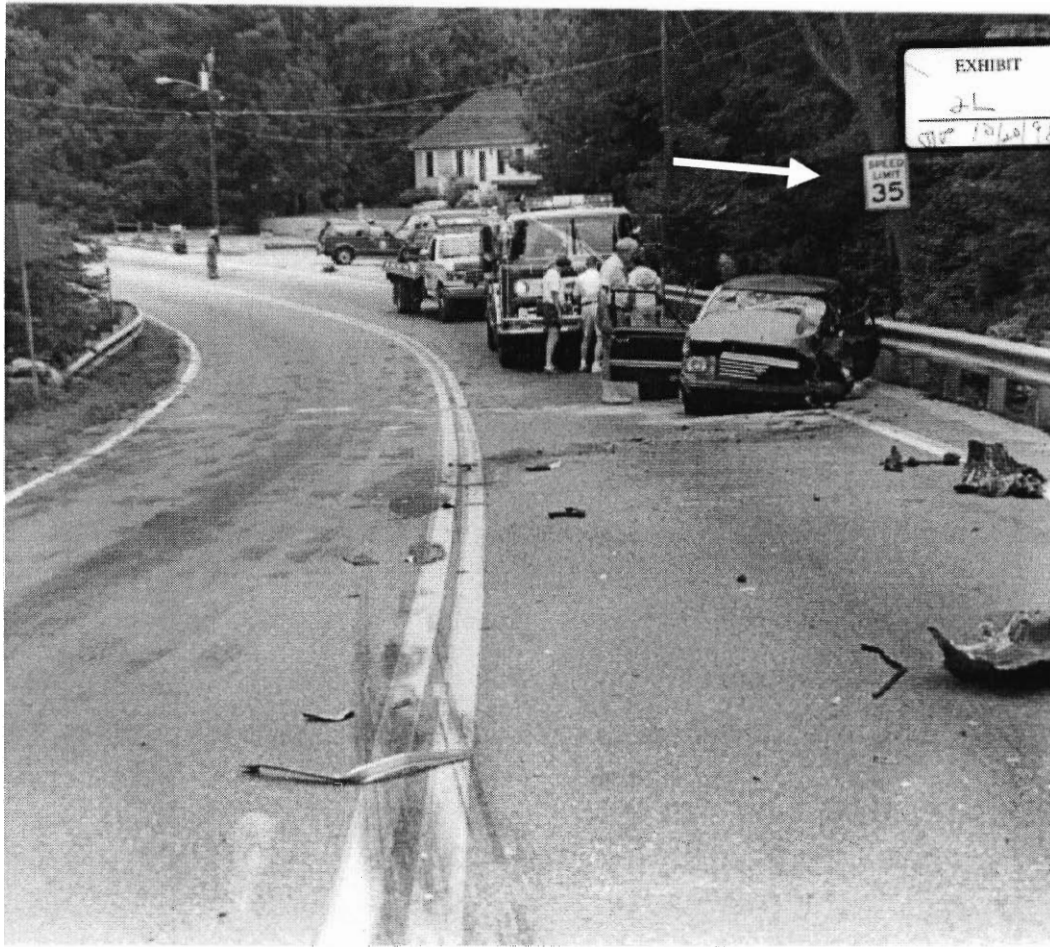
Figure 3-1

First we must examine the testimony of the only witness to the accident, Mr. Mackenzie. He stated that he was travelling in between thirty and thirty five miles an hour. Upon close examination of the photographs, one will notice that the speed limit is 35 miles per hour.

According to his testimony, he should have been within the speed limit. A car that would most likely be safe, but with tractor-trailers they have a much larger mass and higher center of gravity. A tractor-trailer would be more likely to carry into the another lane, then a car would.
