# **The Church Floors in Venice, Italy: An Archeological Study and Analysis**

31 July 2002

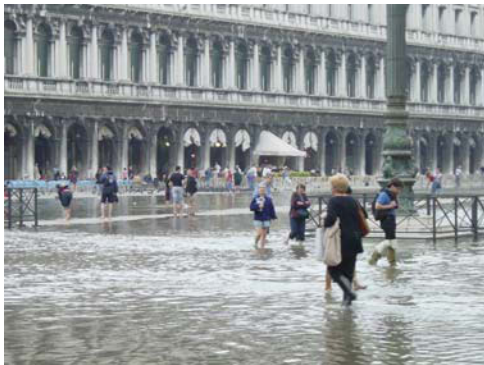
Figure 1: Flooding in San Marco in June of 2002.

The churches of Venice hold many great historical works of art and are among the many places that accrue damage throughout Venice. Many different causes have led to the deterioration and damage of these buildings. One of the major causes is high flood waters that are occurring more frequently and at greater heights (Figure 1).

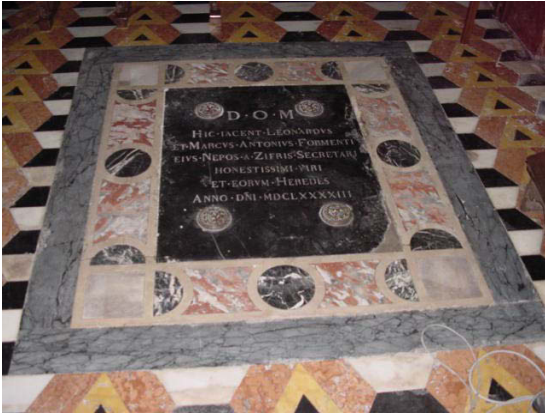
Figure 2: An artifact found in the Santa Maria di Nazareth

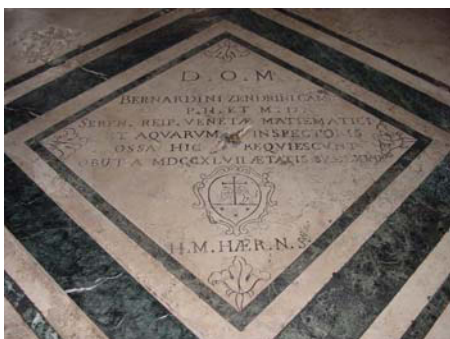
Figure 27: Artifact from the *Santa Maria Assunta dei Gesuiti*.

For example, the artifact seen in Figure 27 has all three categories of letters. The total amount of letters is 133. The amount of perfectly readable, damaged, and

unreadable letters are 121, 11, and 1 respectively. Therefore the equation is as follows

$$\begin{aligned} (121/133 * 100) * 1 &= 91 \\ (1/133 * 100) * 2 &= 2 \\ (11/133 * 100) * 3 &= 25 \end{aligned}$$

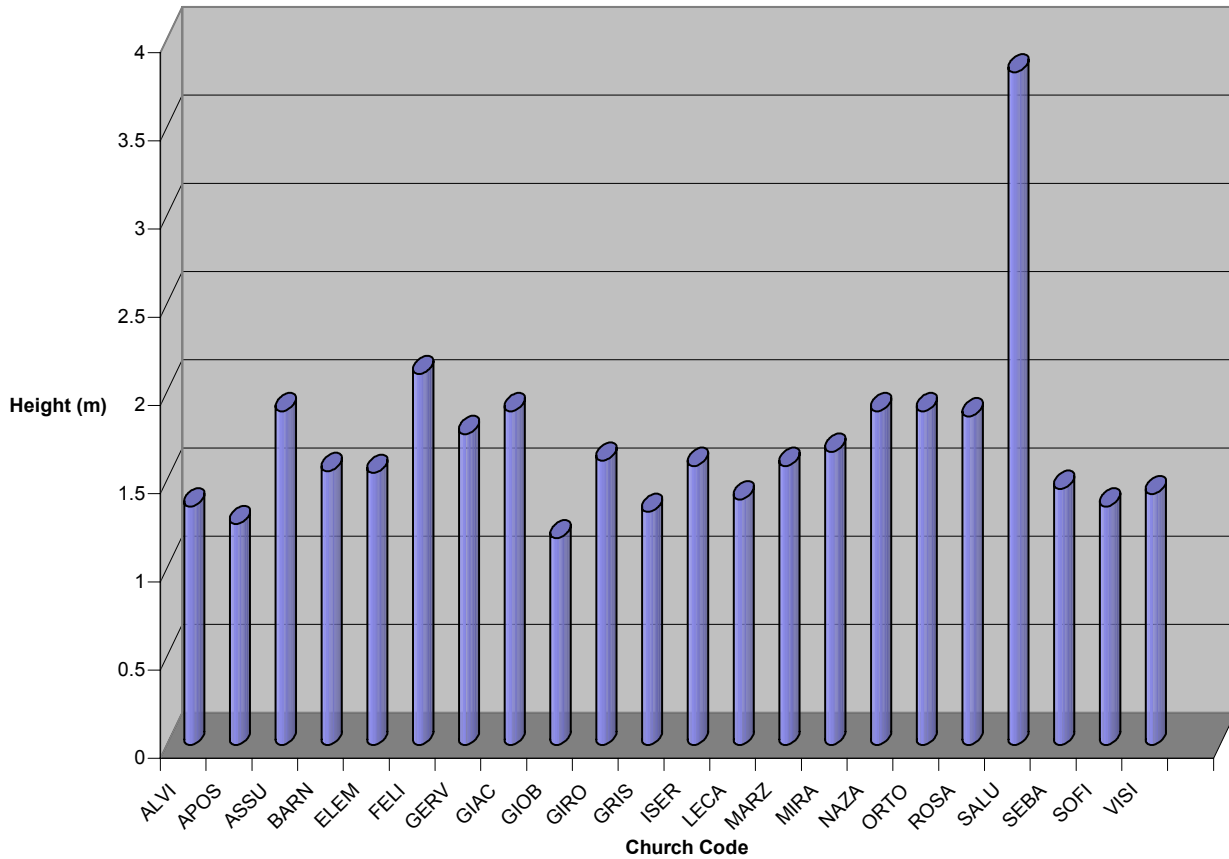
Figure 32: Heights of main church floors in meters. A list of church codes and names is in the Appendix.

Shown in the chart above, Figure 32, are the heights of the main floors of the church floors. These heights will be important to the assessment of the threat from high floods. As seen in this chart the *San Giobbe* (GIOB) has the lowest main floor, while the main floor of *Santa Maria della Salute* (SALU) is well above the heights of the other floors.

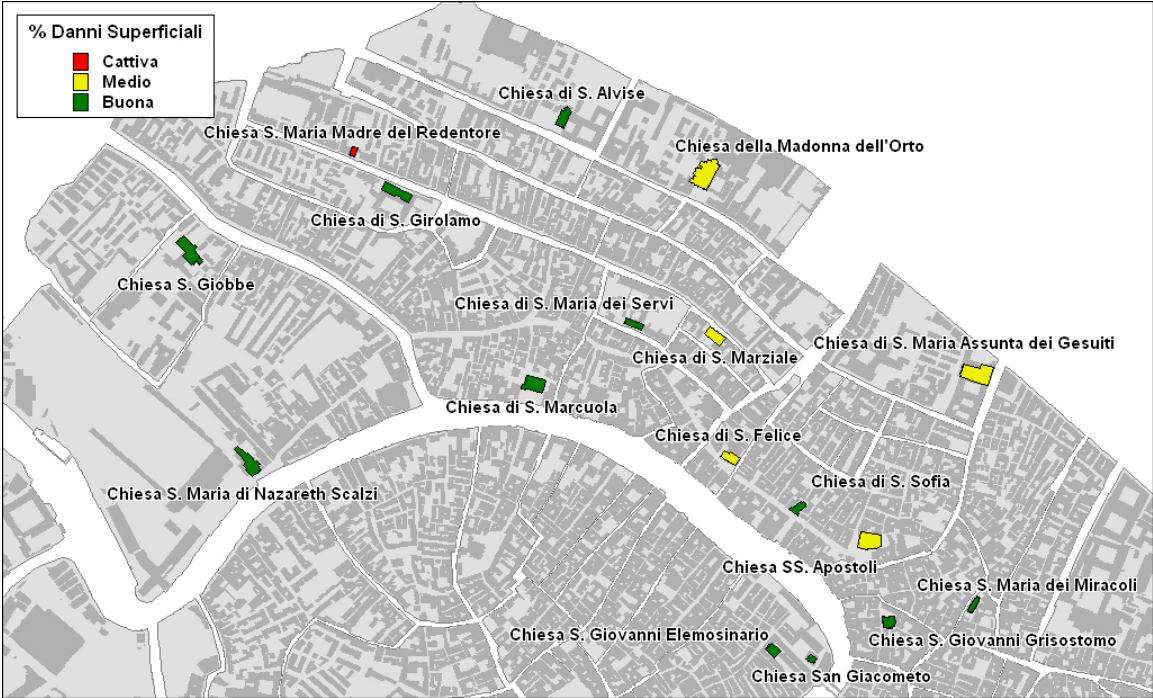
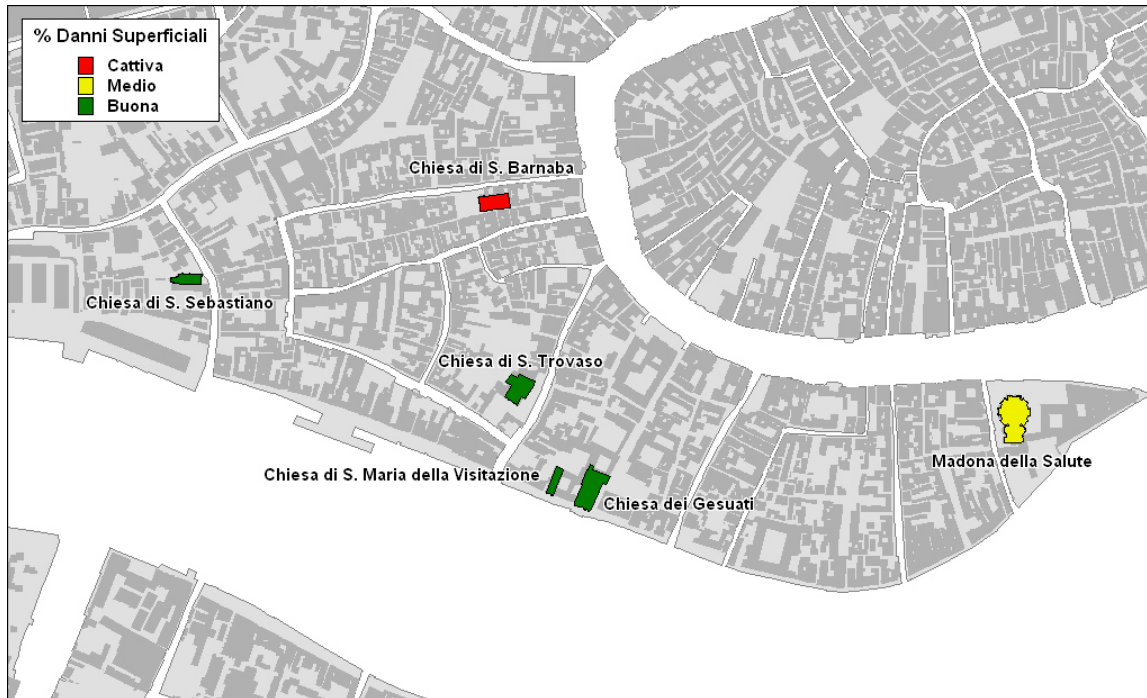
Figure 33: Surface damage for Cannaregio and San Polo

Figure 33 and Figure 34 show the amount of surface damage to the floors of the churches. The church of San Barnaba and Le Cappuccine, also known as Santa Maria Madre del Redentore, are found to be in the worst conditions.

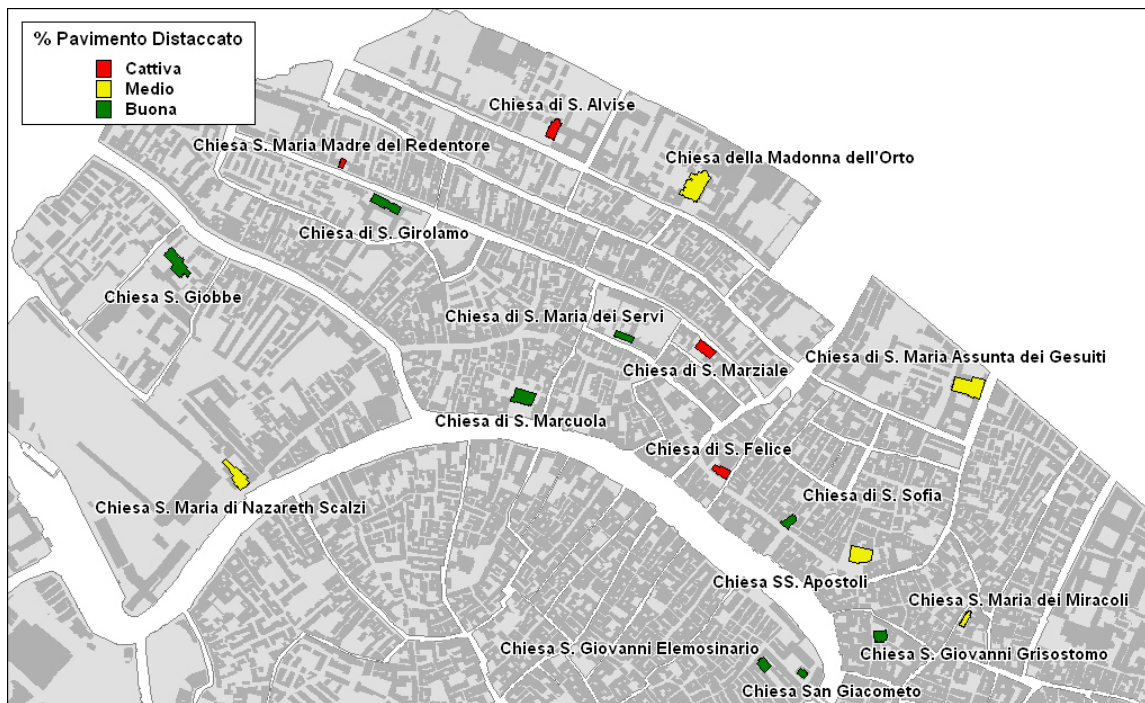
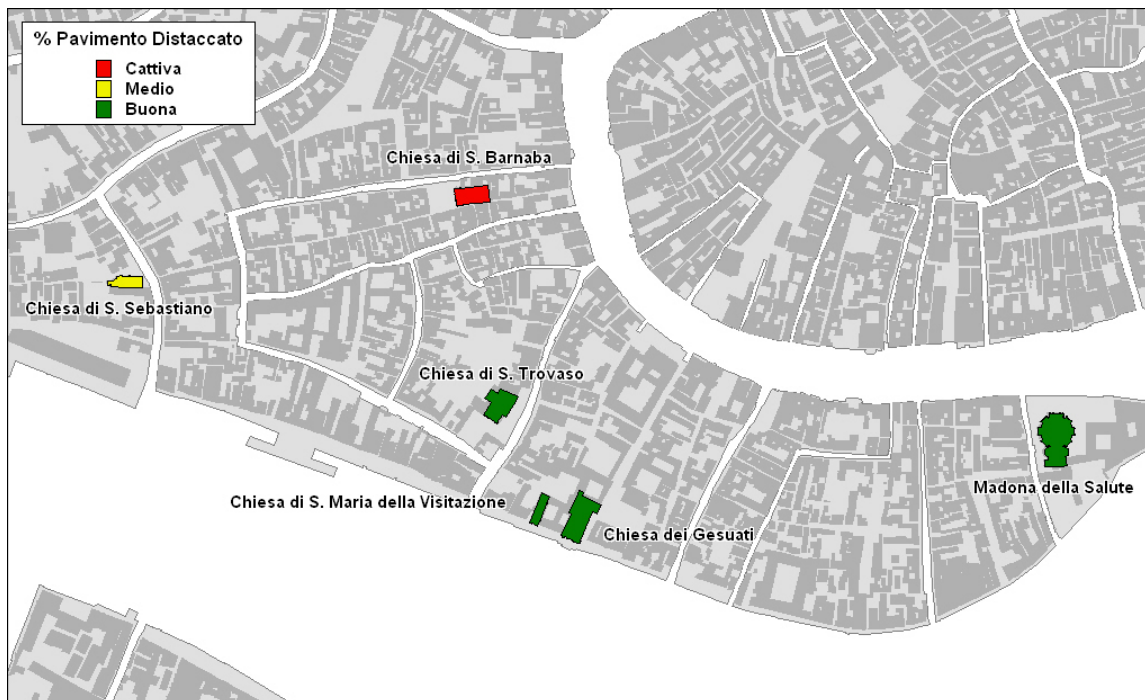
Figure 36: Floor Detachment in Cannaregio and San Polo

In the above two figures, Figure 36 and Figure 37, the amount of floor detachment is classified in three categories based on percentages of the floor per square meter. Some of the worst churches included San Barnaba, San Felice, San Alvise, Le Cappuccine, and San Marziale, also known as San Marcelliano.

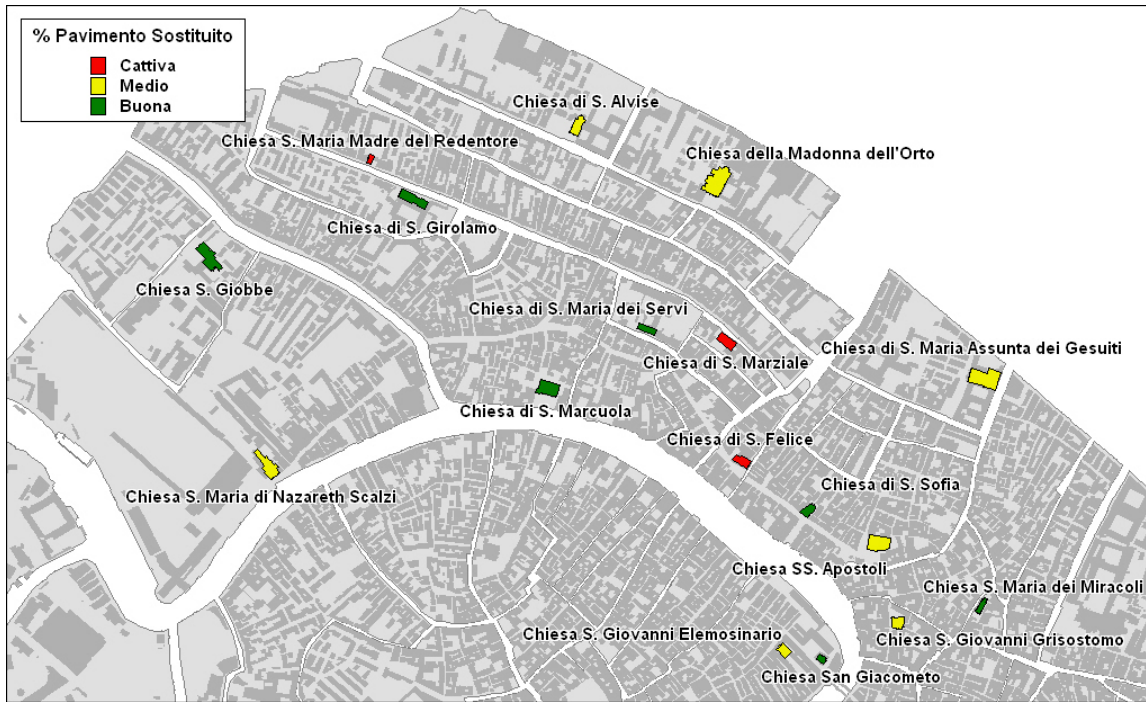
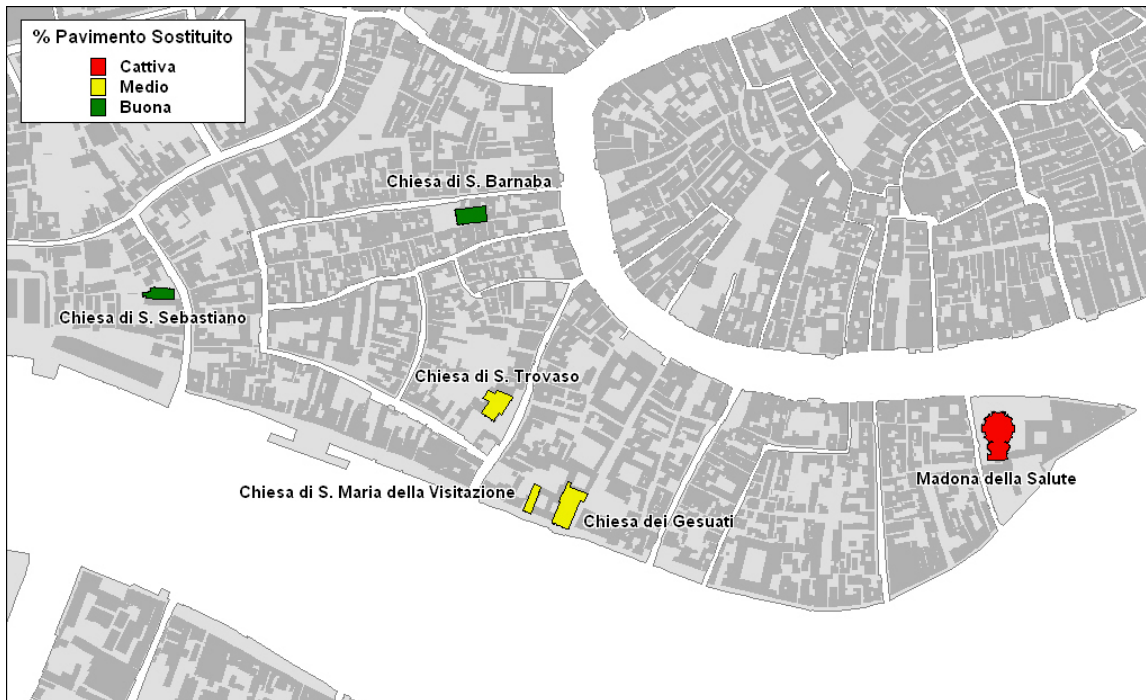
Figure 39: Floor Replacement in Cannaregio and San Polo

The degree of floor replacement for each church is shown in Figure 39 and Figure 40. Floor replacement is when a section of floor is replaced with new materials, such as the filing in of pitting or of areas of floor detachment. Some of the worst churches with floor replacement were the Madonna della Salute, San Felice, San Marziale, and Le Cappuccine.

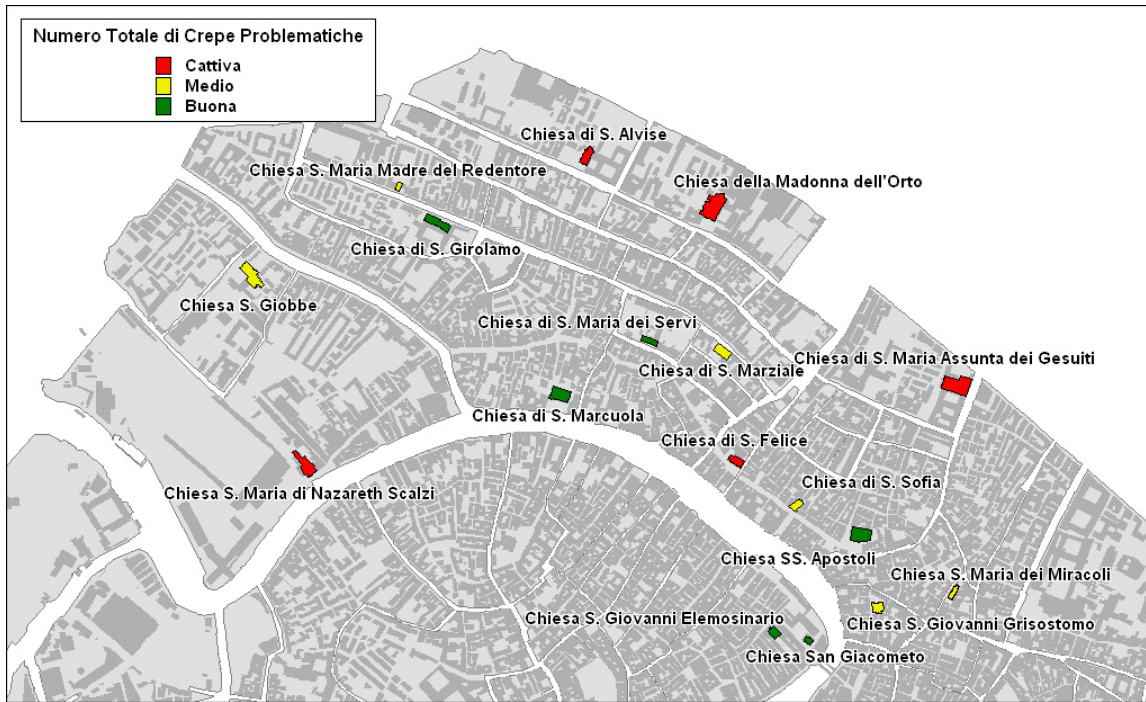
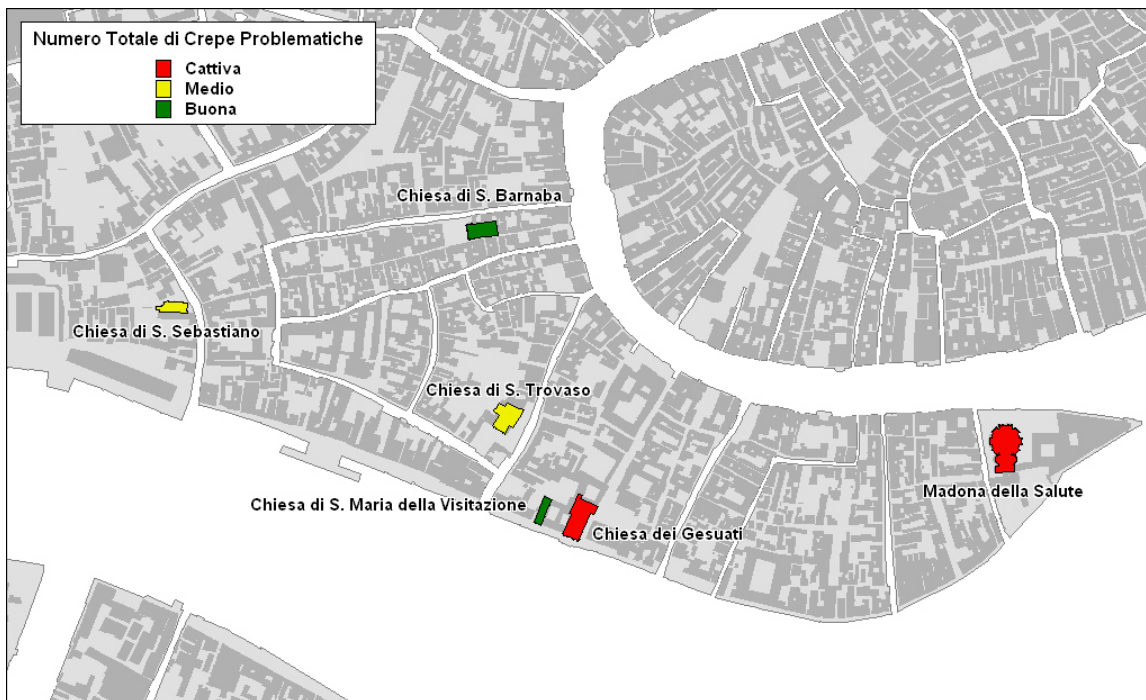
Figure 42: Number of Problem Cracks in Cannaregio and San Polo

In Figure 42 and Figure 43, the total number of cracks per church is classified in three categories. The three churches, the *Santa Maria della Salute*, *San Felice* and *Santa Maria Assunta dei Gesuiti* showed some of the worst conditions in number of problem cracks.

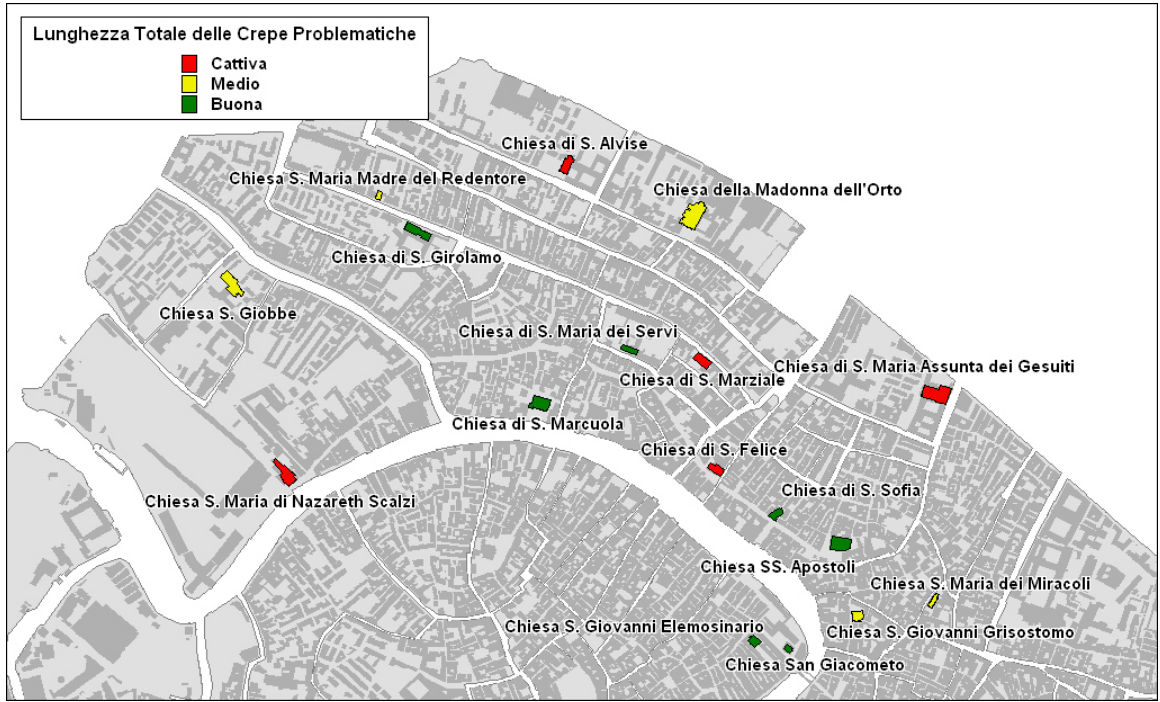
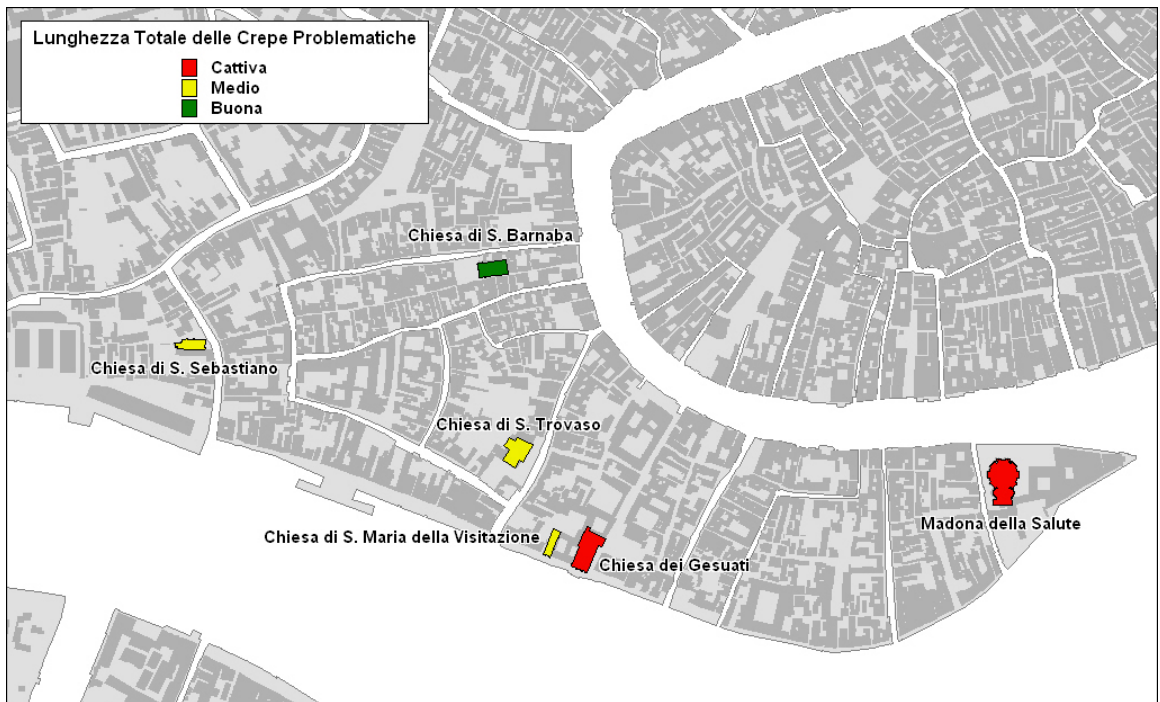
Figure 45: Total Length of Problem Cracks in Cannaregio and San Polo

Figure 45 and Figure 46 show the churches by the total length of problem cracks found on their floors. The *Santa Maria della Salute* was the worst case with its total almost doubling that of the second worst church (*Santa Maria di Nazareth*). Five of the twenty-two churches (the *San Giacomo Apostolo*, *San Girolamo*, *I Santi Apostoli*, *San Barnaba* and *Santa Maria de Servi*), had no cases of problem cracks whatsoever.

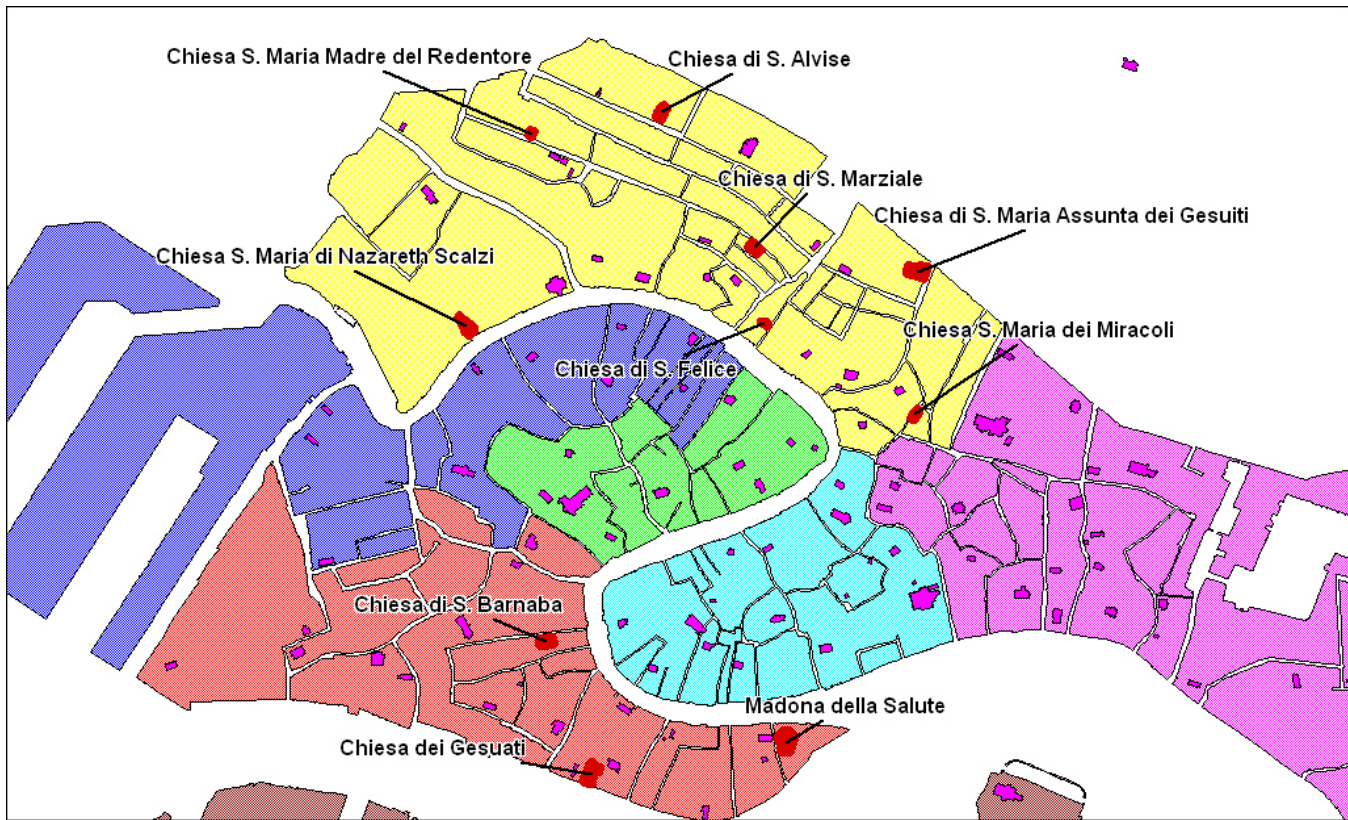
Figure 48: Location of the churches with the worst floors

In the above figure, Figure 48, the locations of the churches with the worst floors are highlighted in red and labeled. The San Felice, located in the Cannaregio sestiere, contains the worst floor of the ten shown.

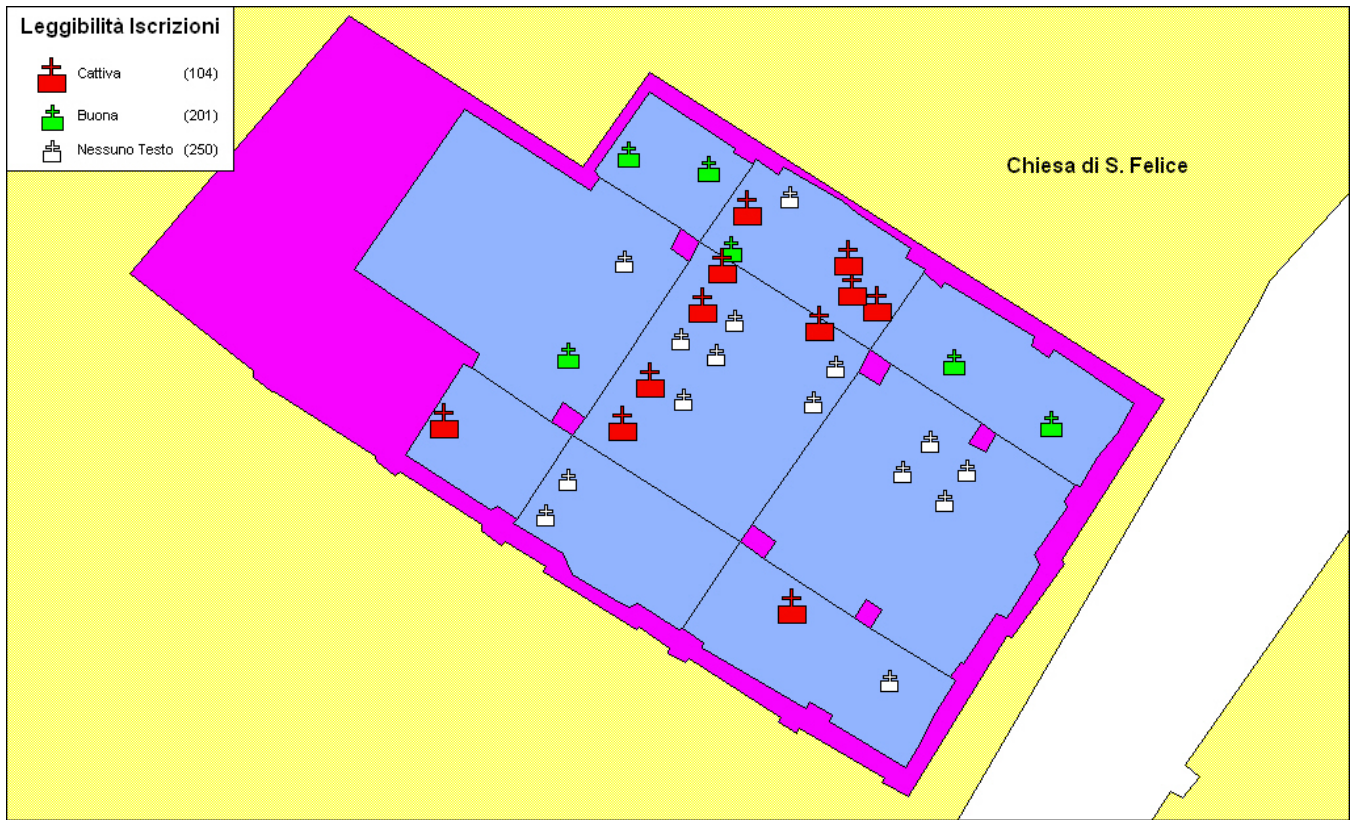
Figure 50: The Text Readability Ratings of the San Felice

The text readability of the artifacts of the *San Felice* is illustrated above in Figure 50. Of the seventeen artifacts that contain text in *San Felice*, eleven had bad text readability.

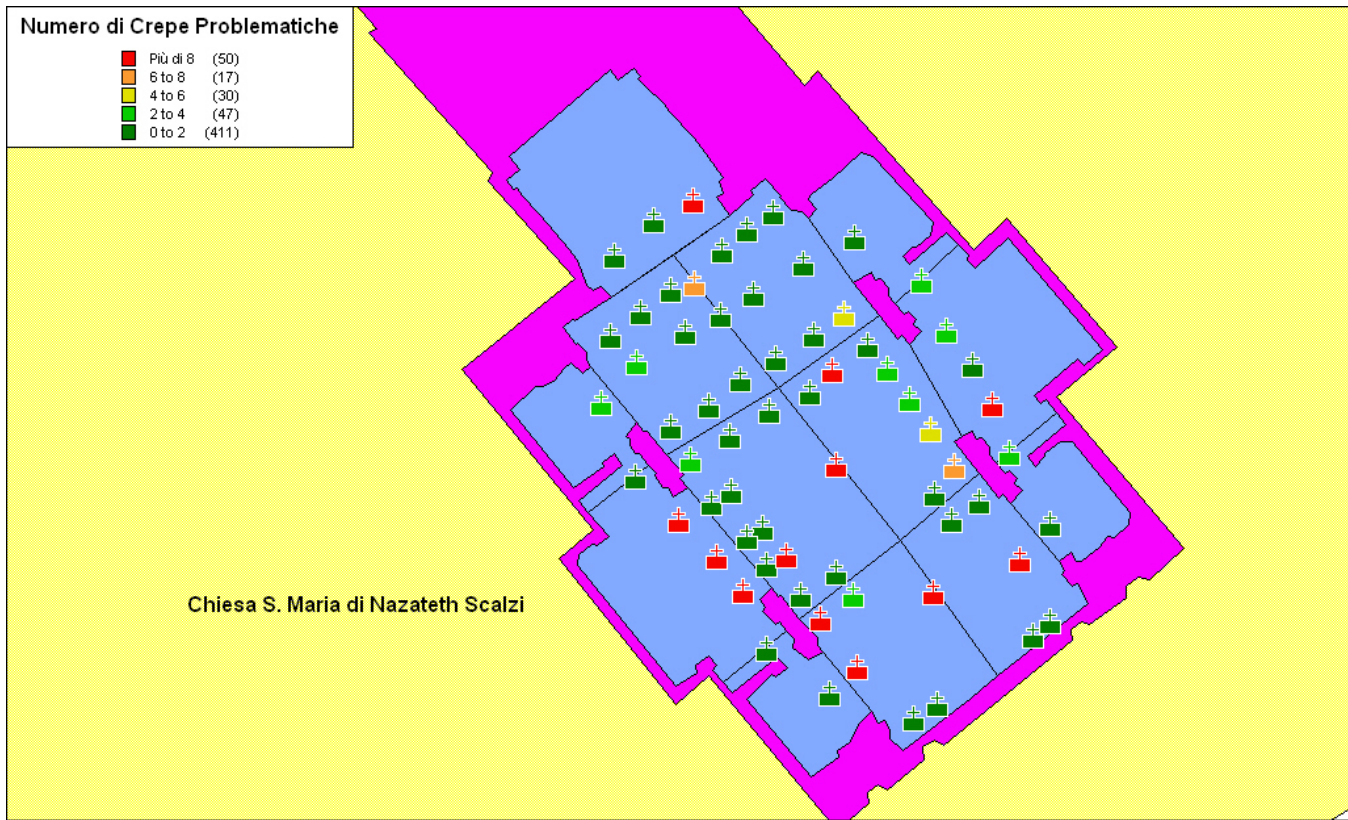
Figure 51: Total Number of Problem Cracks on artifacts in the Santa Maria di Nazareth

Figure 51 visually shows the number of problem cracks found on each artifact within the *Santa Maria di Nazareth*. Many artifacts found in this church are in fairly good condition, but twelve artifacts each contained more than eight problem cracks.

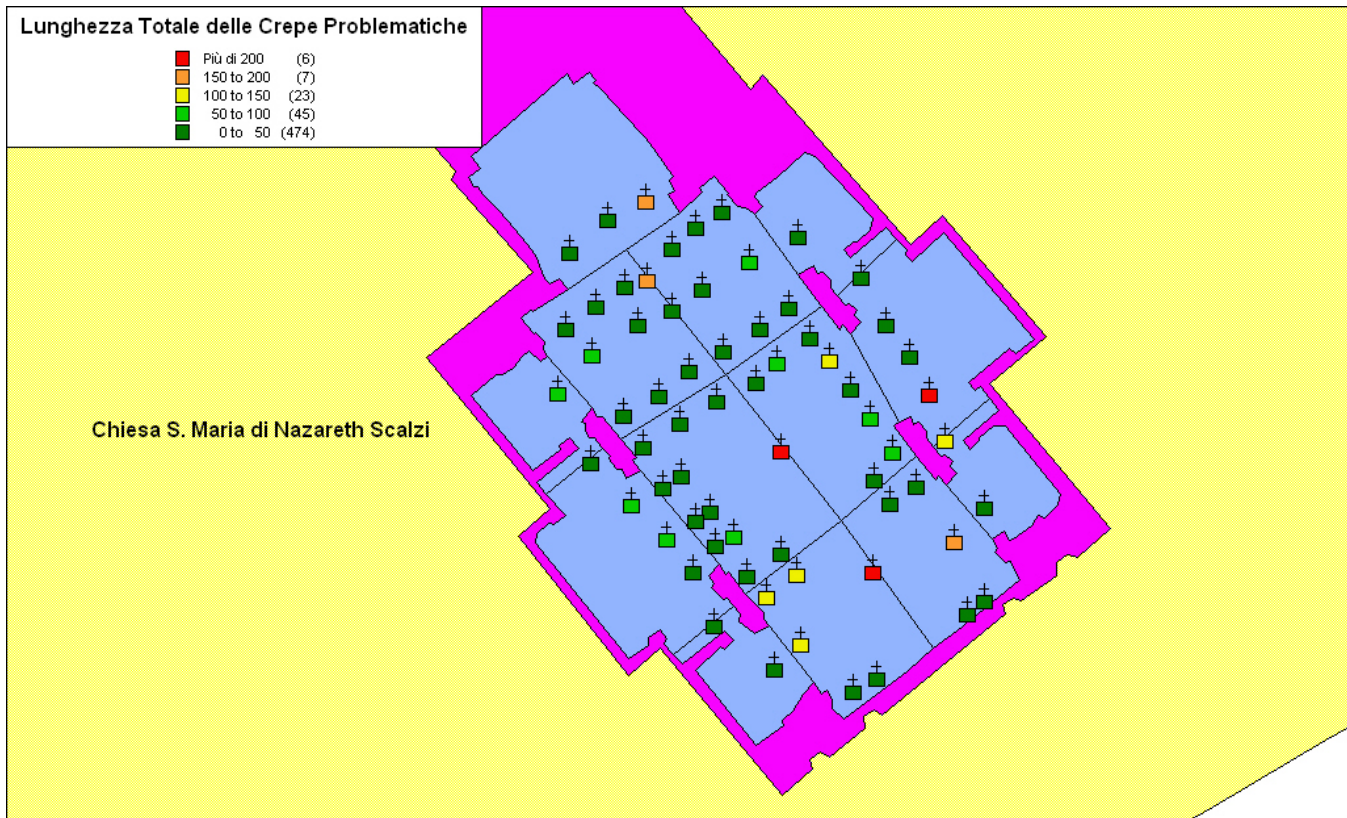
Figure 52: The Total Length of Problem Cracks on Artifacts in the Santa Maria di Nazareth

Illustrated in Figure 52 is the total length of problem cracks found on the artifacts within *Santa Maria di Nazareth*. Many of the artifacts within this church were in good condition, while eleven artifacts produced a greater part of the total length. Three of the six worst total lengths of problem cracks per artifact can also be found within this church, having lengths greater than 200cm.

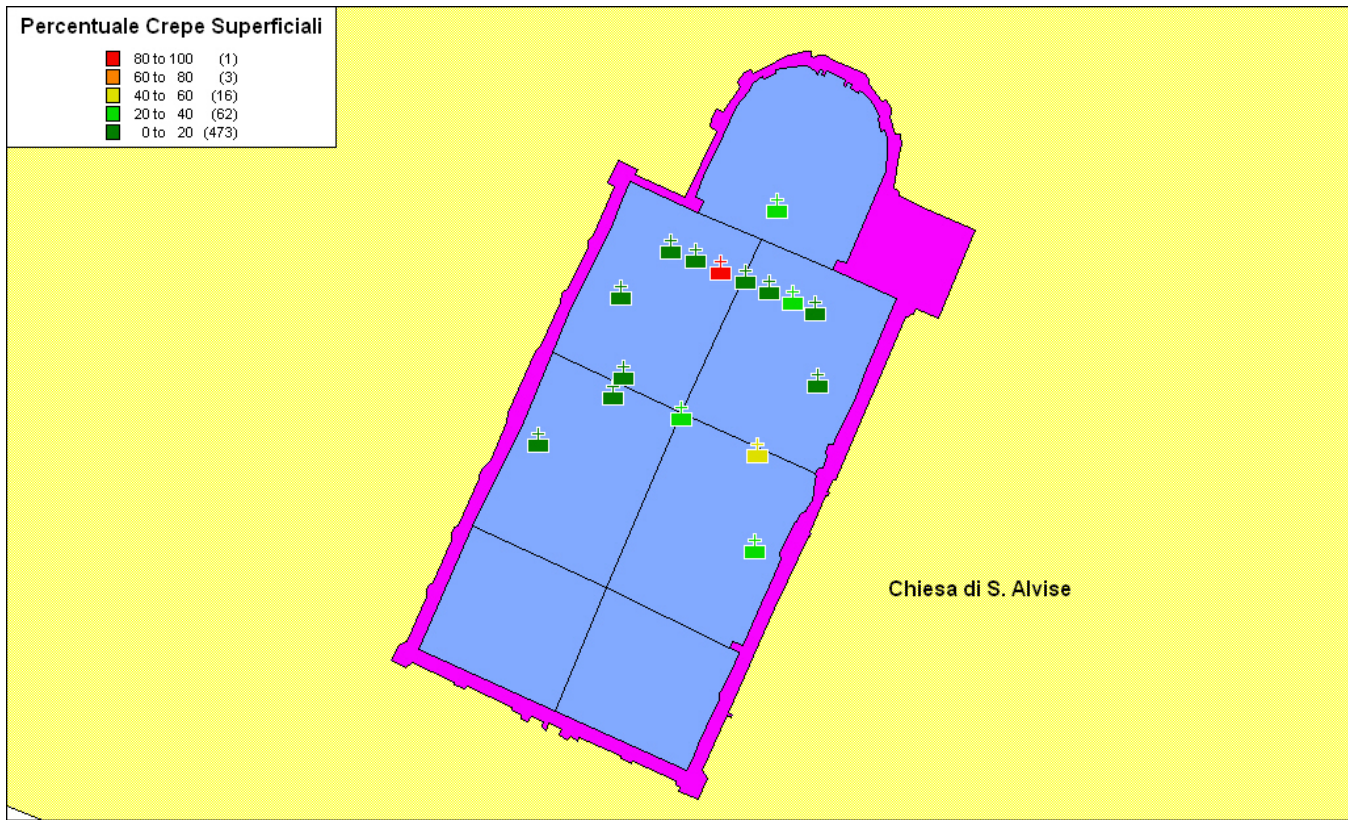
Figure 53: Percentage of Surface Cracks Found on the Artifacts in the Sant' Alvise

Figure 53 displays the percentage of surface cracks found on the artifacts in the *Sant' Alvise*. The worst case artifact can be found within this church, sustaining damage on greater than 80 percent of the artifact. Most of the church's artifacts remain in good condition.

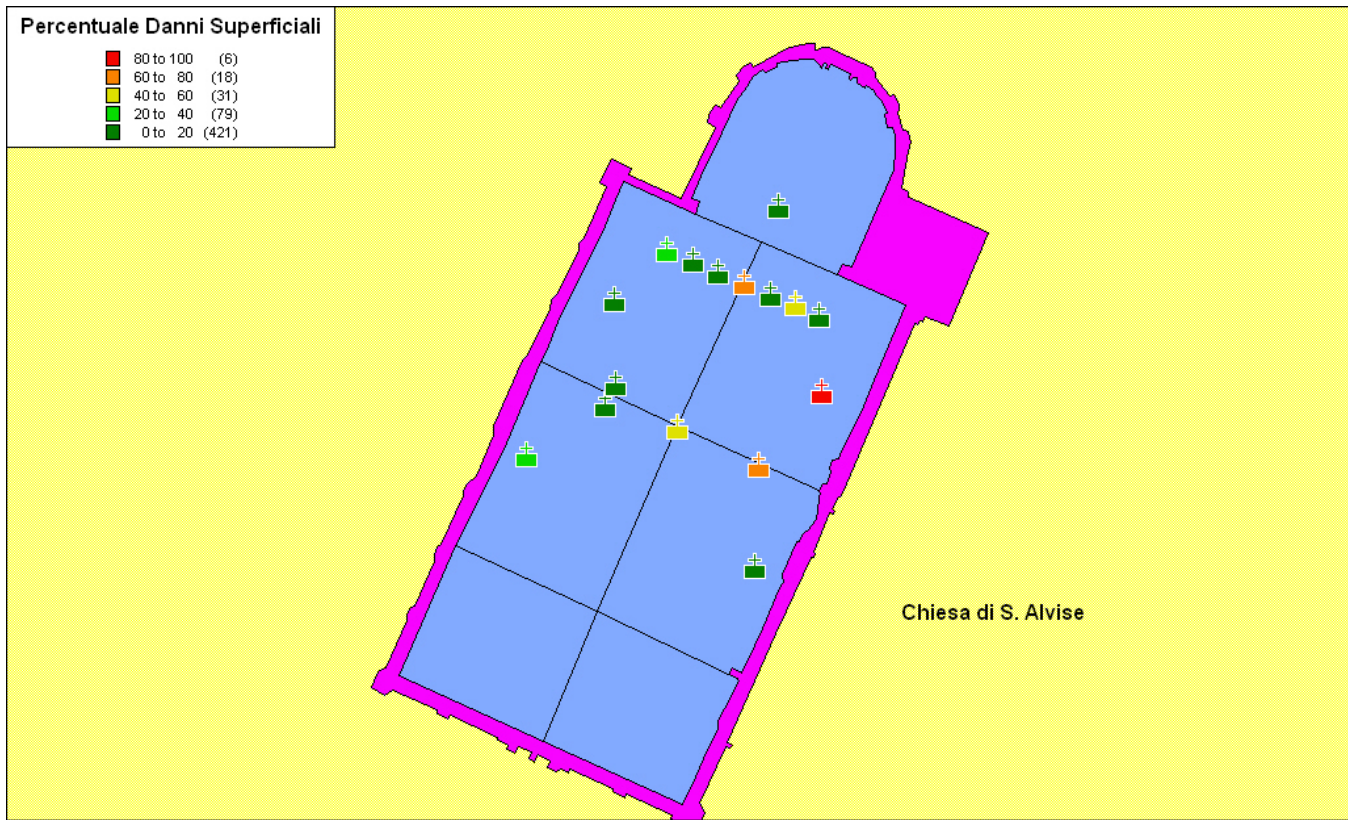
Figure 54: The Percentage of Surface Damage found on Artifacts in the Sant' Alvise

The percentage of surface damage found on the artifacts in the *Sant' Alvise* is shown in Figure 54. One of the six worst cases of having over 80 percent surface damage can be found within this church.

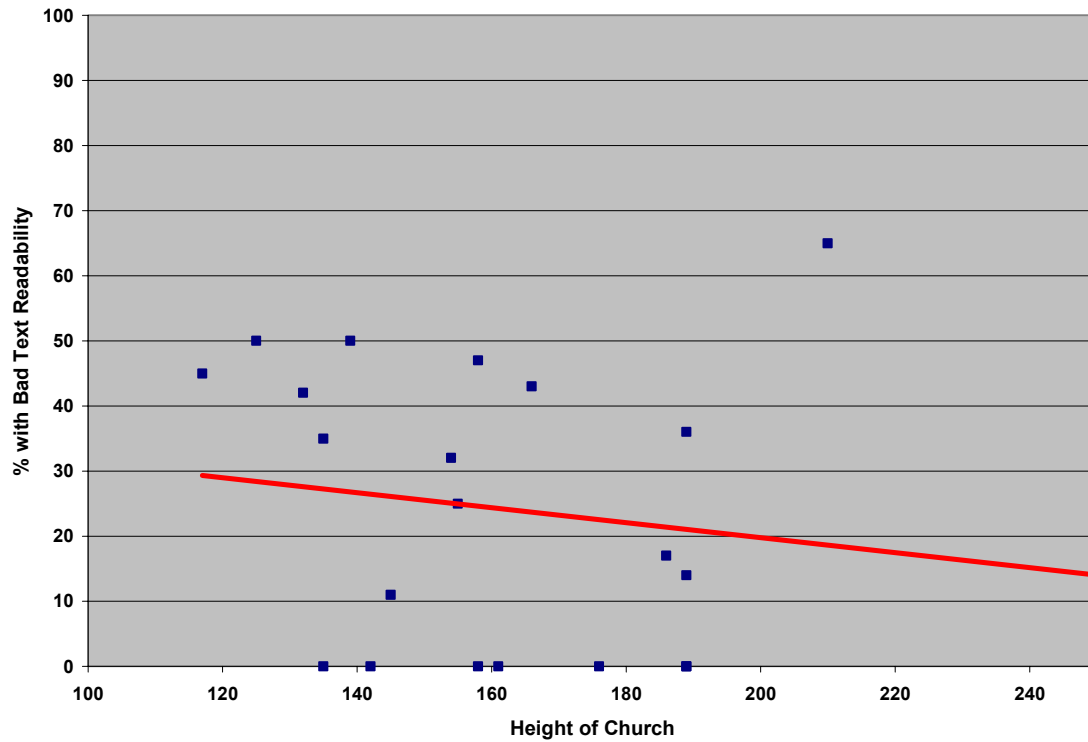
Figure 61: Church height in relation to text readability

Figure 61 illustrates that high tides have a tendency to adversely affect the text readability of artifacts. The *I Santi Apostoli* and the *Santi Giobbe e Barnardino* both have low heights and a high percentage of artifacts with damaged and/or unreadable text. The *Sant' Alvise* has a higher floor and the percentage of artifacts with bad text readability is less than the *Apostoli* and the *Giobbe*. Finally, the *San Sebastiano* has a higher floor and few artifacts that have damaged text. This brought us to the conclusion that artifacts located within lower church floors, which are susceptible to a greater number of high tides, are in fact being damaged by the water and the chemicals that might be present within the water.

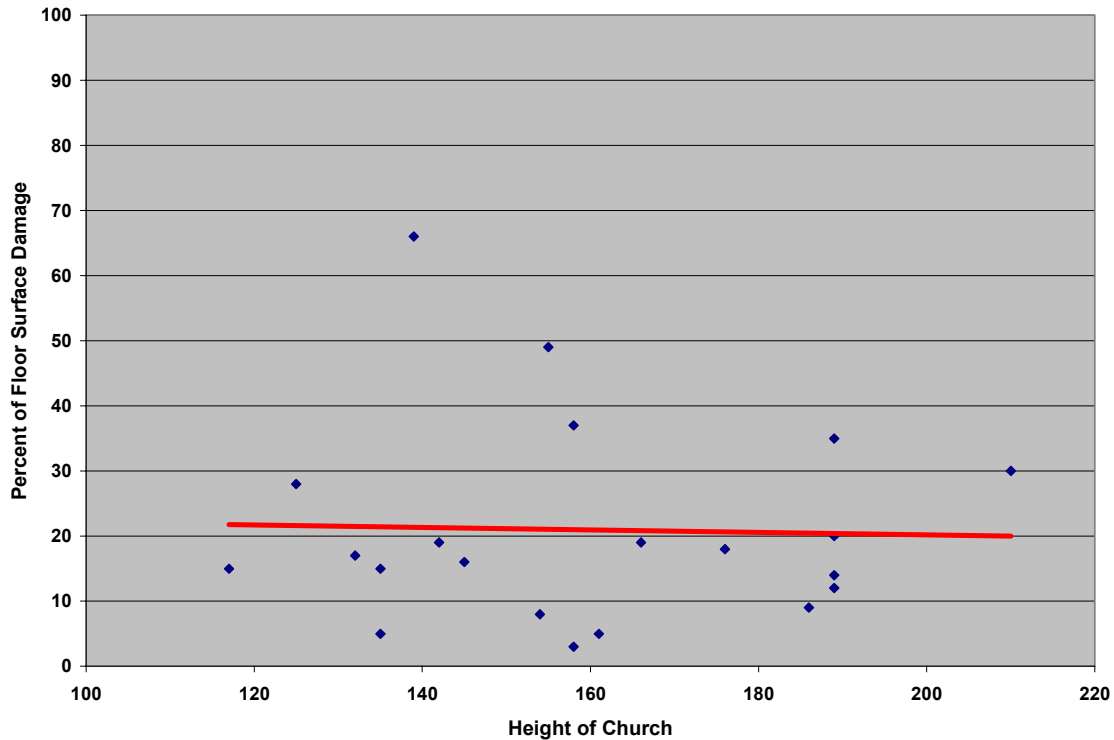
Figure 62: Church height in relation to floor surface damage.

Figure 62 demonstrates the effect that high tides have on church floors. The church floors that are higher from the absolute zero point, therefore less susceptible to greater number of floods, are not being damaged as greatly as those churches which are closer to the absolute zero. Ultimately, these charts lead us to the conclusion that the high tides cause damage to both the floors and artifacts of churches that are closest to sea level.

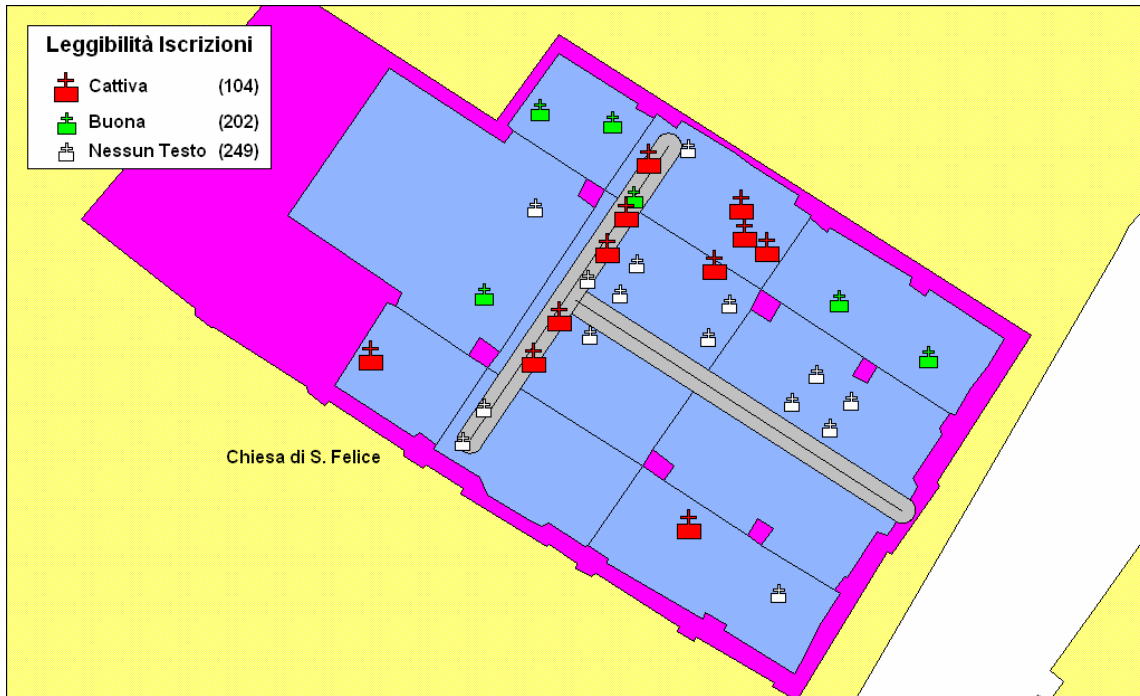
Figure 63: Artifacts in the San Felice with foot traffic paths marked in grey.

As can be seen in Figure 63, the artifacts within the paths of the *San Felice* have mostly damaged or unreadable text. This is the visual representation of a trend can be seen in 13 of the 19 churches that we studied that have artifacts.

With the heavy flow of tourism in Venice, buildings and artwork are at the mercy of tourists. Heavily trafficked areas of floors show major signs of wear and must be protected. A simple and economic solution would be to rope off areas of the floor that are in danger. Churches already rope off their altars and other sacred areas to prevent tourists from entering, and as a result we found that altar floors were in better condition than other quadrants of the church that are open to everyone. There were a few exceptions, such as was seen in the Santa Maria Assunta dei Gesuiti, because the main floor had been restored but the side altars and altar had not. The only instance we've observed in which the church protected artistic designs in the floors, that were not sacred areas, was the *Santa Maria della Salute* (Figure 66). Roping off certain areas diverts foot

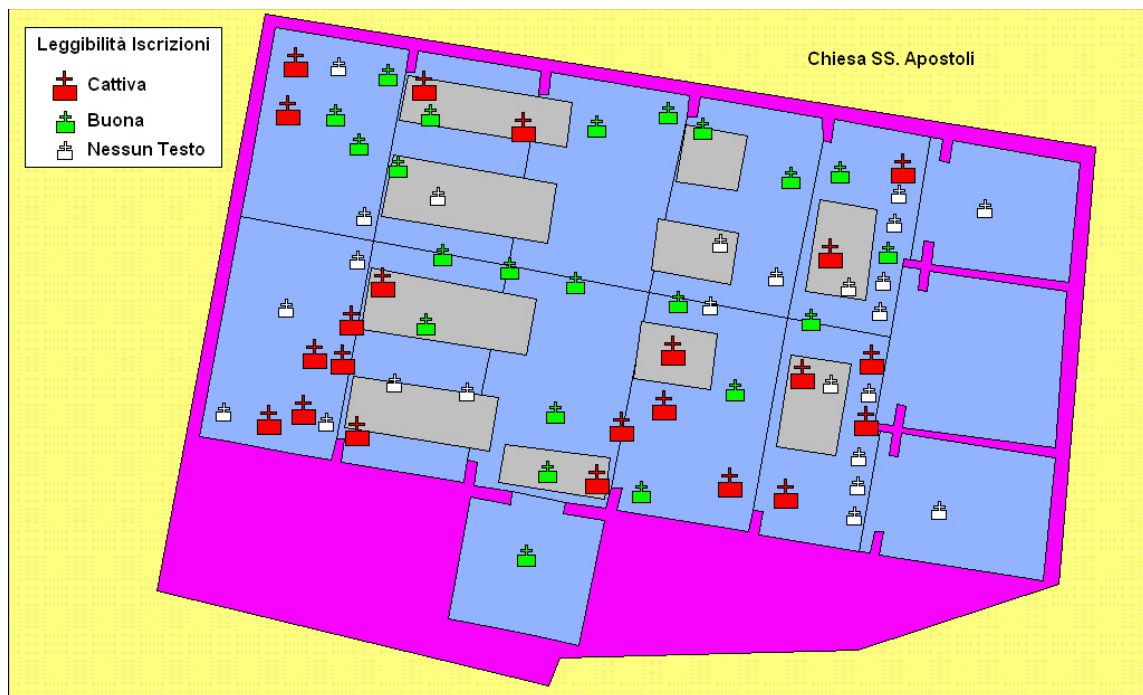
Table 11 illustrates that the text on artifacts underneath pews is in worse condition than artifacts that are neither walked upon nor underneath pews. Like the artifacts located in main walkways, the other three damage assessments do not confirm that artifacts underneath pews suffer structural damage.

Figure 64: Artifacts in the *I Santi Apostoli* with the pews shown in grey.

Figure 64 further demonstrates that an artifact's text readability is adversely affected if it is located underneath a pew. This trend can be seen in 8 of the 12 churches we studied that contain artifacts with text located under pews.

*I Santi Apostoli* – The condition of the floor in this church is better than most we observed. However, the condition of the artifacts should be of some concern. We recommend that, to preserve the historical value of these artifacts, areas with many damaged artifacts be roped off. These areas include the back two corners of the church as well as in front of the altar.

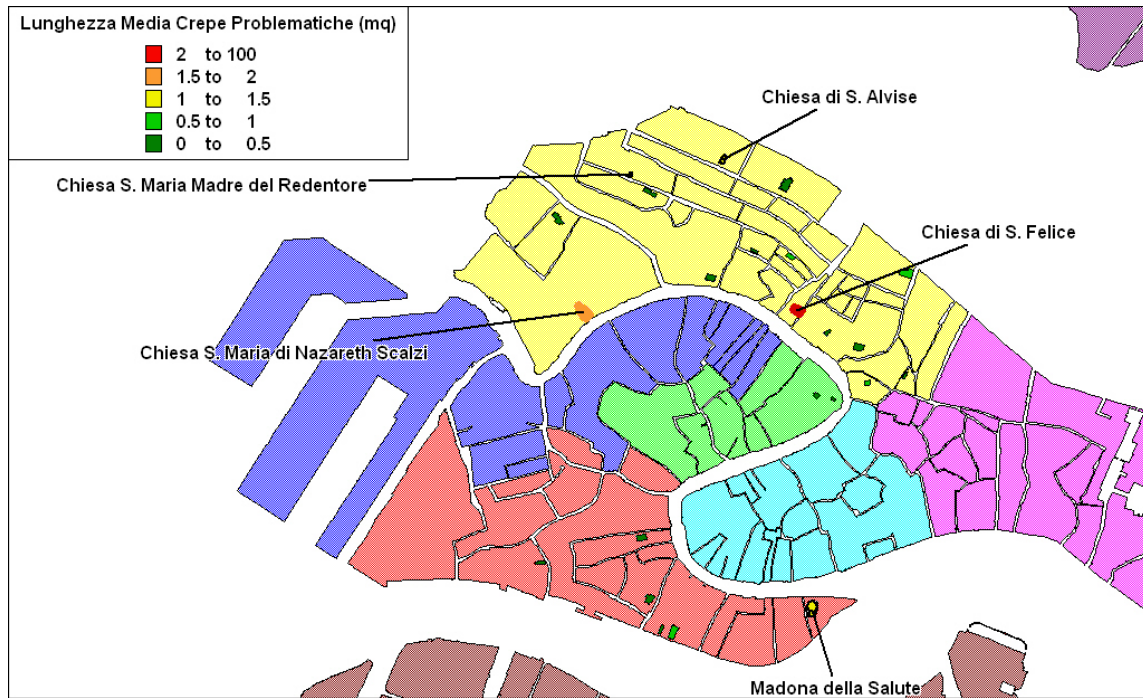
Through our study we have encountered churches that had major structural damage in the form of cracks. A common characteristic that churches with the largest problem cracks share is the close proximity to a canal.

Figure 65: A map indicating the five churches that have the longest problem cracks in relation to the size of the church.

Figure 65 shows the location of five churches that have the largest problem cracks per square meter. It is interesting to note that three of the churches are close to the Grand Canal, while the other two are located on other canals. This leads to the assumption that churches located close to canals are more susceptible to structural damage.
