# **The Church Floors in Venice, Italy: An Archeological Study and Analysis**

31 July 2002

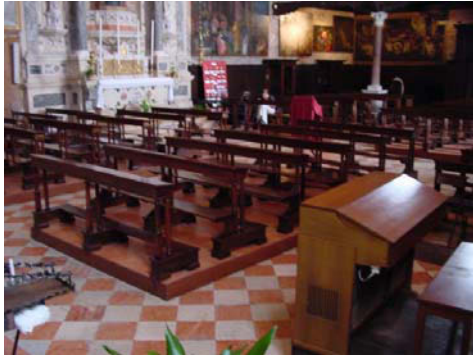
Figure 69: Raised pews in the *Sant' Alvis*.

of pews themselves only adds about 100-200 pounds depending on size, but once the pews are filled with people, the total weight can be over 1000 pounds. Also, most pews are not completely stable and as people sit on the pews and get up off the pews, they have a tendency to shift or move. The pews cause both structural and surface damage to the floors and artifacts

due to the pew's weight being distributed through three to four legs. Churches such as the *Sant' Alvis*, have placed their pews on wooden platforms in order to remedy this problem (Figure 69), but this solution obscures the majority of the floor and floor embedded artifacts. A better solution would be to replace their existing pews with ones have the weight distributed throughout the whole pew. An example can be seen in Figure 70. This way, rather than have the entire weight of the pew localized in small areas, it would be dispersed throughout the whole length of the pew. There would be more contact area with the floor, but since the pressure applied by the pew would be less the amount of damage is reduced. To prevent surface damage, such as pitting, that is not prevented by these pews, the bottom of the pew could be covered in rubber or another soft material.
