AN ARCHEOLOGICAL AND ANALYTICAL STUDY OF VENETIAN CHURCH FLOORS

A Preliminary Qualifying Project Proposal
Submitted to the Faculty of the
WORCESTER POLYTECHNIC INSTITUTE
In partial fulfillment of the requirements for the
Degree of Bachelor of Science By:

30 July 2003

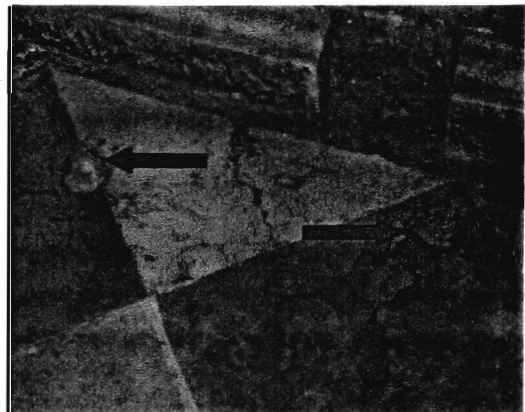
A hole is considered an area of missing floor material that has a depth of at least 1.5 cm. To assess the presence of holes on the floors we used a five point scale that was similar to the scale we developed to assess cracks. This scale is explained in Table 5.

Figure 27: Example of holes in floor tile

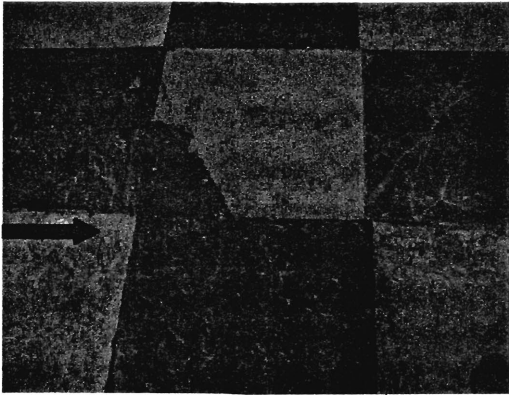
Replacement occurs when pieces of the floors have been filled with new materials. This includes whole tiles replacing damaged sections of the floors, as well as the filling of pitting or areas of floor detachment with different materials. The percentage of each quadrant that has been replaced was estimated and recorded for our analysis.

Figure 30: An example of floor replacement

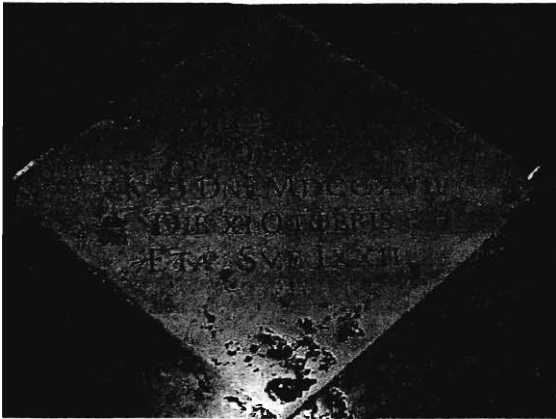
Figure 36: An example of an inscription of a tomb marker in SS. Giovanni e Paolo

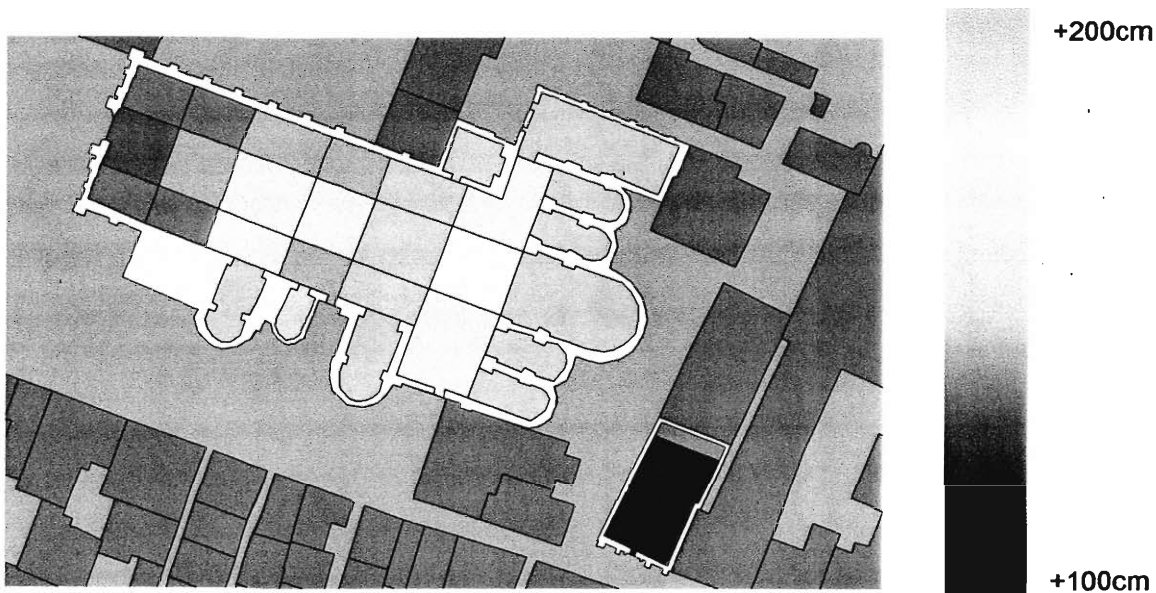
Many of the floors we measured suffered from what we call a wave effect. This effect is the variation of floor elevations for the different quadrants within the church, giving the floor a ripple effect. Figure 41 shows an example of this effect in the Chiesa dei SS. Giovanni e Paolo and the nearby Chiesa S. Maria dei Dereliti.

Figure 41: The variation of floor elevation in quadrants in Ss. Giovanni e Paolo and S. Maria dei Dereliti

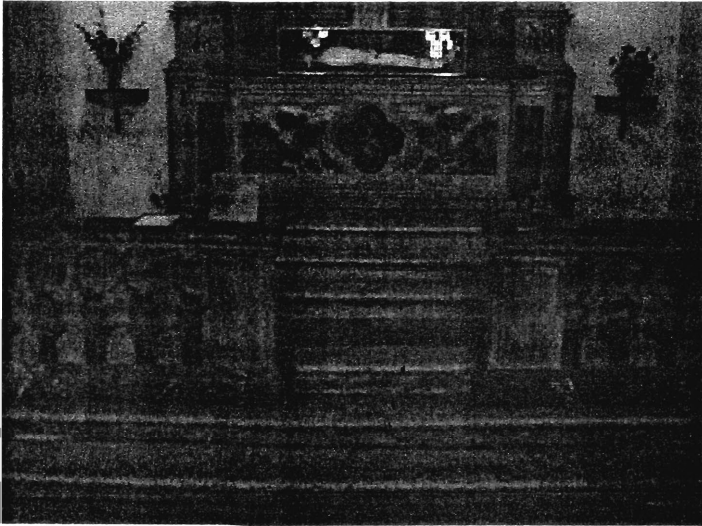
The highest quadrants of the churches are the chapels and altars because they are raised off the main floor by sets of stairs. This made the main floor the lowest quadrants in the church typically. Figure 42 shows an example of a raised floor quadrant in a chapel in S. Francesco de

Figure 42: An example of a raised floor in SS. Francesco de la Vigna

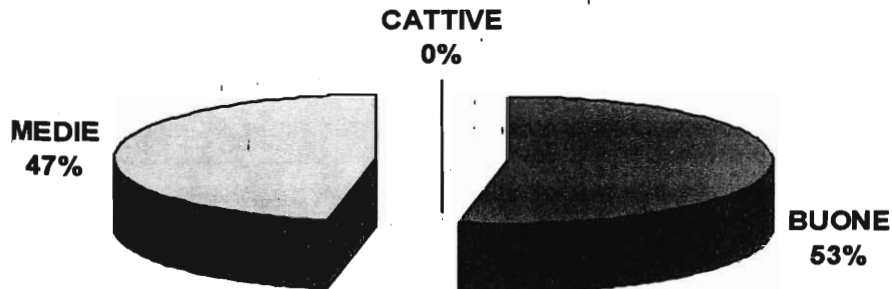
Figure 45: Percentages of churches in Castello in condition level for cracks

As the pie chart shows, 53% of the churches rated on a buone condition level overall, 47% of the churches rated a medie condition level overall, and 0% of the churches rated a cattive condition level. Figure 46 shows a map of the Castello sestiere with the churches color coded according to their condition level for cracks.

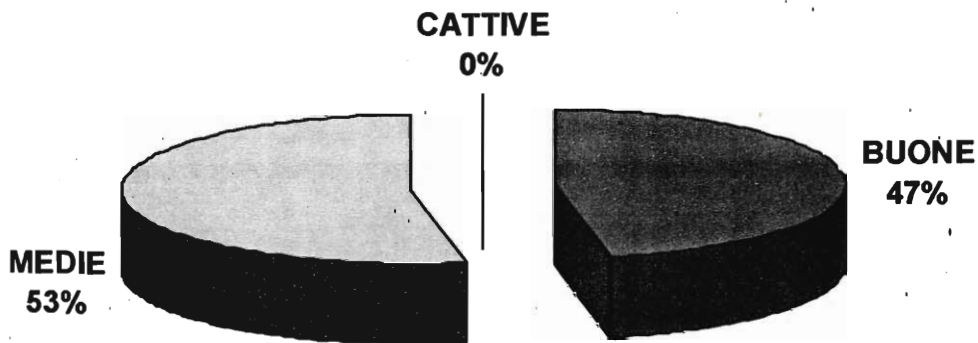
Figure 52: Percentages of churches in Castello in each condition level for joint gaps

As the pie chart shows, 47% of the churches rated on a buone condition level overall, 53% of the churches rated a medie condition level overall, and 0% of the churches rated a cattive condition level. Figure 53 shows a map of the Castello sestiere with the churches color coded according to their condition level for joint gaps.

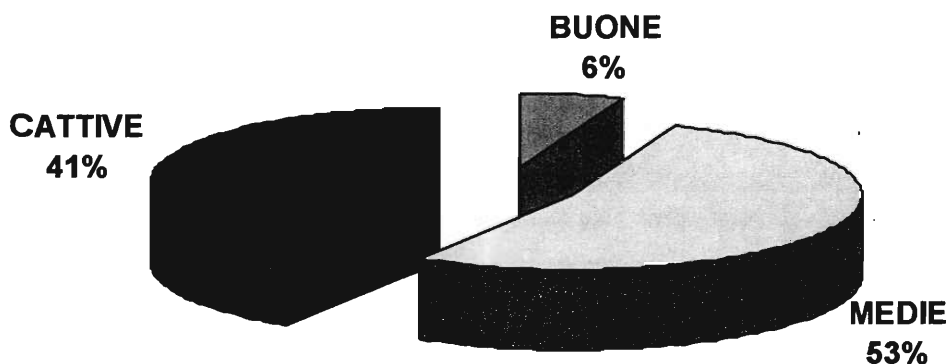
Figure 56: Percentages of churches in Castello in each condition level for surface damage

As the pie chart shows, 6% of the churches rated on a buone condition level overall, 53% of the churches rated a medie condition level overall, and 41% of the churches rated a cattive condition level. Figure 55 shows a map of the Castello sestere with the churches color coded according to their condition level for surface damage.

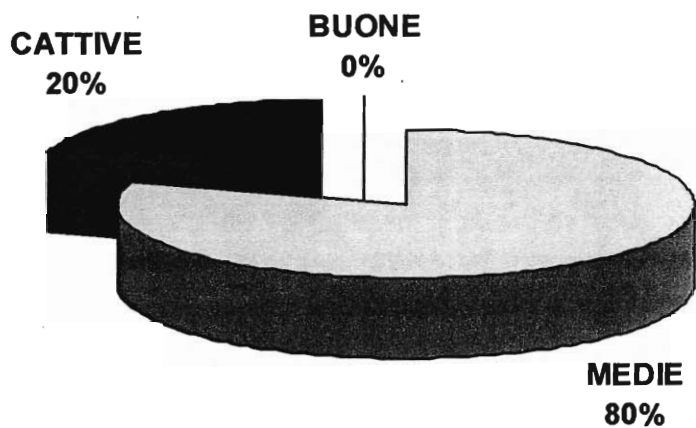
Figure 58: Percentages of churches in San Polo in each condition level for surface damage

As the pie chart shows, 0% of the churches rated on a buone condition level overall, 80% of the churches rated a medie condition level overall, and 20% of the churches rated a cattive condition level. Figure 57 shows the locations of the churches in the San Polo sestere and color codes them according to their condition level for joint gaps.

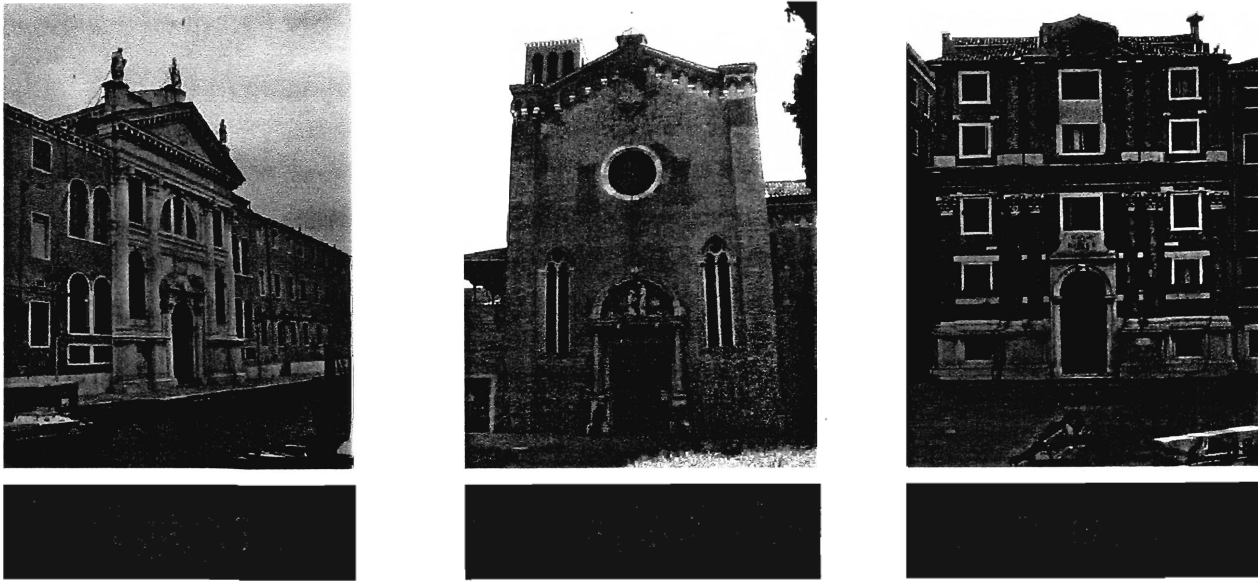
Figure 60: S. Lazzaro dei Mendicanti, S. Elena and S. Biagio (left to right)

Our condition assessment results show that the churches tend not to differ greatly in the amount of cracks, holes, and surface damage on the floor. The one category that has a wide range of scores is surface damage. This is the category we chose to examine more closely in our analysis section. The five worst churches for surface damage are S. Lazzaro dei Mendicanti, S. Elena, S. Biagio, S. Giorgio di Greci, and Casiano. Figure 58 and Figure 59 show these churches and their average surface damage scores.

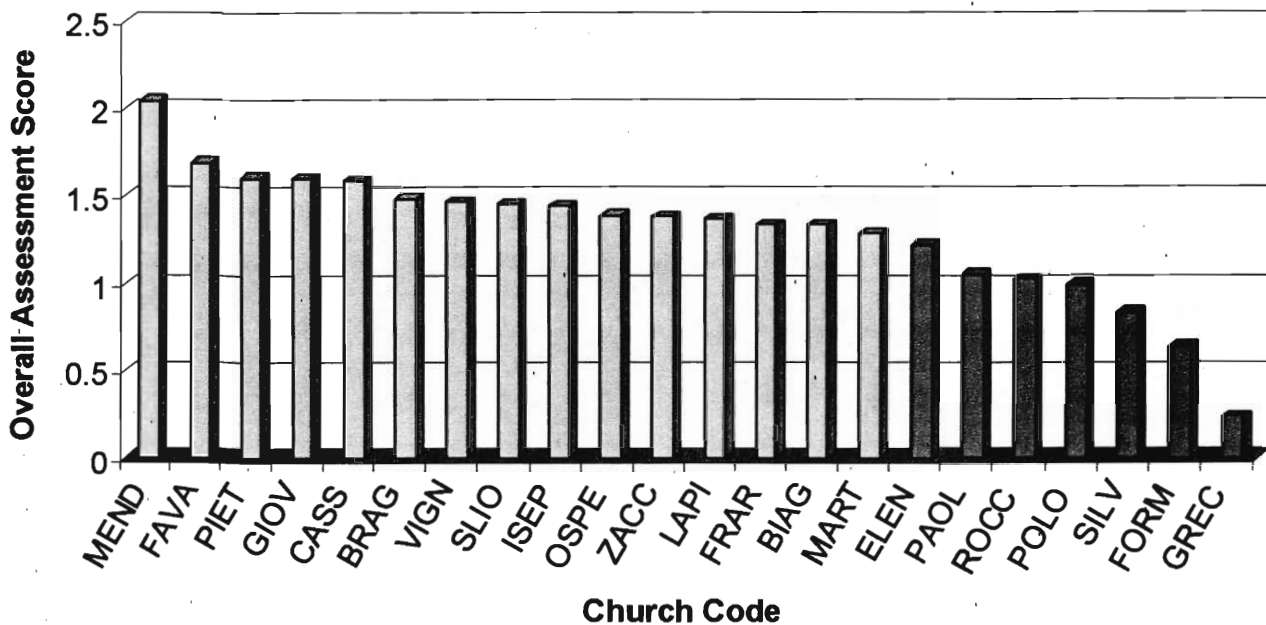
Figure 62: Final assessment scores for all the churches (a list of church codes is in Appendix B)

From this chart we can see that the majority of the churches fall into the medie condition level. S. Lazzaro di Mendicanti contains the most surface and structural damage overall. This church also has the greatest amount of surface damage, which shows that the floor of this church is in the worst condition overall.

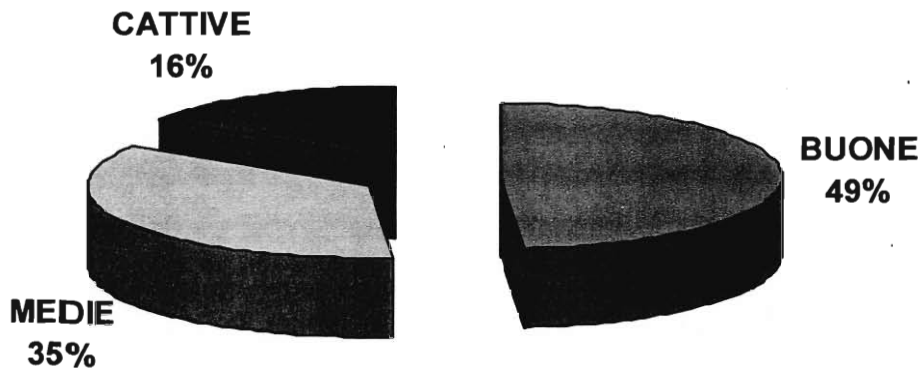
Figure 69: The percentages of total artifacts in each condition level for text readability

We determined the text readability of the 660 artifacts we located in the churches. Each artifact received a score ranging from 100 to 300. The artifacts in the cattive range are not salvageable, and the information contained in their text is lost. This constitutes 16% of the artifacts in the churches of San Polo and Castello. The percentage of damaged but salvageable

artifacts is 35% – these are the artifacts that have priority for restoration. The final category buone shows that 49% of the artifacts with text are not in need of any restoration.

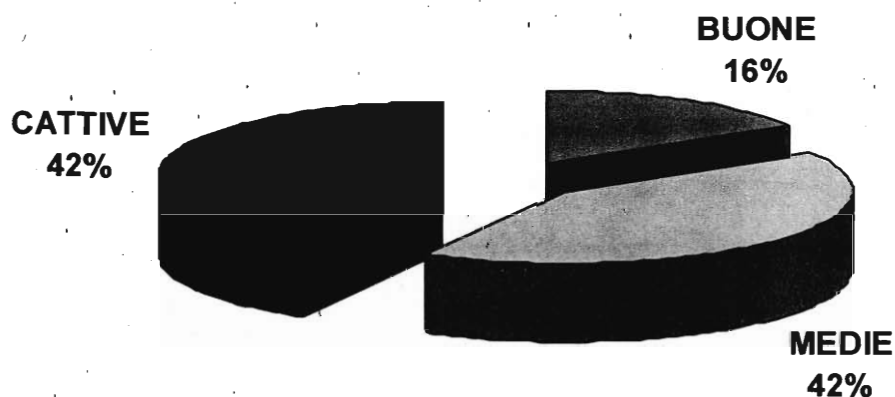
S. Biago had only one artifact in its church, but that artifact is completely unsalvageable as its text has completely worn away. Therefore 100% of its artifacts fall into the cattive range. Following S. Biago in terms of bad text readability was S. Francesco di Paola. Figure 70 shows the percent of artifacts in S. Francesco di Paola that fall into each condition level for text readability.

Figure 70: The percentages of artifacts in S. Francesco di Paola that fall into each of the condition levels

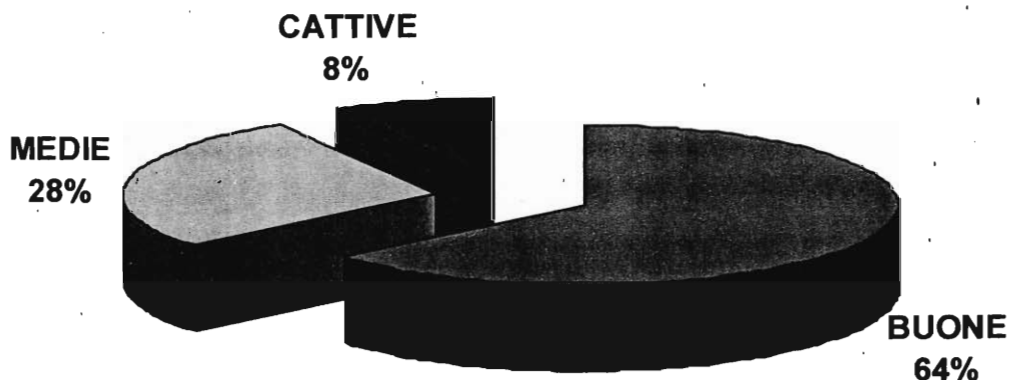
Figure 71: Percentages of total number of artifacts in each condition level for cracks

As 64% of the artifacts landed in the buone range and only 8% of the artifacts were in the cattive range for cracks, this suggests that cracks are not a high priority threat to artifacts. It also suggests that cracks play only a medium sized role in the overall condition assessment of an artifact. The church that had the artifacts in the worst condition for cracks was S. Maria dei Dereliti. Figure 72 shows the percentage of artifacts in S. Maria dei Dereliti in each condition level for cracks.

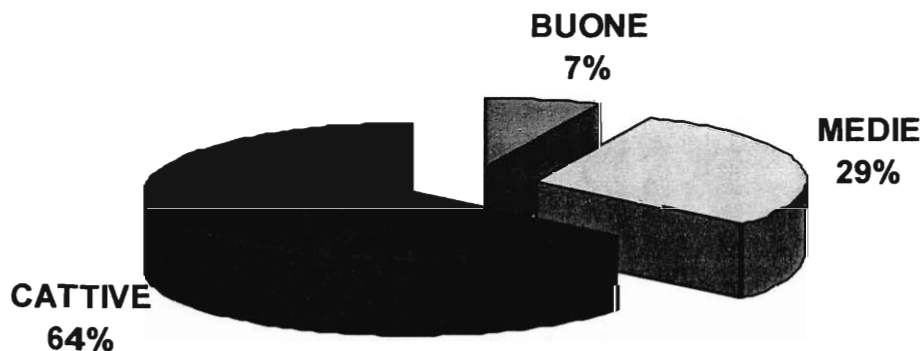
Figure 72: The percentage of artifacts in S. Maria di Dereliti in each condition level for cracks

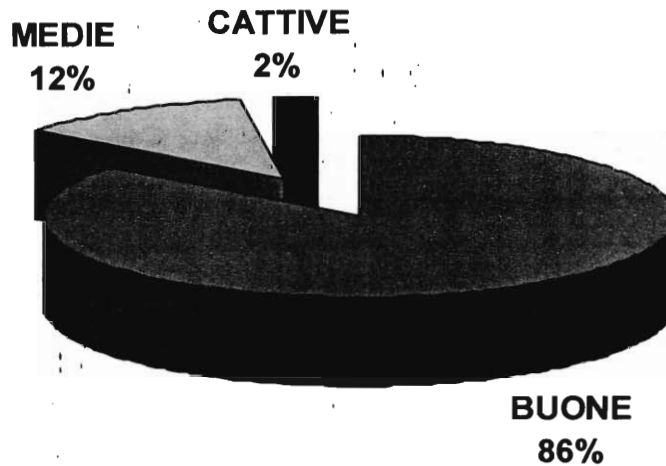
Figure 73: The percentage of total artifacts that fall into each condition level for holes

As Figure 73 shows, the percentage of artifacts in the cattive condition level for holes is only 2% and the percentage of artifacts that fall into the buone condition level is 86%. These numbers show that few artifacts suffer from damage caused by holes, and therefore holes are not a large threat to artifacts. The church with the largest percentage of artifacts damaged by holes was Frari. Figure 74 shows the percentage of artifacts in Frari that fall into each condition level.

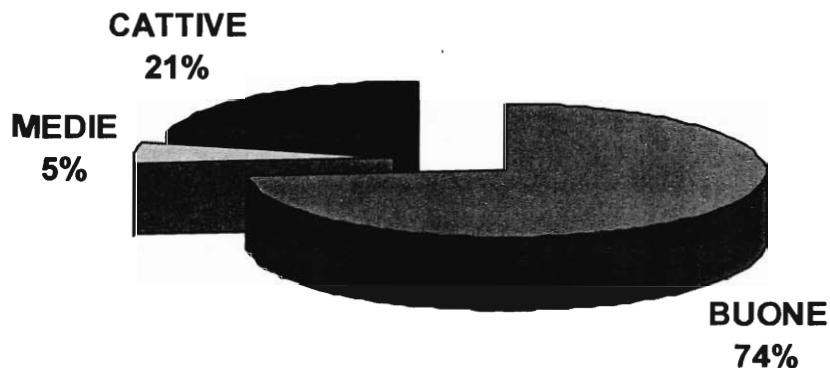
Figure 74: The percentage of artifacts in Frari in each condition level for holes

The pie chart shows that even the worse church has 74% of its artifacts in the buone condition level for holes. Thus holes play a very small role in the over all assessment of the artifacts condition.

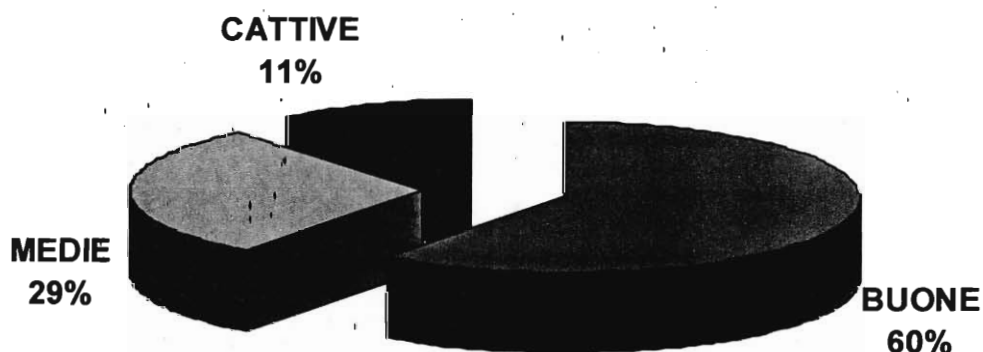
Figure 75: The percentage of total artifacts in each condition level for joint gaps

As the pie chart shows, the percentage of artifacts in the buone condition level is 60% and the percentage of artifacts in the cattive condition level is 11%. These numbers again show that few artifacts were seriously affected by joint gaps. The church with the worst artifacts in terms of joint gaps is S. Maria dei Dereliti. Figure 76 shows the percentage of the artifacts in S. Maria dei Dereliti in each condition level for joint gaps.

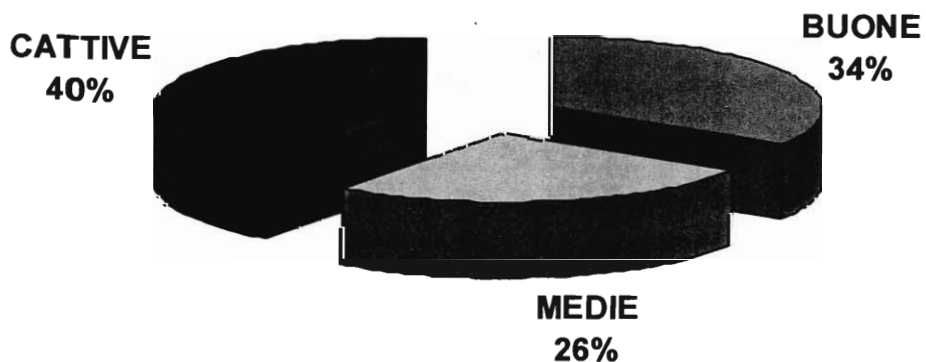
Figure 76: The percentage of artifacts in S. Maria dei Dereliti in each condition level for joint gaps

Although not a vast majority of artifacts suffered greatly from them, joint gaps are one of the most important structural issues to examine. This is because some of the artifacts we found

had very large, deep joint gaps that had not be caulked yet. This resulted in the tomb cover visibly and audibly moving when stepped upon. Tombs with these types of joint gaps can be easily opened with little damage to the original surface.

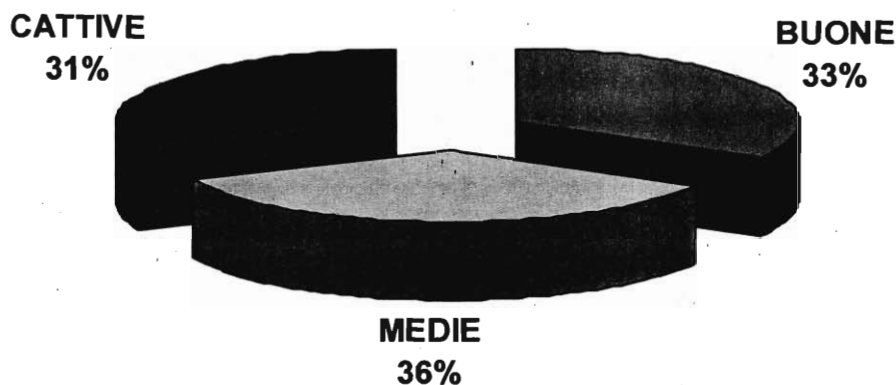
Figure 77: The percentages of total artifacts falling into each condition level for surface damage

Of all the 661 artifacts we found in the churches, 31% of them were in the cattive condition level and 33% in the buone condition level. These numbers show that surface damage is the greatest threat to artifacts. It accounts for the majority of the illegible text in the inscriptions, and determines whether or not the artifact is a candidate for restoration.

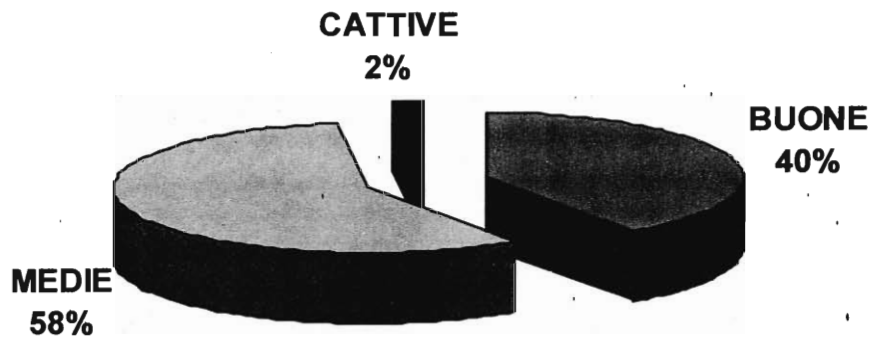
Figure 78: The percentage of total artifacts that fall into each condition level after the final assessment

These numbers did not seem to accurately portray the condition of the artifacts when compared with the results from the surface assessment. Our objective was to find the damaged but salvageable artifacts; however the damage that the artifacts suffered from was mainly surface damage and few holes, cracks, and joint gaps. Weighing each category equally showed the overall condition structurally and on the surface. While this system worked for floors, it did not accurately portray the artifacts. Therefore we decided to use our surface damage condition results for the majority of our analysis as they portrayed the state the artifacts were in more accurately.

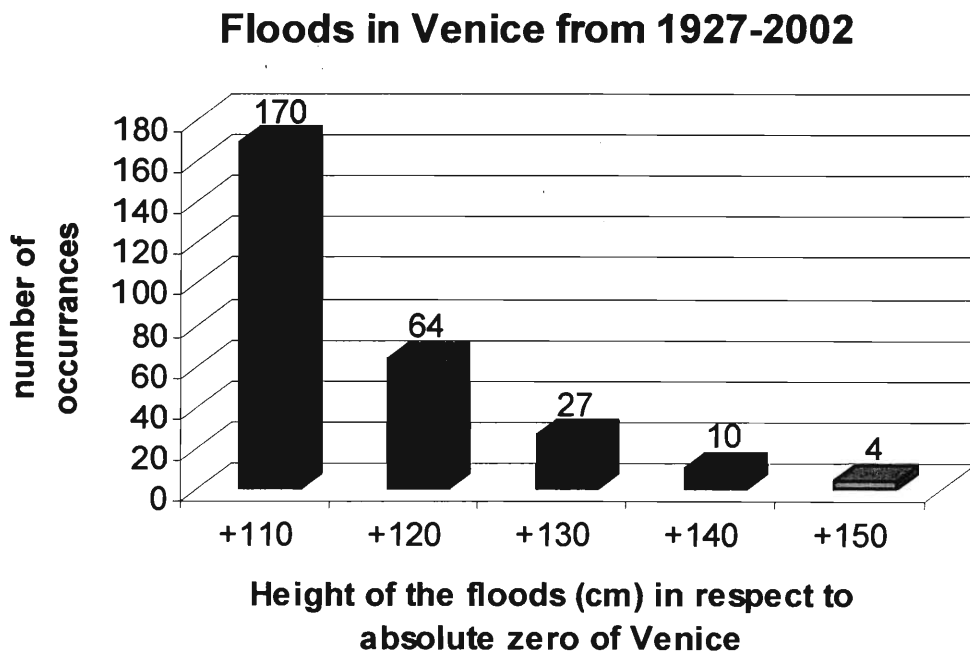
Figure 79: Number of Floods in Venice from 1927 to 2002

Figure 79 shows that flood waters at heights above 110 cm have occurred 170 times from 1927 to 2002. The only church of the ones we studied that was affected by these floods is S. Elena. The churches affected by floods higher than 120 cm are S. Lazzaro dei Mendicanti and S. Maria dei Dereliti. The churches affected by floods higher than 130 cm are Frari and S. Giorgio di Greci. The churches affected by floods higher than 140 cm are S. Francesco de la Vigna, S. Polo, and S. Martin. From looking at the elevations of the churches and the frequency of flooding we concluded that S. Maria dei Dereliti, S. Lazzaro dei Mendicanti, and S. Elena are the churches with the greatest vulnerability to water damage because they have elevations lower than 130 cm above sea level. Therefore we decided the first level of vulnerability to high tides would be churches with elevations below 130 cm with respect to the absolute marker of Venice. We then decided the second category of vulnerability was churches between 130 cm and 150 cm in elevation. The final category was churches with elevations above 150 cm.

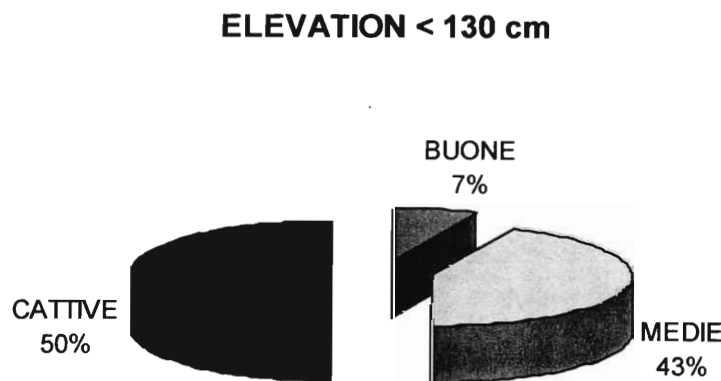
Figure 80: The percentages of floor quadrants at elevations below 130 cm in each surface condition level
 Half of the floor quadrants at elevations below 130 cm are in the cattive surface condition level. The remaining quadrants are mostly in the medie condition level, with only 7% of the quadrants

below 130 cm landing in the buone condition level. This pie chart shows that the floors with low elevations are heavily damaged.

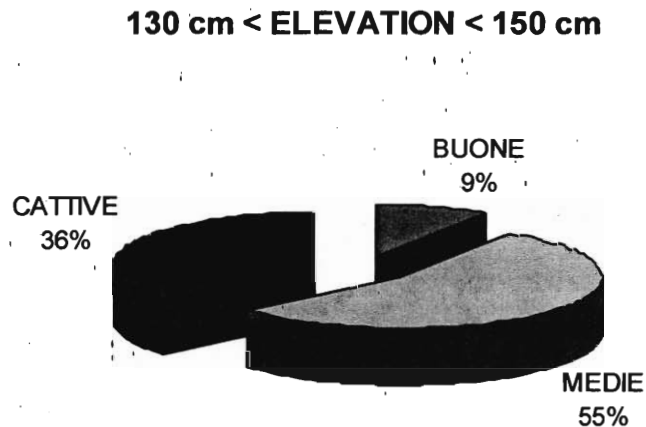
Figure 81: The percentages of floor quadrants at elevations between 130 cm and 150 cm in each surface condition level

This pie chart shows that as the elevation increases the percentage of floor quadrants in the cattive range decreases and the percentage of floor quadrants in the buone and medie category increase.

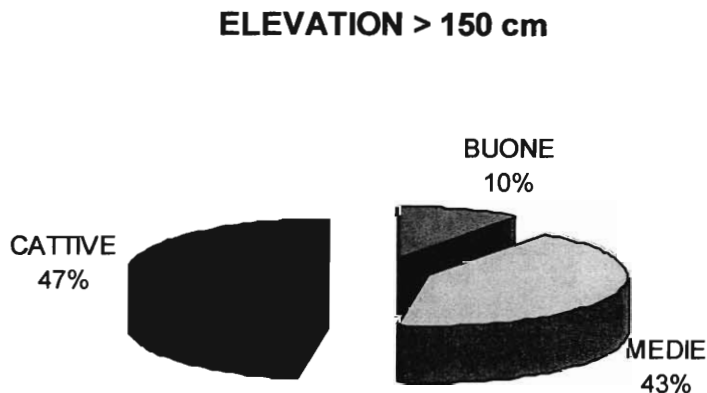
Figure 82: The percentages of floor quadrants at elevations above 150 cm in each surface condition level

Once again as the elevation increased so did the percentage of quadrants in the buone condition level. However, the percentage of quadrants in the medie level decreased and the percentage of quadrants in the cattive range increased. This was not an expected result, so we examined other causes of damage for those floor quadrants. We discovered that 41% of the quadrants in the cattive range contained pews or other movable furnishings. We therefore conclude that the surface damage in these specific quadrants had other causes than flood waters. We believe there is a strong correlation between elevation and surface damage as the lower floors are more vulnerable to water damage from the high tides. Our analysis of the surface condition of the artifacts and their elevation supported this theory.

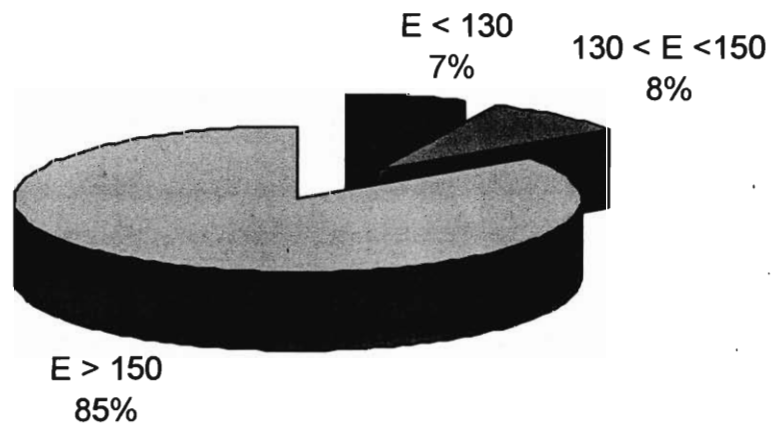
Figure 83: The percentages of artifacts at each elevation range

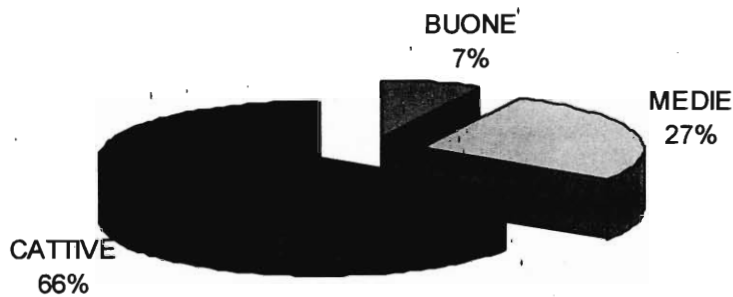
ELEVATION < 130 cm

Figure 84: The percentages of artifacts at elevations below 130 cm in each surface condition level

As the pie chart shows, the majority of the artifacts are in the Cattive category which shows that the condition of the artifacts on the lower floors is very severe. Figure 85 shows the percentages of artifacts in each surface condition level at elevations between 130 cm and 150 cm with respect to the absolute zero of Venice.

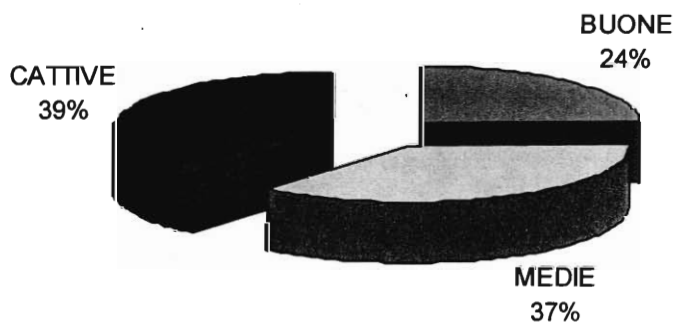
130 cm < ELEVATION < 150 cm

Figure 85: The percentages of artifacts at elevations ranging 130 cm to 150 cm in each surface condition level

The pie chart shows that as the floor elevation rises the percentage of artifacts in the Cattive condition level decreases and the number of artifacts in the Buone condition level increases. Figure 86 shows the percentages of artifacts at elevations greater than 150 cm above the absolute zero marker in Venice in each surface condition level.

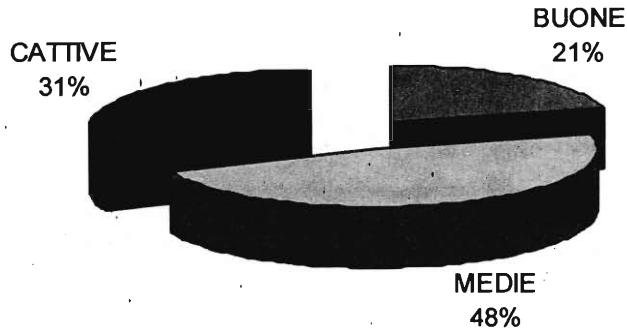
ELEVATION > 150 cm

Figure 86: The percentages of artifacts at elevations greater than 150 cm in each surface condition level

As the floor height rises the percent of artifacts in the Cattive condition level decreases greatly and the number of artifacts in the Buone condition level increases greatly. This analysis shows that raising the floor heights is a good solution to the problem of flooding as it decreases the risk factor of water damage. However as the artifacts found on the higher floors were mostly tomb markers rather than tombs, raising the floors covers over much of the historical information the churches possess. Artifacts located on higher floors are less likely to be candidates for restoration, as the floors have probably been raised or restored recently.

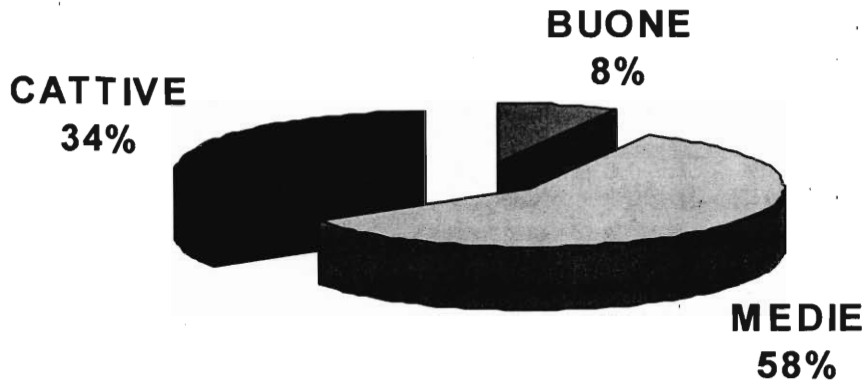
Figure 87: The percentage of artifacts in each surface condition level that contained a main entranceway

Very few floor quadrants that contain entrances fall into the buone condition level. This pie chart shows that it is difficult to find quadrants in the buone condition level by the entranceways. It supports our hypothesis that foot traffic is a threat facing the floors and the artifacts they hold.

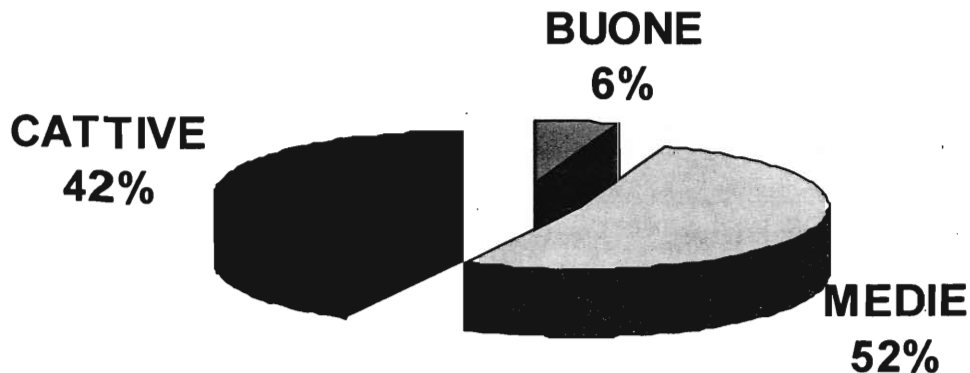
Figure 88: The percentage of floor quadrants containing aisles in each surface condition level

The pie chart shows that only 6% of the floor quadrants that have aisles in them fall into the buone condition level. This shows again that foot traffic is a risk factor facing church floors.

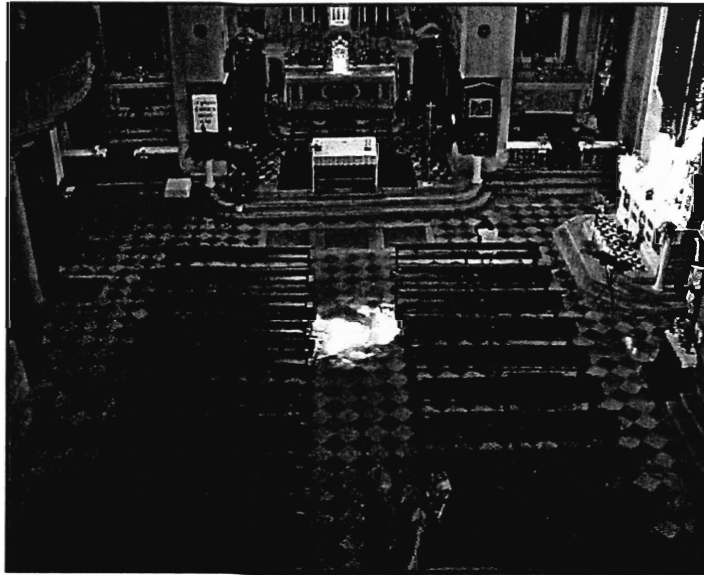
Figure 89: An aerial shot of the location of pews in S. Francesco di Paola

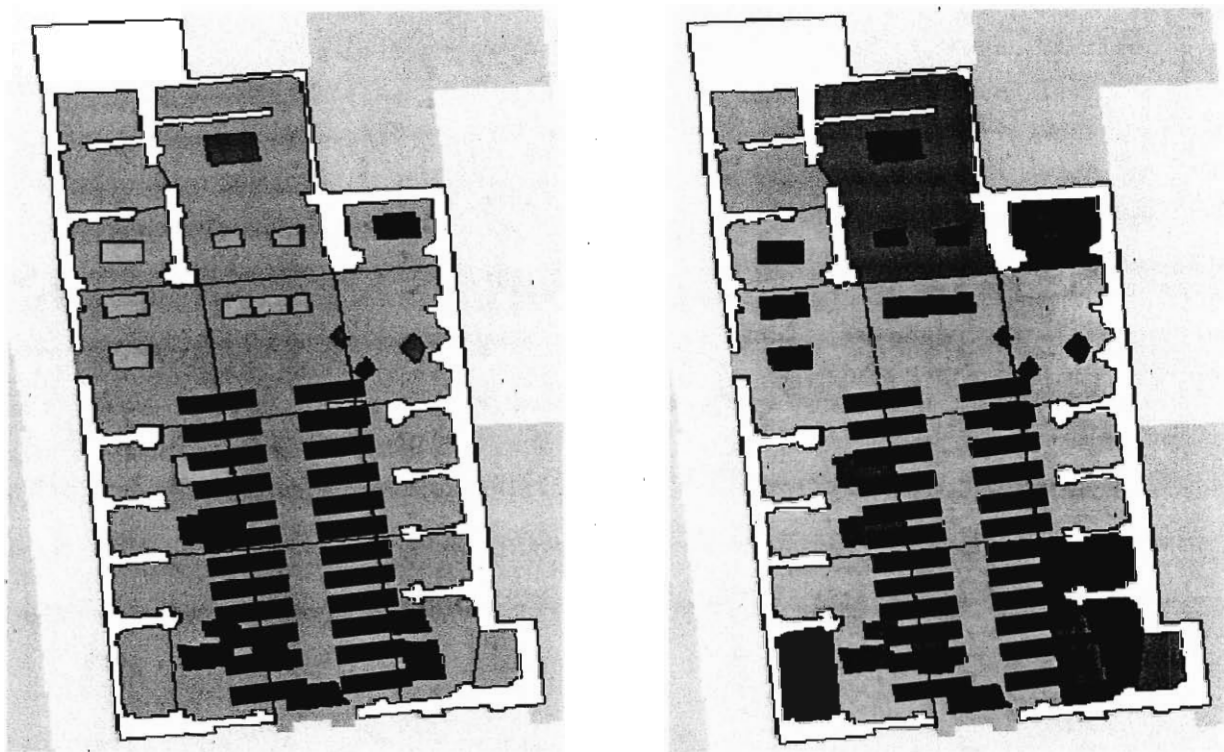
Figure 90: Floor plans containing pew location for S. Francesco di Paolo with the artifacts and quadrants color coded for surface damage (buone = green, medie = yellow, cattive = red)

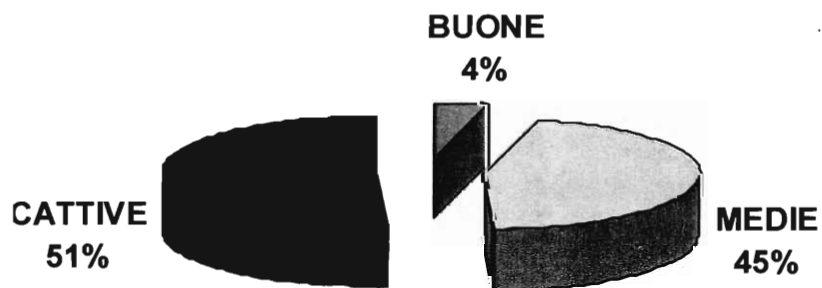
The percentage of floor quadrants covered by pews that are in the cattive condition level is 51%; the percentage of floor quadrants covered by pews that are in the medie condition level is 45%; the percentage of floor quadrants covered by pews that are in the buone condition level.

Figure 91: The percent of floor quadrants containing pews in each surface condition level

The pie chart shows that more than half the quadrants with pews have major surface damage and that only 4% of the quadrants with pews are in the buone condition level. These numbers show that it is very unlikely to find a floor quadrant with pews in good condition.

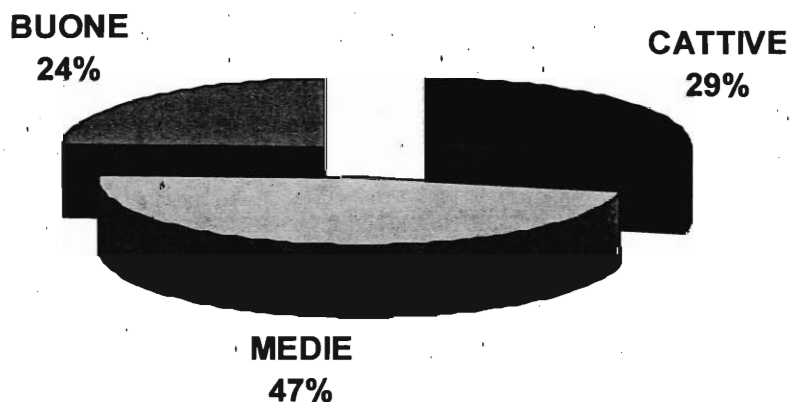
The percentage of artifacts covered by pews that are in the cattive condition level is 29%; the percentage of artifacts covered by pews that are in the medie condition level is 47%; the percentage of artifacts covered by pews in the buone condition level is 24%.

Figure 92: The percentage of floor quadrants containing pews in each surface condition level

Although these numbers are not as drastic as for the floor quadrants, there are more artifacts in the cattive condition level than the buone condition level. Only 24% of all the artifacts with pews on them are in the buone condition level. The effect the pews have on the floors and artifacts can be

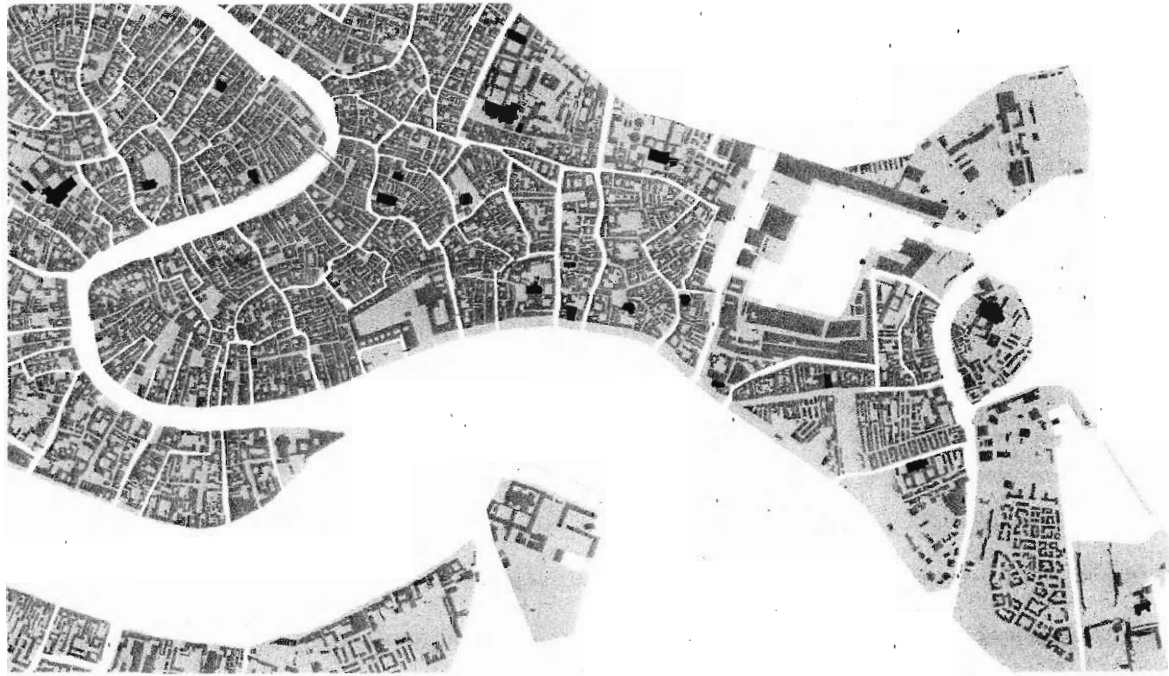
Figure 95: Churches of archeological opportunity (shown in orange)

Chiesa di S. Pietro – This church contains three known floor levels along with sever amounts of surface damage, high floors and many tomb markers. From this we conclude that there are other floor layers below the current floor with the possibility of containing many artifacts below, as suggested by the tomb markers. We also believe that this church will undergo restoration in the future because of its poor surface condition

Chiesa di S. Isepo – This church contains high elevation of main floor, sever surface damage and numerous artifacts. The high elevation of this church along with its many tomb markers suggests multiple floor layers. This church also contains many artifacts which makes it a source for vast amounts of information on and beneath the floor. The severe surface condition of the floor also makes it a probable site for restoration

Chiesa di S. Lazzaro dei Mendicanti – This church contains a low floor elevation and low number of artifacts so therefore the possibility of any relics beneath these floors are very low. There also is severe surface damage but the church is only used for funerals so the need for restoration is not on high priority for this particular church.

Chiesa de la Fava – This church was built on the site of a previous church, contains extremely high floors, along with numerous tomb markers and severe surface condition. These high floors, along with the tomb markers, give great evidence of a preceding floor beneath the main walking surface. The high surface damage makes it a probable site for future restoration, and the fact that it was built on the site of a previous church demonstrates a great opportunity to discover what may be hidden beneath the current structure.

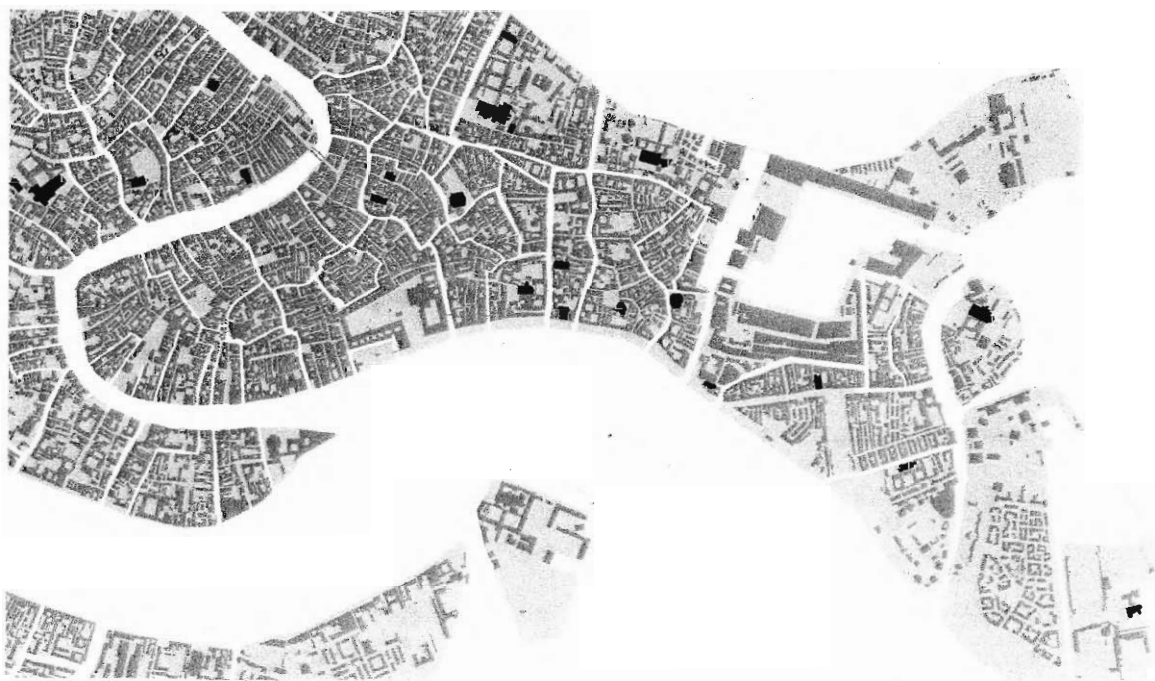
Figure 96: Churches where the opportunity to look beneath the floors has been lost (shown in pink)

Chiesa di S. Martin – This church was recently refinished so therefore a restoration process in the near future is improbable. The church also contained low floors which implied very little chance of numerous layers of floors beneath. This data plus the information that there exists a

low number of artifacts demonstrates that little is to be found beneath these floors due to the small information the church possesses.

Chiesa S. Maria Formosa – This church was recently refinished and therefore a restoration process in the near future is improbable. There were no artifacts contained in this church and although it had high floors the conditions of the floors are in almost excellent condition so the floors will see no restoration and therefore no excavation anytime in the near future.

Chiesa S. Giorgio dei Greci – This church was also recently refinished and its floors are in excellent condition so there is little chance of any restoration that may occur. Furthermore the church is owned and operated by the Republic of Greece and therefore has no ties with the Republic of Venice. This church is privately owned and therefore the Archeological Superintendence has very little chance of any relationship with this particular church.

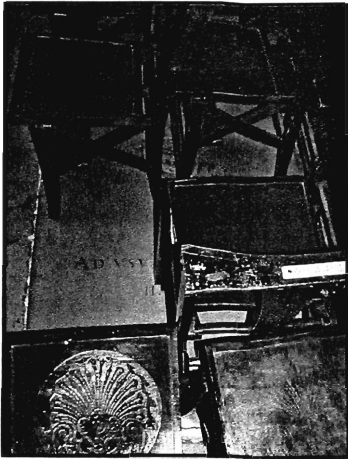
Figure 97: An example of the neglect of artifacts in S. Isepo

examples of the mistreatment of artifacts in many of the churches we visited. Figure 97 shows another example in S. Isepo in which the caretakers have stacked chairs on top of the artifacts on the side of the church.

Our solution to this issue was to first clear the movable furnishings off of the artifacts. Many of the churches have side rooms or chapels without artifacts in them that would be better holding places for extra furniture like chairs. We then recommended that the church administration take an active interest in the history on the floor. Each church should have a copy

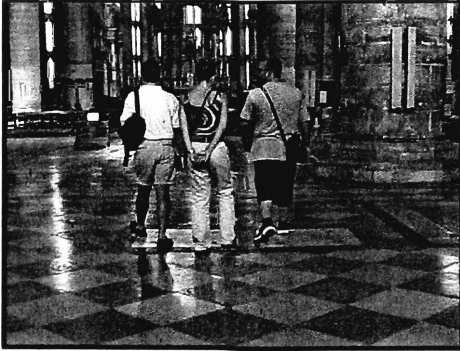
Figure 99: Tourists unaware of the damage they are causing the artifact below their feet

Giovanni e Paolo that are walking across artifacts on the floor. We stopped to ask these tourists whether or not they were aware there were artifacts on the floor they were walking. They did not realize there were historical objects on the floors and

There are some simple low cost solutions to the problem of foot traffic. First to make tourists and patrons aware of their surroundings, each

church should implement the idea of information plaques and keep detailed floor plans available to the general public. For the elaborate or ornate artifacts, we suggest the churches preserve the designs and artwork in one of two ways. The first solution is to create barriers between the artifacts or quadrants and the general public. This has been achieved in Ss. Giovanni

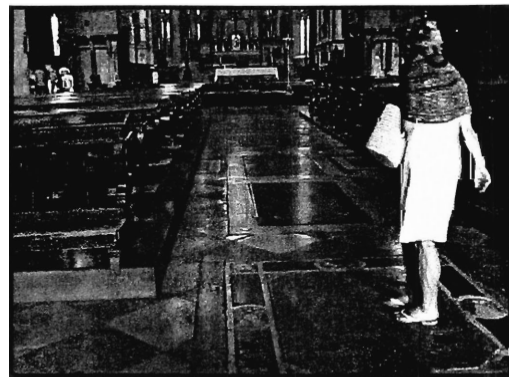
came to the church to see the monuments and paintings on the walls. We found that regular patrons of the church also did not recognize the historical value of the artifacts in the church. Figure 100 shows a woman on her way through the church to afternoon mass in Ss. Giovanni e Paolo. She also was not aware of any historical value in the artifacts on which she was walking.

Figure 100: A patron of the church unaware of the damage she is causing the artifact below her feet

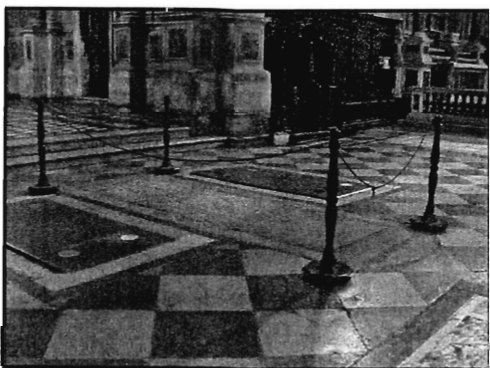
Figure 101: A protective barrier in Ss. Giovanni e Paolo

e Paolo, where an ornate tombstone has been roped off to prevent wearing from foot traffic.

Figure 101 shows this tomb and its barrier. We found this to be a common solution for floor quadrants in the majority of churches we visited.

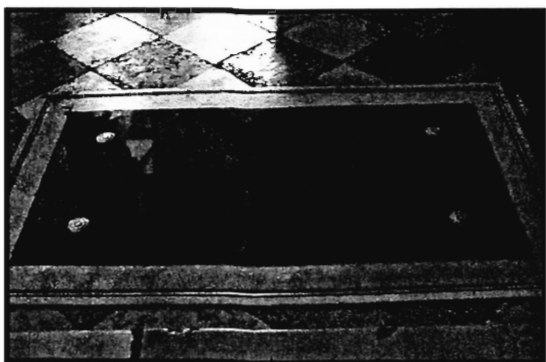
Figure 101: A protective barrier on an artifact in Frari
