# Evaluating Effectiveness of the Signage and Other Markings for Guidance and Warning Placed by OCN

An Interactive Qualifying Project submitted to the faculty of  
WORCESTER POLYTECHNIC INSTITUTE in partial fulfillment of  
the requirements for the degree of Bachelor of Science

12/17/2013

Sponsoring Agency: Department of Natural and Environmental Resources in Puerto Rico

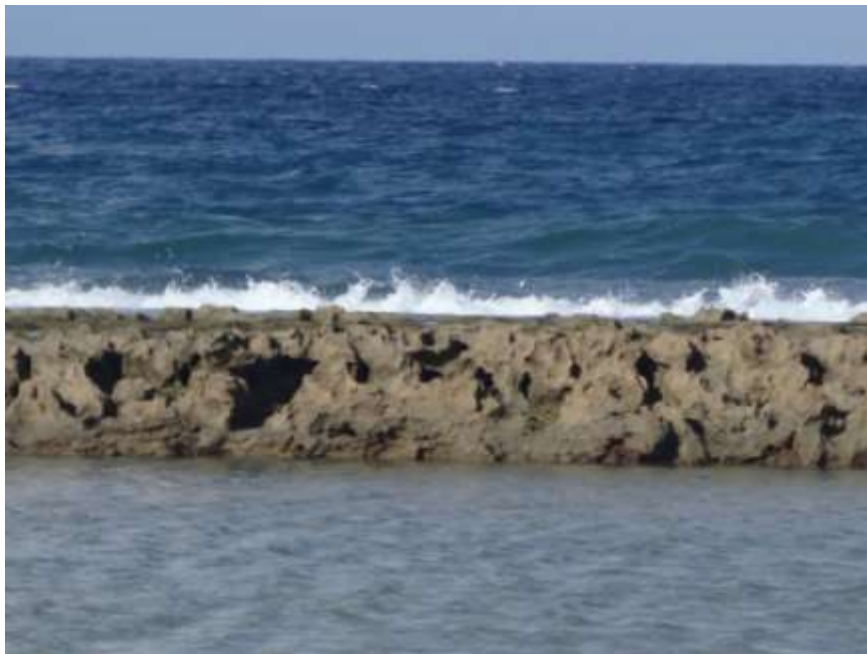
**Figure 11: Wave Breaker at La Poceta**

Another similar characteristic among many of these high-risk beaches are rock formations. Some of these beaches have structures that could cause serious injury or death if swimmers collide with them. Also, rip currents can be created when water funnels through the rocks into tight spaces. At La Poceta, the large wave breaker splits the sea and the swimming area, but in a time of very high swells, this wave breaker disappears under the water level.

Any strong currents would drag a swimmer straight into this formation. The same occurs at La Poza del Obispo and Jobos. Both beaches have very large rock configurations that pose serious threats to beachgoers who are not taking the necessary precautions. At Mar Chiquita, there is a cross on the rocks as evidence of someone already losing a life.

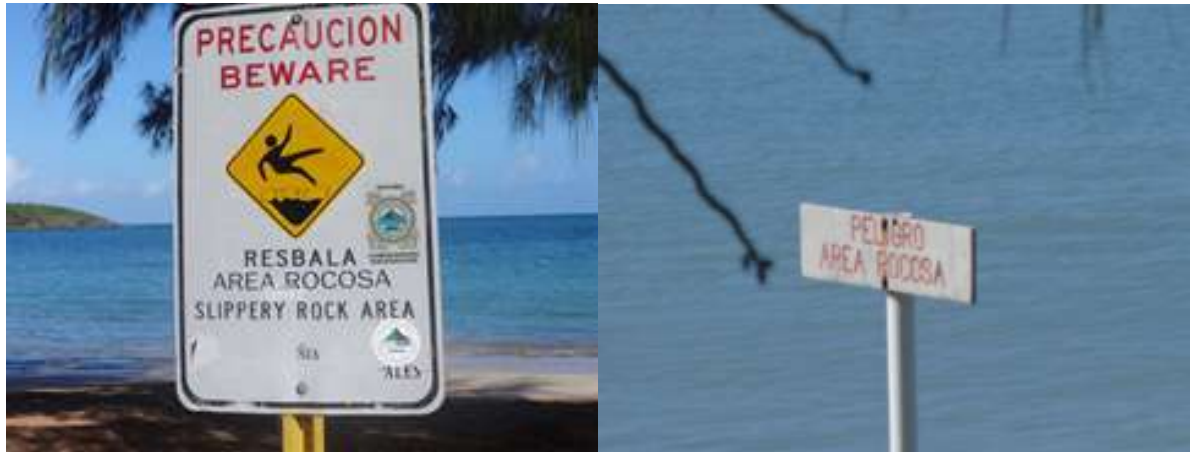
**Figure 13: Slippery Rock Signs**

have been irrelevant. If there were any rocks in the water, every beach would have stated this danger in some way, whether by a generic sign or a sign unique to the particular beach. Caña Gorda, Boquerón, Punta Salinas, and Cerro Gordo contained small rock formations that would not injure beachgoers unless in times of strong swells, which were not likely at these beaches. Below are two variations of the signs, and a more detailed description is included in [Appendix E](#).

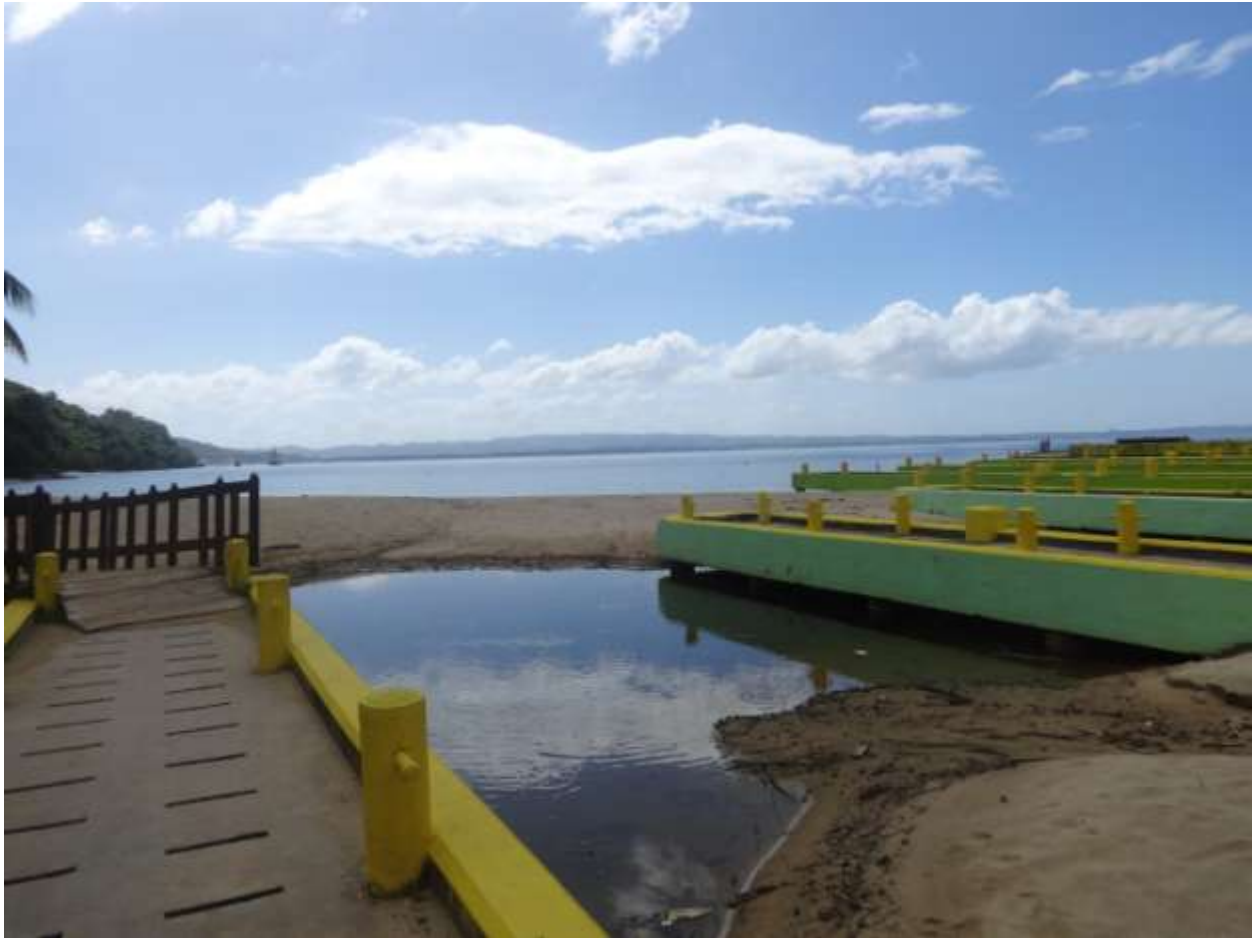
**Figure 25: Pier at Crashboat Beach**

Due to the configuration of the beach, the only glaring danger is the pier in the middle. During heavy swells or simply larger waves, the pier could become a serious problem for swimmers. Another problem is that many people were swimming on the boaters' side of the pier anyway. This could be a problem for swimmers if any boats came into the area. Also, the rip currents were significantly stronger on the boaters' side of the pier. The water was very calm on the swimmers' side, with constant waves less than one foot. However, the wind speed during the time of our team's visit was 2 mph, so wind could possibly play a role at Crashboat that we did not observe.

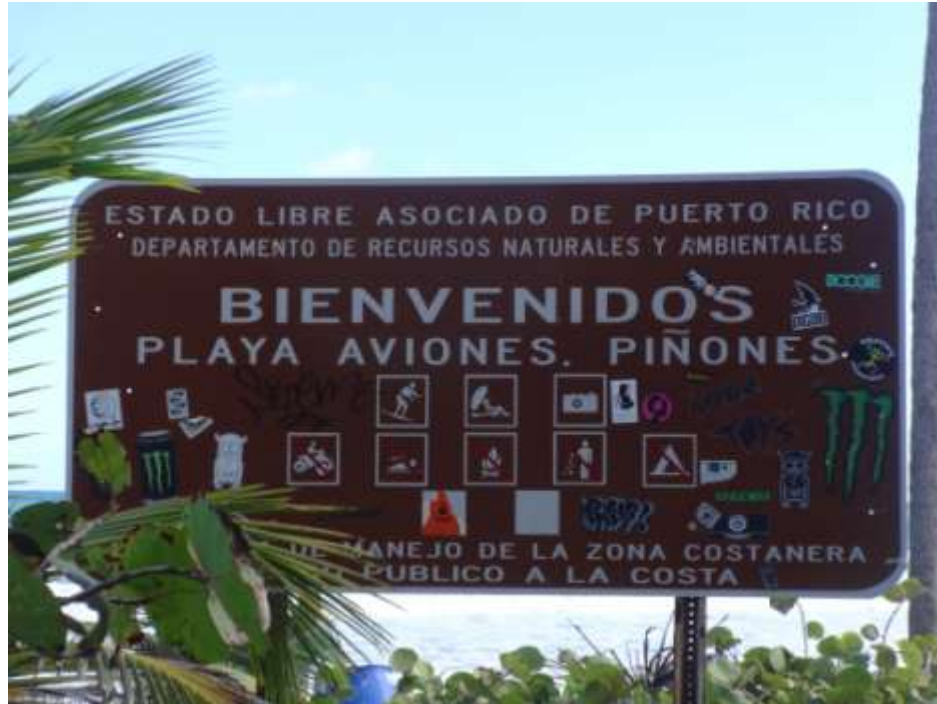
**Figure 34: Playa de Aviones Main Entrance Sign**

At this beach, there was little information for the beachgoers. At the main entrance of the beach, a large, unique sign welcomed people to Aviones. There were multiple pictures on the sign designating multiple rules of the beach, including that swimming is not allowed at Aviones. The only people allowed in the water at this beach are surfers, as seen below in the sign.

There were multiple small entrances to the beach from the street where beachgoers could enter in which there were no signs, apart from the main entrance above. If somebody entered through one of these smaller entrances, the important information would not be known by the person. At Aviones, there are two other signposts. However, at one post, the sign is completely removed so it is unknown what that sign displayed. The other post has two signs, one displaying that there is a “dangerous shorebreak,” which is conveyed through a picture and is in both English and Spanish. The other sign shows large waves but is only written in Spanish. These signs are shown below.

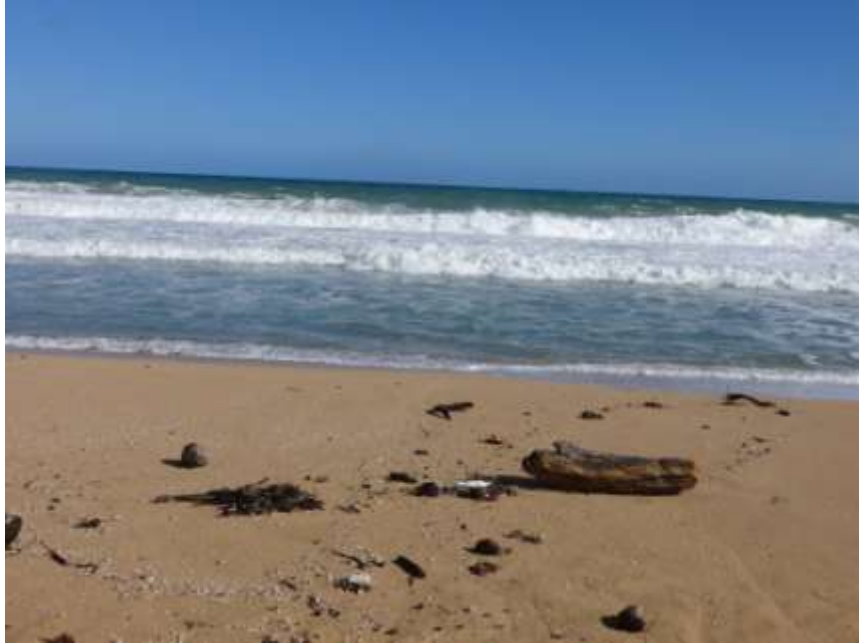
**Figure 36: Large Waves at Aviones**

Our team visited this beach on a day where the average wind speed was measured at 18 miles per hour, the highest wind speed at any beach during the period of beach visits. The effect the wind had on the waves was very noticeable, with common swells over 10 feet crashing every few seconds. The waves carried a large amount of material, including seaweed, high amounts of sand, logs, and larger rocks that could cause injury. These large waves did not break near shore, but the power they had carried so far that most of the noticeable beach had disappeared. They also caused severely strong rip currents that would drag any swimmers out to sea. Although the amount of wind on this particular day may skew our observations of Aviones, the large waves must always be prevalent because there is no swimming allowed at any time at this beach.

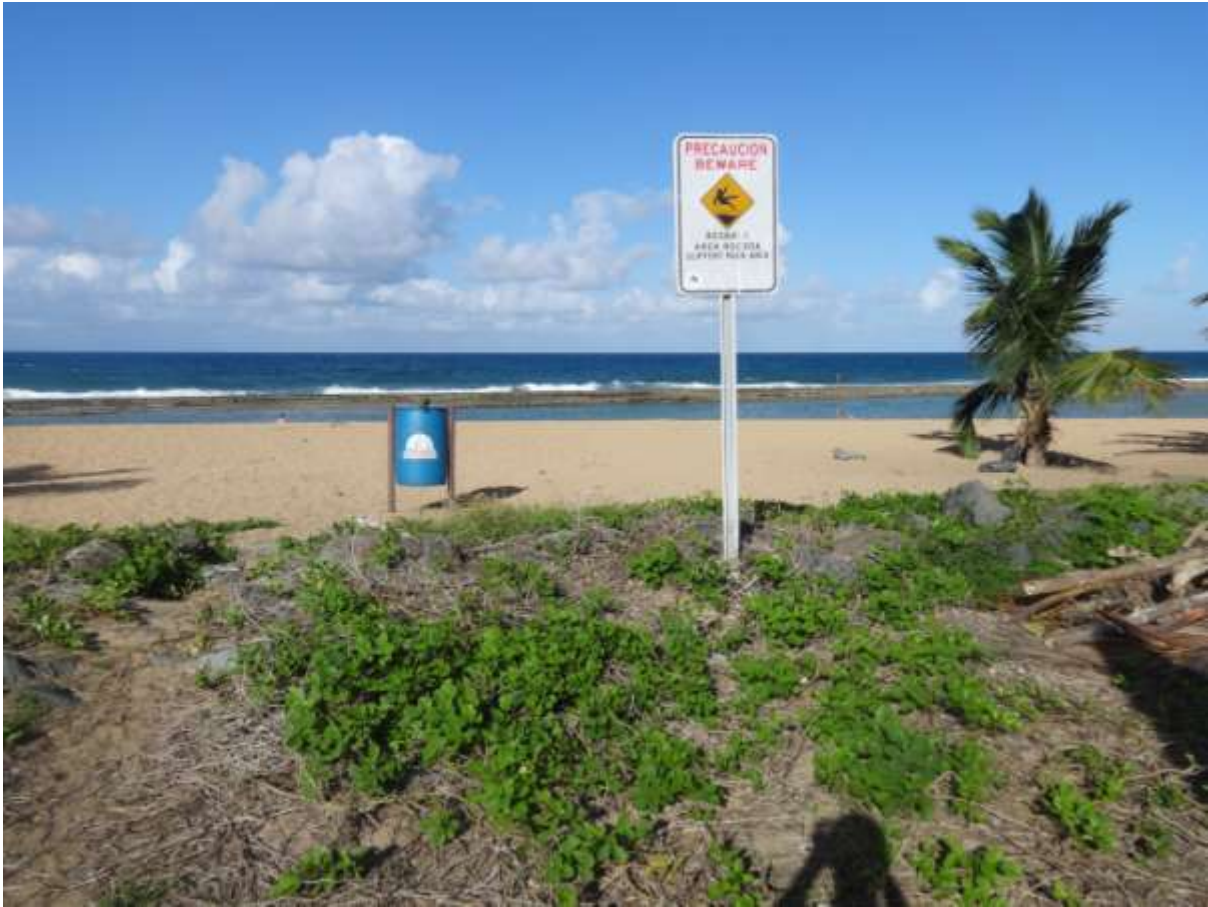
**Figure 37: Slippery Rock Sign at La Poceta**

At La Poceta, there are no main entrances to the beach. A major road is located directly next to the beach, where most people park and simply walk onto the beach. There is a small area of rocks, a sidewalk, and a barrier that separate the beach from the road. However, this area of rocks is dangerous so there are many signs that display “slippery rock area,” as seen above. These signs are double sided, saying “slippery rock area” on the side facing the road, and “dangerous shorebreak” facing the beach.

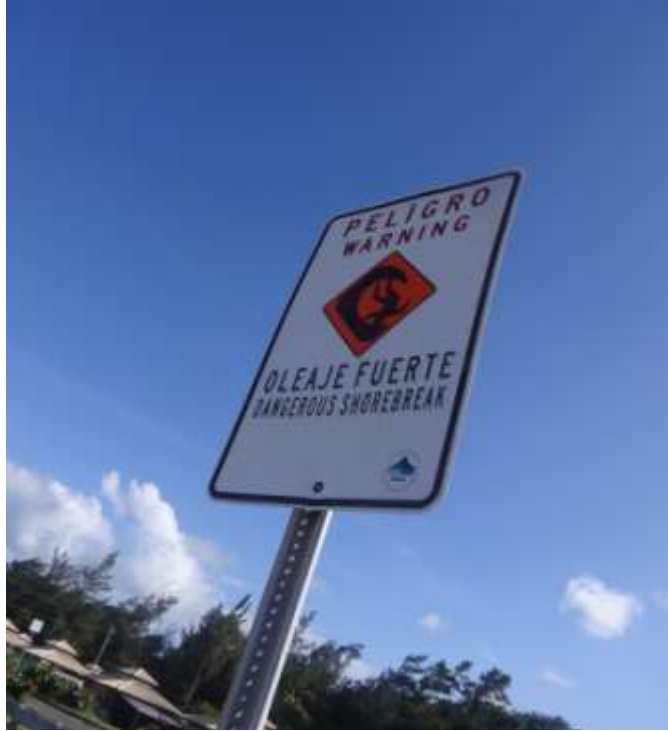
**Figure 38: Dangerous Shorebreak Sign at La Poceta**

There are effective pictures on both sides of the sign and give the information in both English and Spanish. The signs are also separated enough to not overload the beach, but also close enough so people entering at any entrance will notice them.

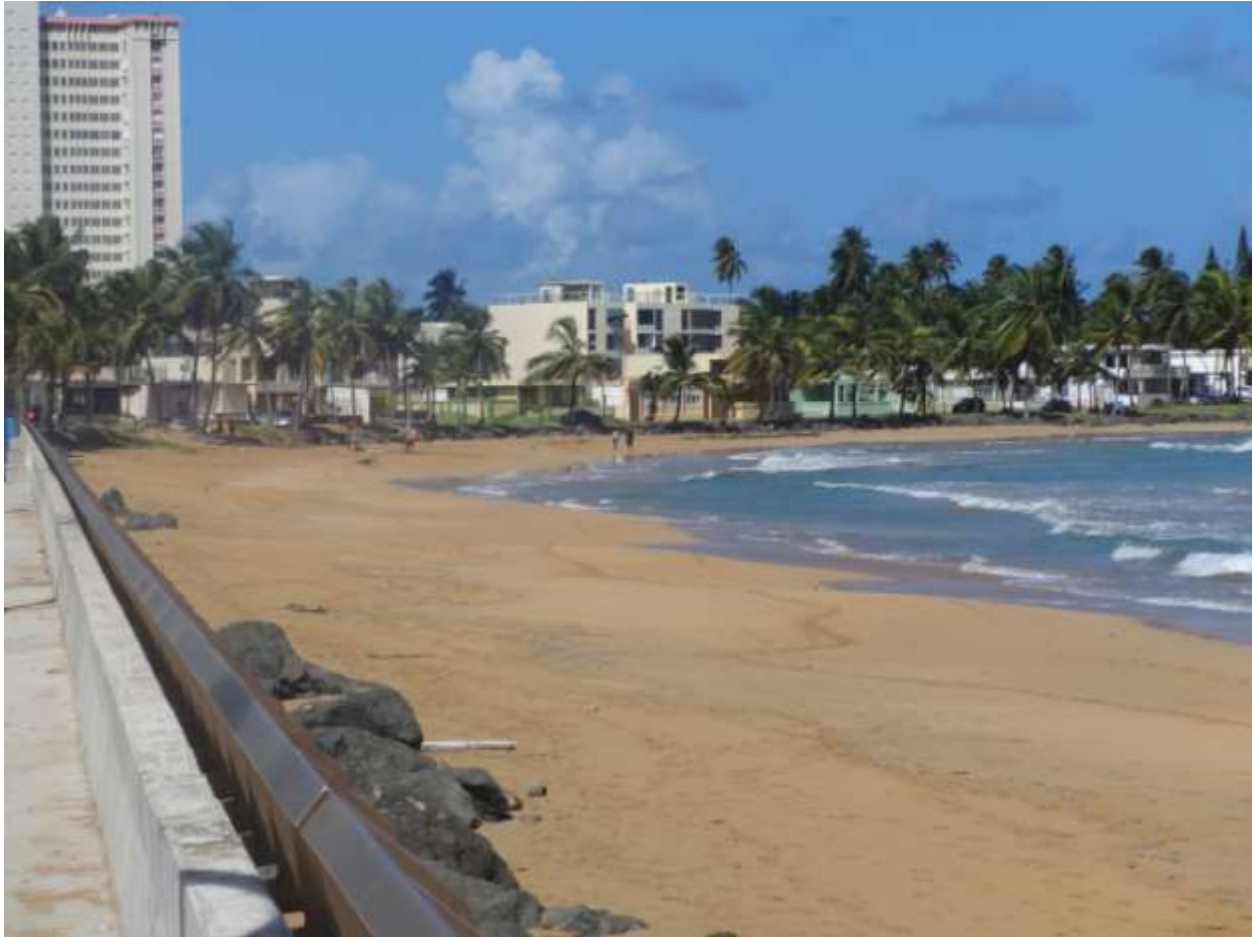
**Figure 40: Beach and Concrete Wall at La Pared**

This beach is very long, with one main entrance to the far right and a long concrete wall that separates the road/sidewalk from the beach. At the end of the concrete wall, there are no determined entrances to the beach, so any beachgoer can simply walk on. In the entire analyzed area, there were only two signs. On the edge of the cell, there is a “strong currents” sign in both English and Spanish with a picture. There is also a pole that has two signs on it. The first is a sign that designates a “dangerous shorebreak” on the beach. The other is an escape plan for a swimmer caught in a rip current.

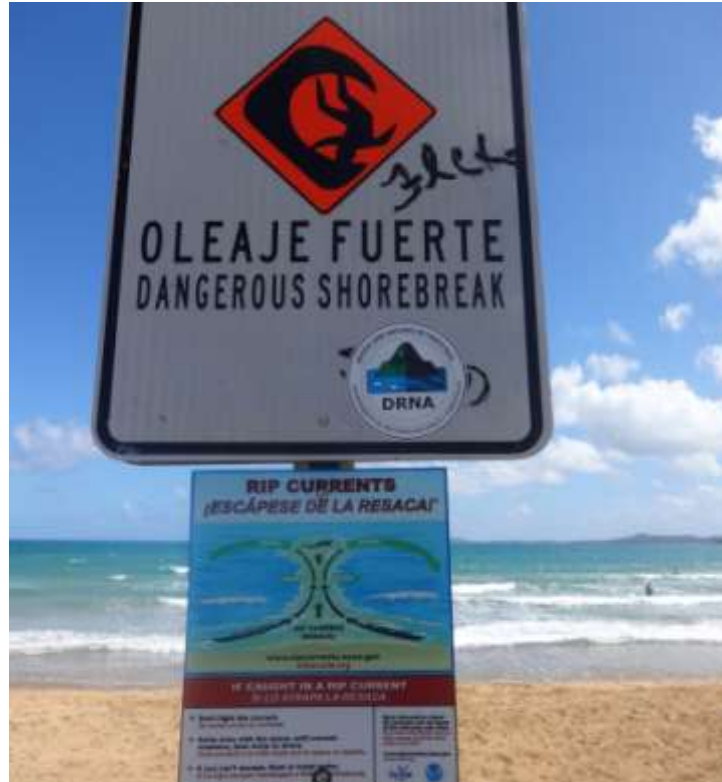
Figure 41: Dual Signs at La Pared

This is especially important at La Pared because of the dangers the beach poses. A talk with a local safety volunteer also stated that he wished more beaches had these escape plans because many people do not know the steps to take if caught in a rip current. A better view of the escape plan is shown below, with a picture and written in both English and Spanish.

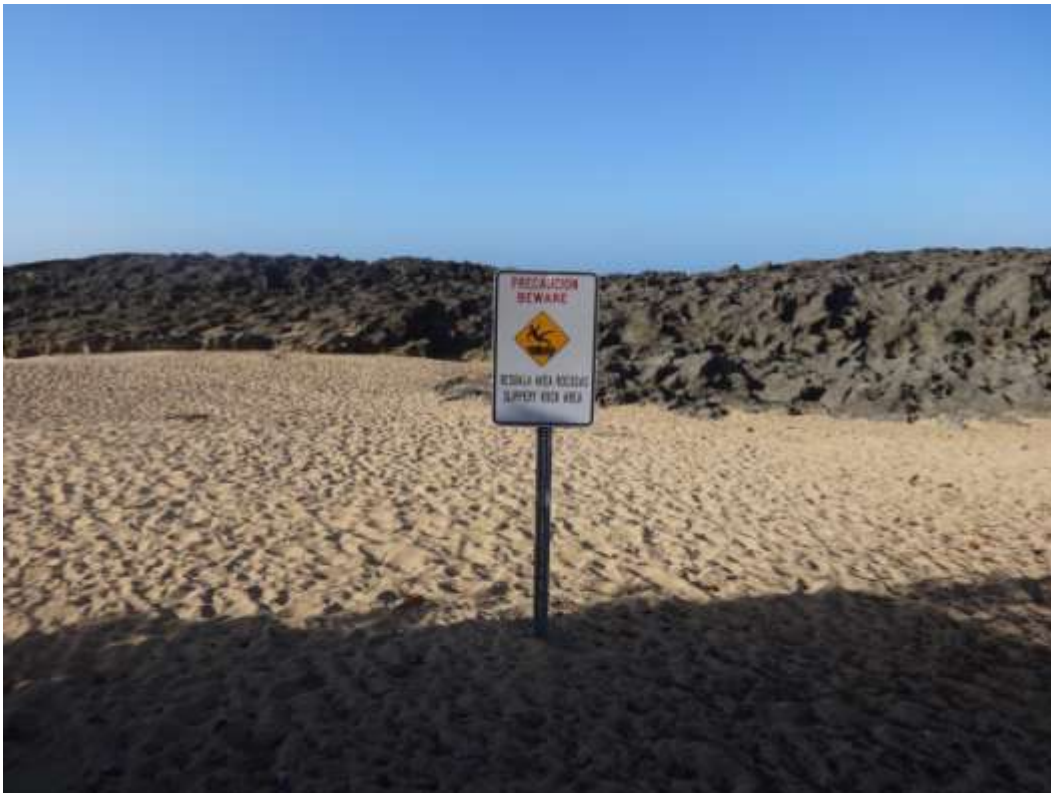
**Figure 44: Slippery Rock Sign at Mar Chiquita**

This beach had a number of signs to warn beachgoers of various dangers. All the signs were facing the parking lot, which wrapped around the perimeter of the beach. One of the signs warned beachgoers of slippery rocks. The sign was in both English and Spanish and had a picture of a person slipping on a ledge. It was located near the edge of the beach facing the beachgoers and was parallel to the shoreline.

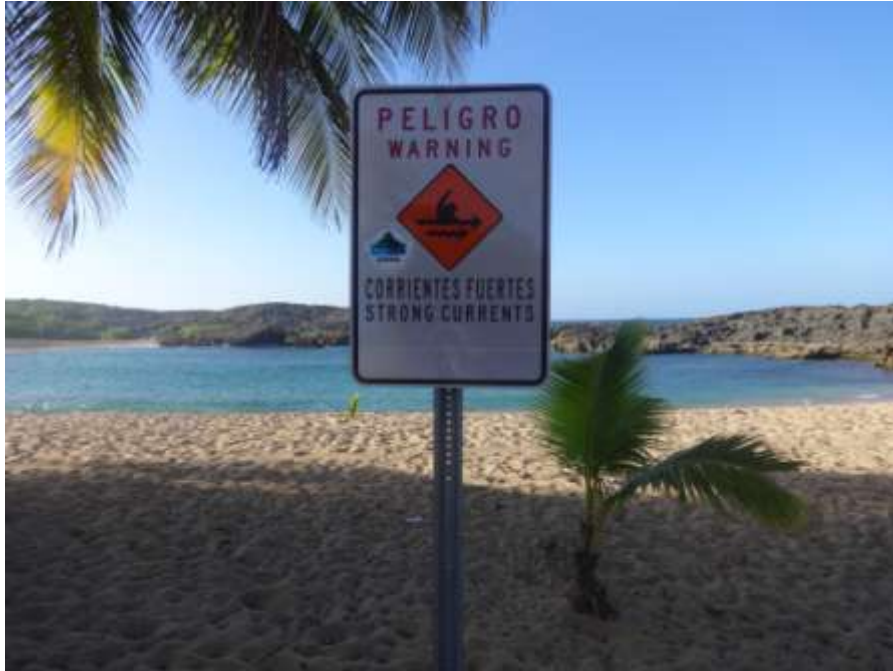
**Figure 45: Strong Currents at Mar Chiquita**

Another sign warned beachgoers about strong currents and was positioned in the middle of the beach facing away from the water. The sign was in English as well as Spanish and had a picture of a swimmer.

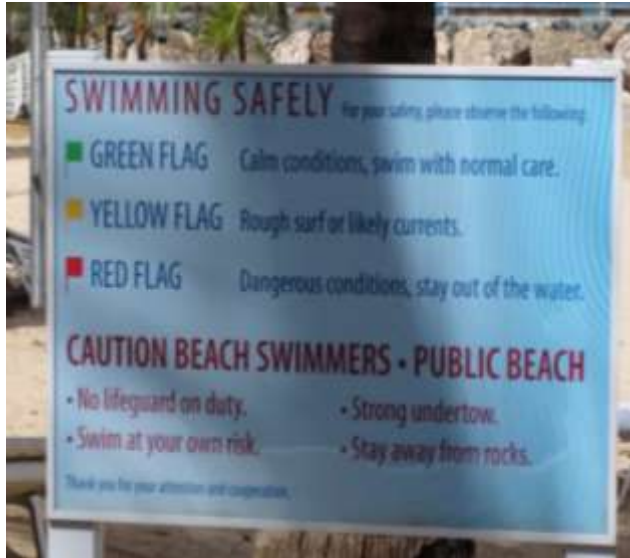
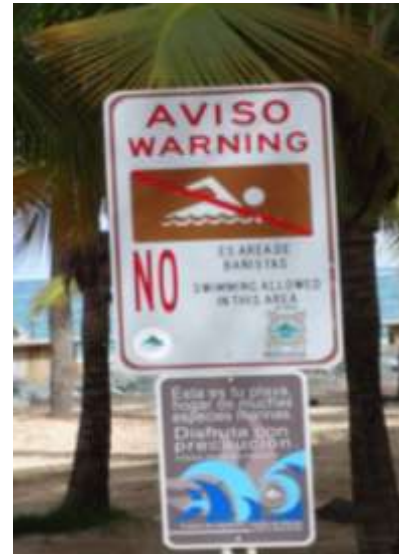
Figure 47: Sign at Condado defining Flag colors and No Swimming sign

Marriott Condado is a long stretch of beach located directly behind the La Concha Renaissance Resort and the Marriott resort in the Condado area of San Juan. It had the higher number of signs out of the beaches our team visited; however, the danger level at Marriott Condado is very high so more signs are needed. Next to La Concha Renaissance, there is a sign that states absolutely no swimming allowed in the area.

Also, a red flag flies behind the resort to signal no swimming, as well as signs explaining what the flag colors mean. There is also a flag and sign behind the Marriott resort, which also states no swimming is allowed. In the stretch of beach in between the two resorts, there are “dangerous shorebreak” and “strong currents” signs which are in ideal locations; however, the “dangerous shorebreak” sign is damaged with graffiti. Also, people entering through the area in between the two resorts would not see any warning signs.

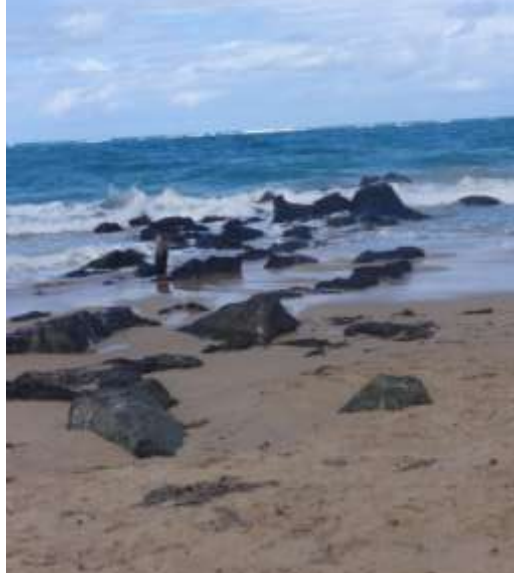
**Figure 48: Wave Breaker at Marriott Condado**

On the edge of the shore behind La Concha Renaissance, a large rock formation is present that multiple people swim near. Also, behind the Marriott resort, a large wave breaker is present to decrease the size of waves.

This also intensifies rip currents, however. Waves continuously rose between 7-10 feet during our visit (although the wind was minimal), which caused very strong rip currents. In the water, there are many random areas of large rocks that are not visible from shore. These rocks and the strong rip currents make it one of the most dangerous beaches on the north coast of Puerto Rico.

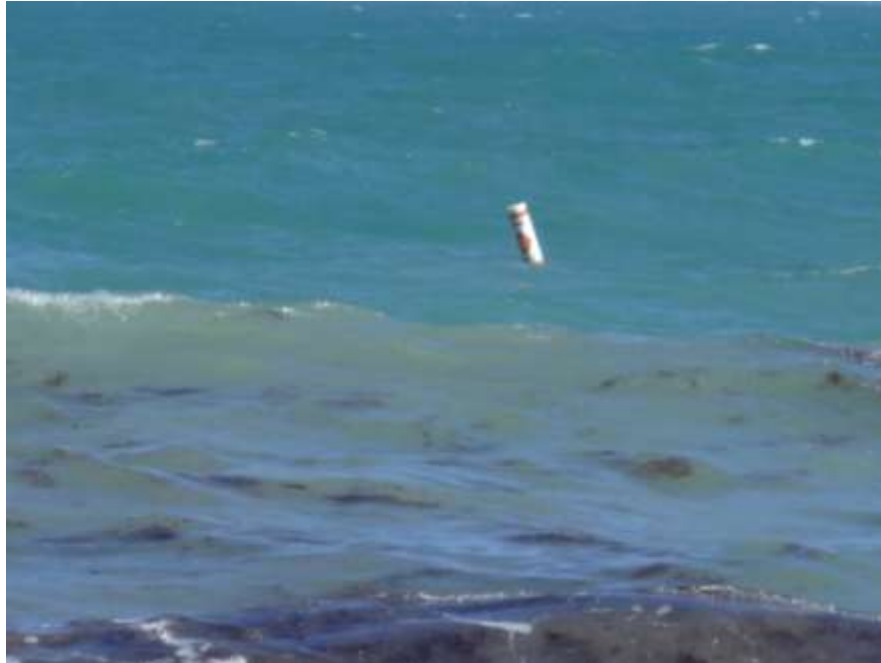
**Figure 52: Buoy Line at Último Trolley**

The first observation at this beach is that there are buoys in the water marking the allowed swimming area. This means that beachgoers are in the most danger if they pass the buoys, although the buoys are several hundred feet into the water.

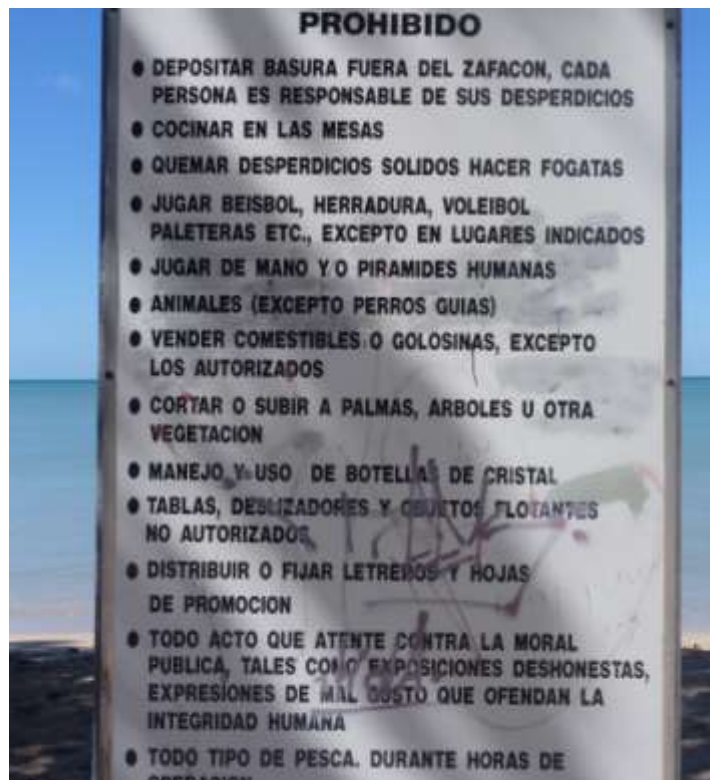
Figure 54: Rules of the Beach Sign at Boquerón

There are many entrances to the Balneario, which is a very safe beach. This beach is Blue Flag certified. There are two overall “rules of the beach” signs which discuss many things. One sign is in only Spanish and is covered in graffiti; the other is in both English and Spanish.

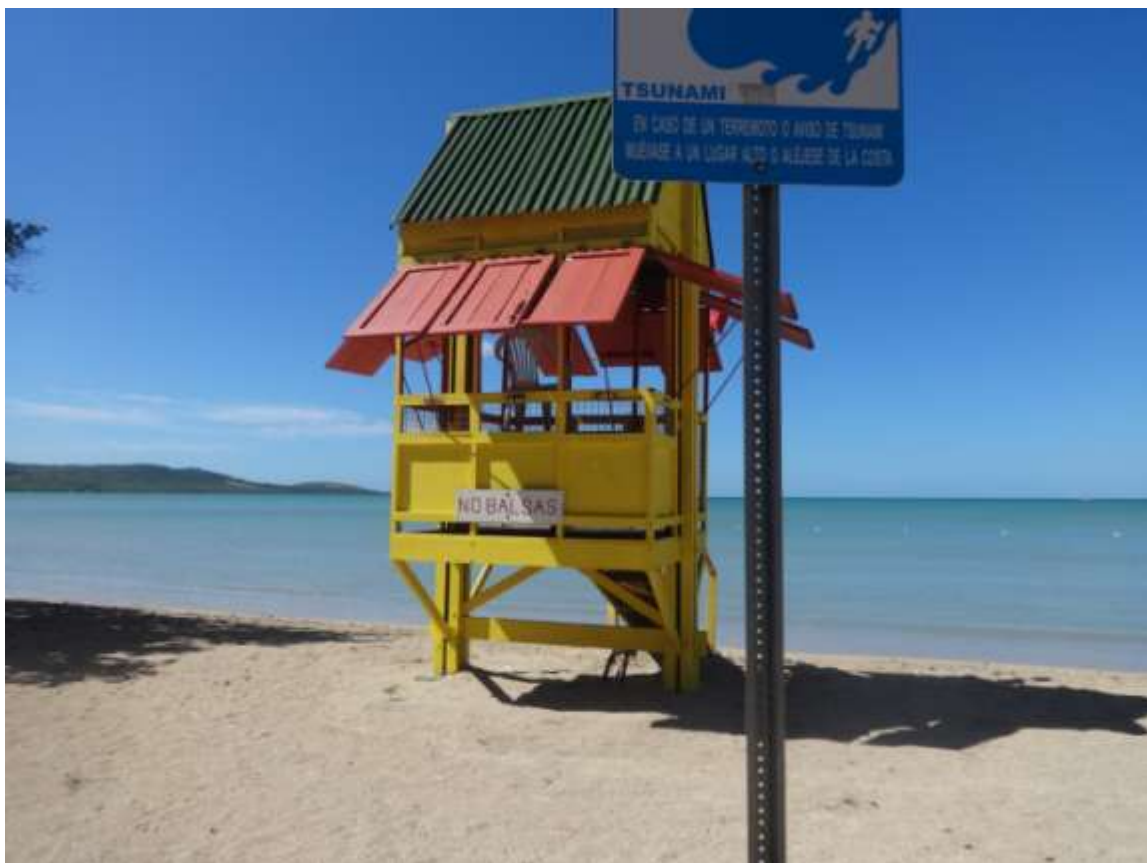
**Figure 58: Lifeguard Stand at Boquerón**

Since this is a Blue Flag certified beach, there are not many dangers. There is a very small pier that would not pose a serious threat because the waves are so small, averaging 1-2 feet. The rocks near the sign would only cause problems during times of very strong waves, which would not be a problem due to the location of the Balneario. There were also no noticeable rip currents on the beach which may be another reason that it is Blue Flag certified for its safety. Our team noted the lifeguard stations, but there were no lifeguards on the beach at the time of our visit, although it was within the normal lifeguard hours. There were also buoys marking the swimming area.

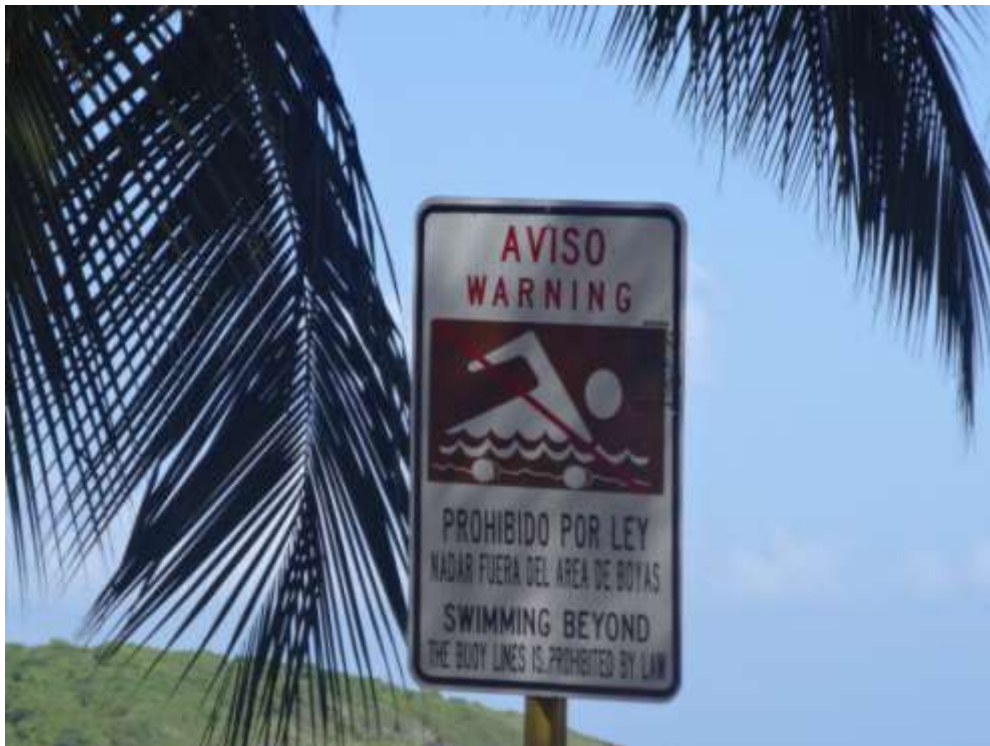
**Figure 59: No Swimming Beyond Buoys at Seven Seas**

At this beach, the signs were prevalent, as with all Balnearios. Signs such as “swimming behind buoy lines is prohibited,” “no diving,” and “slippery rock area” were in good locations at the beach, all places in relevant locations for the dangers present. The number of signs at Seven Seas was also greater than that of any other Balneario that our team visited.

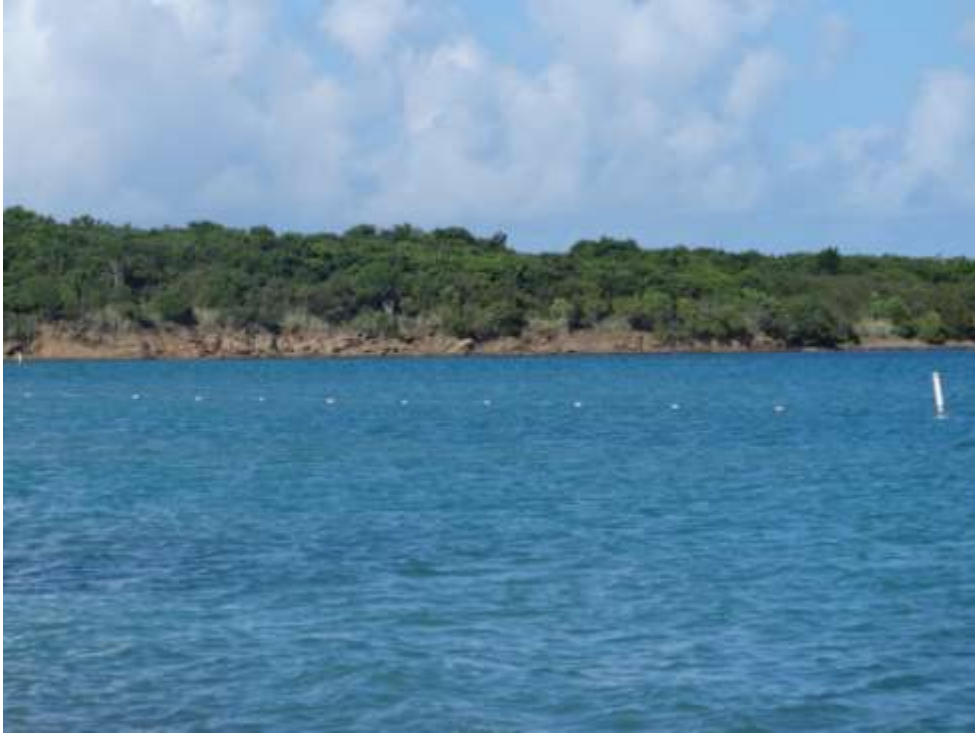
**Figure 60: Buoy Lines at Seven Seas Beach**

Signs for flags were present but no flags were being flown at the time the team was at the beach. Three lifeguard stands were located in good places on the beach. Signs showing beachgoers that this is a Blue-Flag certified beach were at the entrances. The buoys were all at their designated locations; these were the limit for swimmers to travel out into the ocean.

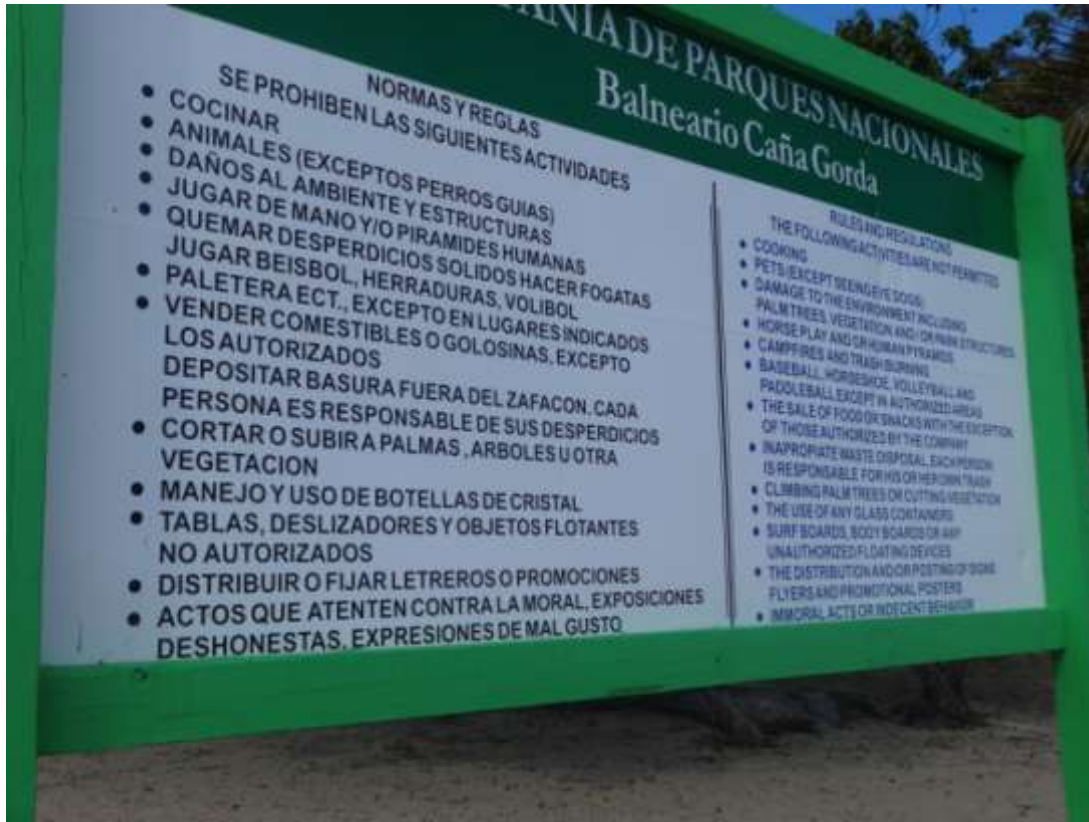
Figure 61: Rules Sign at Caña Gorda

This is a relatively short beach and since it is a balneario, it is very safe. The only sign on the beach is a simple “rules of the beach” sign, which is given in both English and Spanish. On the other side of this sign, it displays what the colors of the flags mean, however only in Spanish.

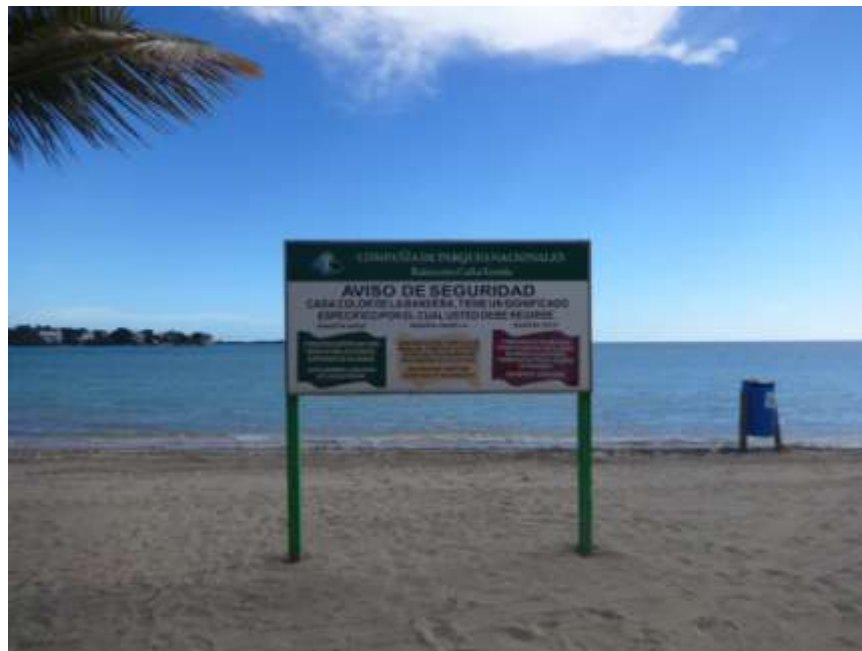
Figure 62: What Each Flag Means at Caña Gorda

There are no other danger or warning signs anywhere on the beach.

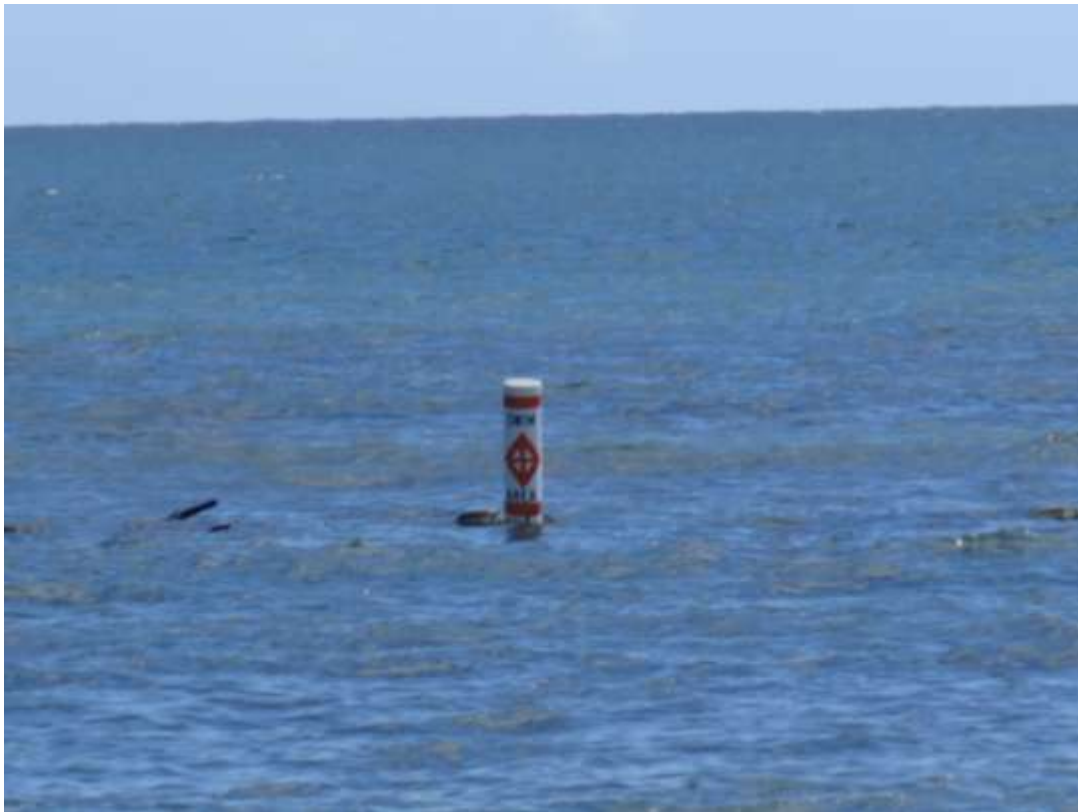
**Figure 63: Marking Buoy at Caña Gorda**

Although the beach is very safe, the shore is rocky to the right side. However, the rock formation is small and would not cause any problems to beachgoers. The area is very well marked with buoys demarcating the allowed swimming area, with small rocks around it.

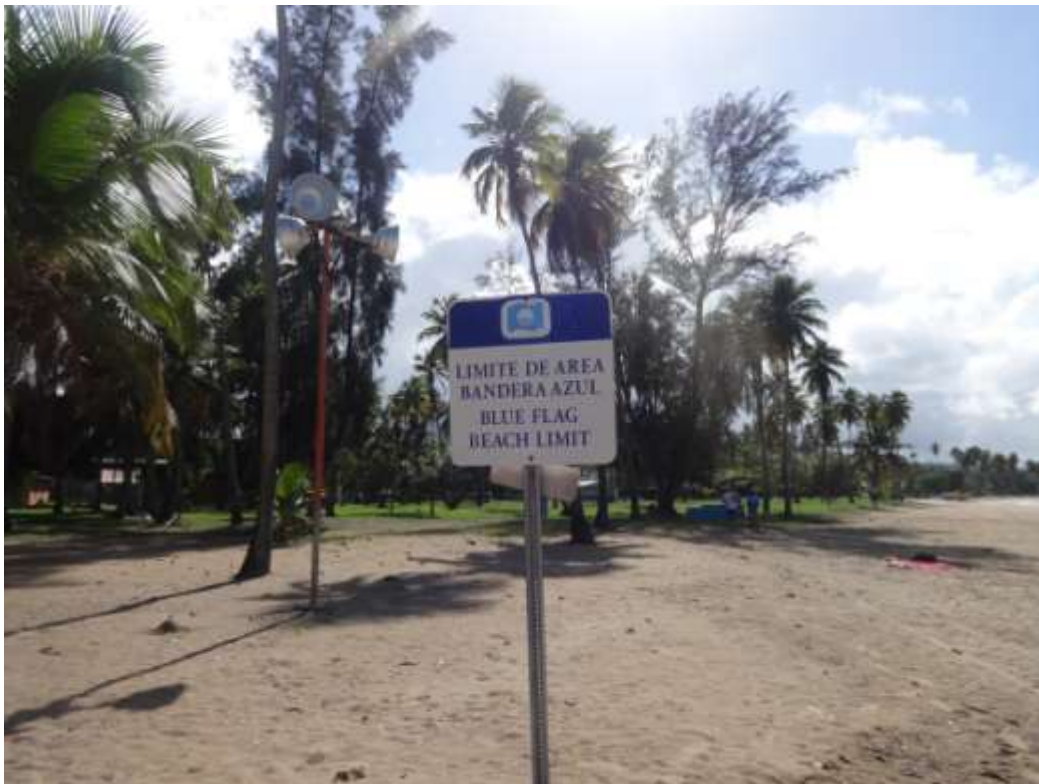
**Figure 64: Blue Flag Beach Limit Sign at La Monserrate**

The only flags on the beach were the flags on the lifeguard stands. There was a bulletin board in the middle of the beach facing away from the ocean that defined what each flag color represented and was written in Spanish and English. The board also defined a Blue Flag beach in both languages. The sign was located in the middle of the beach. Another sign indicated the edge of the Blue Flag beach zone. It had a small picture of a blue flag and had English and Spanish writing.

There was also a third sign behind the sign indicating the end of the zone but all the paint had faded or been removed so the sign was completely illegible. Buoys were used to mark the swimming area. There were a number of ways to enter the beach which made predicting the most likely entrance difficult.

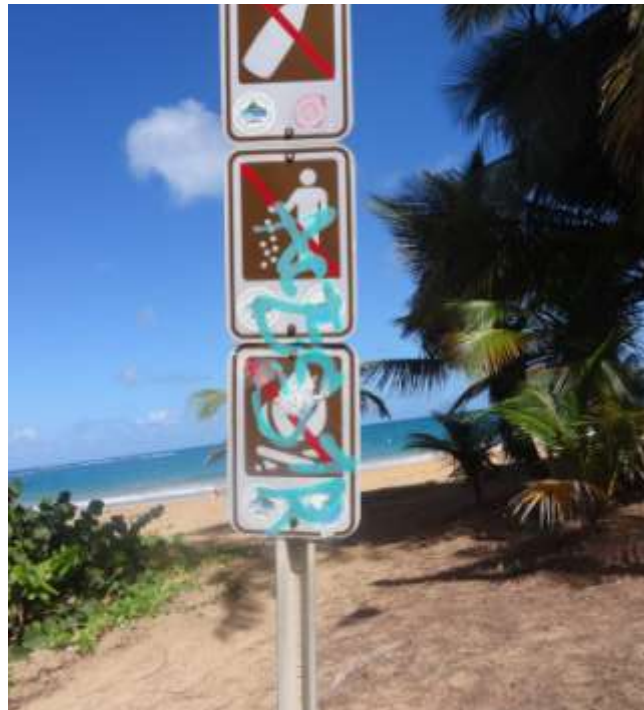
**Figure 66: Graffiti-Covered Sign at Costa Azul**

This beach is considered a safe, or low-risk, beach and does not have any signs warning beachgoers of dangers. The only signs prevalent are those displaying “rules of the beach,” such as the no littering policy, which were covered in graffiti.

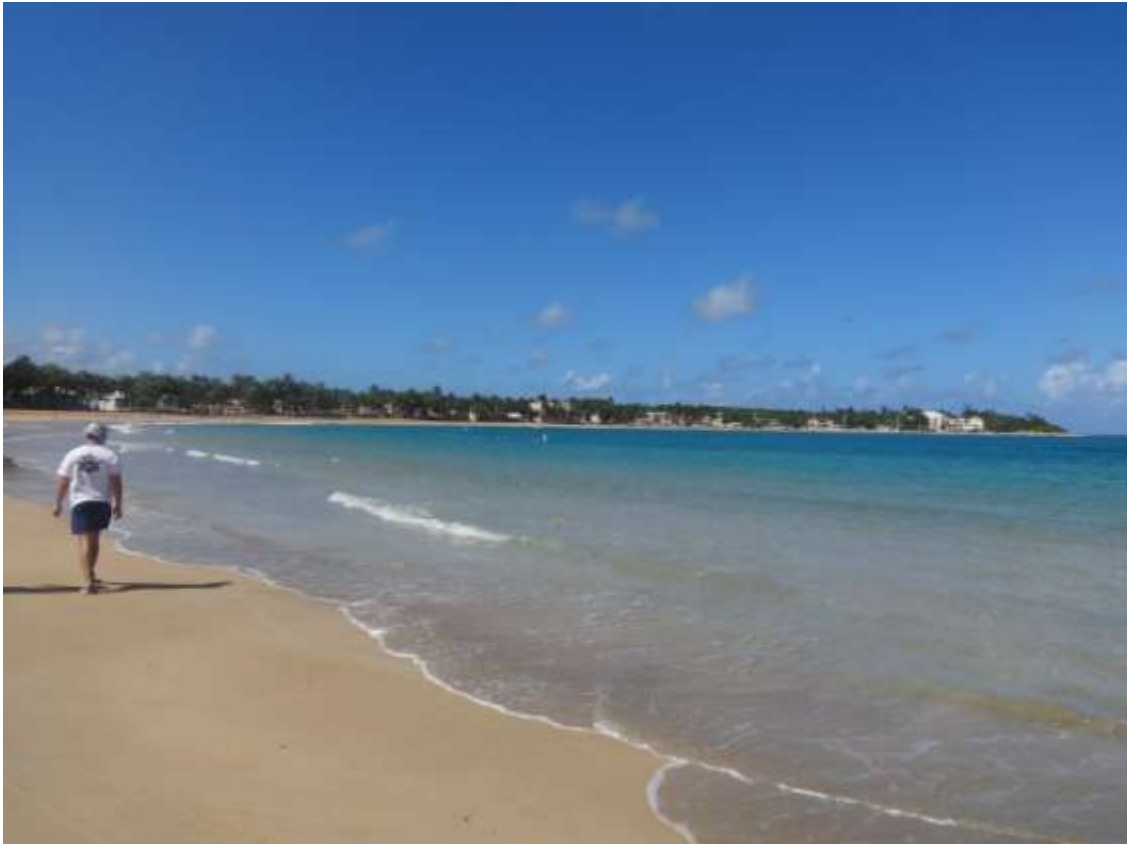
**Figure 67: Very Small Waves at Costa Azul Beach**

During our visit, the wind blew at a low speed of 4 miles per hour creating waves that reached 1-2 feet in height. Small rip currents could be seen in the water but nothing of any significant magnitude. Rocks could also be seen in the ocean but since they were flat, they did not present a serious hazard to swimmers unless in the time of very strong swells, which did not seem likely at this beach.

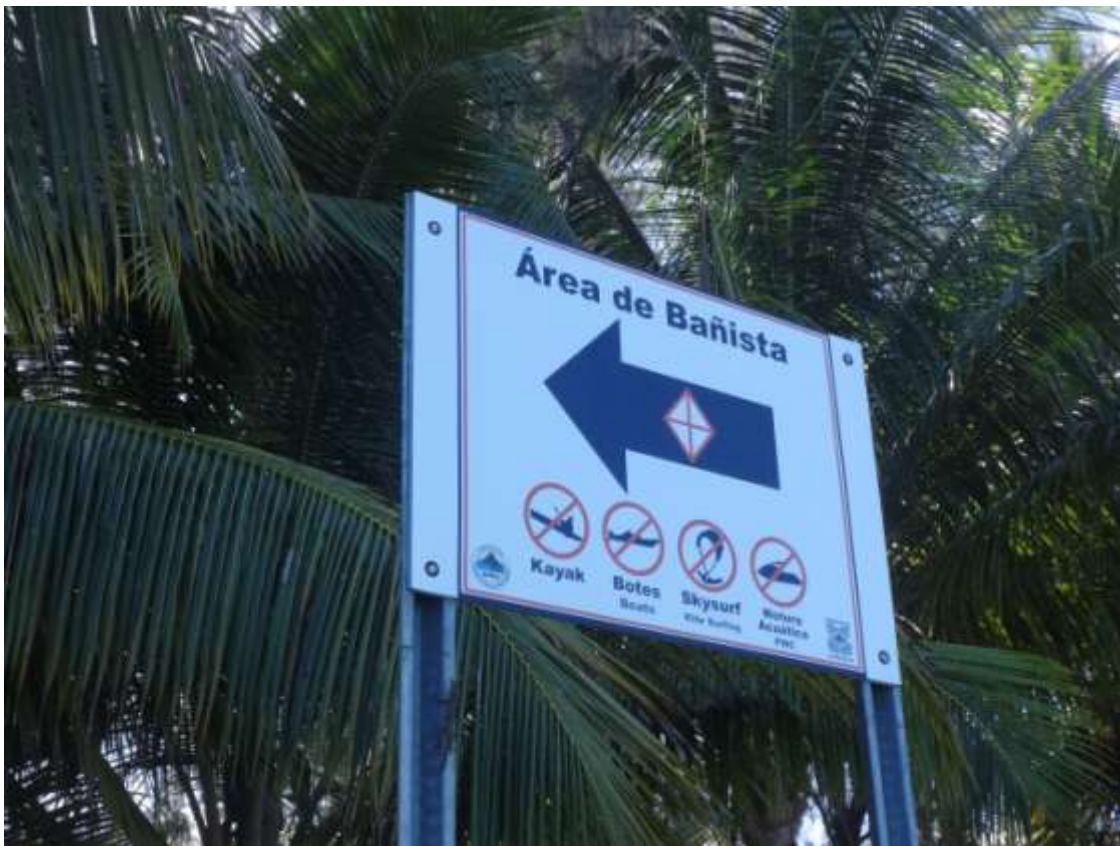
Figure 68: Swimming Area Sign at Punta Salinas

This location had many signs and flags to communicate with beachgoers about dangers in the water. There were three lifeguard stands, each with a flag. Two of the flags were red while one was yellow. The stand with the yellow flag was on the side of the beach and was the only one with a lifeguard. A sign on each end of the beach indicated where the swimming area was using an arrow that pointed towards the swimming area. These two signs also forbade kayaks, boats, surfers, and motor boats. The part of the sign that said “Area for Swimmers” was in Spanish only, while the rest of these signs were in English and Spanish, using a circle with a line through it to indicate that the activity in the picture is forbidden. The sign is shown below.

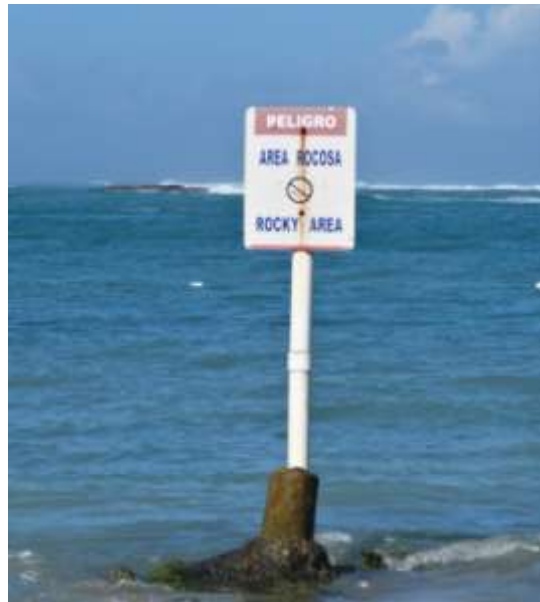
**Figure 71: Rocky Area Sign at Cerro Gordo**

On this beach, there was a lifeguard stand with a yellow flag. The swimming area had one sign at each end that says “Swimming Area,” but only in Spanish. The sign also had an arrow pointing toward the side of the sign that was the swimming area. This sign also used pictures to indicate that kayaks, boats, surfing, and motorboats were banned from the swimming area. The rules and forbidden activities were listed in both Spanish and English while using a circle with a line through it to indicate that the activity was not allowed. There was also a sign facing the beach at the edge of the water warning beachgoers that the area around it was rocky. The sign was small and was written in both English and Spanish. The top of the sign said “Danger” but only in Spanish.
