# Evaluating Effectiveness of the Signage and Other Markings for Guidance and Warning Placed by OCN

An Interactive Qualifying Project submitted to the faculty of  
WORCESTER POLYTECHNIC INSTITUTE in partial fulfillment of  
the requirements for the degree of Bachelor of Science

12/17/2013

Sponsoring Agency: Department of Natural and Environmental Resources in Puerto Rico

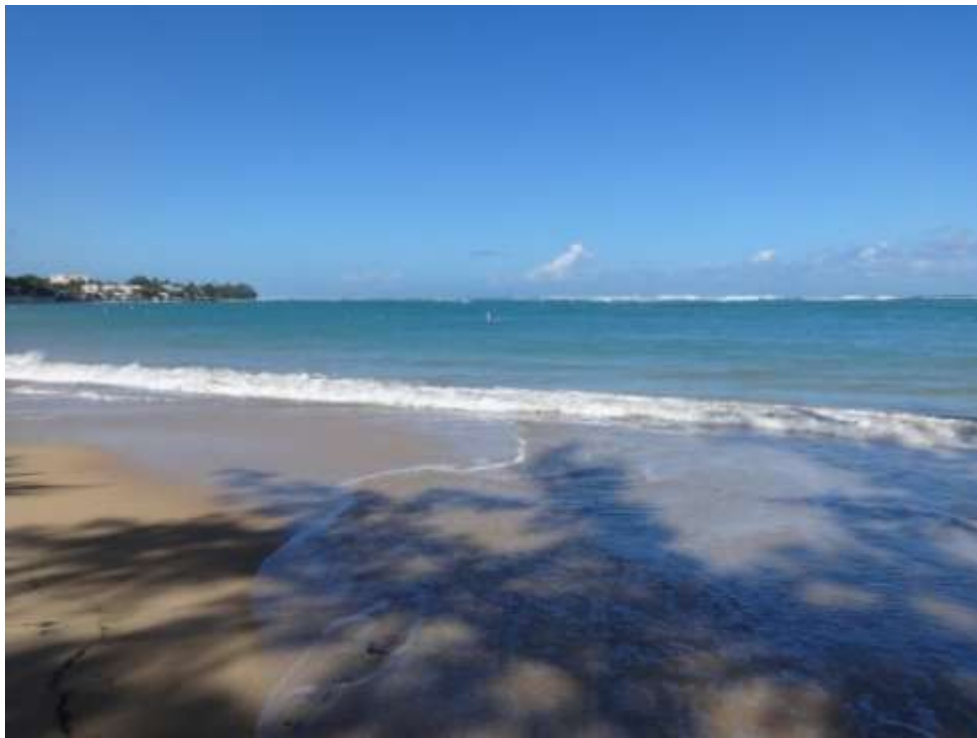
**Figure 72: Small Current at Cerro Gordo**

Since this beach is Blue Flag certified, it is very safe. There was also a lifeguard present at this beach for added security. This beach had a rocky patch in the middle of the swimming area near the shore, which was very noticeable because there was a sign denoting the rocky area. Although the waves were consistently between 3-5 feet, which are higher than most Blue Flag certified beaches, the rip currents produced were very small. The currents posed no problems to swimmers because they were not strong enough to be able to pull people away from shore.

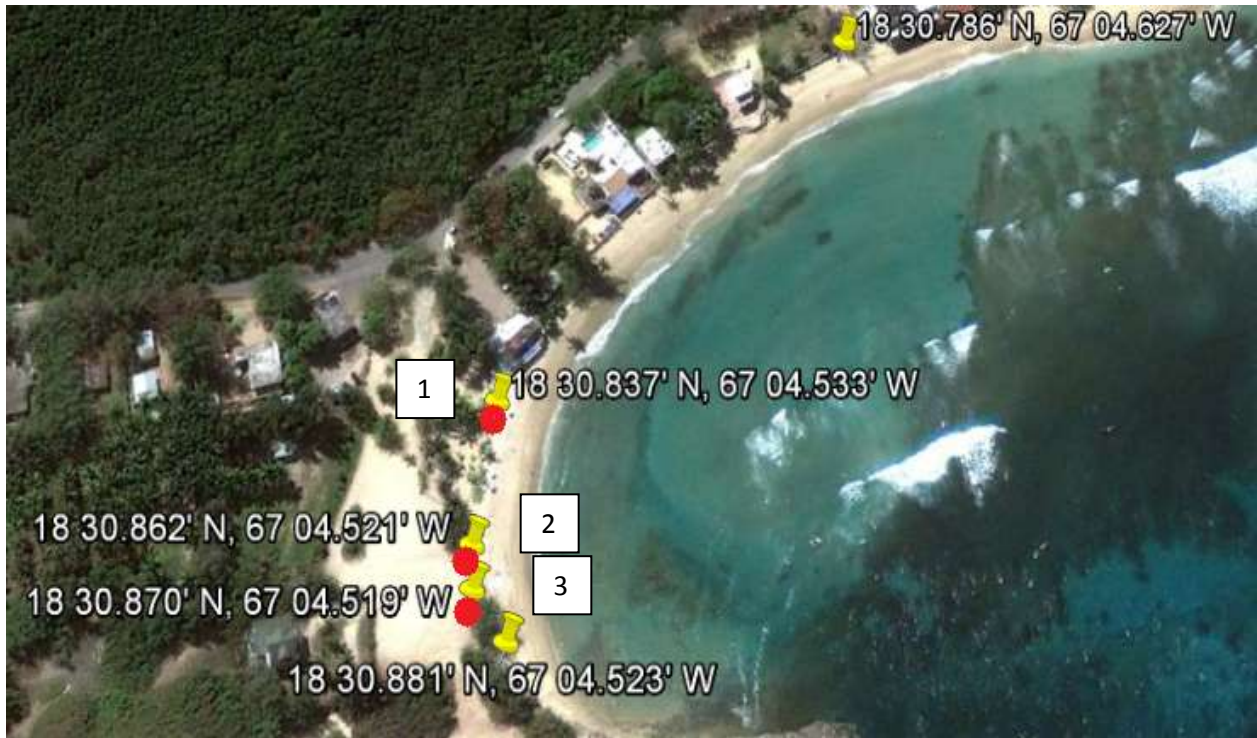
Figure 79: Jobos Beach Map

1. Sign with Large Hole
2. Dangerous Shorebreak
3. Strong Currents

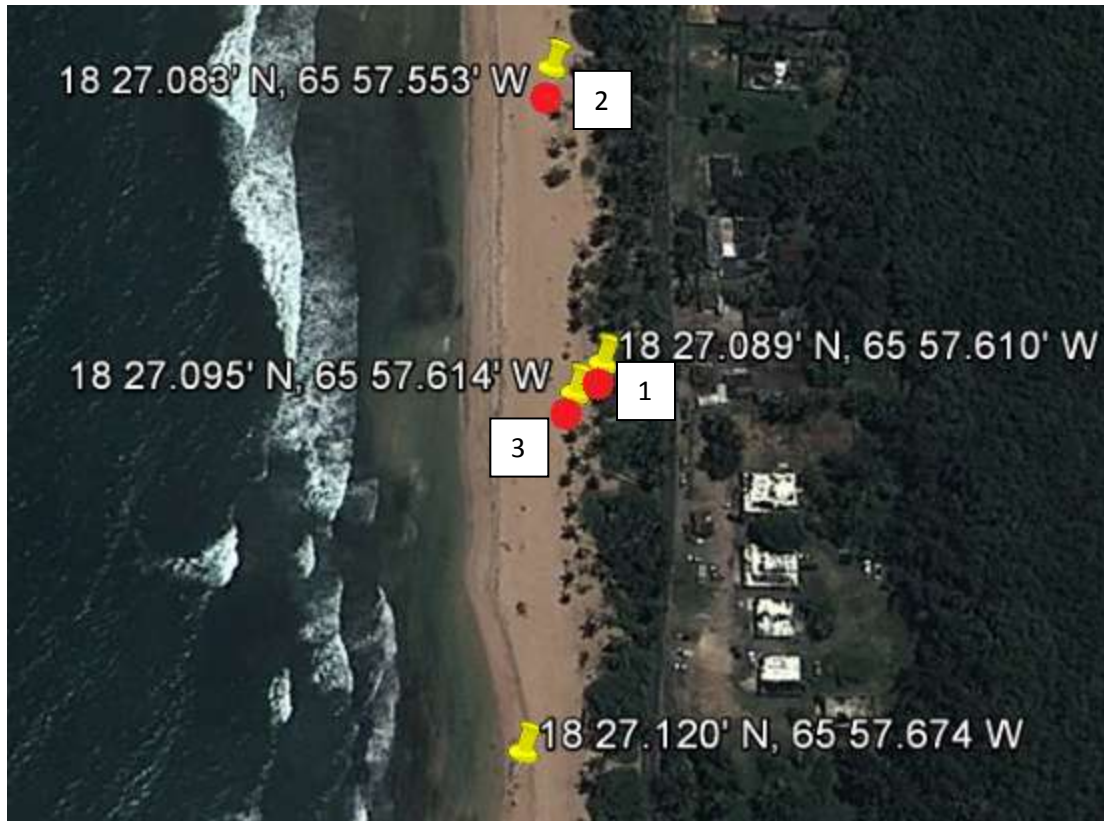
Figure 80: Aviones Beach Map

1. Welcome/Warning Sign
2. Sign Post with Missing Sign
3. Dangerous Shorebreak

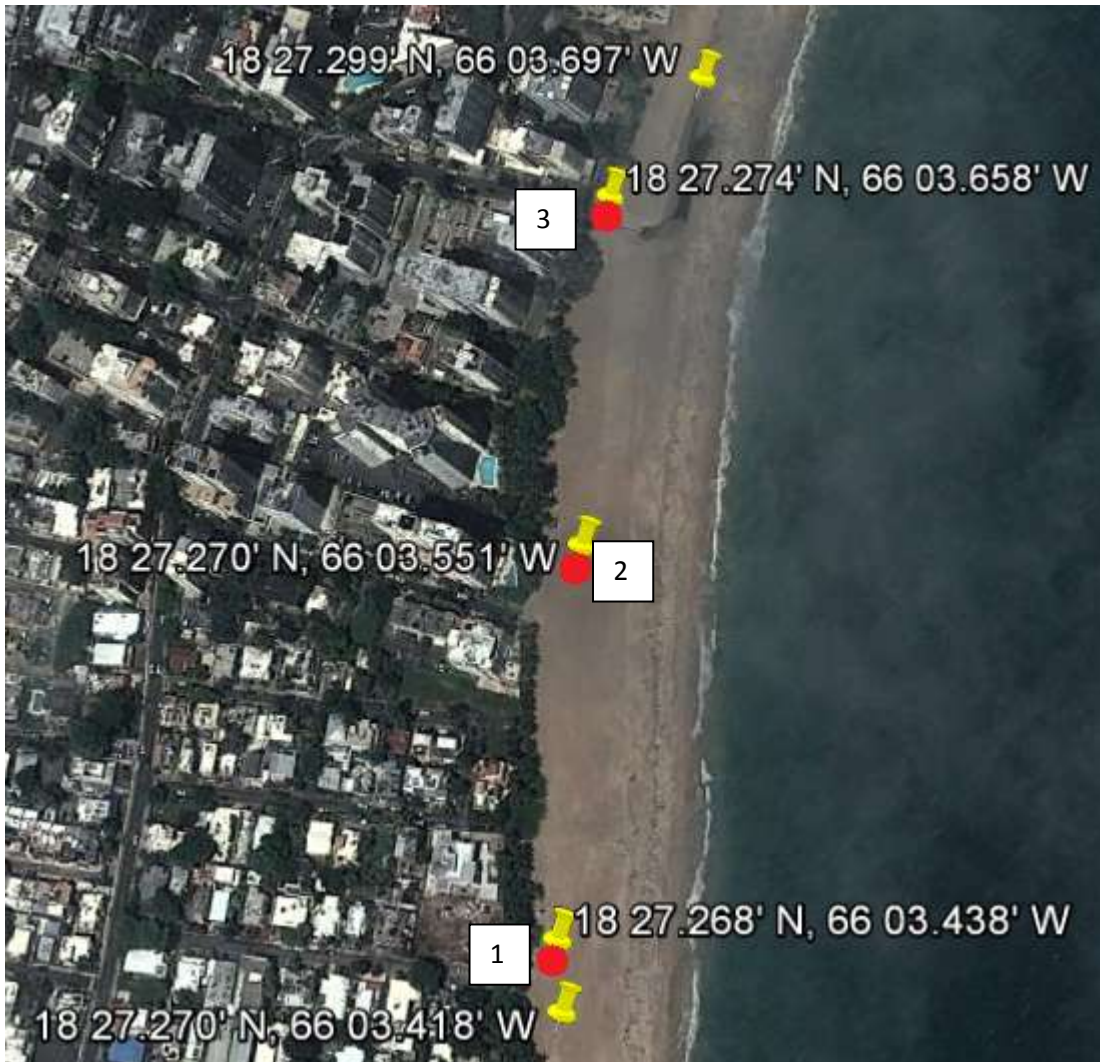
Figure 87: Ocean Park Beach Map

1. Signpost with Missing Sign
2. Strong Currents
3. Strong Currents
