Rio Piedras Conservation Management Plan

Prepared for: The Conservation Trust of Puerto Rico

May
2009

Report Submitted to: Professor Ingrid Shockey and Professor Karen Lemone

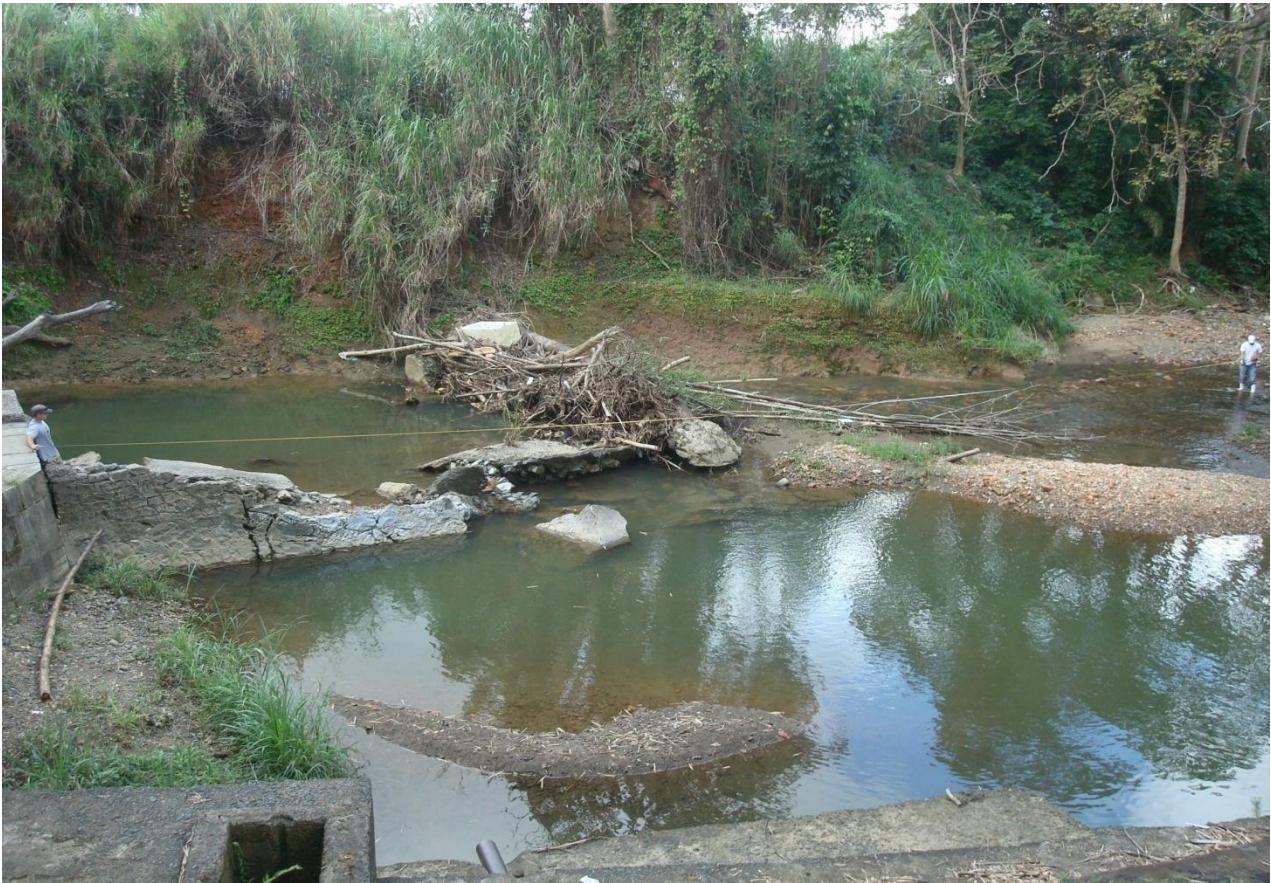
Figure 14: 30-meter Interval Measurement Process

To begin, we divided the Rio Piedras region into smaller zones of similar ecological health. We surveyed along the river, filling out a river bank health assessment sheet (see Appendix I of the Management Plan) at thirty-meter intervals independently for each side of the river (urban and aqueduct bank sides). The dam of the aqueduct was used as a reference point for the start of the thirty-meter intervals. At each interval, a flag was placed with a reference number assigned accordingly. This gave our team an accurate idea of our location on the river. The assessment sheet included shade cover, vegetation, bank integrity, algae concentration in the river, both human and natural debris, and continuity from the previous interval. Each assessment sheet also contained a notes section to include the distinguishing features of each interval (ex: large river bank, water depth, vegetation, etc). After the initial interval assessments, we combined intervals of similar characteristics to form larger, continuous zones. We identified these regions as "Zone 1, Zone 2, etc." for easy referencing. Then, a brief description identifying the aspects of the zones was given for future reference in the report. This process is demonstrated in Figure 14, as team members are seen measuring out the thirty-meter intervals.

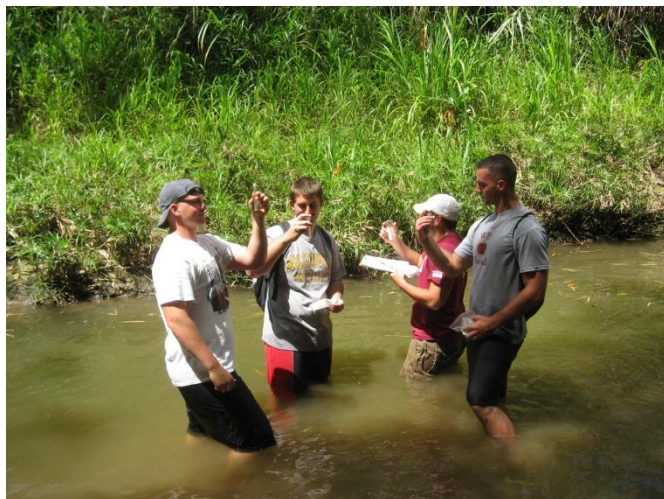
Figure 18: Team Members Performing Water Testing

In testing the water quality at the end of each zone, we found little variances between testing locations. The experimental results are shown in Table 1. There are however slight

patterns that we have discovered. The water temperature increased as each group proceeded downstream. This is primarily due to the decreasing amount of canopy cover. Based on the dissolved oxygen testing, the levels are not consistent with a healthy river. Yet, in speaking with Fideicomiso employees, we learned that the Rio Piedras possesses similar values to other San Juan water systems. In testing the phosphate levels, we found similar

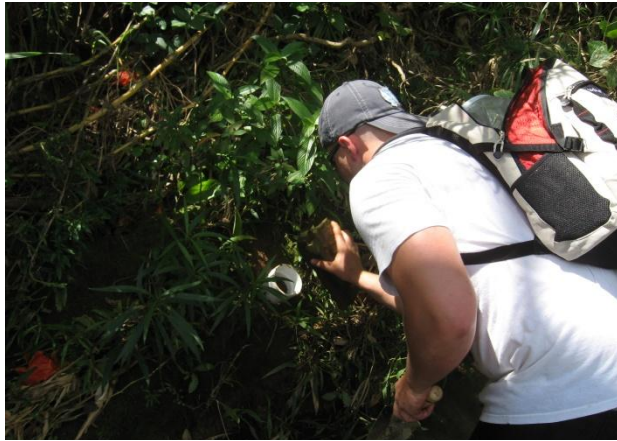
Figure 19: Team Member Performing Soil Collection

Soil testing was conducted twice per zone with the exceptions of Zone 2 and Zone 11, as they were larger zones with a wider variety of soils. We found the majority of the samples were composed of clay with varying amounts of roots, rocks and organic matter. Our team observed that where there was a higher range of biodiversity, the samples contained a greater number of roots and were more difficult to extract. This demonstrates that those zones with a greater

biodiversity have a solid bank integrity, which creates a larger resistance to erosion.

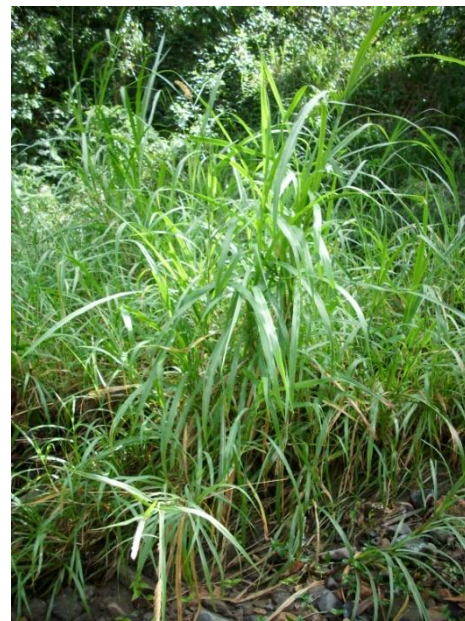
Figure 20: Elephant Grass

Elephant Grass (*Pennisetum purpureum*) is another widespread invasive species. As it grows so quickly, it chokes out the smaller shade intolerant vegetation. However, Elephant Grass does not contribute to the canopy cover which is important to maintain water temperatures. As this species can spread and develop much faster than most, it often occupies vast expanses of land along the river. Consequently, Elephant Grass is the second most abundant species our team discovered. Elephant Grass exists in nine of the thirteen zones and appears in large stretches of open land. Therefore, this species needs to be maintained and eliminated in order to allow other species to mature. A photograph of the grass is seen in Figure 20.

Six plant species received an abundance grade of widespread (+++), yet five of them are invasive species to Puerto Rico. Within this collection of plants, our group recommends controlling and limiting the growth of two plants. These two species are *Bambusa vulgaris* (Common Bamboo) and *Pennisetum purpureum* (Elephant Grass). Controlling the growth and spread of these plants will allow the native species, which we recommend be planted in the riparian zone, a chance to mature and thrive. We suggest that the other two invasive species, *Spathodea companulata* (African Tulip) and *Terminalia catappa* (Indian Almond) remain undisturbed because they have qualities that help the riparian zone. However, we suggest The Trust control the spreading by eliminating the saplings of these trees. For a more detailed report of the abundant species and their characteristics, refer to Chapter 4 of the Management Plan in Appendix B.

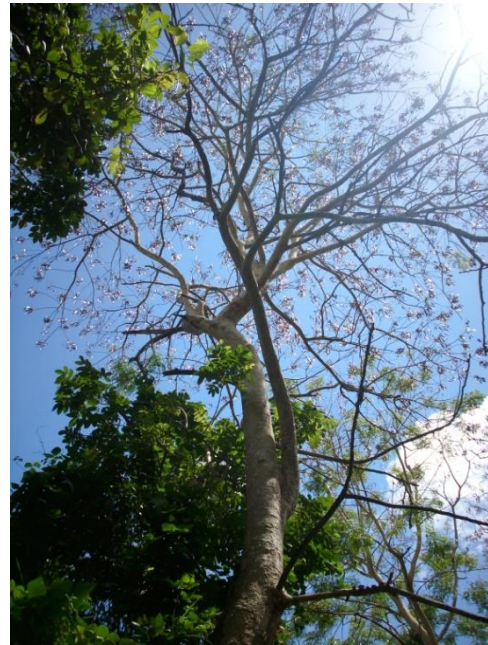
Figure 22: Tall Albizia

We also propose specific plants be used in conjunction with the implementation of the tiered vegetation system. A list of twelve plant species was chosen to be used in the vegetation system. They were chosen based upon their contribution to the riparian zone health, ease of growth, and The Trust's ability to obtain the plants. This list includes trees and shrubs such as the *Andira inermis* (Angelin), *Calophyllum calaba* (Maria) and the *Thespesia grandifora* (Maga). Nine of the trees are grown in The Trust nursery. One plant is an invasive species, the *Albizia procera* (Tall Albizia), but the positive characteristics of this tree prevail over the fact that it is invasive. The Tall Albizia can be seen in Figure 22. For a more detailed report of the

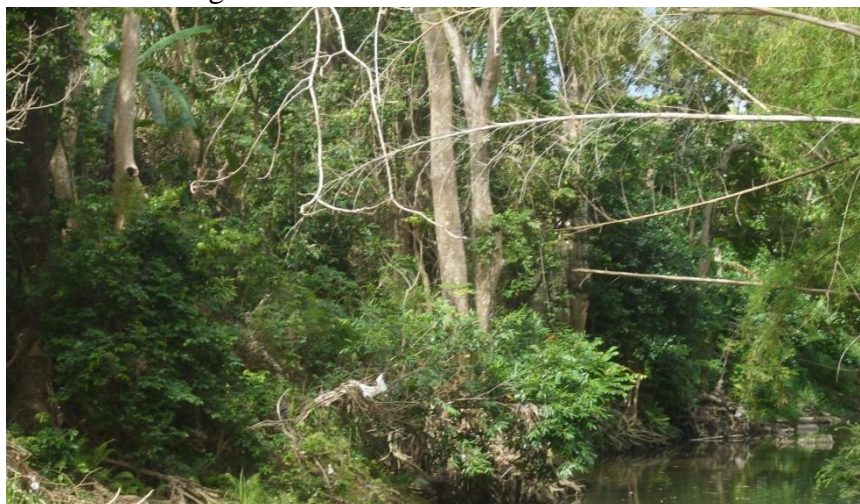
Figure 9: Zone 2 at Left

Intervals 2, 3, and 4 are grouped together to form the ninety-meter Zone 2. There are many trees that have root structures reaching into the river. These trees provide good shade cover for the river bank. The bank was steep and difficult to traverse because of extending roots, dense undergrowth, and moss covered rocks. There is an abundant amount of natural and human debris, but there were no large objects found. This zone distinguishes itself because of its canopy cover and related vegetation, a deeper water level, and the presence of rocks along the bank. The features of the zone can be seen in Figure 9.

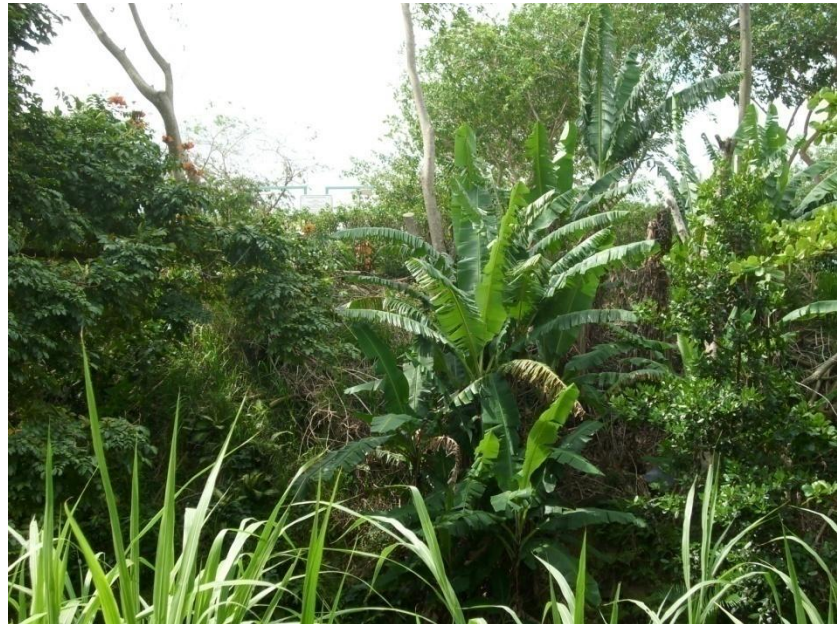
The soil samples from Zone 3 are varied from place to place. The first sample, taken from the top of the bank, is a loose soil that contains rocks with a small amount of roots and organic matter. This soil is prone to erosion as there are not enough roots to hold the soil in place. The second sample was taken at the end of the zone and contains hard

Figure 12: McArthur Palm and Zone 3 (Building in Far Background)

packed clay that was very slippery. The packed clay contains a few minute roots. The sample exhibits the zone's typical bank close to the water's edge. This type of bank allows for the growth of moss, small shrubs, and small grasses. Consequently, the bank is eroded and very steep. The first sample has a density of 0.765 g/cm^3 while the second sample has a density of

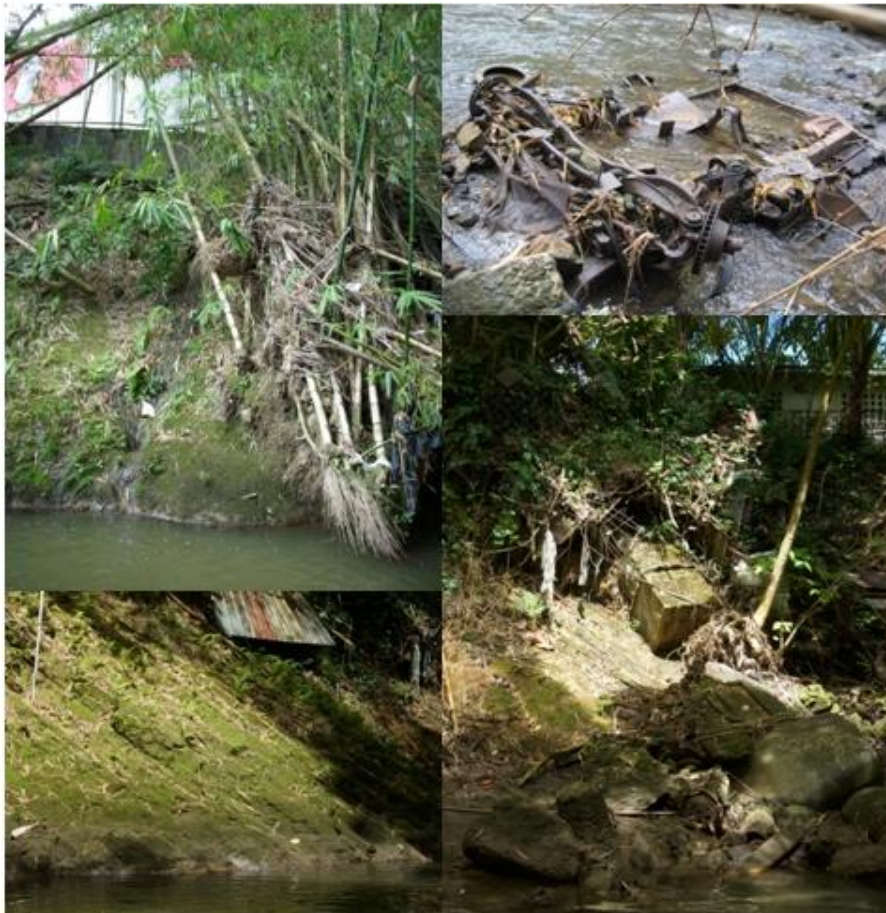
Figure 13: Features of Zone 4

Intervals 6, 7, 8, 9, and 10 are grouped together to form the one hundred fifty-meter Zone 4. This zone marks the point where urban development meets the river's riparian zone. Consequently, an excessive amount of human debris characterizes the zone. At the end of the zone, items such as scrap metal, televisions, tires, and a car chassis are present. The canopy

cover consists largely of Bamboo, positioned at the peak of the bank where the riparian zone meets a concrete foundation and fence. There are also scattered trees within the zone and little undergrowth. Some of the debris items, erosion, and bank composition can be seen in Figure 13. The resulting weak soil has caused Bamboo trees to upend and they are on

the verge of falling into the river. The moss covered banks are very steep and house various sized rocks. This zone distinguishes itself because it accommodates Bamboo and is surrounded by numerous buildings. These features may be the cause of the severe erosion and urban dumping that also distinguish the zone. Recognizable features can be seen in Figure 14 and Figure 15.

We identified extensive amounts of garbage and natural debris spanning the course of the river. We recommend that The Trust hold an annual or biannual river cleanup event with either volunteer or professional crews. Professional crews will be needed if large objects such as the refrigerator or car chassis need to be dismantled.

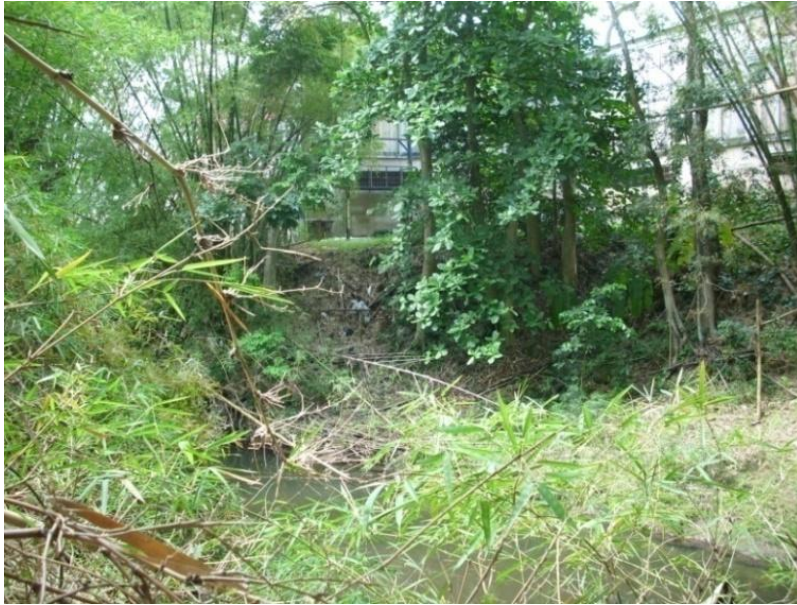
Figure 14: View of Zone 4 from Aqueduct Side, Building and Fence Present

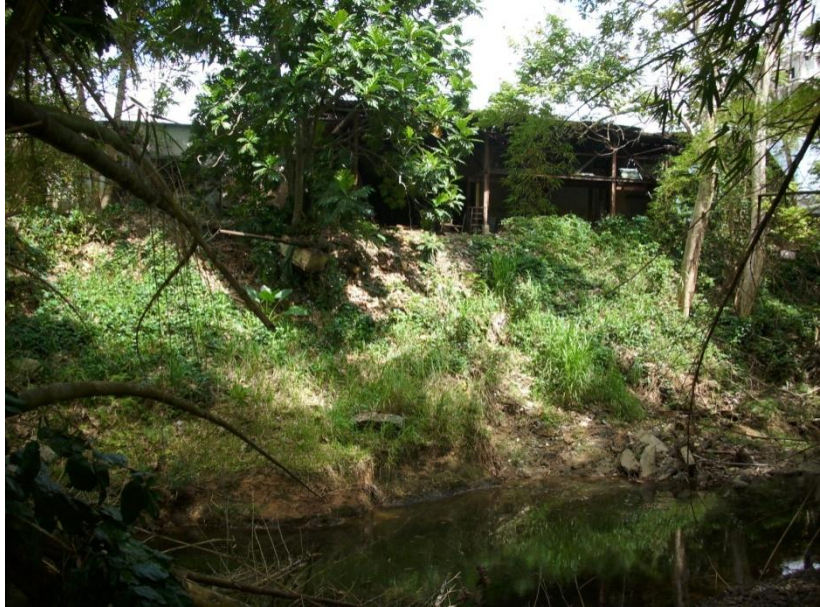
Figure 15: Zone 4 River Bank and Building

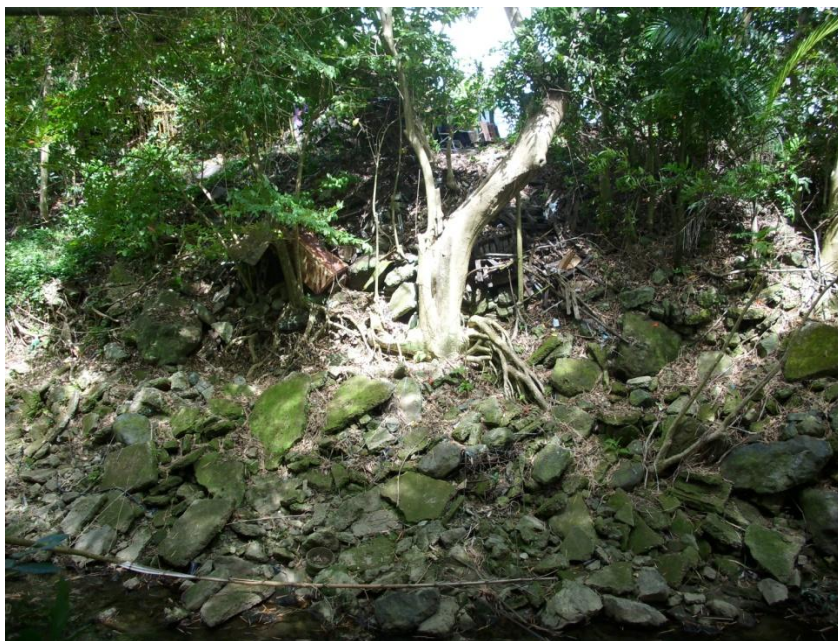
Intervals 11 and 12 are grouped together to form the sixty-meter Zone 5. This zone has a steep bank composed of many large rocks, limiting the vegetation in the area. There are various trees at the top of the bank providing somewhat good shade, but there is no vegetation alongside the river. The zone also holds a lot of human debris, originating from the urban development at the edge of the riparian zone. The border of the zone is fenced in with numerous buildings at the top. The width of the riparian zone is noticeably small because the buildings are at the peak of

the rock bank. This zone distinguishes itself because it has a rock embankment, close bordering urban development, no undergrowth, and large trees at the bank peak. Figure 16 and Figure 17 present the rock embankment of Zone 5, its main distinguishing feature.

Figure 16: Zone 5 Rock Bank and Urban Development

In Zone 5, the embankment is covered by very large rocks. We advise The Trust to remove the large rocks and reveal the soil. The tiered vegetation system should be used in this area along with the appropriate planting soil to increase growth. Once the vegetation is planted, we recommend that a geo-textile material be placed on the ground. This will prevent the newly exposed soil from eroding while allowing the plants to grow. The geo-textile material will eventually decompose into the natural habitat.

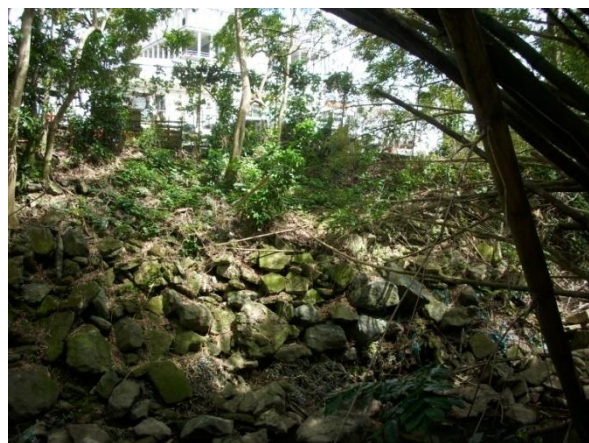
Figure 17: Rock Embankment of Zone 5

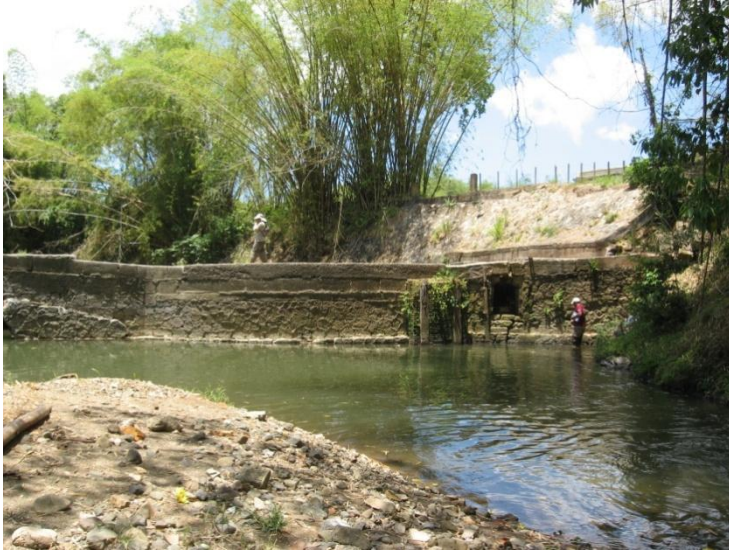
Figure 23: End of Zone 7 at the Aqueduct

located throughout the zone. Other than Bamboo, the other prevalent species is *Guarea guidonia*, or Muskwood. Wild coffee (*Casearia guianensis*), Jagua Box Genip (*Genipa americana*), and Muskwood are solely present in Zone 7. This is likely due to the aqueduct rock wall that spans thirty meters and separates the zone from other vegetation. The lone invasive species is the abundant Common Bamboo. To view the abundance and

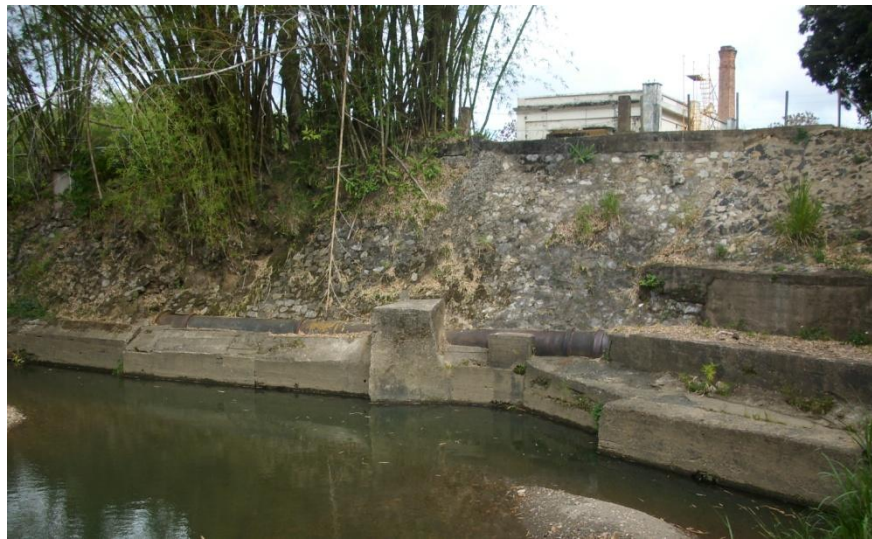
Figure 24: Aqueduct Concrete Wall of Zone 8

Interval 1 makes up the thirty-meter long Zone 8. This zone houses the rock wall which is part of the dam as shown in Figure 24. At the top of the wall at the end of the zone, there is a cluster of Bamboo, but no other noticeable vegetation. The zone has only little human debris such as bathing suits and containers. This zone is distinguished by the large rock wall and lack of vegetation.

patch in Zone 8 is comprised of mostly Bamboo, while younger tree species are also present. The small patch contains Bamboo, *Citrus sp* (tree species), and an African Tulip. The concrete and rock wall of the aqueduct prevents the growth of vegetation.

Furthermore, the feature prevented the team from taking soil samples. To view the abundance and characteristics of species in Zone 8, see Appendix XII.

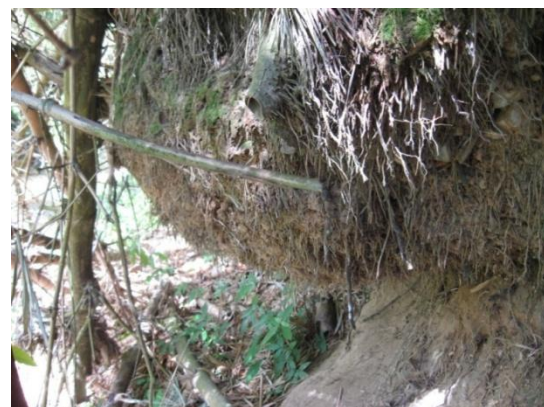
Figure 25: Erosion with Zone 9

Intervals 2, 3, and 4 make up the ninety-meter Zone 9. The vegetation is moderate, and it is made up mostly of Bamboo and small amounts of grass. There is also a lot of natural debris from the

fallen dead Bamboo. However, the Bamboo provides good shade cover for the bank. The bank ranges from stable at some points to unstable at others. The excessive Bamboo has prevented the natural growth pattern of native species and has not controlled the erosion within the zone as seen in Figure 25. This zone distinguishes itself because of the presence of Bamboo and grasses.

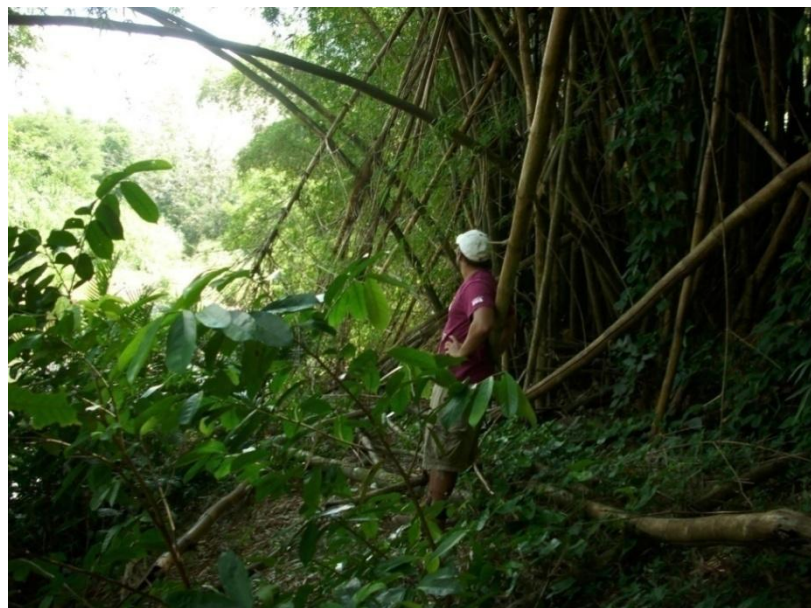
Figure 30: Team Member within Zone 12

Generally the banks are

stable with a good grade, but in places the grading is sheer. The decent grade within Zone 12 can be seen in Figure 30. There is no human or natural debris in any part of the zone. This zone distinguishes itself because there is comparatively little Bamboo and no human debris.

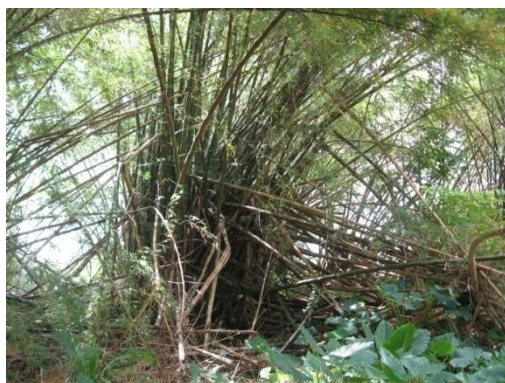
Figure 37: *Bambusa vulgaris*

Bambusa vulgaris (Common Bamboo) is an invasive species from south Asia and is found in Zone 4 and Zones 7 through 13 of the river. This is the most abundant plant on the aqueduct side, especially in Zone 10 where it is the lone species found. Bamboo is most known for its extremely fast growth rate and its cluster growth pattern. It can grow to a height of 16 meters and has an average root depth of 0.6 meters.

The clusters of Bamboo create a complex matrix of roots that helps prevent erosion. Bamboo is able to grow in any soil type and in a wide range of pH values making it an adaptable plant. It has the ability to thrive in any circumstance which is why it is so widespread throughout the river. However, it disrupts and kills competing plants because it grows quickly and blocks sunlight.

Although Bamboo does help with erosion, The Trust should control the spread of the species. Additionally, we recommend the removal of the dead Bamboo debris that

is found in clusters, allowing other native species to grow. A typical Bamboo cluster is seen in Figure 37.

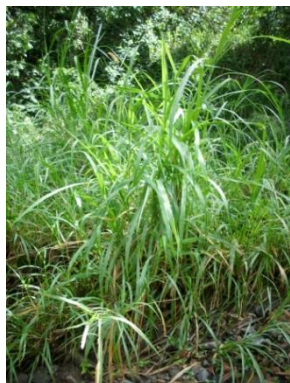
Figure 40: *Pennisetum purpureum*

Pennisetum purpureum (Elephant Grass) is an invasive grass species originating from the plains of Africa. It is found in Zones 1 through 6, 9, 11, and 12. The plant grows to a height of 3 meters with a root depth of 0.4 meters. It can grow in any soil type however it prefers growing in soil with a pH of 5.2 – 6.8. Elephant grass is tall, fast growing, and spreads easily. It blocks sun light from reaching the ground

smothering any seedling that is trying to establish itself. We recommend the removal of the dense Elephant Grass in Zones 1 and 6. This will open up areas for the implementation of the tiered vegetation system. However in order to protect the young trees from the Elephant Grass, monthly trimmings or weeding is suggested. Typical Elephant Grass growth is seen in Figure 40.
