An Analysis of the Archaeological Potential of Venetian Church Floors

An Interdisciplinary Qualifying Project
Submitted to the faculty of
Worcester Polytechnic Institute
in partial fulfillment of the requirements for the
Degree of Bachelor of Science

Soprintendenza all'Archeologia
UNESCO

Date: July 29, 2004
www.wpi.edu/~mshaw323/venice
churches-c04@wpi.edu

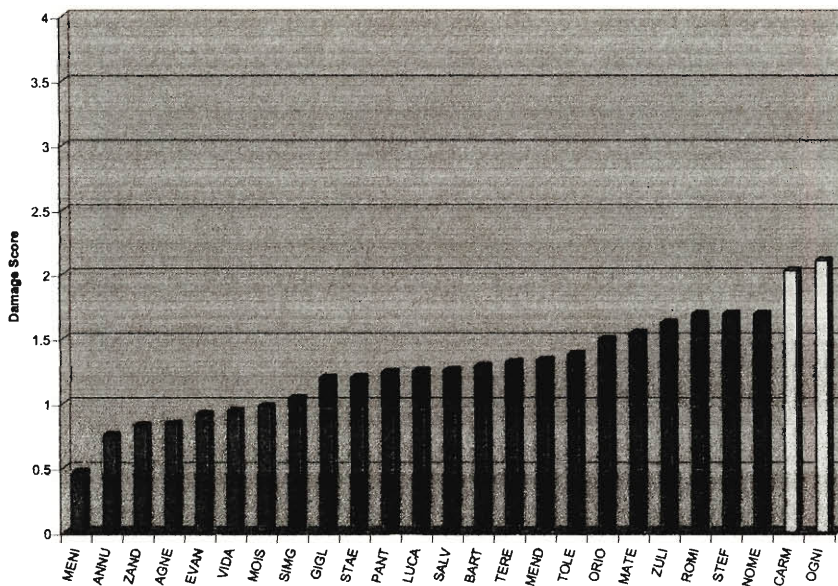
Figure 24: Average Quadrant Damage

Quadrant damage information was collected and entered as described in the methodology section. Once collected, the data was entered into the assessment formula to attain numbers on the 0-4 scale. The damage scores for all of the quadrants of a church were averaged to obtain the numbers shown here.

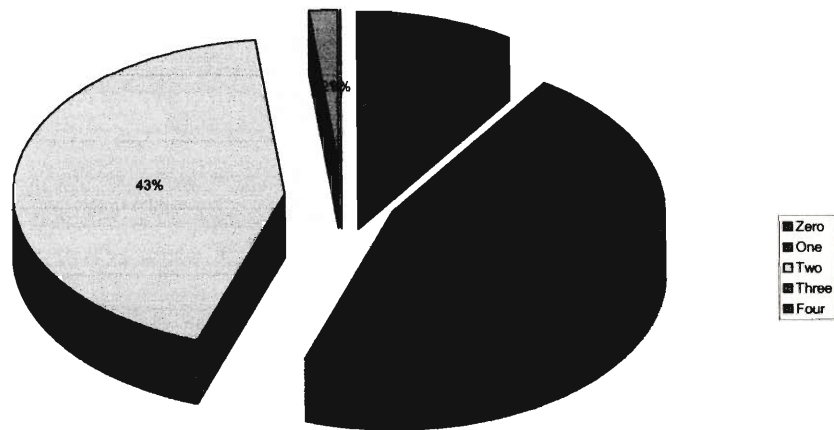
Figure 25: Quadrant Damage on 0-4 Scale

The following pie chart displays the number of floor quadrants whose damage score falls into each of the five categories on the 0-4 scale. The assessment formula was used to generate the values shown here.

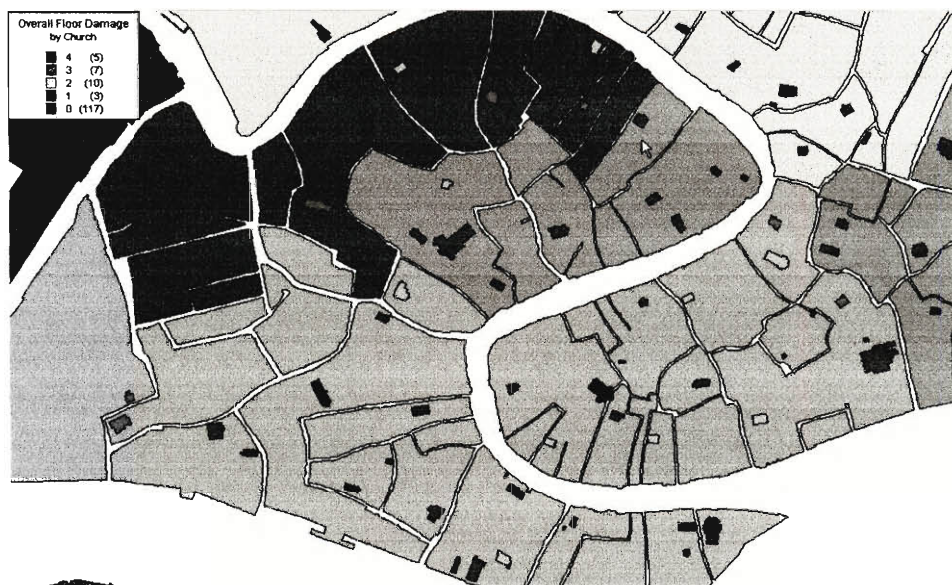
Figure 26: Map of Overall Floor Damage by Church

This map displays the average floor damage by church on the 0-4 scale. These scores were taken by averaging the overall floor damage scores for each quadrant in each church and rounding them to the nearest number on the 0-4 scale.

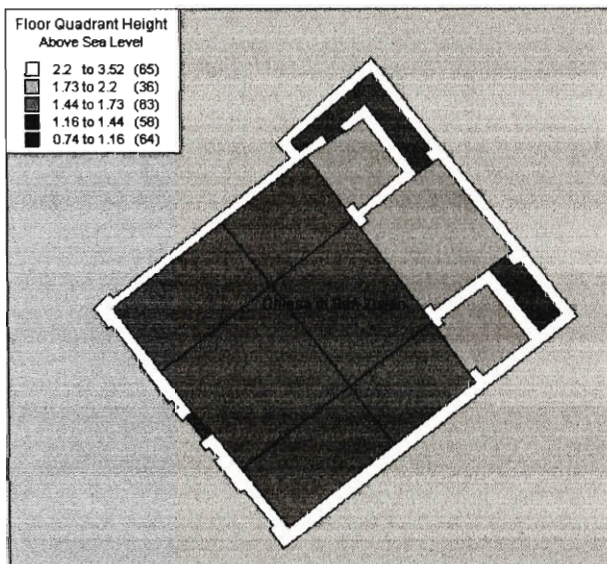
Figure 31: Quadrant Height in San Zulian

Figure 31 is a MapInfo capture of floor heights in San Zulian. Similar images for each of the other churches surveyed by our group can be found in the appendices.

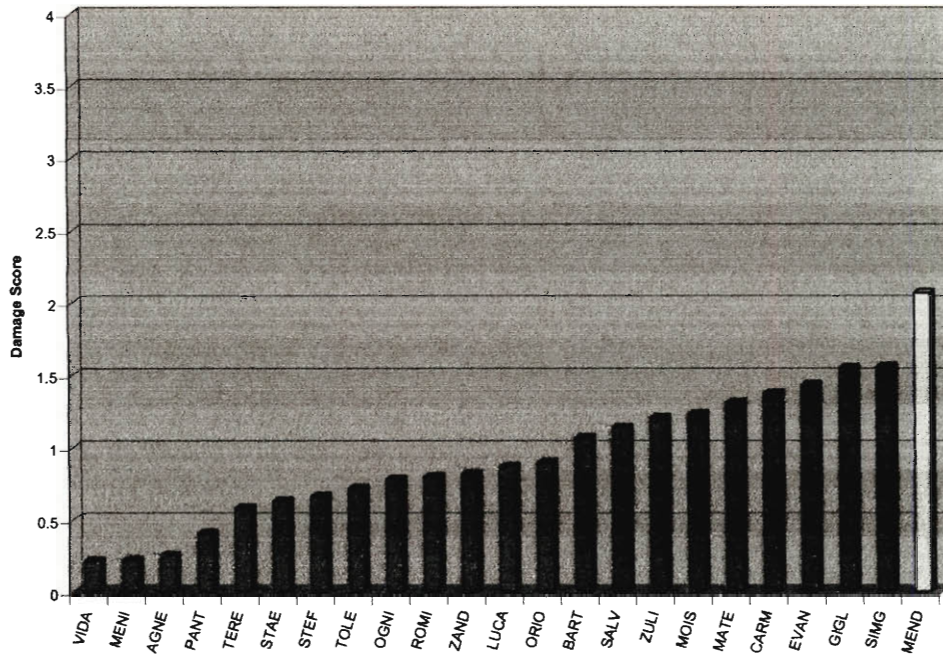
Figure 32: Average Artifact Damage

The first graph shows average artifact damage organized by church. This graph utilizes the group's assessment formula to generate a final score between 0 and 4 for each artifact. The scores are then averaged for each church, and the average is displayed as the height of a bar.

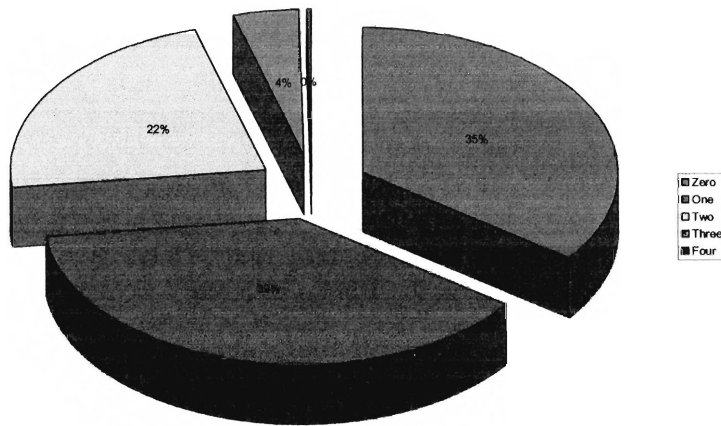
Figure 33: Artifact Damage on 0-4 Scale

The second graph is a pie chart that displays the number of artifacts whose damage score falls into each of the five categories on the 0-4 scale. Again, the assessment formula was used to generate the numbers.

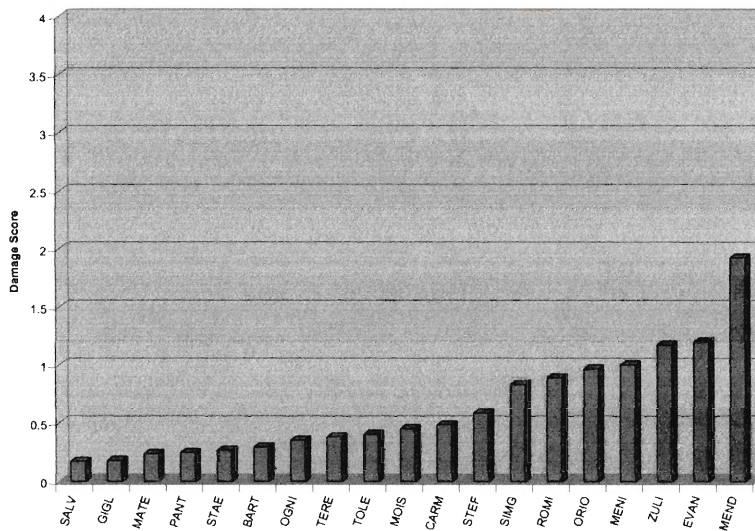
Figure 34: Text Readability Averages

After using the text readability formula to calculate a score for each artifact, the scores for all of the artifacts in each church were normalized onto the 0-4 scale. This graph displays the average scores for each church.

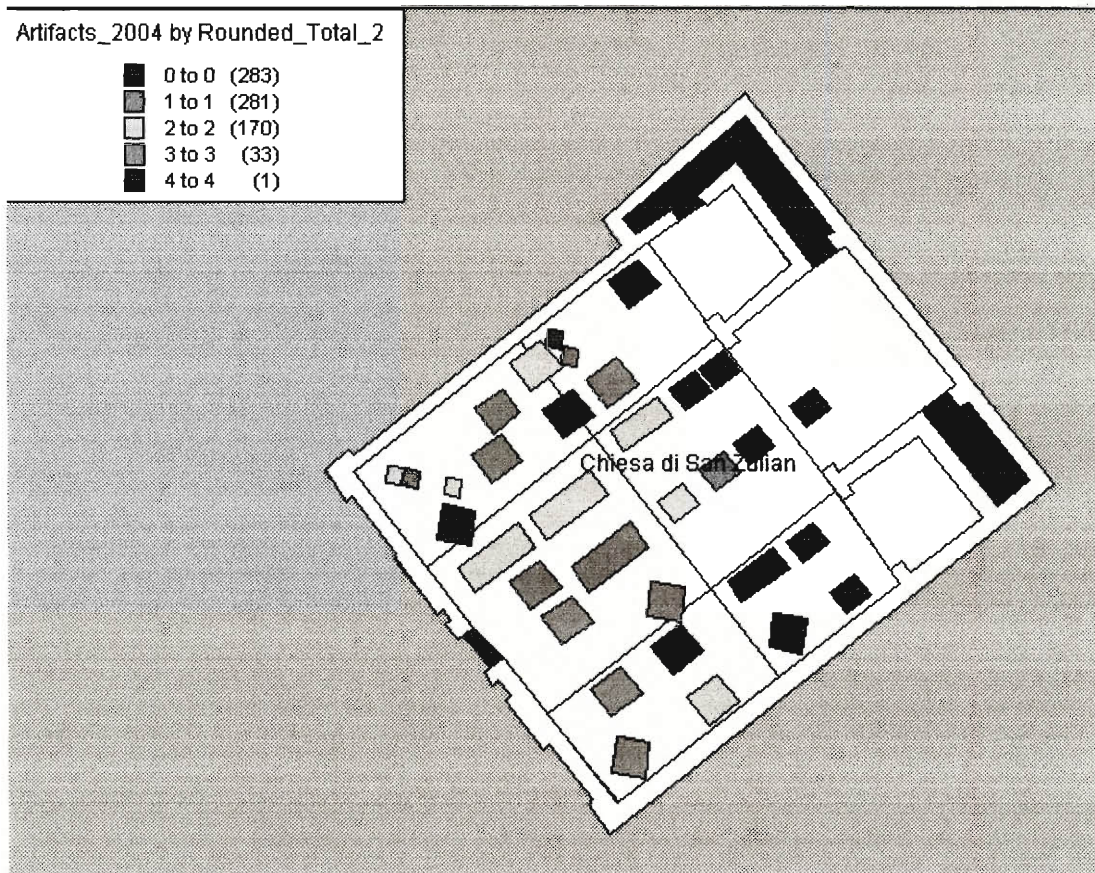
Figure 38: San Zulian Artifact Condition Assessment

In addition to displaying artifact damage for all of the churches collectively, we displayed the information for each artifact in each church individually. Displayed here is a MapInfo capture from Chiesa di San Zulian. The artifact information was collected and the assessment formula was used to determine the damage score on the 0-4 scale.

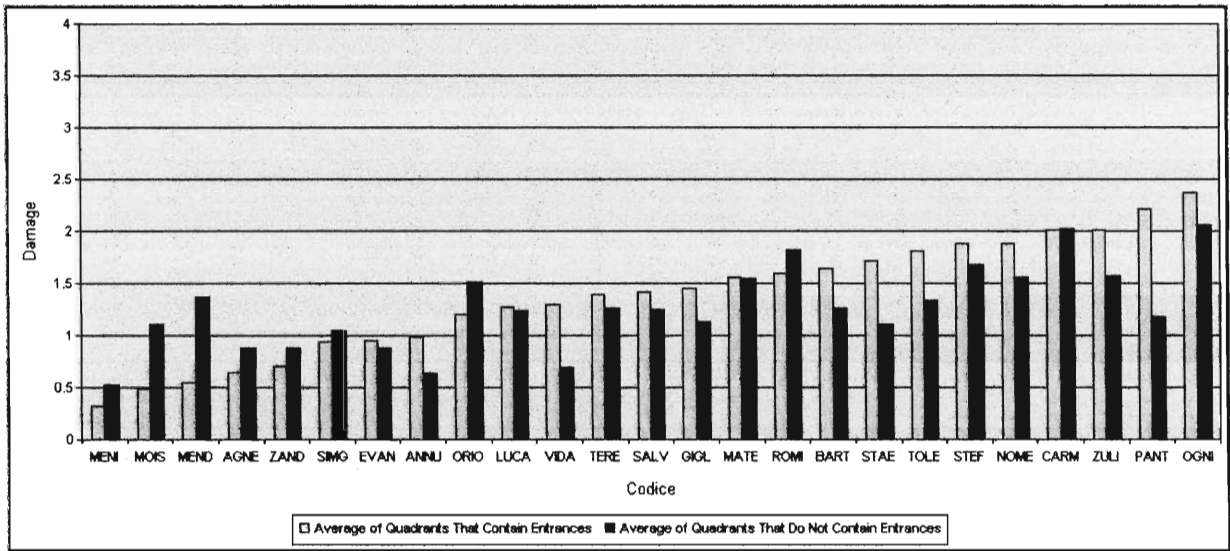
Figure 41: Quadrant Damage vs. Entrances

The first correlation we looked for was one between floor damage and the presence of entranceways. We expected that since the entrances of churches see the most foot traffic, they would be the most damaged section of the main floor. The bottleneck created by doorways, we supposed, would funnel traffic into the same spot which would eventually wear down the floor.

To visually see if there was a correlation, we graphed the average damage scores, for each church, of quadrants with entrances against the averages of quadrants without entrances. Figure 41 shows this result.

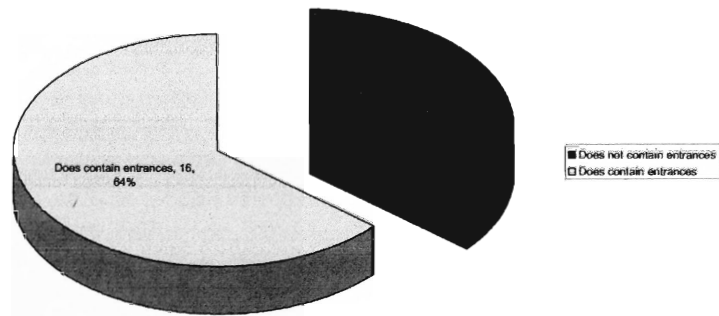
Figure 42: Percentages of Entrances

The following pie chart, Figure 42, shows the percentage of floor quadrants that have average damage scores that are higher than the same church's average. 64% of the churches our group surveyed have average quadrant damage in quadrants that contain entranceways that is higher than the quadrants that do not contain entrances. Analysis done shows a strong correlation between entranceways and floor damage.

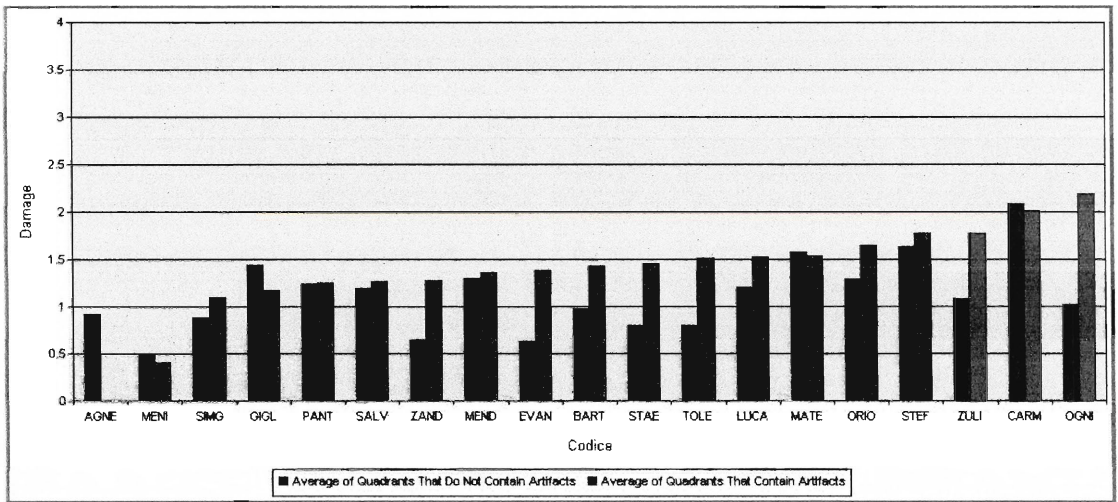
Figure 43: Quadrant Damage vs. Artifacts

Another supposed cause of damage was the presence of artifacts. We considered that since most artifact are tombstones, quadrants that contain artifacts normally have large holes under the floor, which is a structural issue that could manifest itself in the form of joint gaps and floor displacement. We also thought that since artifacts were normally placed in the floor after it was built, parts of the floor would need to be removed or cut into to place the artifact, which could further damage the floor.

On the other hand, we thought that since artifacts are tombstones, they may be considered sacred by the parishioners, and they may be avoided in the general walking path. Figure 43 shows the average damage scores of quadrants that contain artifacts compared to the averages of those quadrants that do not contain artifacts.

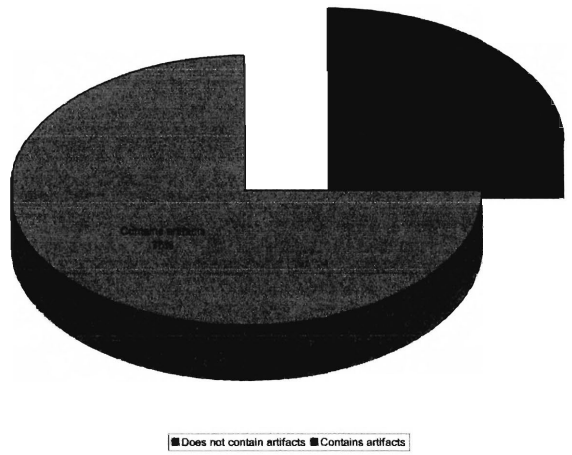
Figure 44: Percentage of damage based on artifacts

Figure 44 is a pie chart that shows the percentage of churches whose quadrants that contain artifacts have a higher average damage score than those that do not. 75% of the churches our group surveyed have average quadrant damage in quadrants that contain artifacts that is higher than the quadrants that do not contain artifacts. Our analysis supports a strong correlation between the presence of artifacts and quadrant damage.

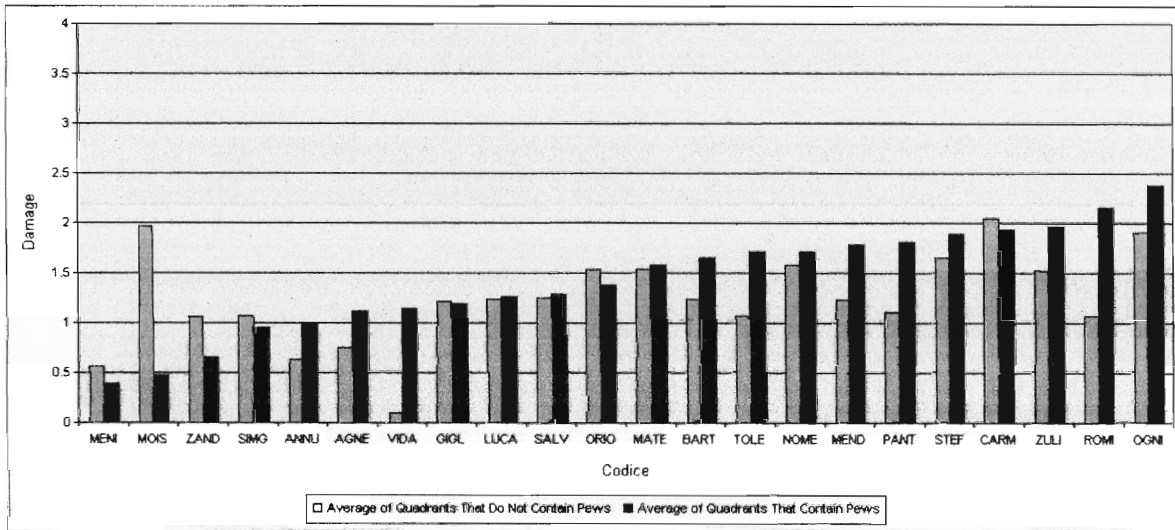
Figure 45: Quadrant Damage vs. Pews

Our group also supposed that there could be a correlation between pew placement and quadrant damage. We thought, based on information from past groups as well as recommendations from experts, that the rubbing of pews on the floor and the high traffic that quadrants with pews would see, that they would have higher damage than quadrants without pews.

We found that there was a strong correlation between damage and presence of pews. Figure 45 is a bar graph that shows the average damage of quadrants that contain pews compared to the averages of those that do not.

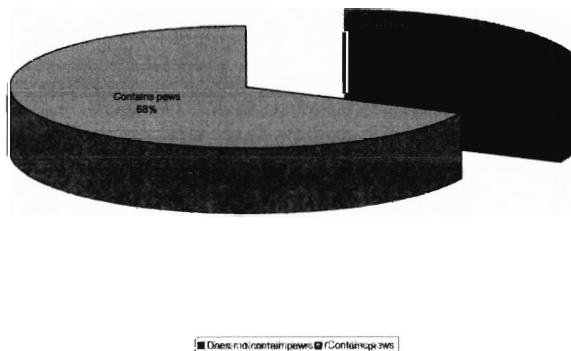
Figure 46: Percentages of damage based on pews

Figure 46 is a pie chart that shows the percentage of churches that have average quadrant damage of quadrants that contain pews that is higher than those that do not. 68% of the churches our group surveyed have average quadrant damage in quadrants that contain pews that is higher than the quadrants that do not contain pews. We concluded from this analysis that there is a correlation between pew placement and quadrant damage.

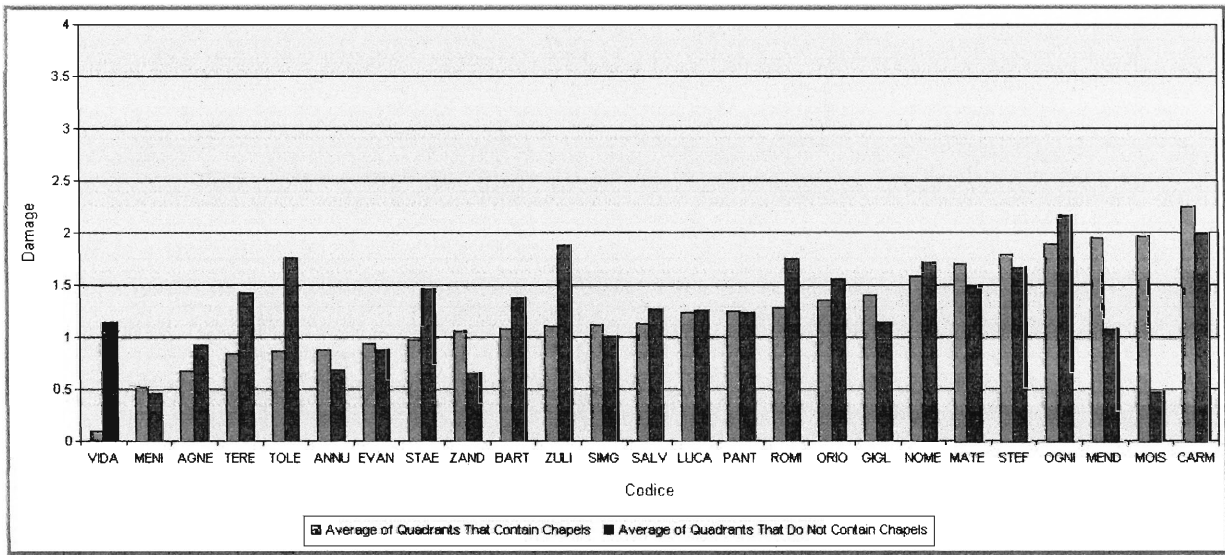
Figure 48: Quadrant Damage vs. Chapels

Figure 48 is a bar graph that shows the average damage of quadrants that contain chapels compared to those that do not.

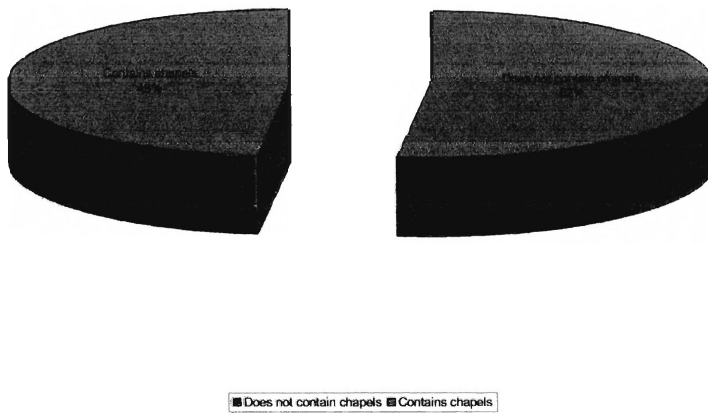
Figure 49: Percentages of damage based on chapels

Figure 49 is a pie chart that shows the percentage of churches that have higher average quadrant damage in quadrants that contain chapels compared to those that do not. 48% of the churches our group surveyed have average quadrant damage in quadrants that are chapels that is higher than the quadrants that are not chapels. Our analysis does not support a correlation between chapels and damage.

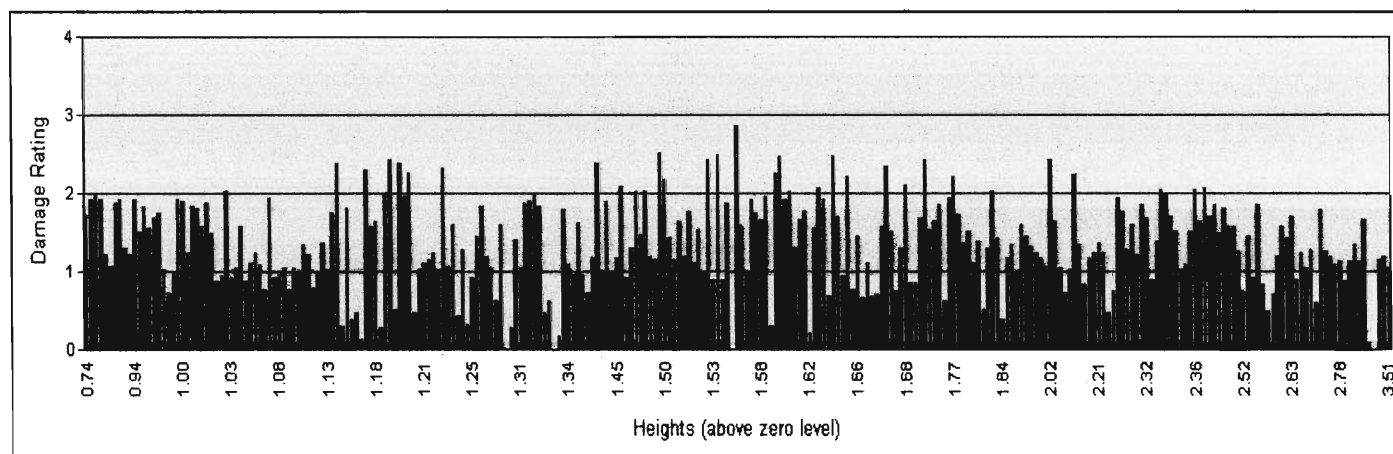
Figure 50: Floor Height vs. Damage

In order to determine if flooding played any role in the damage conditions seen in the floors of the churches our group studied, we compared the overall damage scores per quadrant on a height basis. In the event that flooding played a large role in creating damage, we expected to see a trend in our graph where as the quadrant heights increased, the overall damage would decrease. However, when the quadrant heights and damage conditions where directly compared, no such trend was seen. This can be seen Figure 50.

This discredits flooding as *the* main source of damage since the flooding would effect the lower floors first and more often, yet this is not reflected in the damage scores. Therefore, we do not consider flooding to be a critical source of damage to church floors although it is recognized as a contributing source.

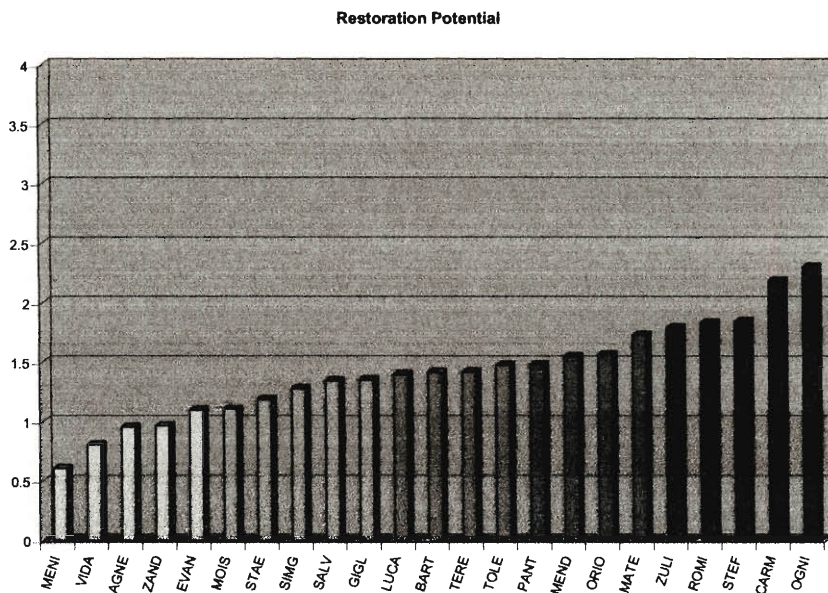
Figure 59: Restoration Potential by Church

The results from the restoration potential formula can be seen in Figure 59. The top five churches most in need of restoration are colored in red. These are the churches that we recommend the *Soprintendenza all'Archeologia* watch so that when they do get restored, they can be excavated at the same time.

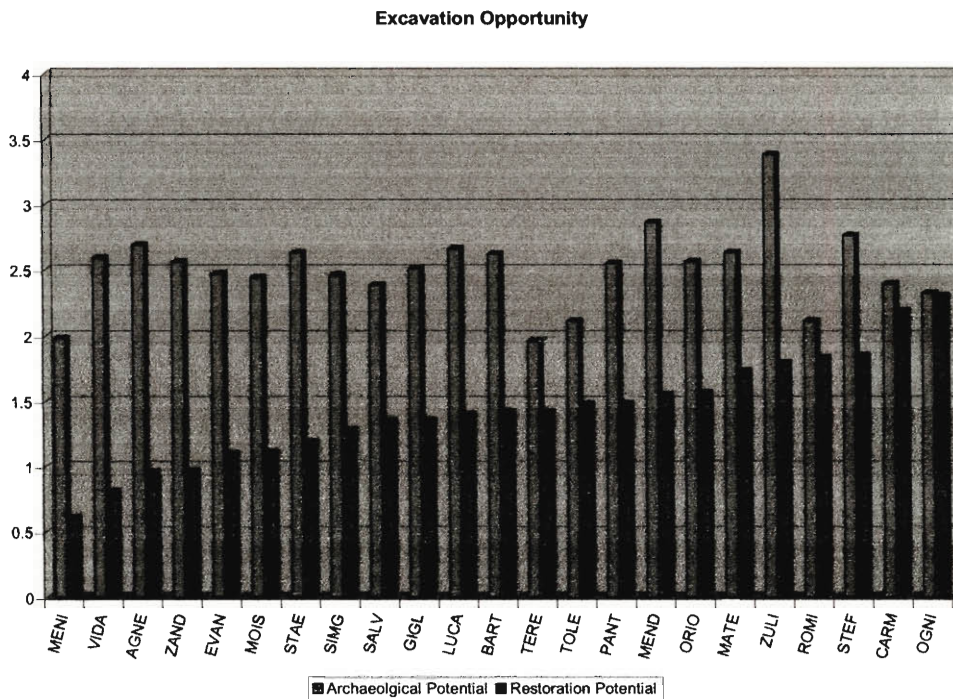
Figure 60: Archaeological Potential

This is a graph of the archaeological potential and restoration potential, which combine to form the excavation opportunity. The graph is sorted by the restoration potential because we feel that it is the most important factor since only churches that are being restored have the ability to be excavated. The churches with a low restoration potential and high archaeological potential that can be seen on the left side of the graph are lost archaeological opportunities. These churches have artifacts beneath their floors but they also have relatively new floors in good condition that do not have a very good chance of being restored in the near future. The churches on the right side of the graph are the churches we are recommending that the *Soprintendenza all'Archeologia* pay attention to for excavation opportunities. A map of the top five churches can be seen in Figure 61. The five churches that we recommend that the *Soprintendenza all'Archeologia* monitor are *Ognisanti*, *Santa Maria dei Carmini*, *San Stefano*, *San Zulian*, and *Eremitane*.

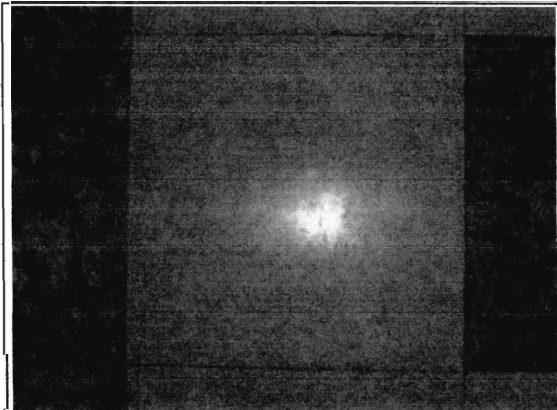
Figure 63: Crack severity 0

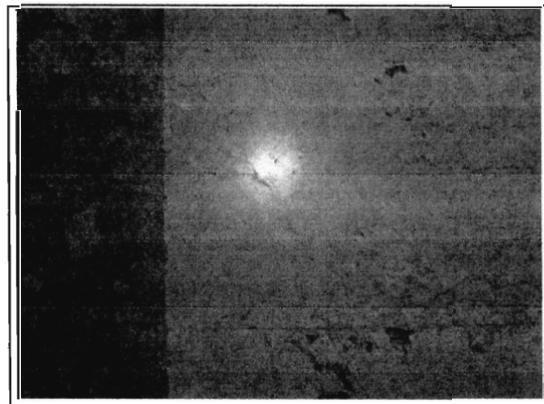
Figure 62: Crack Severity 1

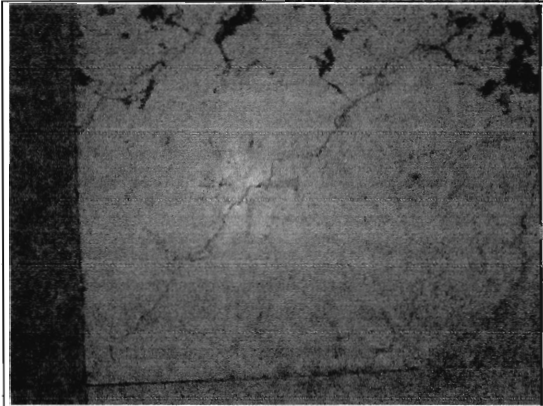
Figure 64: Crack severity 2

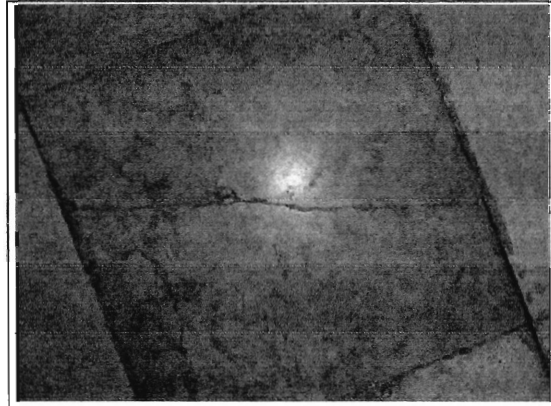
Figure 65: Crack severity 3

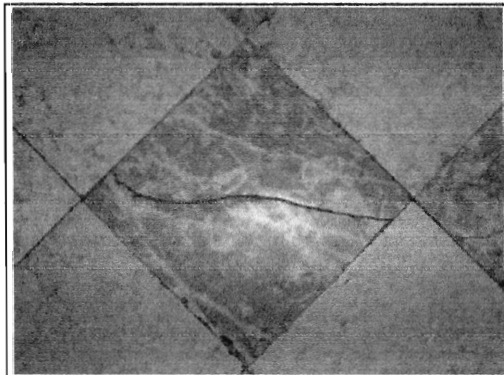
Figure 66: Crack severity 4

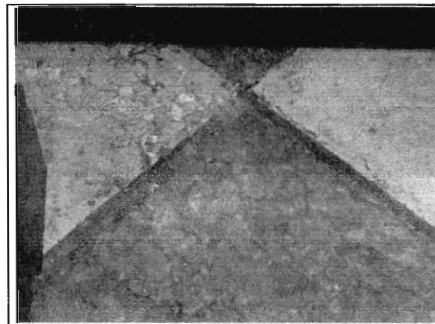
Joint gaps are larger than usual separations between floor tiles, either vertically or horizontally. The following table shows the 0-4 point scale on which the severity of the joint gaps were measured.

Figure 67: Example of a Joint Gap

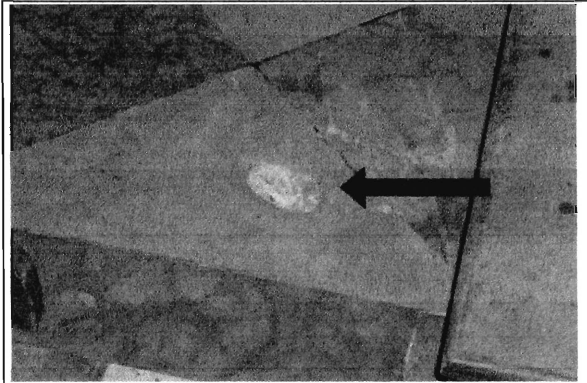
Holes are considered as an area of missing floor at least 1.5 cm deep. The following table shows the 0-4 point scale on which the severity of the holes was measured.

Figure 68: Example of a Hole

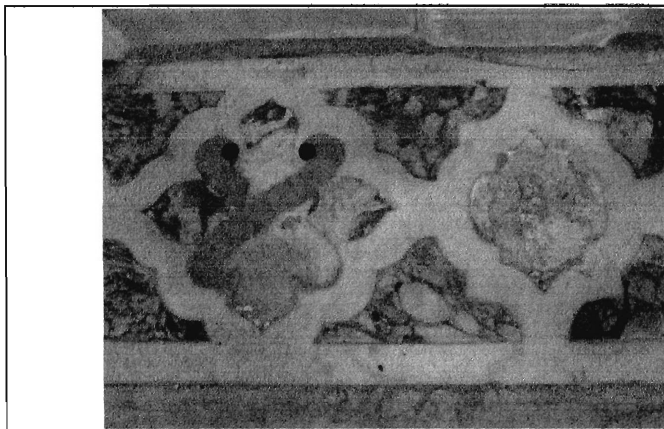
Floor detachment is considered as any piece of a tile missing or an entire tile itself. The team recorded the percentage of each floor quadrant suffering from detachment.

Figure 69: Example of Floor Detachment

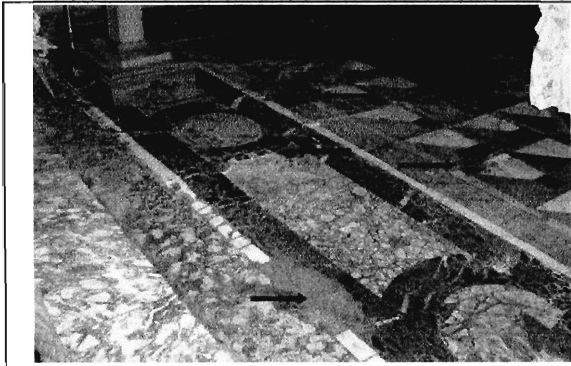
Floor replacement is considered when any part of the floor has been replaced with new tiles or other new materials. The team recorded the percentage of each floor quadrant suffering from replacement.

Figure 70: Example of Floor Replacement

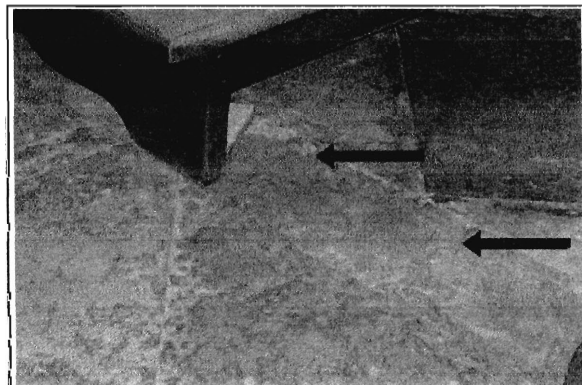
Surface damage has many causes ranging from foot traffic, flooding, and pews rubbing the floors among other things. The three types of surface damage that our team inspected for are wearing and fading, pitting, and discoloration. The following table shows the 0-4 point scale on which the severity of the surface damage was measured.

Figure 71: Example of Surface Damage
