An Evaluation of Nantucket's Town Facilities

December 18, 2014

An Interactive Qualifying Project
submitted to the Faculty of
WORCESTER POLYTECHNIC INSTITUTE
in partial fulfillment of the requirements for the
degree of Bachelor of Science

Gregg Tivnan
Nantucket Town Manager's Office

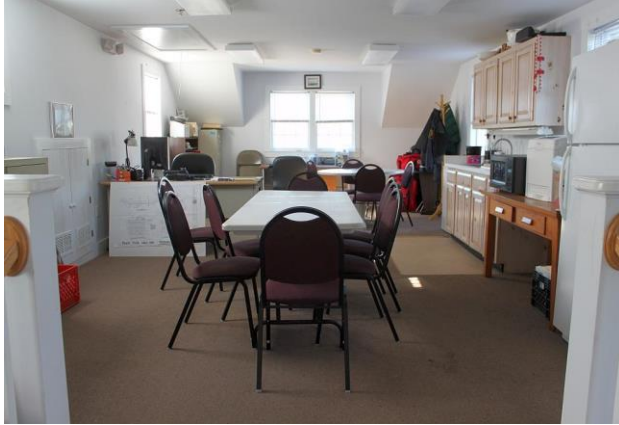
Aside from parking and accessibility issues, many of the town facilities also lack adequate communal and meeting spaces. This is a major inconvenience for town employees and their associates, and often hinders them from conducting comfortable, productive meetings. One such facility with this issue is the Harbormaster Building. According to the Harbormaster, summer staff meetings include up to 50 people, but the facility's conference room can seat only 15 (see Figure 21). Across the road at the Finance Department, the only communal area is a small table in the corner of an employee's office; at best, only four people can be seated at this table (see Figure 22). Similar issues exist at the Town Building, Visitor Services, and the DPW Administrative Building.

Figure 21: Meeting space at Harbormaster Building

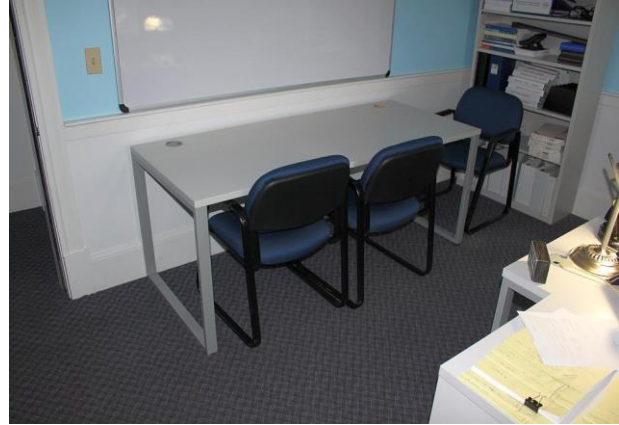
Figure 22: Meeting space at Finance Building

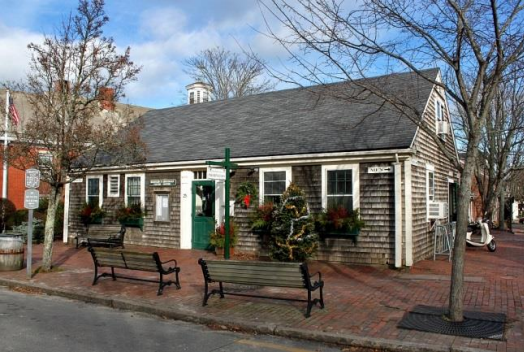
Figure 50: Visitor Services

Nantucket's Visitor Services building, located at 25 Federal Street, was constructed in 1950 and has a wood frame. The building serves as a primary source of island information for newcomers and people who are unfamiliar with all of the island's offerings. Important aspects of this facility that we identified include:

The Level II facilities had less severe issues which we recommend be addressed in the next 3-5 years. Visitor Services needs more energy efficient, handicap accessible doors, as well as interior doors to increase privacy and control noise, better communal space, and a more

efficient heating system to prevent pipe freezing. The DPW needs more garage storage space for equipment and entirely new sheds. Unheated portable schoolhouses are currently being used as sheds and employee communal areas. The Children's Beach and Concession should install a new metal playground to avoid splinter hazards, as well as more adequate lighting and security cameras to discourage loitering. We recommend that the Harbormaster Building bathrooms be upgraded and/or rebuilt. These bathrooms are used by hundreds of people per day in the summer months, but are currently not aesthetically pleasing.

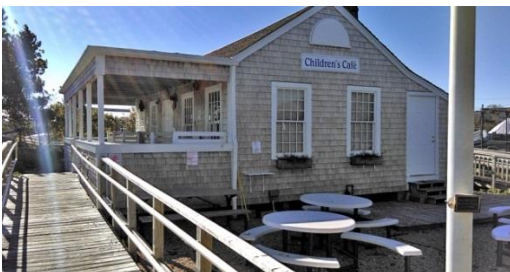
Figure 52: Children's Beach

Children's Beach and Concession, located at 15 Harborview Way, was constructed in 1970 and has a wood frame. This facility provides food, beverages, bathrooms, and seating for those using Children's Beach, or the facility's playground equipment, stage, or grass area. The primary issues of concern that we identified include:

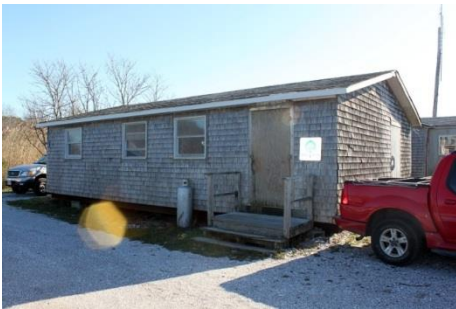
Figure 53: DPW Sheds

The DPW's sheds, located on DPW property at 188 Madaket Road, were built in 1978. These wood-framed buildings, some of which are portable, serve as space for both storage and employee functions. The primary issues of concern that we identified include:

On the other side of town, the DPW Sheds and Garages also need to be repaired (or replaced) and expanded in 3-5 years. Small improvements, like new doors and heated work areas, will help employees to do their work in greater comfort. Garages need to be expanded or rebuilt to better house vehicle repair equipment, and to house DPW trucks and heavy equipment that are currently stored outside, exposed to harsh weather. If these trucks and

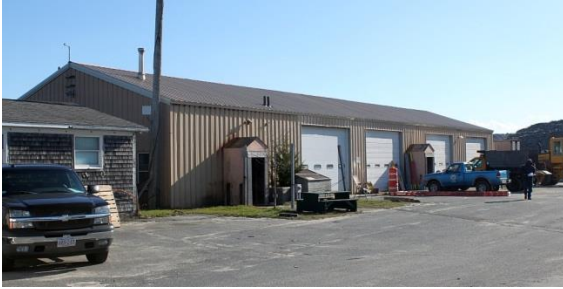
Figure 55: DPW Garages

The DPW's garages, located on DPW property at 188 Madaket Road, were built in 1978, with the exception of the Fleet Maintenance Garage being built in 2001. These garages, varying between wood and steel frames, store DPW vehicles, equipment, and serve as maintenance areas for both of these. Important aspects of this facility that we identified include:

- In generally good condition from a structural standpoint;
- Garages do not provide adequate space to house all of the town's equipment - multiple trucks and pieces of equipment are left outside and exposed to weather (see Figure 56 and 57);
- Inadequate storage space for spare parts for equipment; and,
- Inadequate space to house equipment needed to repair vehicles - it is time-inefficient to not have all equipment on hand, seeing as it already takes, on average, 4-6 weeks for repair requests to get through the procurement process.

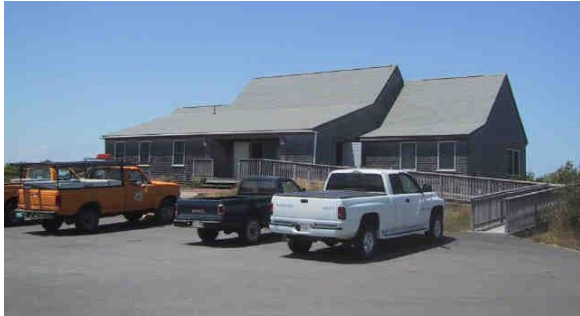
Figure 66: DPW Administration

The DPW's Administrative Building, located on DPW property at 188 Madaket Road, was constructed in 1998 and consists of a wood frame. This building serves as the administrative center for the DPW and is located next to the island's landfill. Important aspects of this facility that we identified include:

- Built more recently than many of the town's other facilities;
- Structure is in overall good condition;
- Cathedral ceiling in main entrance causes issues with heating - space heaters are often used to keep employees warm;
- Sufficient office space for the current staff in the building, however, space will be very tight should the facility reach its intended capacity;
- Oil and diesel storage tanks on the property are 18 years old - will need to be replaced within the next two years;
- Building's close proximity to other DPW buildings and landfill is convenient for employees; and,
- One leak area in the ceiling of the DPW Director's office due to a bad seal where two sections of the building, having two different heights, conjoin.

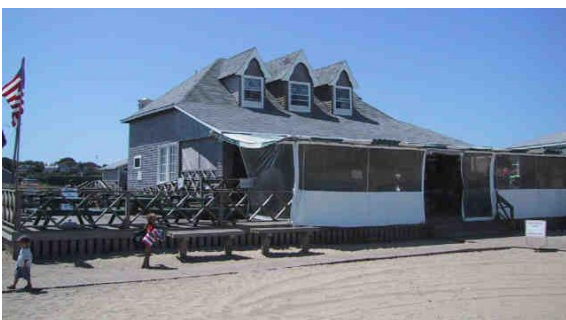
Figure 67: Jetties Beach Concession

Jetties Beach Concession, located at 4 Bathing Beach Road, was constructed in 1890 and consists of a wood frame. This facility provides food, beverages, bathrooms, and seating for those using Jetties Beach. The building also hosts a bar on its water-facing side. Important aspects of the facility that we identified include:

- Building has very few issues and is in generally good condition;
- Some railings are showing signs of wear, but are still in fair condition; and,
- Kitchen ceiling is showing signs of wear and aging - water stains, grease, and mold.

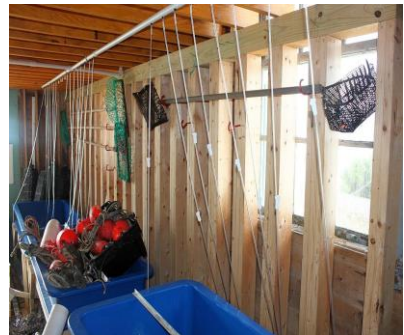
Figure 74: Rebuilt wall frame in Shellfish Lab

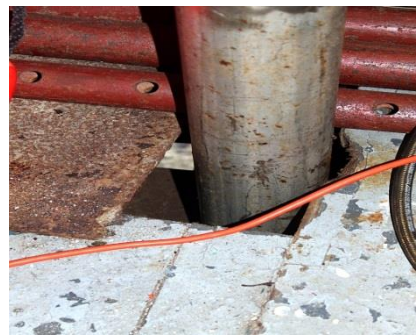
Figure 80: Gap around pillar
