ASSESSING WILDFIRE RISK TO THE BUILT ENVIRONMENT AT THE ESTES PARK YMCA

Sponsor:
The Young Men's Christian Association (YMCA) of the Rockies

May 3, 2022

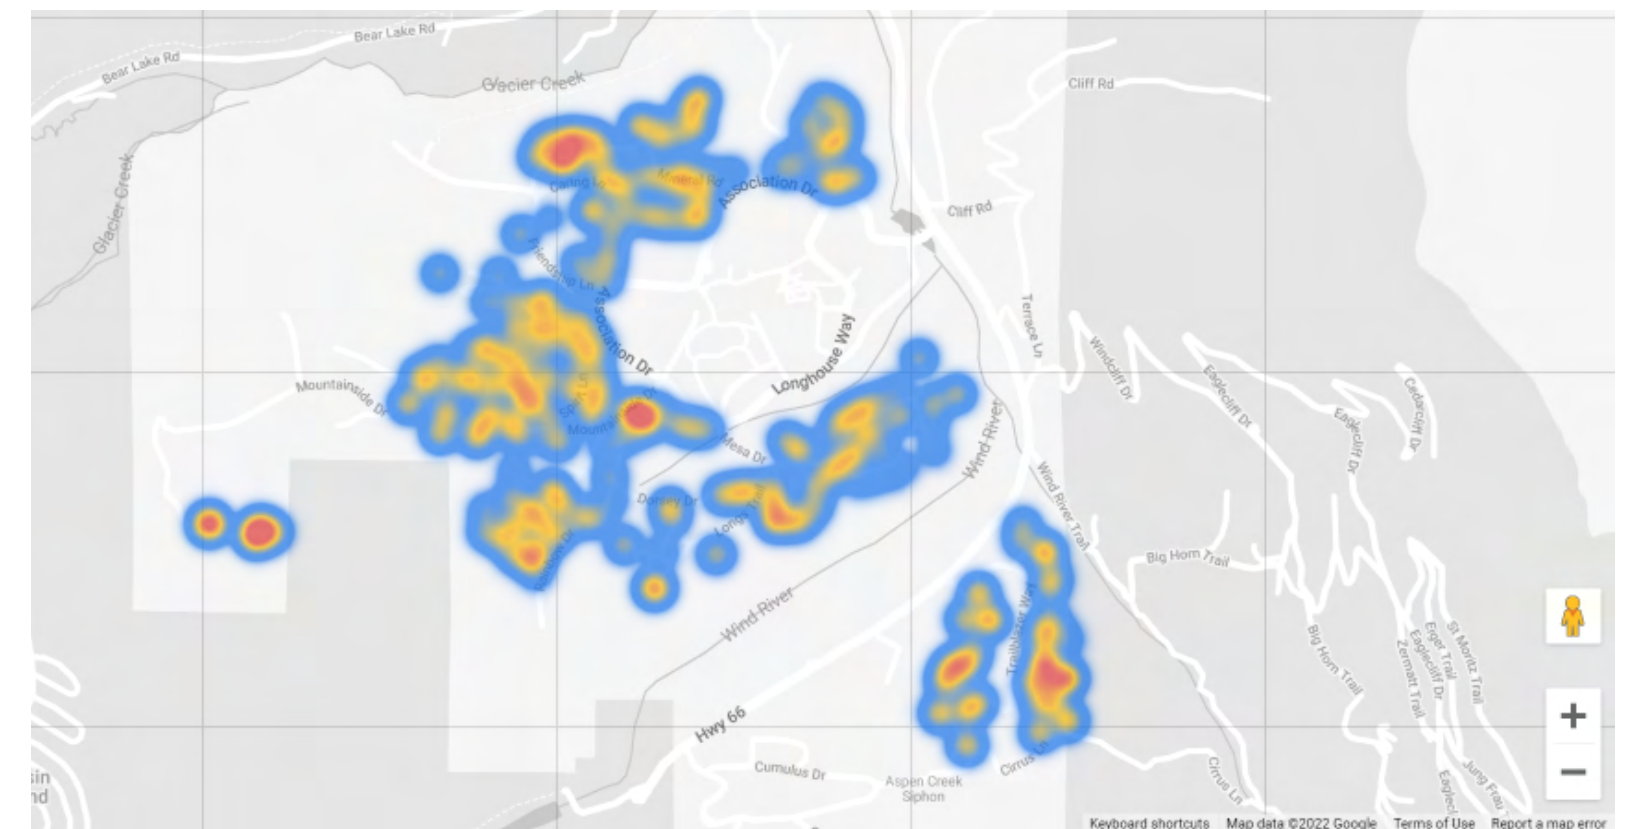
Once the vulnerability of each cabin was calculated, we determined that the average cabin is vulnerable to wildfire but not extremely so. The most vulnerable cabins had scores above 50 points, often caused by combustible siding and decking materials and plant proximity within the cabin's defensible space. The most vulnerable buildings were Bison (114 points) and the Mountainside Lodge (133 points), located at the very end of Mountainside Drive. The least vulnerable cabins were the newest ones, since they were built using more fire-resistant materials and had less damage. These cabins were often located on Mesa Drive and Association Road. The lowest cabin score was 5, belonging to Ponderosa cabin.

Figure D: Heat map of campus showing areas with highest cabin vulnerability.

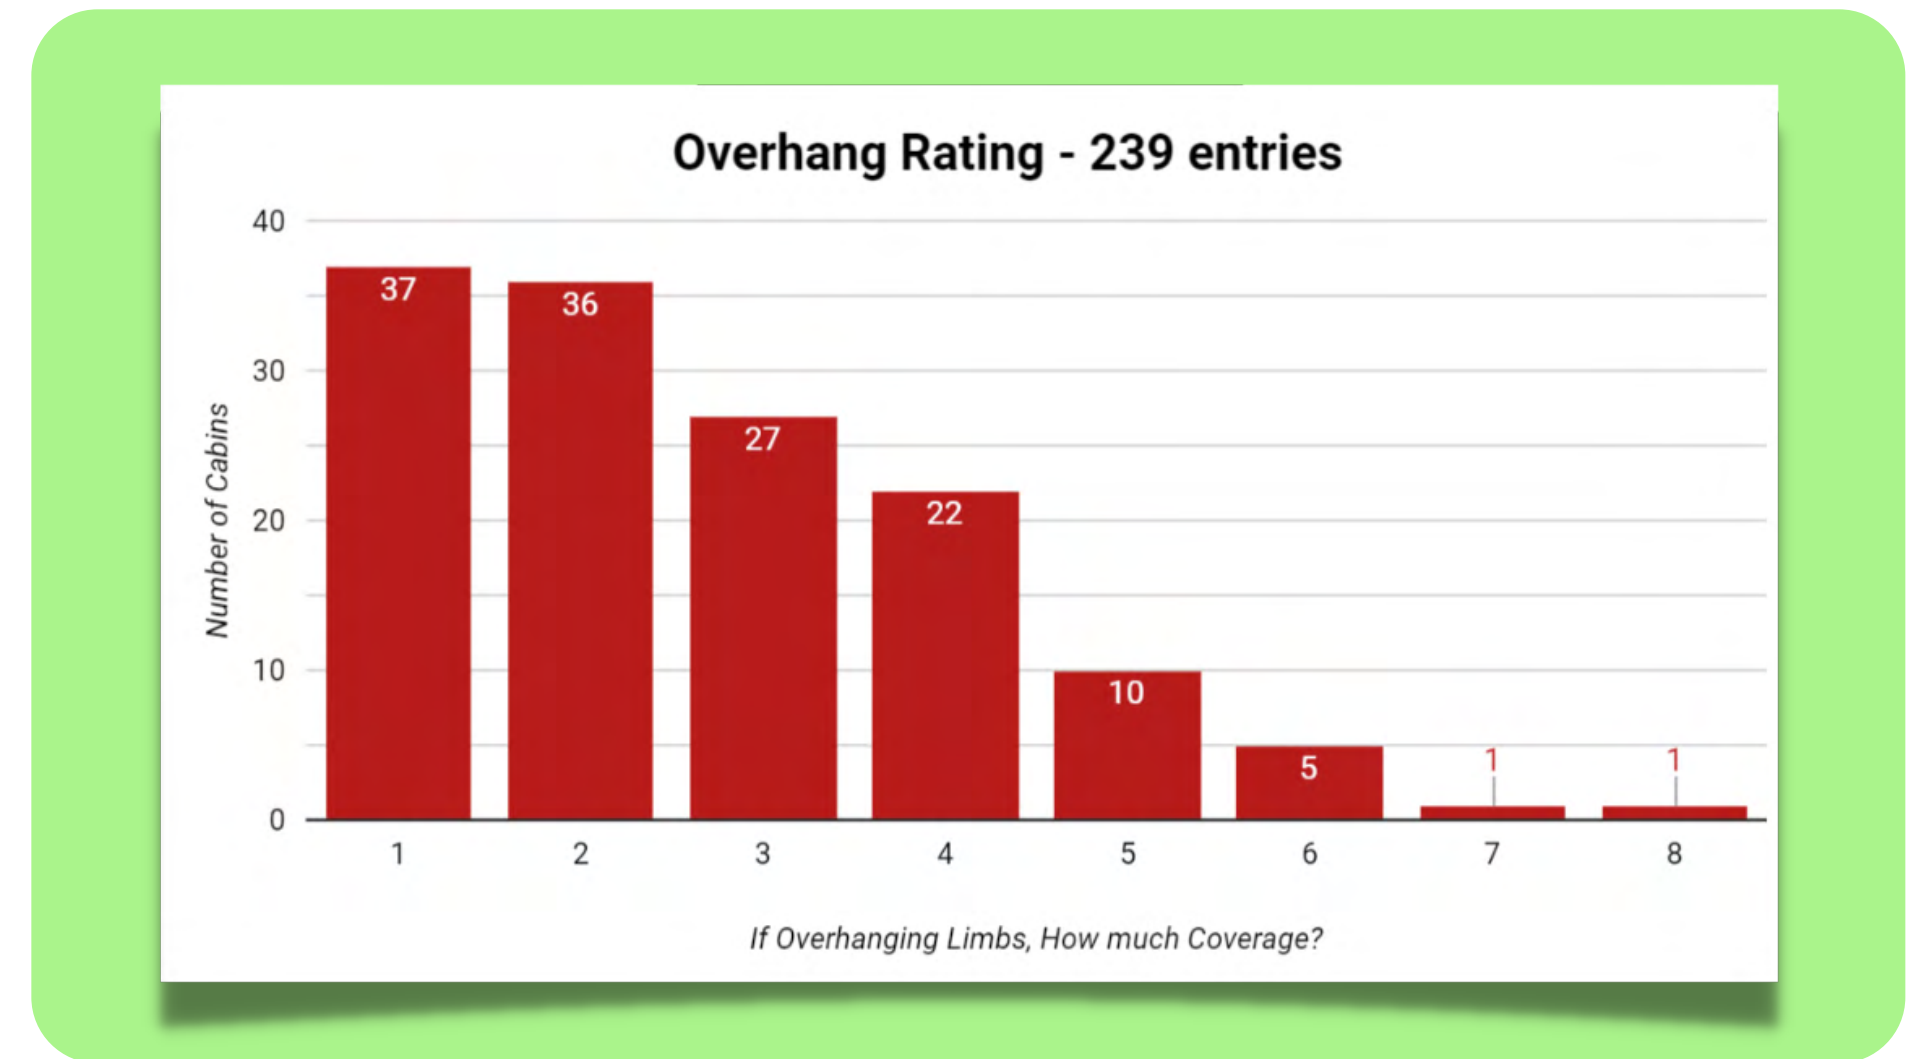
Figure 16: Bar chart of Overhang Rating of the 239 cabins assessed.

We found that 56% of the cabins had some form of overhang. Overhanging limbs mean that they are directly above the roof. Figure 16 consists of a bar chart displaying the rating that was given for any cabins with overhang present. When overhang was present, we rated it on a scale from 1-10 based on what percentage of the roof was covered. A rating of 1 would indicate 10% coverage, while a 10 would mean there were branches above the entire roof (100%).

Overhang can be dangerous because it can increase the risk of flames from tree canopies spreading to buildings. When tree overhang is present, the branch above a roof provides a ladder-like bridge for the flames to spread to the building, providing an entirely new fuel source for the fire to burn. We rated the majority of overhang situations as either a 1, 2, or 3, which means that 10-30% of the roof was covered by trees. Examples of what we rated a 1, 3, and 7 can be found in figure 17 (see page 29).

Although a large majority of the overhang was not extreme, the 17% of cabins with an overhang score of 4 or higher should not be overlooked. These cabins typically had branches touching the roofs in multiple places or had multiple trees with large overhanging limbs. Also, through our cabin assessment, we found multiple instances where the tree trunk was in direct contact with the cabin's siding or roof as seen in Figure 18.

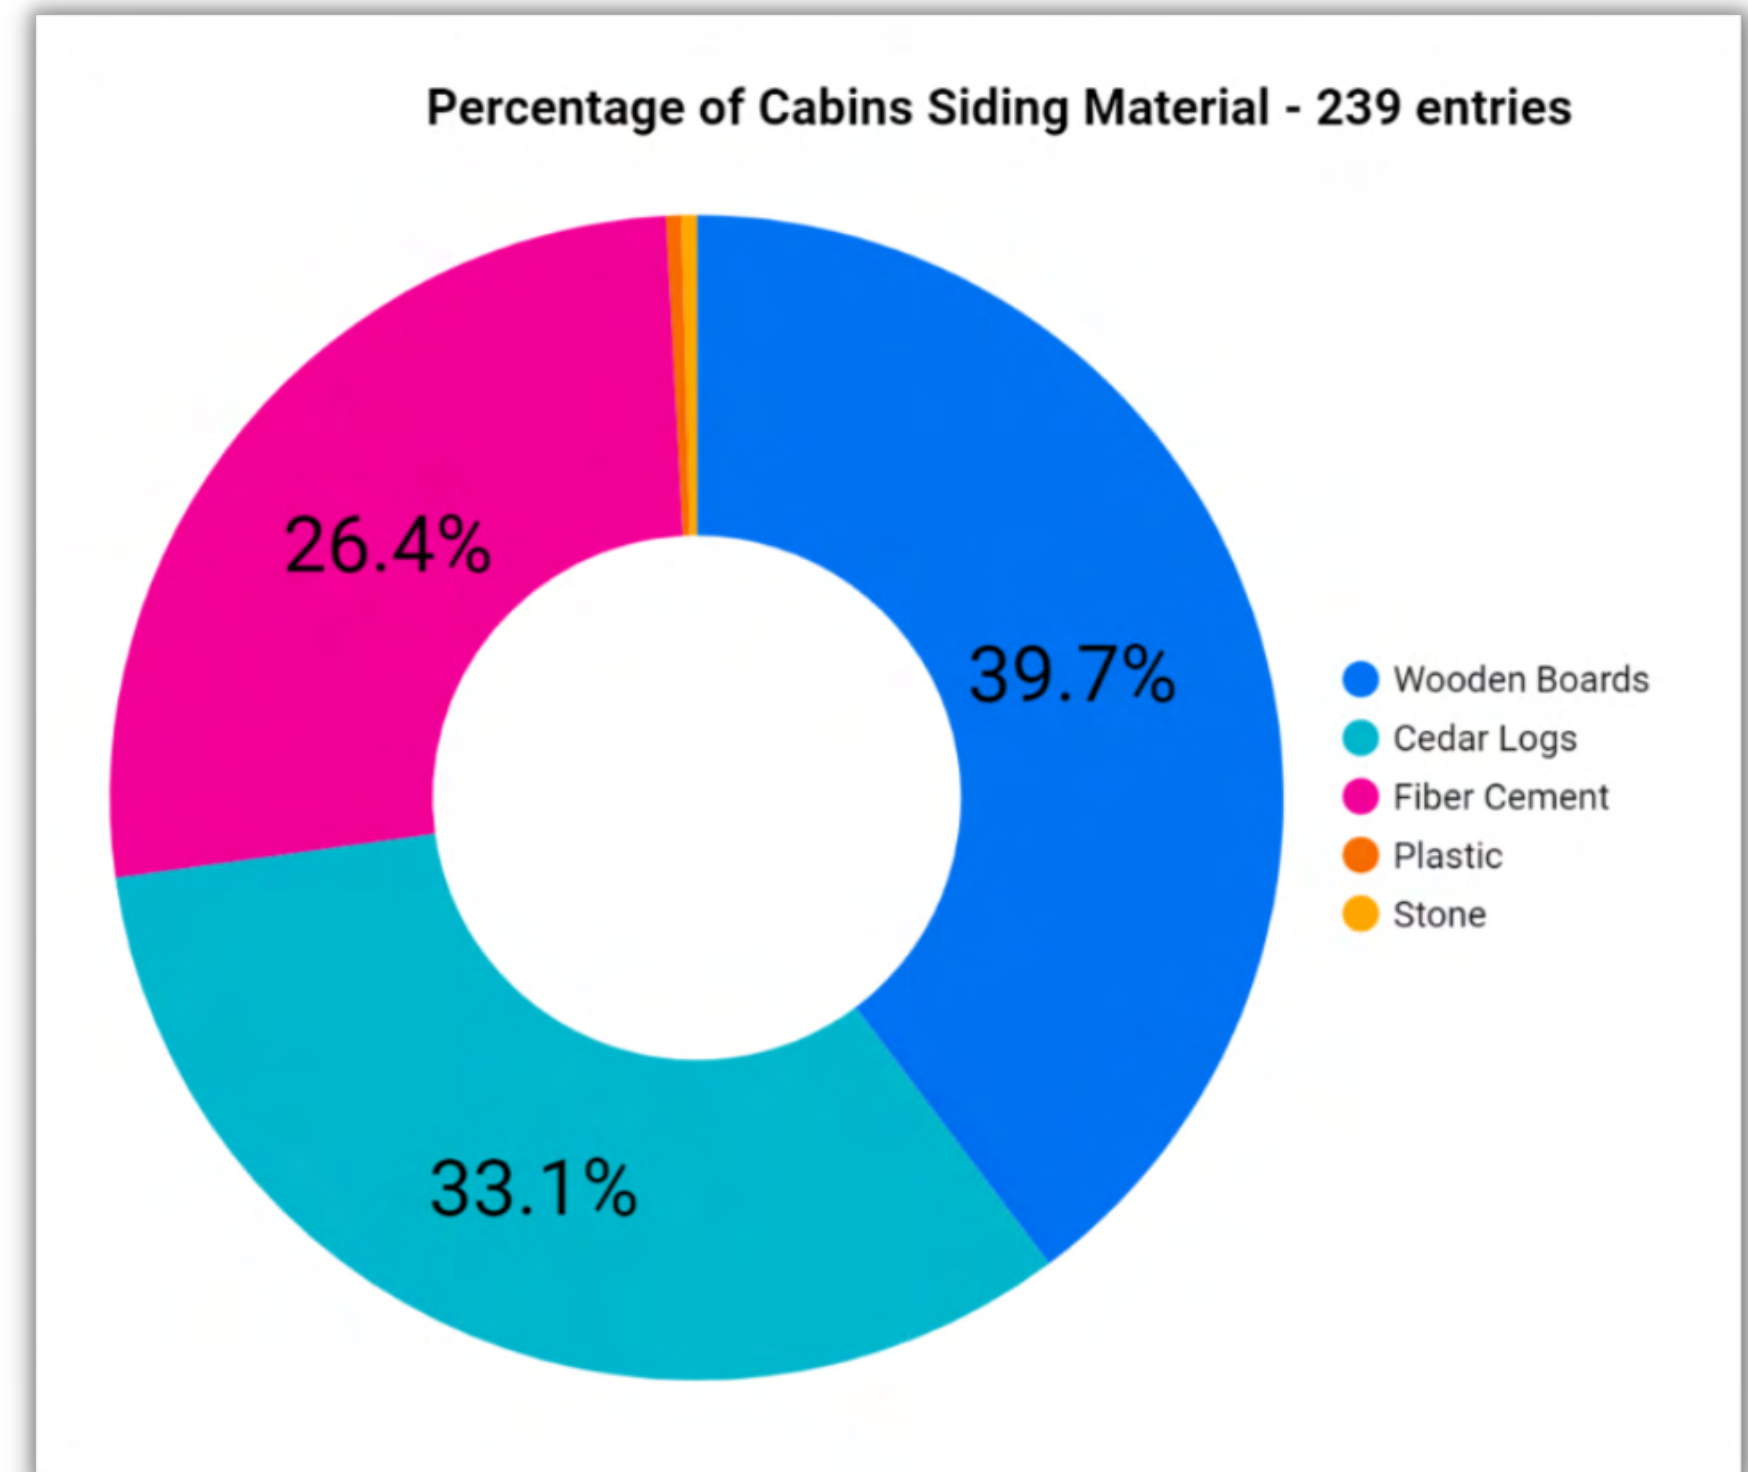
Figure 23: Siding materials on the 239 assessed buildings on the YMCA campus.

Figure 23 (see page 36) shows that 26.4% of the cabin sidings were constructed of fire-resistant fiber-cement boards, which have a Class A Fire rating according to the Flame Spread Index. The 33.1% of cabins with eastern white pine log siding are less fire-resistant, with a Class B Fire rating, while the other 39.7% of cabins have plank plywood siding with a Class C Fire rating. This means that only around a quarter of the cabins on campus are as well protected as they can be in terms of fire-resistant siding.

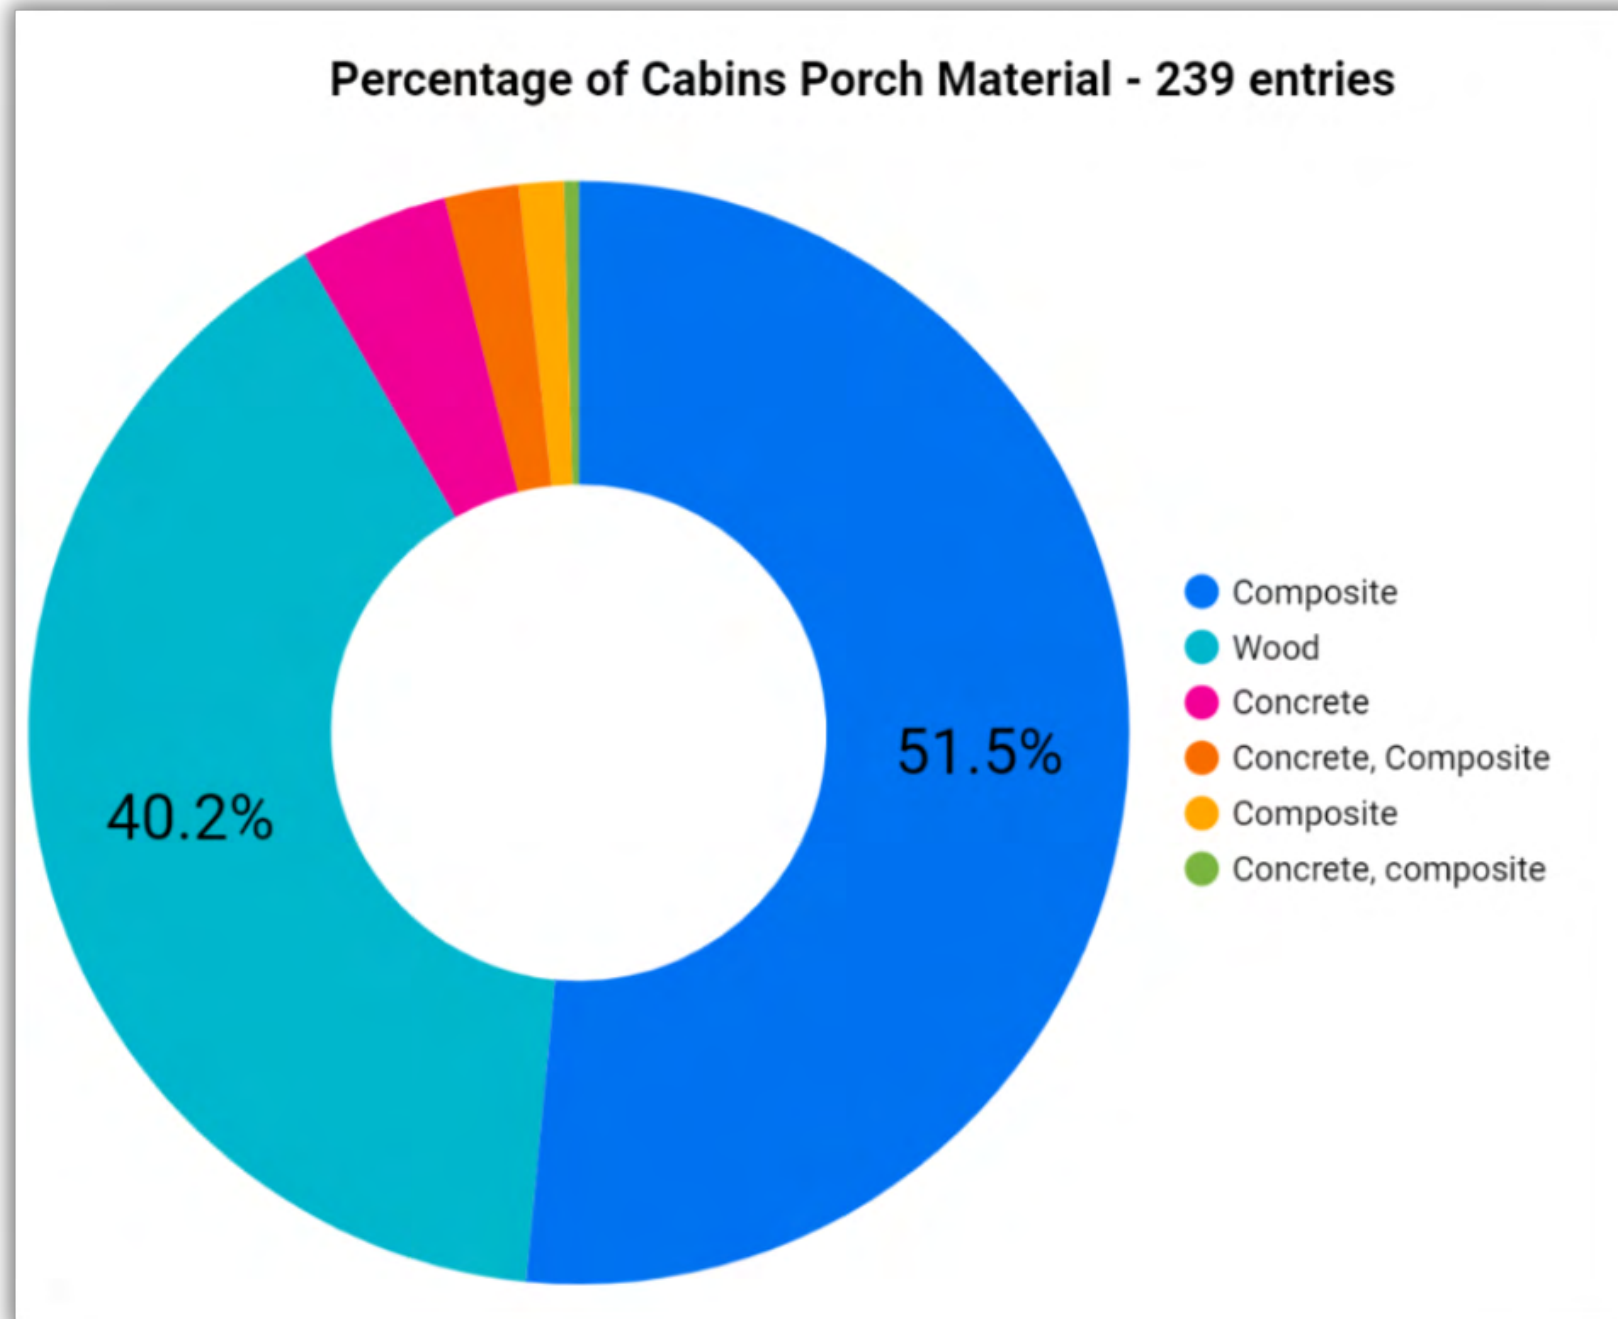
Figure 25: Pie chart of porch materials on the 239 assessed buildings on the YMCA campus.

Figure 25 shows a pie chart of the different porch materials and types of the 239 campus buildings assessed. This included 232 cabins and a few miscellaneous lodges and buildings. Of the 239 buildings, over half (54.9%) of them had a porch/deck made of composite decking, while more than a third (37.7%) were constructed out of wood. The remainder were made of combinations of different materials, such as cement decks with composite railings among others.

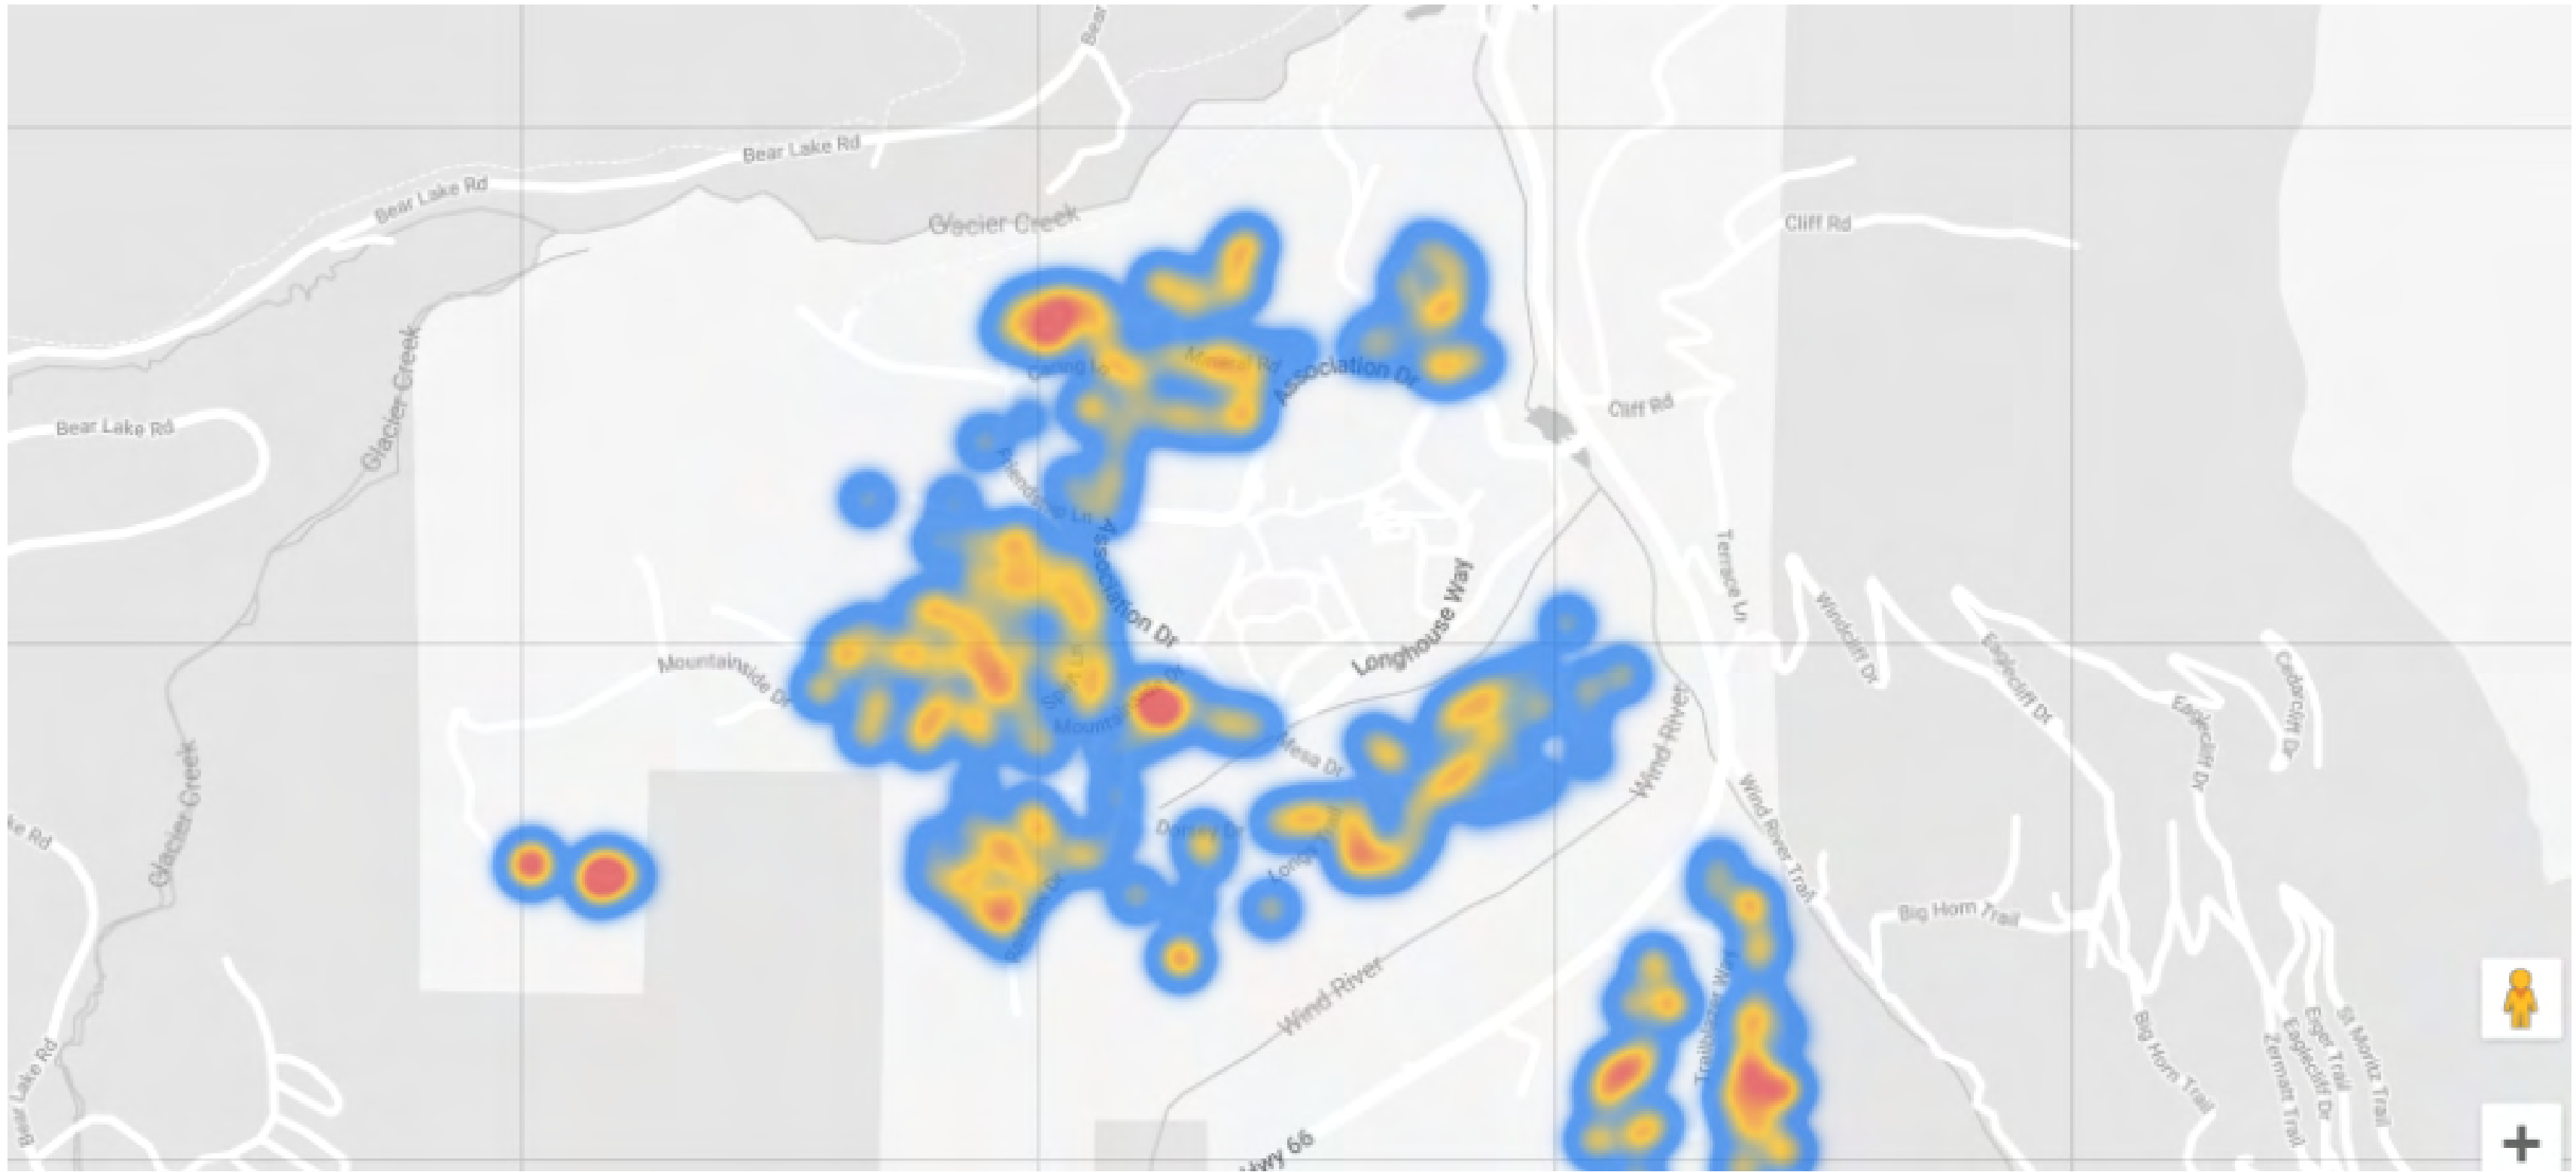
Figure 27: Heat map displaying areas with highest risk cabins.

To spatially analyze the overall most vulnerable areas on campus, we applied the database scores with their area markers to create a heat map, which can be seen in Figure 27. This map shows where the largest clusters of high-risk cabins are, so the YMCA may determine where to first apply mitigation tactics. On the map, the areas highlighted in red are the places with the most high-risk cabins, the yellow areas with the cabins at medium risk, and the blue areas are the places with lowest risk cabins. Based on this map, we determined the most at risk areas of campus to be the very top of Mountainside Dr., The Summit, Samson Ct., and Friendship Ln.
