Products Liability

An Interactive Qualifying Project

WORCESTER POLYTECHNIC INSTITUTE

Date: May 6, 1997

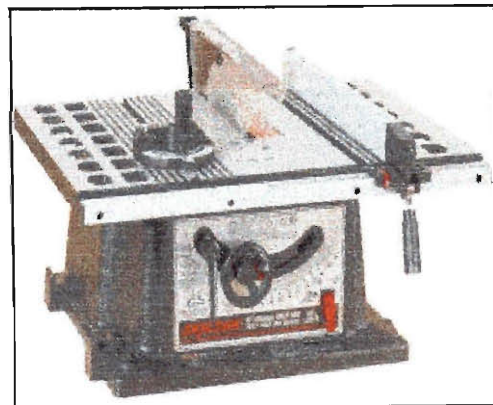
10" Skil Saw (S-B Power Tool Company)

As you can see from the previous picture of the tool, it has a see through blade guard which is intended to protect from injury. Behind the guard is a pronged anti-kick back device which protects the operator from accidental kickbacks. The following is a detailed description of the machine. (Also supplied by the S-P Power Tool Company)

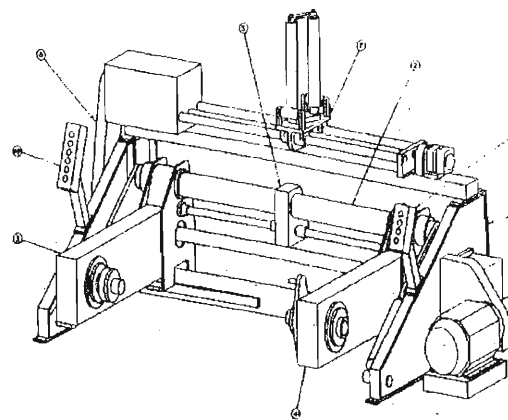
Schematic drawing of MGS take-up rewind machine.

Encore instructed Mr. Lopez to perform an unsafe process, in an unsafe manner which he was not properly trained or warned about. Also that there was no barriers or Spanish warning signs on the machine and they were not in compliance with the safety standards for guarding on the machine. Finally an interlocking system was bypassed on the machine in order to perform the scrapping process which they were warned about a year before. The plaintiff claimed that MGS had a reasonably dangerous design of this machine that lacked safety devices. Safety devices such as a deadman switch and more effective emergency brakes. They also did not warn about unspooling wire onto the floor and that they did not have a safer design alternative for the unspooling process. The complaint against EWC leasing was that they leased a defective product and there were no warnings on the machine in Spanish.
