Brutalist Building Retrofit

A Major Qualifying Project
Submitted to the Faculty
of the
WORCESTER POLYTECHNIC INSTITUTE
in partial fulfillment of the requirements for the
Degrees of Bachelor of Science in Architectural Engineering

March 23, 2018

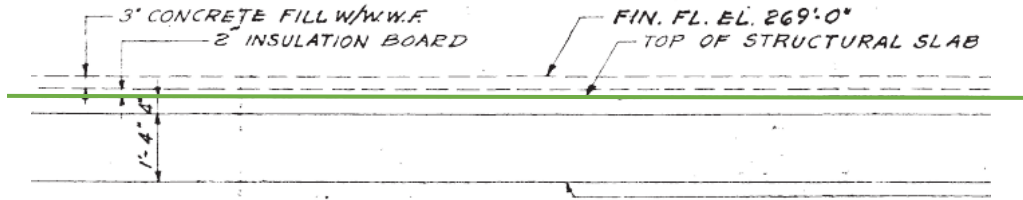
Figure 33: Cross-Section C1-1 showing the exterior (below the green line) and interior (above the green line) layers of the Art Studio floor.

We observed 18 horizontal cracks running North to South along the underside of the art studio bridge and along the interior of the art studio (Table 1 **Error! Reference source not found.**). The horizontal cracks observed on the interior and exterior are not the same crack due to the following reasons. First, we observed 5-10 interior cracks per art studio room as well as multiple long interior cracks running along the hallway as shown in Table 1.2. We observed and recorded 22 exterior cracks as shown in Appendix D. The exterior cracks were much more spread out along the 646 ft Art Studio Bridge and did not extend as long. Overall, we observed more interior cracks than exterior cracks. Second, according to the drawings, there is a layer of insulation between the exterior concrete ribs and the

interior concrete floor slab, meaning that the interior concrete and exterior concrete are two separate pours (Figure 33Error! Reference source not found.).

The Cross-Section show that there are two different concrete members separated by the green line that represents the top of the exterior concrete slab. The horizontal cracks on the exterior and interior do not match up. This is an important observation because it illustrates that the exterior rib cracks do not extend through the entire width of the concrete and does not indicate a localized structural failure.

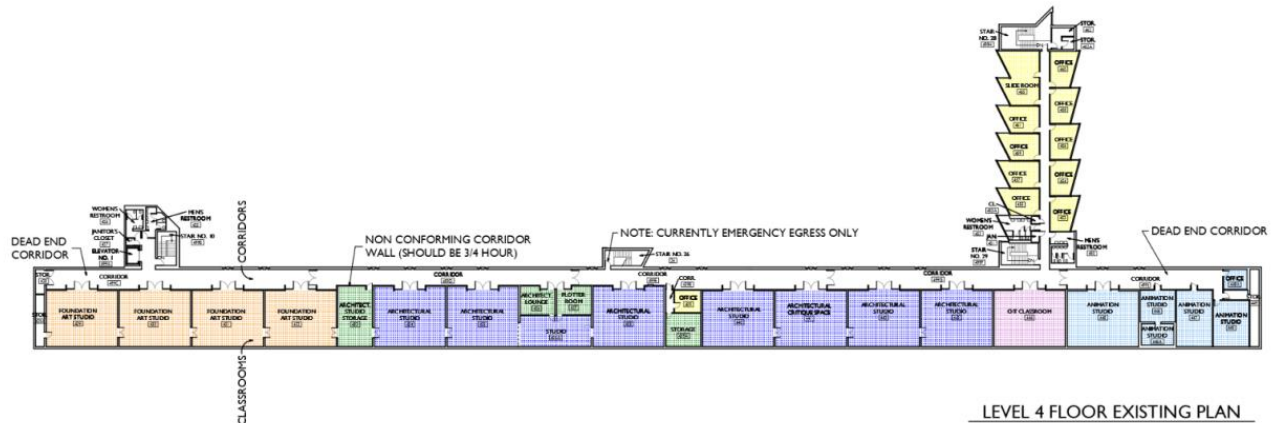
Figure 35: Art Studio Building fourth floor plan.

We also observed efflorescence during the visual interior inspection of the art studio spaces as shown in Table 4. The interior consists of a long hallway expanding from one end of the bridge to the

other with art studio spaces on the South side. Staircases, restrooms, and offices branch off the main hallway as shown in the 2011 Floor Plan.⁴⁴ (Figure 35).

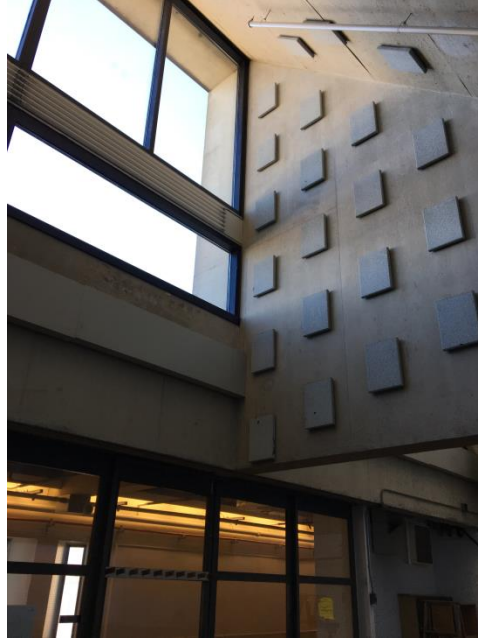
Figure 36: North-facing window and acoustic panels inside one of the studios.

Many of the mechanical systems are exposed, and the floor is polished concrete. The North wall of the building is painted concrete with small windows, and it borders the hallway. The wall that separates the hallway and the studios is also painted concrete, and the walls separating the studios are drywall. The South wall is concrete covered in panels used as pin boards. Looking up, the ceiling above the hallway is flat exposed concrete. In the studios, the ceiling slopes up to large North-facing windows and small South-facing windows. We observed that the ceiling and glazing in the studios are supported by beams perpendicular to the exterior walls, but do not appear to have any supports other than those. The ceiling is exposed concrete and has acoustic panels attached to it (See Figure 36 **Error! Reference source not found.**). The ceiling and floor show cracking and staining.

In conclusion, there are no major cracks, spalls, or deteriorations that suggest the structure is not at full capacity. However, we recommend that the façade of the Fine Arts Center be frequently surveyed for potential safety hazards such as spalls and loose materials. Spot repairs and treating the underlying steel to reduce the rate of steel section loss will continue to be a common repair. To reduce the rate of deterioration of concrete and expectantly decrease the number of future repairs, corrosion inhibiting products and clear-water repellent sealers can be used.

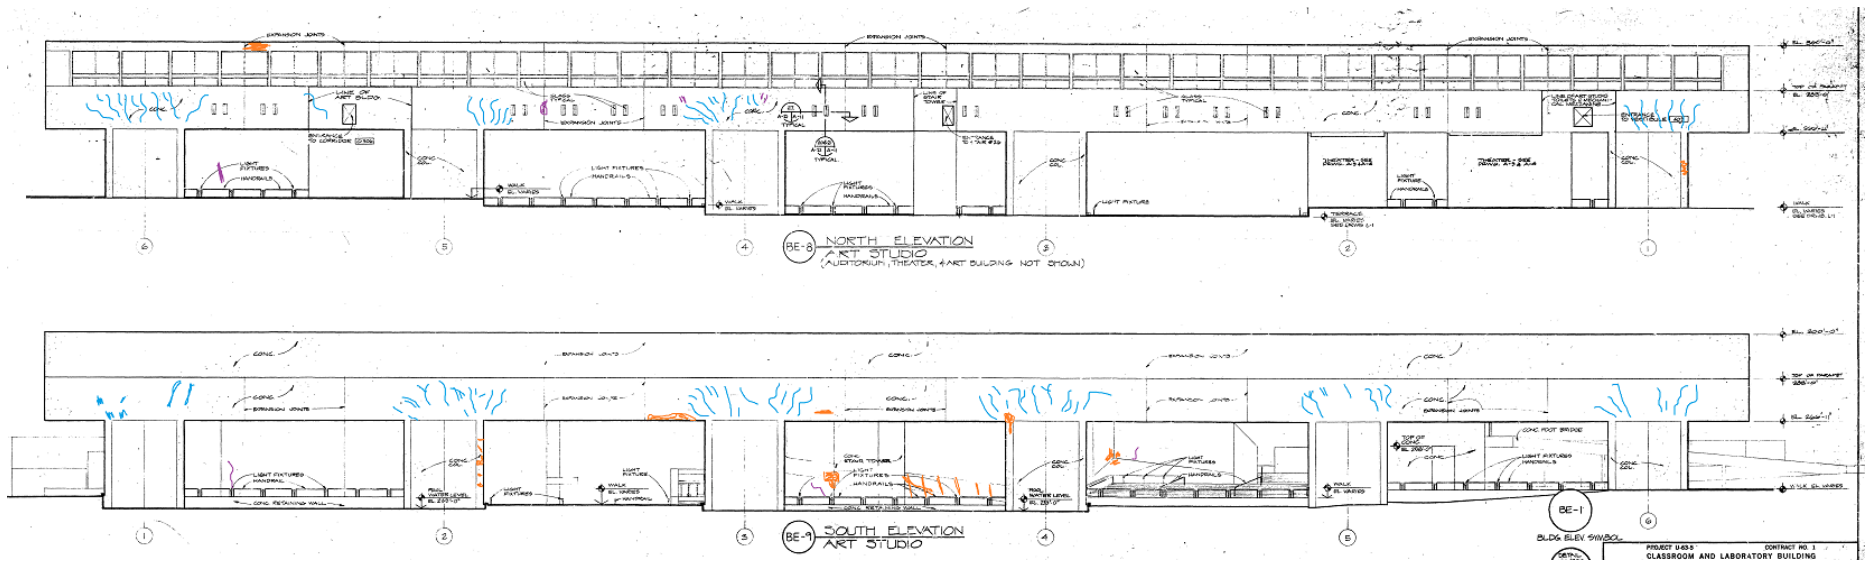
Observations of the North and South elevations of the Art Studio

We noted multiple cracks on all four elevations of the Art Studio Building and on the concrete ribs running on the underside of the bridge. The cracks observed incorporated hairline cracks, larger cracks, vertical cracks, and horizontal cracks. See Appendix D for the location of all observed exterior cracking.

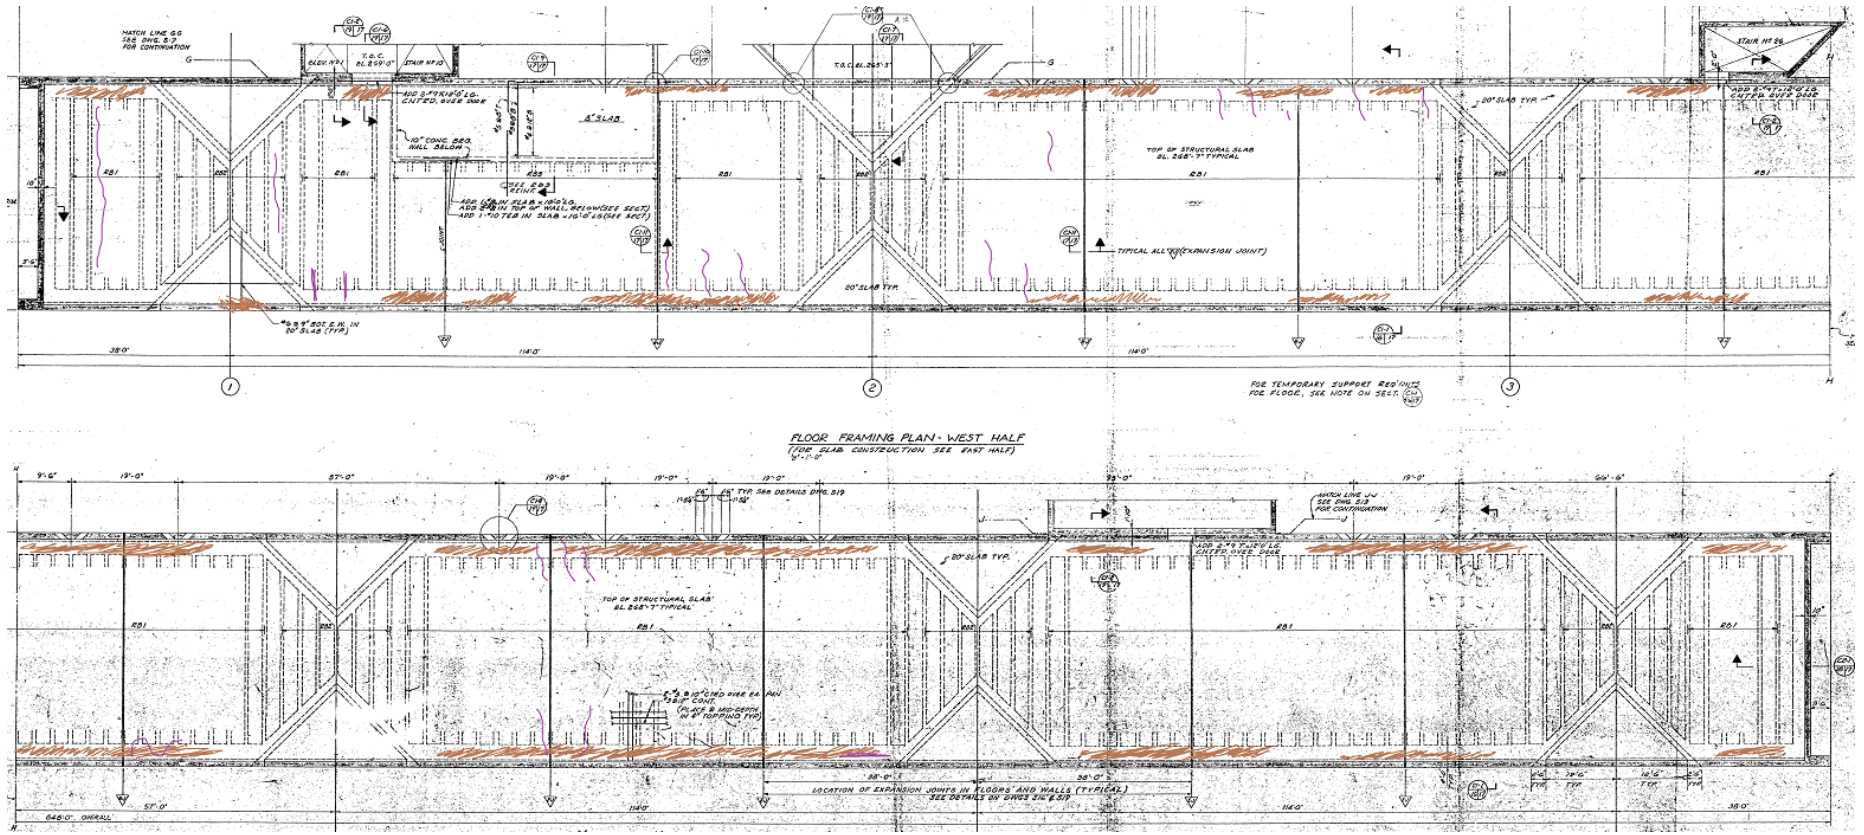
Kevin Roche John Dinkeloo and Associates, 1970, drawing A12.

Observations of the West and East elevations of the Art Studio.
