Sudbury Renewable Renovations MQP

A Major Qualifying Project
Submitted to the Faculty of the
WORCESTER POLYTECHNIC INSTITUTE
in partial fulfillment of the requirements for the
Degree of Bachelor of Science

March 2023

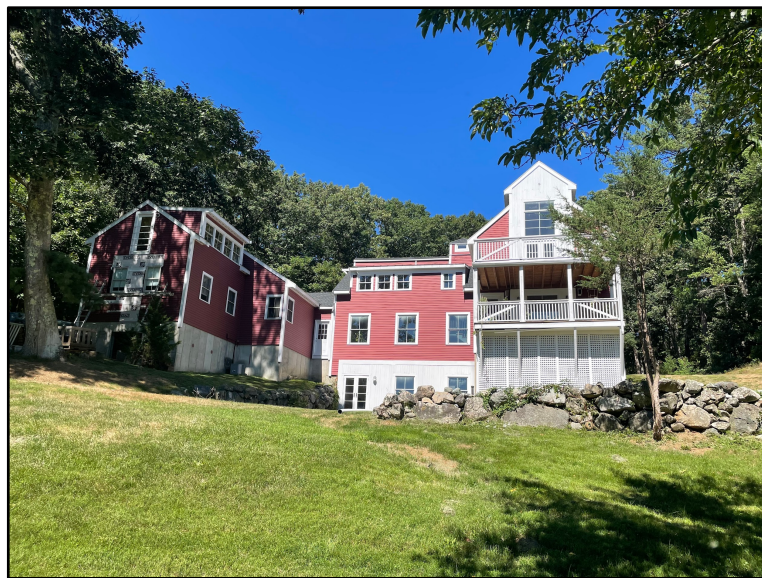
Figure 2.2 Wolbach Road, back (south-east); pictured - two back porches (balconies) to the right, many windows, a door on the basement level (center), a door on the first level (center, floating), door (top left, floating), many south facing windows

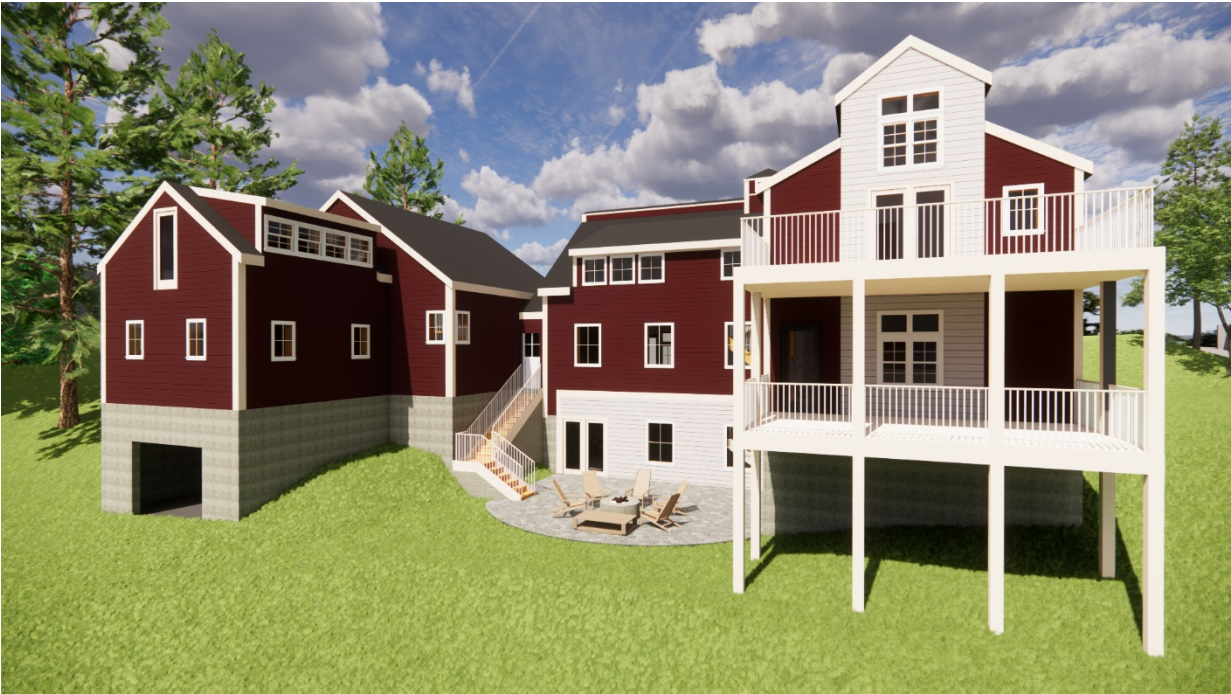
Figure 4.4 Visualization of the new staircase and patio space in the backyard

Solution: A quarter-turn stairwell descending from the back door to the exterior basement door would allow guests staying at the residence more privacy as they would not have to walk through the owner's current living space to use the interior stairwell. A new stairwell and patio

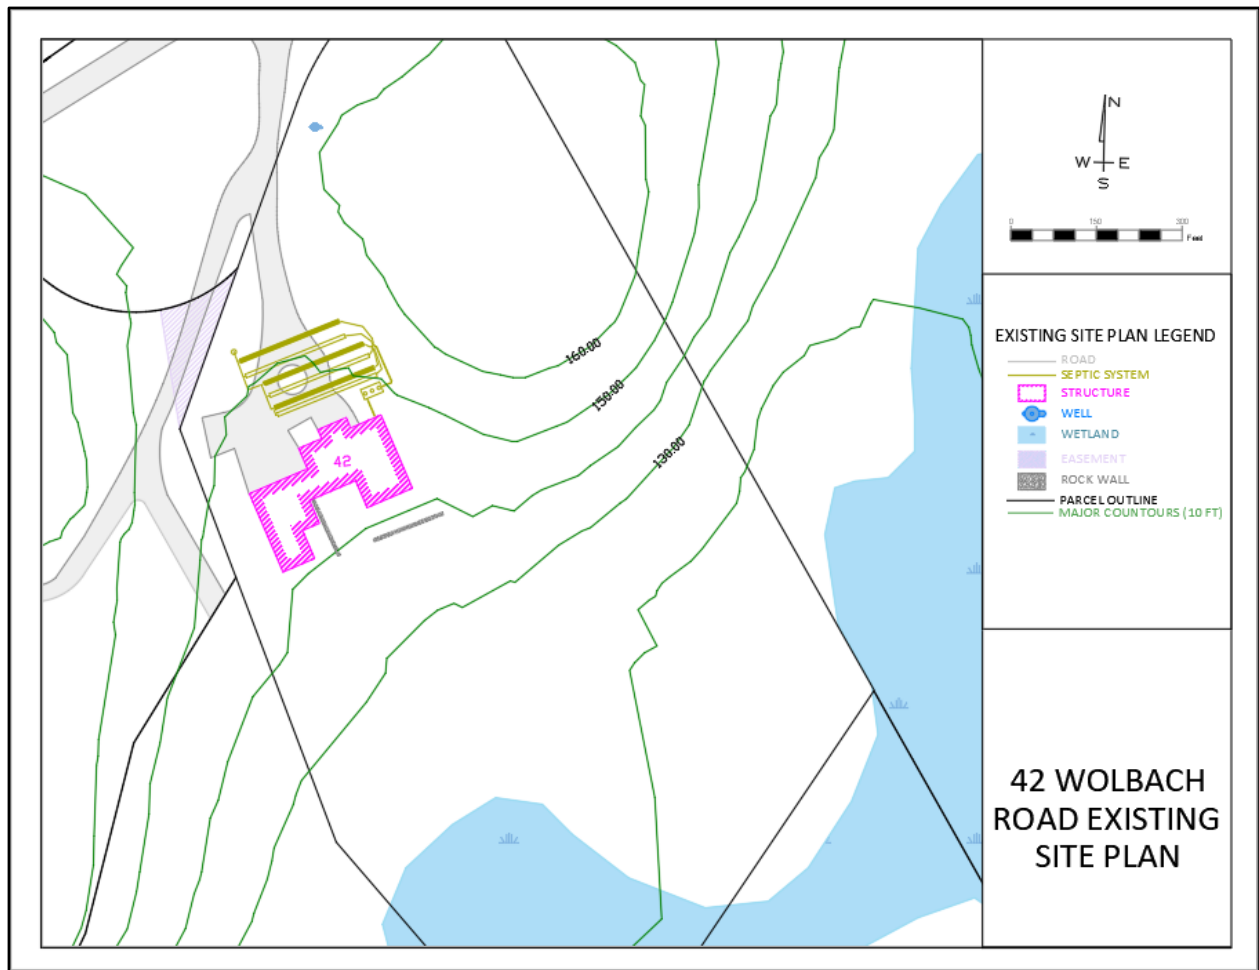
Figure 4.7 42 Wolbach Road Existing Site Plan

42 Wolbach Road is located north of a wetlands area that is overseen by the Sudbury Valley Trustees. Located downhill from the 42 Wolbach house, the wetlands are an environmentally protected area that is used as a flight zone for migrating wildfowl. The existing site plan shows the septic system located under the driveway area, to the front of the house. The North-East slope alongside the house features a densely wooded area (Appendix G). Use of the GIS Mapping software showed that the property of 42 Wolbach fell mainly into Type 104C soil classification or Hollis-Rock outcrop-Charlton complex with a slope up to 15% (Appendix D). *Figure 4.7* presents 42 Wolbach Road's existing site plan, including well placement, septic system, wetland locations, structure locations, roads, elevation levels, and parcel lines.

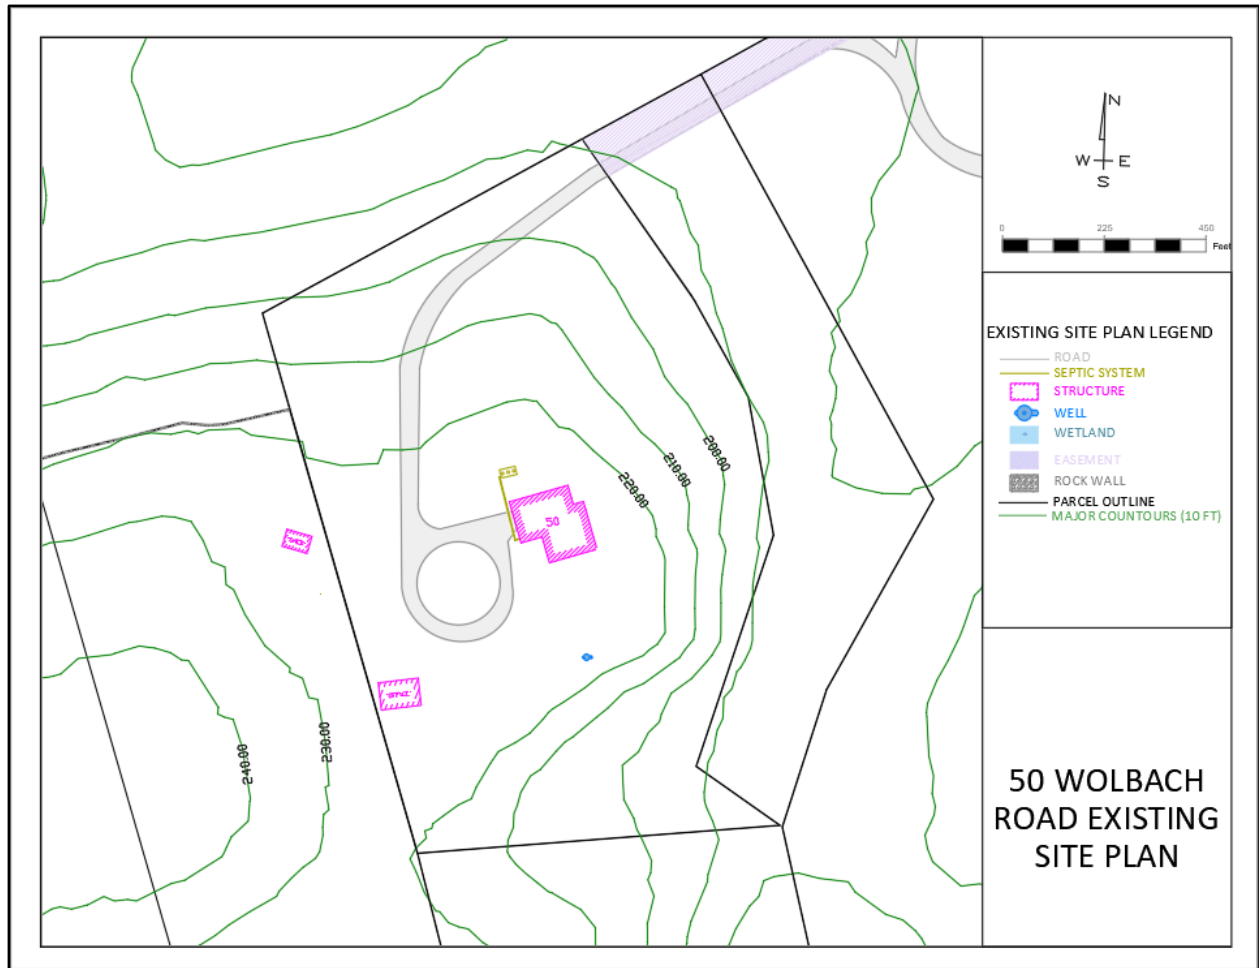
Figure 4.13 50 Wolbach Road Existing Site Plan

clay and has a poor percolation rate. The soil itself is made up of Rock outcrop-Hollis complex, (Appendix D). The property has a slope Categorization of E or above a 25% slope. There are no large water sources located on or nearby the property borders. The property is surrounded by woods on all sides by a wooded area (Appendix G). The current septic tank is located 15 feet north of the existing structure. Figure 4.13 presents 50 Wolbach Road's existing site layout.
