Understanding the Role of HEMS in Emergency Care and Working to Reduce Accidents, Costs, and Transport Time

Project Number: MQF IQP 2814

An Interactive Qualifying Project

WORCESTER POLYTECHNIC INSTITUTE

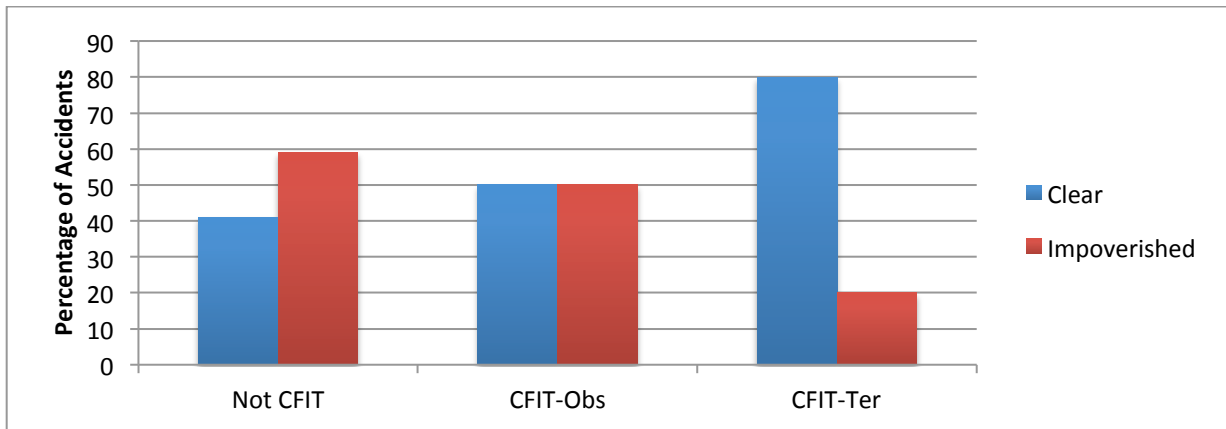
Figure 10 - CFIT vs. Environmental Conditions [Bouquet]

Along with obstacle strikes, improper judgment, usually combined with incorrect or inadequate weather briefings, often leads to controlled flight into terrain [CFIT]. CFIT often occurs under instrument meteorological conditions or at night, and can also be attributed to inability to recognize an aircraft's relation to the terrain. This type of incident is broken down further by the FAA into controlled flight into terrain [CFIT/T] and controlled flight into obstacle [CFIT/OBS]. CFIT/T was found to result in more fatalities, as well as increasingly common during poor environmental conditions [18]. A breakdown of CFIT/T and CFIT/OBS accidents is shown below in Figure 10.

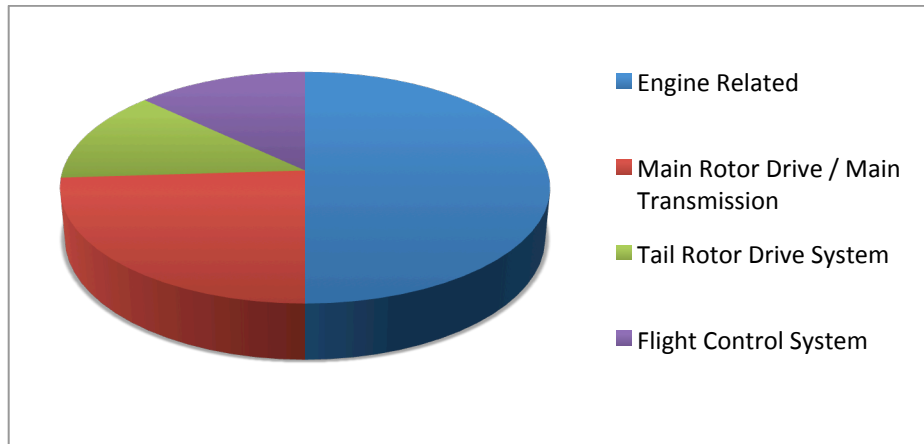
Figure 11 - Probable Cause of Maintenance Related HEMS Accidents [Blumen]

In addition to human error, mechanical issues can be a major factor in the cause of accidents in HEMS operations. Improper maintenance, component failure, and intrusion of foreign objects can cause loss of control, loss of altitude, and a myriad of other aircraft issues leading to a collision or crash. Figure 11 below shows an overall distribution of mechanical failure related crashes. As shown, approximately fifty percent of the accidents are engine related.

In a 2002 report by Rick Frazer, of 122 accidents it was determined that 23% of all accidents were maintenance related. Frazer further categorized mechanical related accidents into four categories, with engine related causes being the broadest, and making up 50% of all maintenance related accidents. While this breakdown generalizes the actual failures in mechanical related accidents, the causes are spread across a slightly larger spectrum, shown below in Table 11 [16].

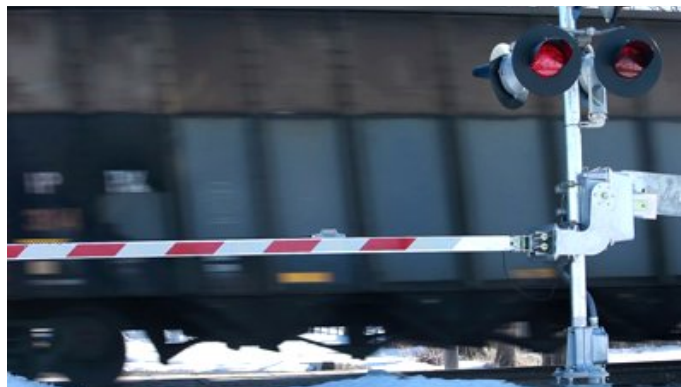
Figure 20 - Train crossing gates that may be adapted for use for road closures for helicopter landings.

For a city, due to the tall building and lack of extra space, it would be more complicated to implement a landing zone system. However, four lane highways and roadways are the perfect size for a helicopter to land. There are three possible solutions for integrating helicopter landing in major cities. The first suggestion would be to implement a system similar to the one currently used when a train is passing through. When a driver approaches a train crossing and the train is on its way, a barricade comes down, preventing the car from driving in front of the train. A very similar barricade system can occur on city roadways and intersections that are large enough for a helicopter landing. When a helicopter approaches the barricades come down at the intersection. The only difference would be the emergency personnel monitoring the landing area. Current problems with this plan would be the cost of installing barricades at viable intersections and the amount of time needed to land, transfer the patient, and depart from the landing site. To help ease this problem traffic would be diverted away from the landing zone as best as possible with the city conditions.

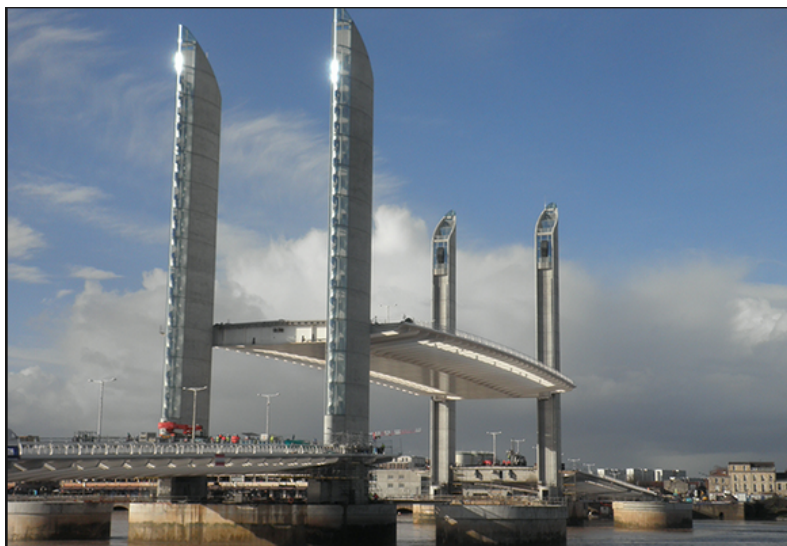
Figure 21 - Concept bridge that included helicopter-landing pad.

The final suggestion to increase the number of available landing zones in the United States would be to implement a system similar to the one use for vertical lift bridges. Vertical bridges have an implemented system that stops traffic in order to let the road rise so a ship can pass under it. A similar process can occur where a patient transfer occurs when the roadway is raised and then after the helicopter departs the road settles back down again. The main problem with this possible solution is there currently aren't many vertical lift bridges that allow for the dimensions needed to create a landing zone.

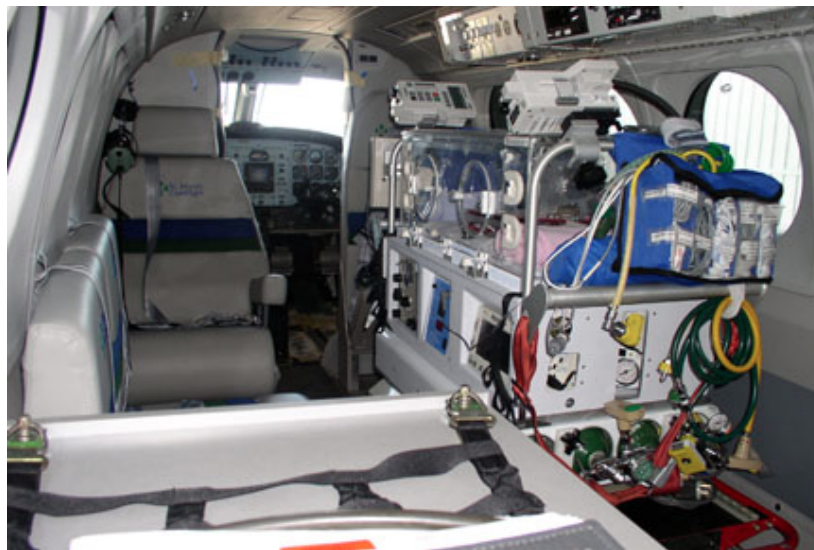
Figure 22 - Helicopter interior showing opening between patient bay and cockpit.

just as important that a pilot does not get emotionally attached to the patient. This can lead to risky decision making because the pilot feels additional need to help the patient. With current helicopter layouts, the medical workspace is open to the pilots cabin in smaller vehicles, as shown in Figure 21. One possible fix may be to introduce a shroud between the pilot and patient. A simple curtain would still provide the EMS workers access to the pilots, while providing a bit of emotional distance between the pilot and patient. A curtain would not even impede operations as HEMS crewmembers can still relay important information.
