## **Developing a Marking Arm for Autonomous Cable Detection**

A Major Qualifying Project Report  
Submitted to the Faculty of Worcester Polytechnic Institute  
In partial fulfillment of the requirements for the  
Degree of Bachelor of Science

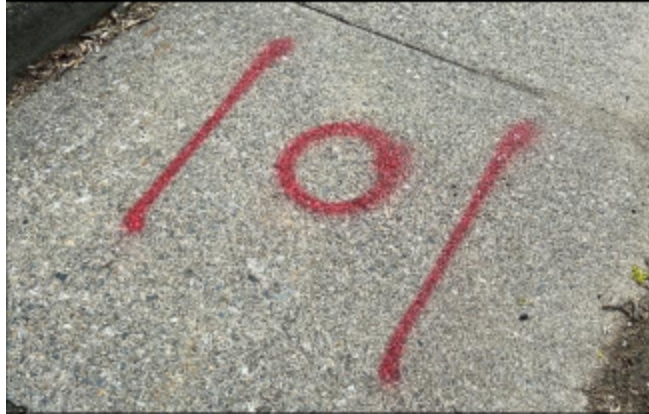
Our robot is required to make a specified pattern on the ground every 10-50 feet to denote an underground cable. This pattern, specified by Eversource, denotes an electrical cable underground, and is to be approximately 18" wide to match Eversource's existing standards.

**Figure 1: Example “IOI” Mark**

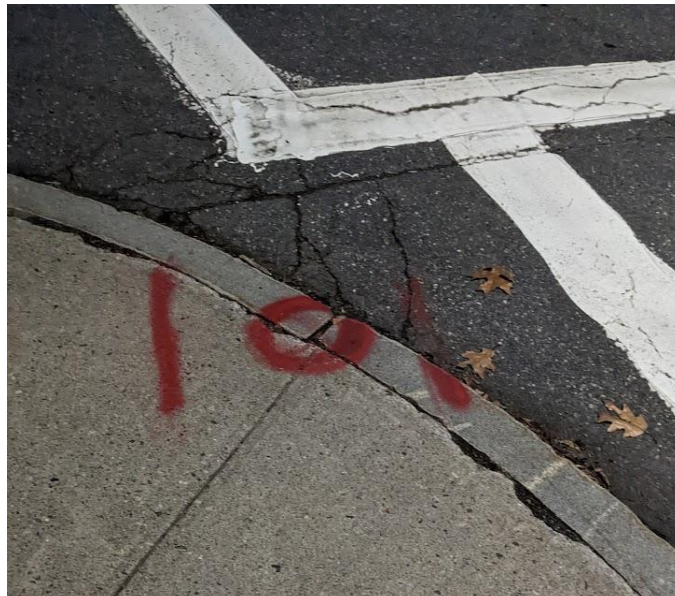
The robot needs to be able to make this mark on surfaces of varying smoothness and height, and the marking operation needs to be performed in a manner that does not require the robot to reposition itself beforehand. This required an arm that has high fixed ground clearance (8-10”) or can vary its height in order to paint on top of curbs, sidewalks, or siding. It also needs to be able to paint ground-level surfaces when the robot itself is elevated or inclined.

**Figure 2: Example Cable Mark on Varying Terrain**

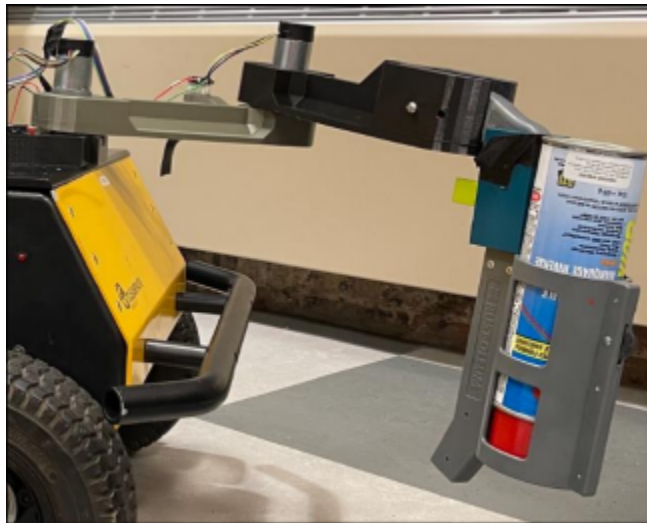
The first version of the arm had slightly modified size and mounting requirements, as it was intended to mount to a Husky UGV chassis. Since the entire robot was much shorter than the current one, the arm was mounted to the top plate of the robot, but still reaching over the back side. It used much smaller and lighter motors than all future iterations, with 2 Pololu 50:1 gearmotors powering it. These were located at the shoulder and elbow joints, and directly powered the 2 stages of the arm.

**Figure 3: 2021 Arm**

This arm was able to demonstrate initial operability, however it had underpowered motors and supported the heavy can of paint at the end. The 2021-22 team noticed some

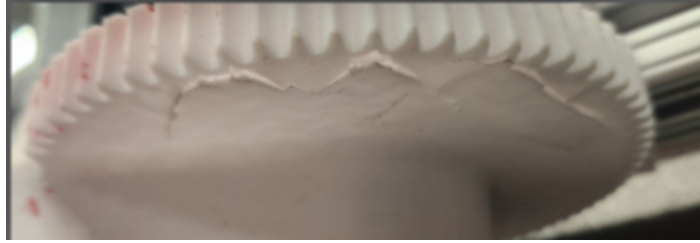
The final major issue with this iteration was that the 3d-printed plastic of its structure was cracking under stress. We believe this is largely due to the weight of the bearings and hollow shaft for the 2nd stage, as well as the valve and its metal-gear servo located at the tip. The cracking we noticed was in 2 primary areas. The first of these areas was the surface of the 1st stage gear, which was splitting in several areas. These cracks caused the teeth to shift slightly (adding friction to the gear's motion) and also caused protrusions that directly caught on the stationary part above the gear.

**Figure 6: Cracking on Surface of Arm Stage 1 Gear**

This deformation in the gears resulted in inconsistent, jerky motion of the arm when in motion. The other area we noticed cracking was in the structure of the 1st stage, where cracks were expanding from the bolts used to assemble it. Due to redundancies in these bolts there wasn't a major structural failure yet, however if we continued using the existing arm we believe these cracks would have continued appearing until it failed.

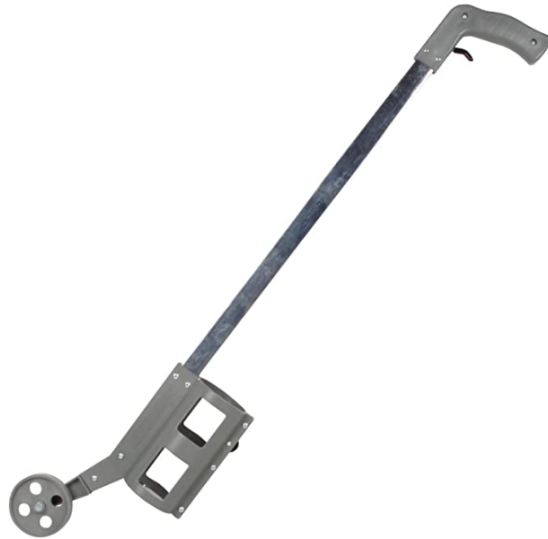
The first arm iteration used the same method of marking, with a modified paint gun attached at the tip of the arm. A servo pulled on the gun's trigger cable to activate the can. Due to the minimal modifications from the original COTS paint gun this was a consistent, reliable marking mechanism. However, it placed a much heavier weight at the end of the arm than the other iterations, slowing down the maximum speed of the arm.

**Figure 7: COTS Paint Gun**

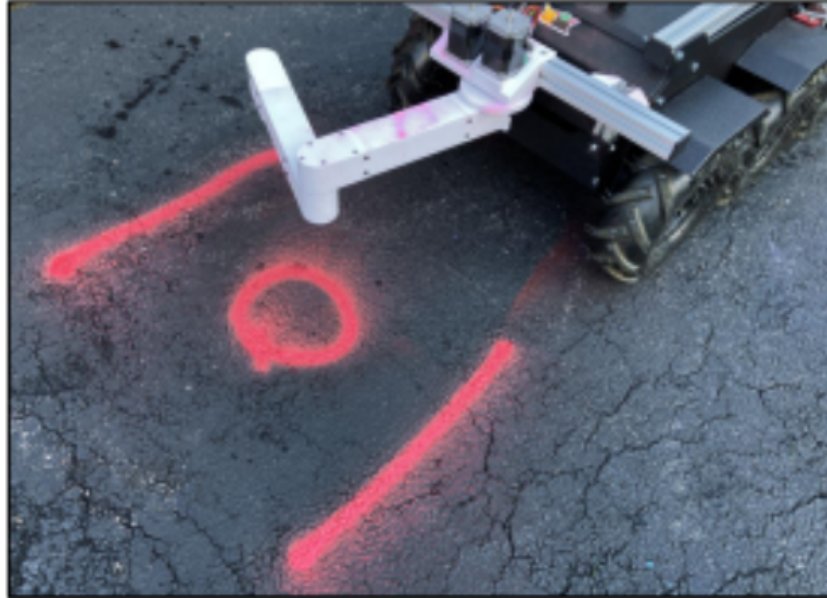
The third iteration was intended to deal with the timing issues to allow painting with consistent start and stop times. A servo-actuated valve was placed at the tip of the arm, allowing the can's servo to depress the can nozzle before the start of a marking and leave it open for the entire time, with the valve at the end starting and stopping the flow. One issue with this design was that the servo at the end still took time to open and close the valve, meaning the spray timing was still slightly off. This is noticeable by looking at their test images, where the end of each marking is wider since the paint continued spraying after the arm stopped. The more critical issue with this iteration was that the valve clogged with dried paint, rendering it inoperable.

**Figure 8: Iteration 3 Paint Demo**

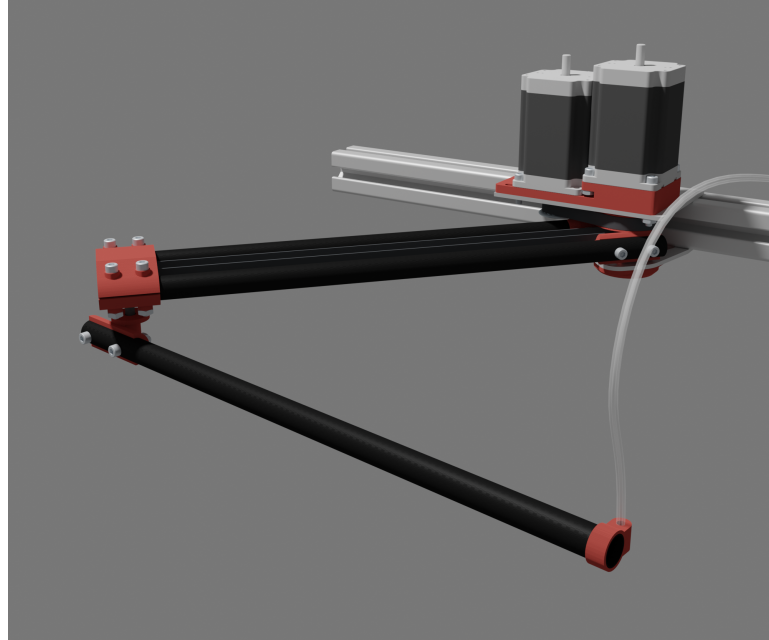
During the Fall 2022 semester, the arm was fully redesigned. The new design focused on weight and rigidity, in order to enable fast, accurate movement. These design goals were focused on because the third iteration previously attached to the robot was unable to move consistently or paint at all. The new carbon-fiber structure and improved hinges solved the motion issues, and reverting to the second iteration's painting strategy with the delay before paint starts flowing being corrected in software is expected to fix the painting issues. The arm reused the existing motors and SCARA configuration from iteration 3 in order to keep costs low and enable the use of the redesigned arm code created this year.

**Figure 9: Render of Arm Iteration 4**
