**Responding to Challenges following the  
Panama Canal Expansion Project**

A Major Qualifying Project Report:

in cooperation with the Autoridad del Canal de Panamá

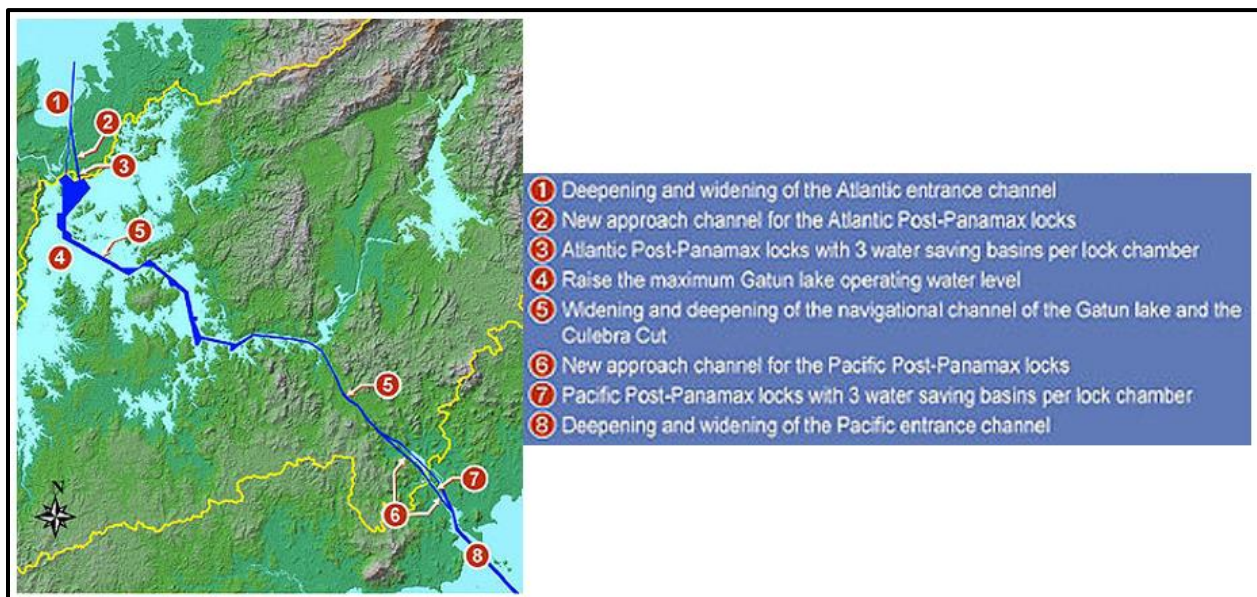
Figure 8: Components of the expansion project (Panama Canal Expansion Project, n.d.)

Despite this initial construction, a great deal of work remained (Figure 8). Before efforts could begin on the Pacific side of the canal, 198 acres (80.1 hectares) of land west of the locks needed to be cleared of debris, as they sat on the site of a former testing range for experimental weapons (House, 2013). While the U.S. military still occupied the Panama Canal Zone, they

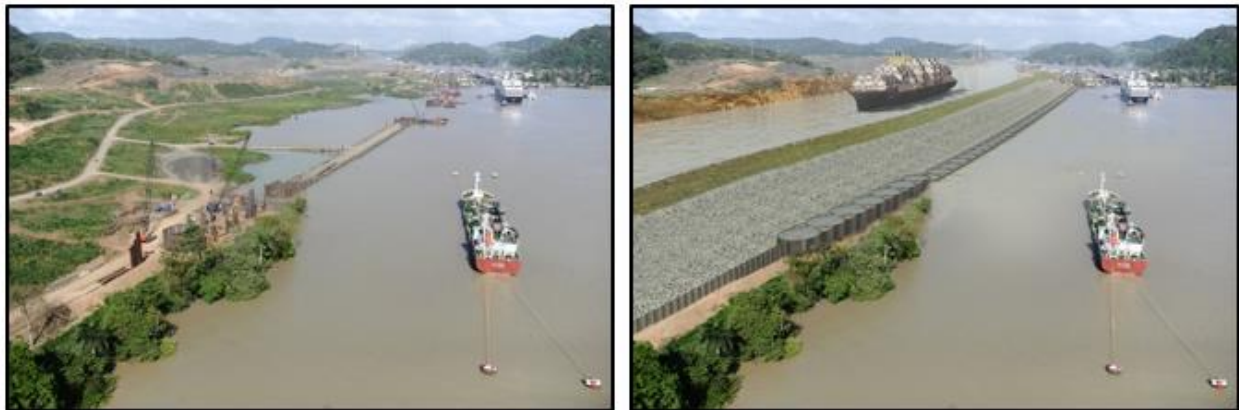
*Figure 9: Cofferdam and earth dam during construction and rendering of after construction (Autoridad del Canal de Panamá, 2015)*

dam (Figure 9) (Lyew, 2016b). A 0.9 mi (1.5 km) containment structure made up of cofferdams was first built on the southwest edge of the access channel leading to the Miraflores Locks in order to be able to build the earth dam without interfering with ongoing transit through the canal. Once in place, a dam constructed of multiple layers and materials was laid southwest of the cofferdams, ensuring the permanent separation between the Miraflores and Cocolí access channels. The dam is 1.8 mi (2.9 km) long, 492 ft (150 m) wide, and 85 ft (26 m) high (House, 2013).

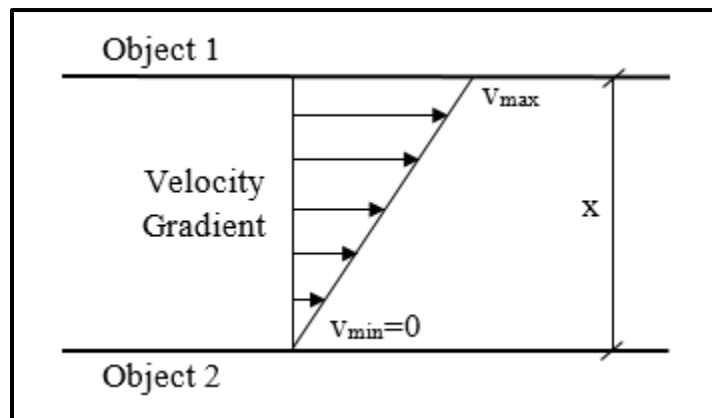
Figure 12: Velocity gradient between two objects (Ring, 2016b)

The velocity gradient of a flowing fluid measures the relative velocity between two particles over the distance between them (Figure 12) (Kocamemi, n.d.). This parameter is often used in the study of fluids, especially when discussing hydraulics. In terms of the hydraulic flows through a water treatment plant, the velocity gradient parameter provides facility operators with information about the motion of the water. It is applicable when analyzing rapid mixers and flocculators. High velocity gradients are more commonly found in rapid mixers, where the fluid particles have high energies and collide with one another roughly and frequently. Low velocity gradients indicate a gentle flow pattern with low energy, often sought after when designing flocculators.

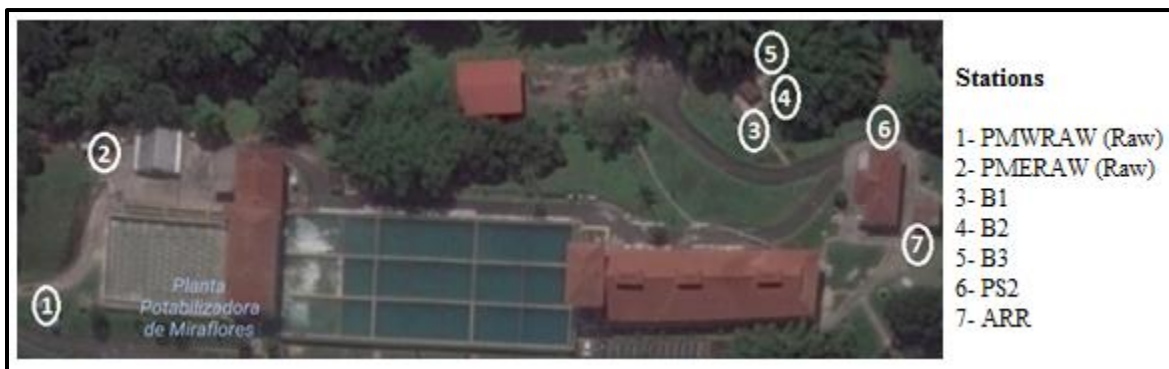
Figure 15: Water collection stations at Miraflores Water Treatment Plant (Google Maps, 2016)

A variety of water quality parameters were collected through field measurements starting on July 5, 2016 (Table 8). Utilizing a YSI Professional Plus multi-parameter instrument, water samples were analyzed within the Miraflores plant distribution system. Seven different stations were sampled daily; two containing raw water and five containing treated water (Figure 15). Faucets at each station were opened to let water run for an average length of three to five minutes

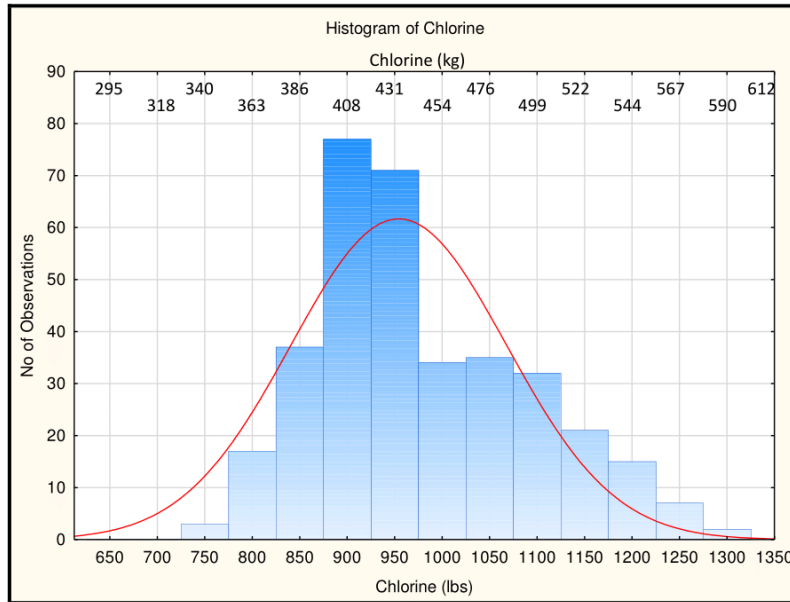
Figure 19: Histogram of chlorine with Anderson-Darling test results

hypothesis stated that the data followed a normal distribution. Contrarily, the alternative hypothesis,  $H_a$ , stated that the data did not follow a normal distribution. Anderson-Darling results showed that the consumption of chlorine,  $p = 0.0043$ , and alum,  $p = 0.0015$ , did not follow a normal distribution, and therefore resulted in the rejection of the null hypothesis. This can also be seen through the lines superimposed over the histograms; the data lack the symmetry necessary for the distribution to be considered normal (Figure 19 and Figure 20).

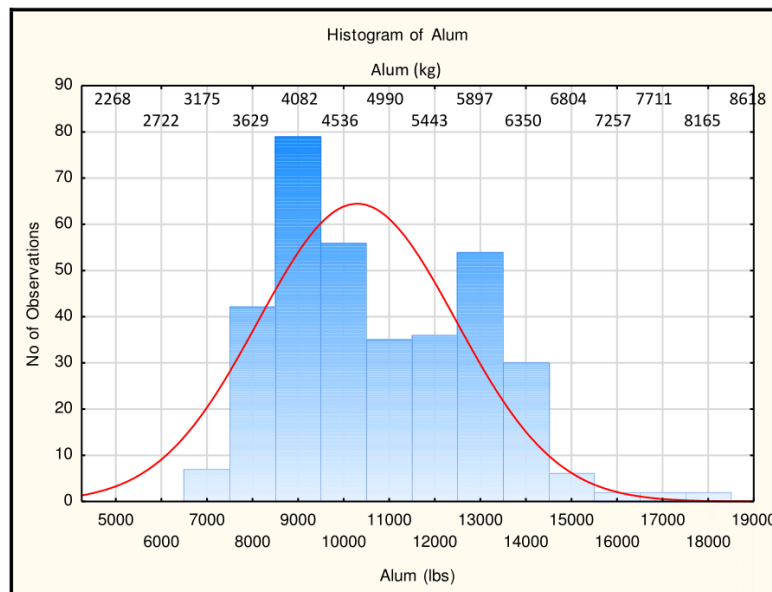
Figure 20: Histogram of alum with Anderson-Darling test results

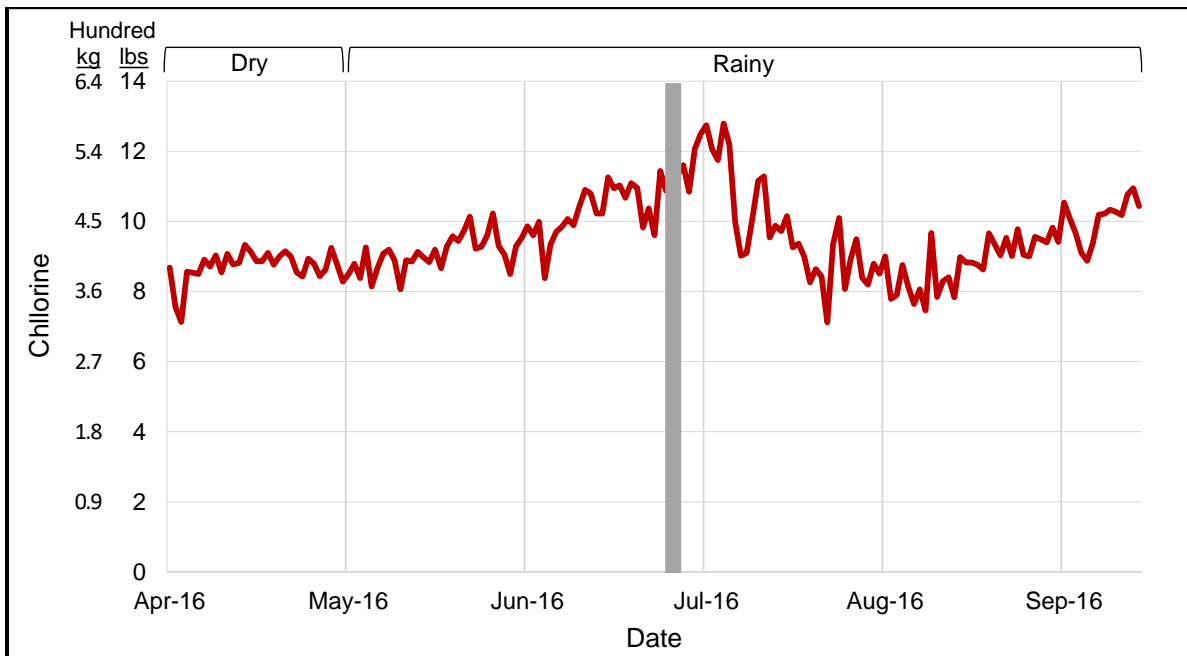
Figure 21: Consumption of chlorine between Period 3 and 4 (gray line represents expansion inauguration date)

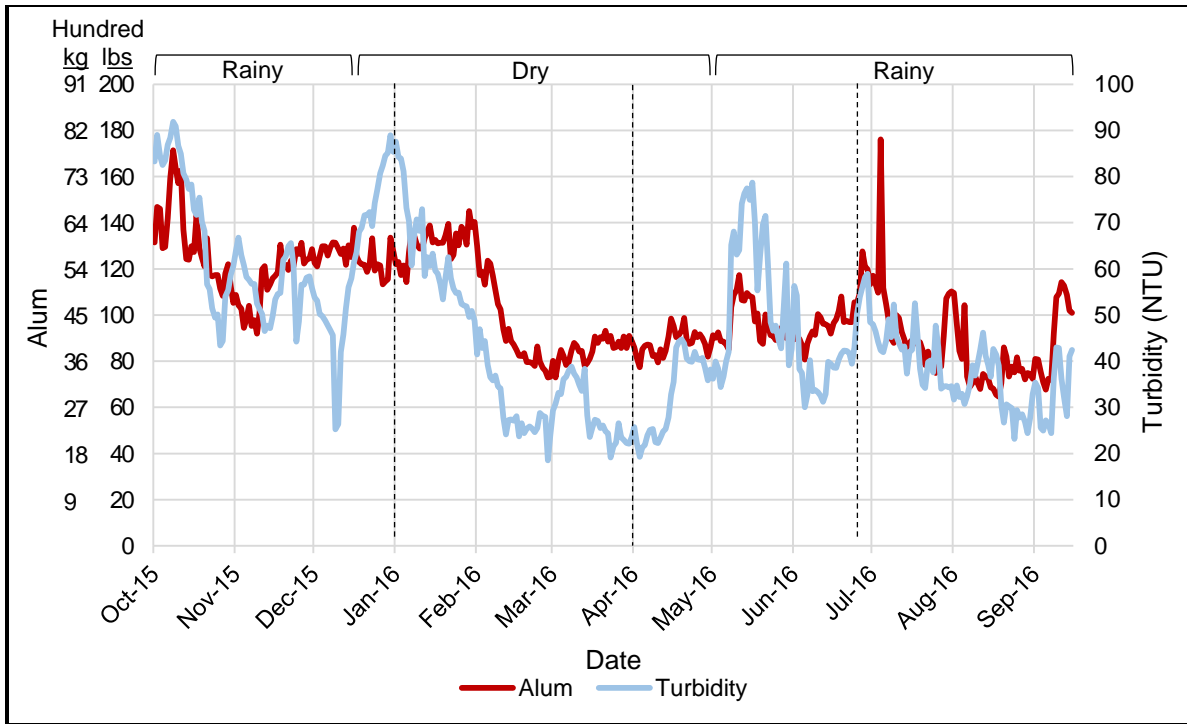
Figure 22: Alum consumption in relation to turbidity levels at Miraflores

Across all periods analyzed, alum consumption presented a significant, positive correlation with turbidity (Figure 22). During Period 1, the positive correlation can be seen until November 2015, where both alum consumption and turbidity decreased. A stronger linear relationship can be seen during Period 2, where both variables decreased until March 2016. During Period 3, an increase in both alum consumption and turbidity occurred until mid-May 2016. Afterwards, the variables decreased until the conclusion of Period 4, excluding June 2016 where an increase of both can be seen. Overall, the graph shows that high values of alum consumption were associated with high values of turbidity. In addition, alum consumption presented a significant, positive correlation with the volume of influent. While the correlation coefficients between alum consumption and volume are lower than those of turbidity, the relationship was still considered significant and can be understood because a higher volume of influent water requires an increase of chemicals during water treatment.

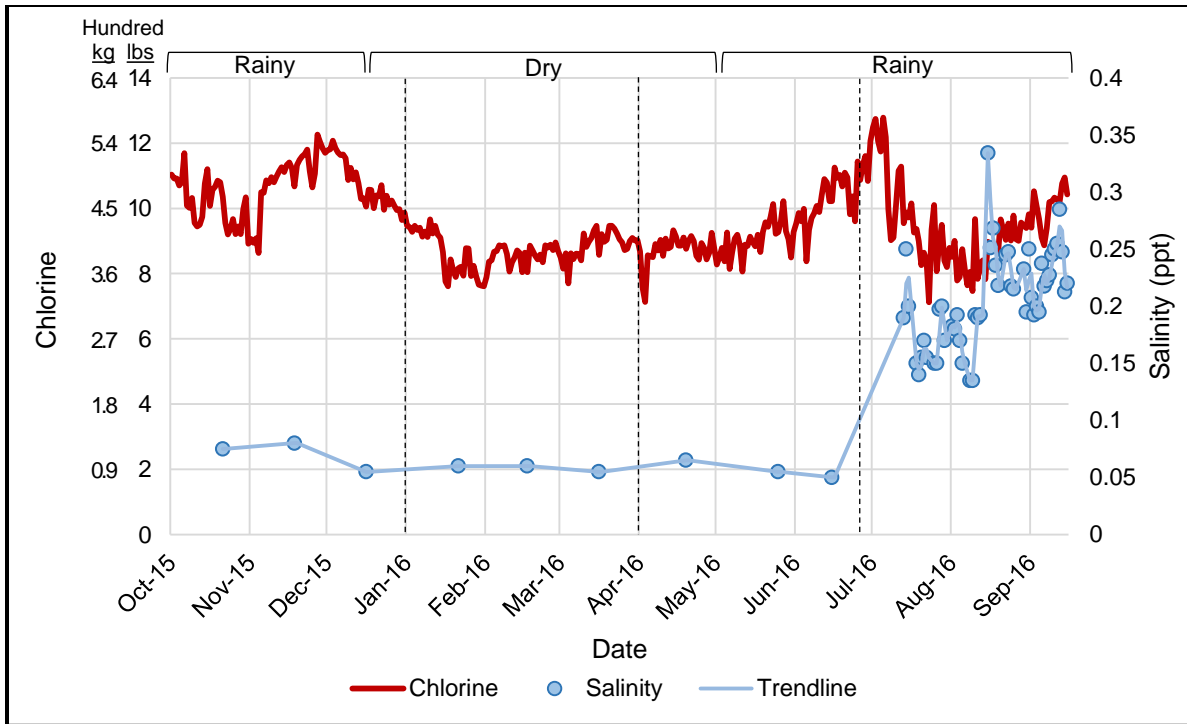
Figure 23: Chlorine consumption in relation to salinity levels at Miraflores

Finally, chlorine consumption presented a significant, positive correlation with salinity across all periods, despite limited values for salinity prior to the expansion (Figure 23). During Period 1, chlorine consumption and salinity showed a decrease after December 2015. During Period 2, both variables remained consistent, with neither variable presenting distinctive variations. This same behavior continued through Period 3, with an increase occurring after June 2016. During Period 4, chlorine consumption decreased after the expansion but, similarly to salinity levels, presented a continuous increase after August 2016.

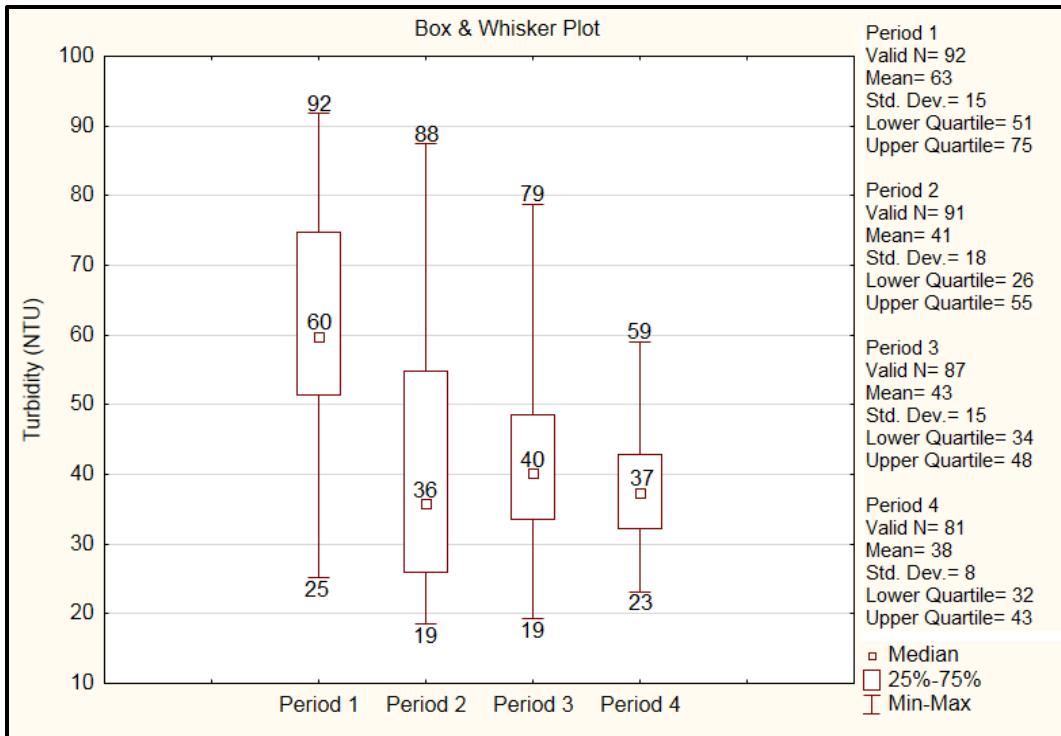
Figure 24: Box and whisker plot of turbidity levels

Recognizing that a relationship exists between chemical consumption and the water quality parameters analyzed, it is important to understand how post-expansion operations have affected the parameters. A mean value of 63 NTU (Nephelometric Turbidity Units) for turbidity indicates that the highest levels occurred during Period 1 (Figure 24). A comparison of maximum values explain that, following Period 1, turbidity levels have continuously decreased, with the lowest mean value, 38 NTU, occurring during Period 4. Contrarily, a mean value of 0.21 ppt for salinity indicates that the highest levels occurred during Period 4 (Figure 25). While salinity levels remained within a mean range of 0.06 – 0.07 ppt during Periods 1, 2, and 3, an increase occurred during Period 4. Through this analysis, it can be assumed that post-expansion operations have impacted salinity levels but not turbidity levels.

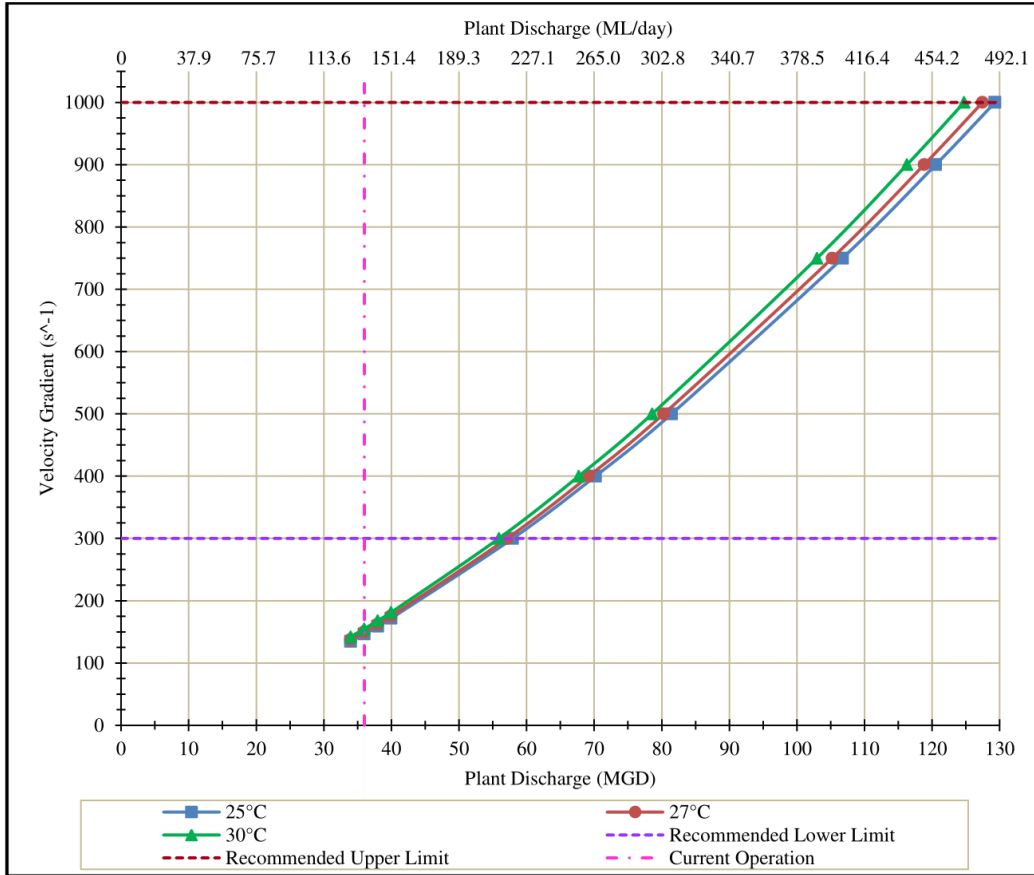
Figure 27: Velocity gradient vs. total plant discharge through a vertically baffled rapid mixer with varying water temperature

Compared to recommended values between  $300$  and  $1000\text{ s}^{-1}$ , the results for the structure's current performance,  $146.69 - 154.81\text{ s}^{-1}$ , fell below the prescribed range (Table 17). As discussed in Section III.4.1.2, data points were created and graphed for three different water temperatures, under ten different plant discharges each (Figure 27). Four of the discharges were set to fall between 34 and 40 MGD (129 and 151 ML/day) to provide data for flows close to Mount Hope's current operation of 36 MGD (136 ML/day), as indicated by the vertical pink line on the graph. The other six discharges were chosen to provide velocity gradients that fell within the ranges found in the literature review portion of the project, as can be seen between the two horizontal lines on the graph. From the latter portion of the data, it was determined that discharges between 55.9 and 129.3 MGD (211.6 and 489.5 ML/day) would elevate the velocity gradient to a suitable level. While discharges in this range mathematically produced velocity gradients from  $300 - 1000\text{ s}^{-1}$ , they were physically unrealistic. The lack of feasibility of such flows was deduced from field observations. When one of the pathways through the plant was drained so measurements of the structures could be taken, the transition region between the rapid mixer and sedimentation basin began to overflow. If the two remaining pathways could not

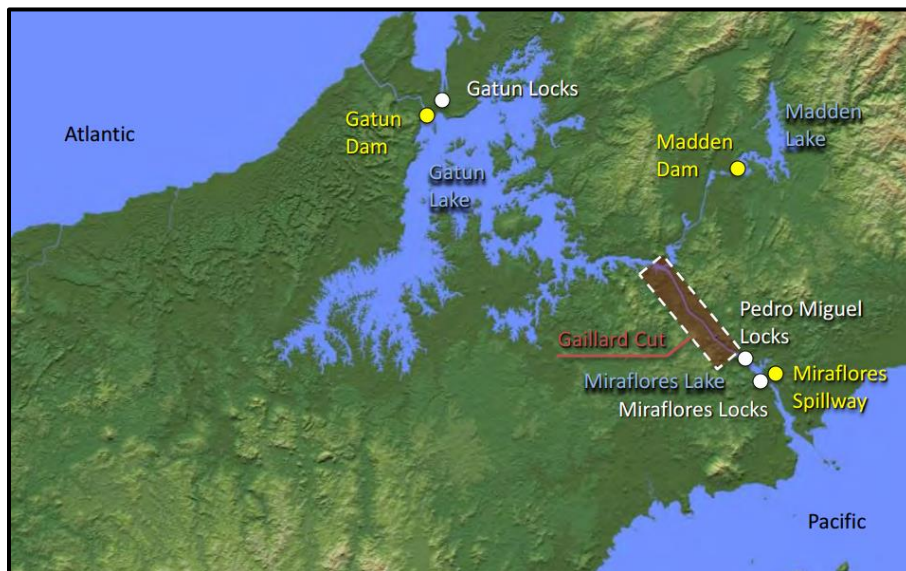
Figure 34: The Panama Canal principal components (Alfaro, 2012)

There are three spillways that aid in keeping the Panama Canal operational (Figure 34, yellow dots). Gatún Spillway is located on the Atlantic side of the canal, Miraflores Dam and Spillway is on the Pacific, and Madden Dam and Spillway is on the Chagres River (Alfaro, 2012). The three spillways use an ogee design and allow the ACP to maintain a safe water level for ships transiting the Panama Canal, while providing enough water for residents of the surrounding areas.

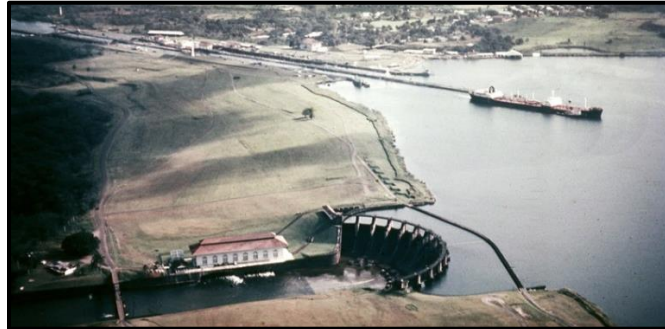
*Figure 35: Aerial view of Gatún Spillway and Locks (Panama Canal V.I.P. Slides, 1969)*

Gatún Spillway and earthen dams are responsible for maintaining the levels of Gatún Lake and the Culebra (Gaillard) Cut, which make up 21 mi (33 km) and 7.8 mi (12.6 km) of the Panama Canal, respectively (Panama Canal Flood Control Facilities, 1977a). Gatún Lake is also responsible for supplying water to residents of Panama. The lake, created during the construction of the original canal, was once the largest artificial lake in the world, with a surface area of 164 mi<sup>2</sup> (425 km<sup>2</sup>) and a volume of 183 billion ft<sup>3</sup> (5.2 km<sup>3</sup>) (Panama Canal Museum, 2014). The Gatún Spillway is located on the Atlantic side of Gatún Lake, adjacent to the original Gatún Locks (Figure 35).

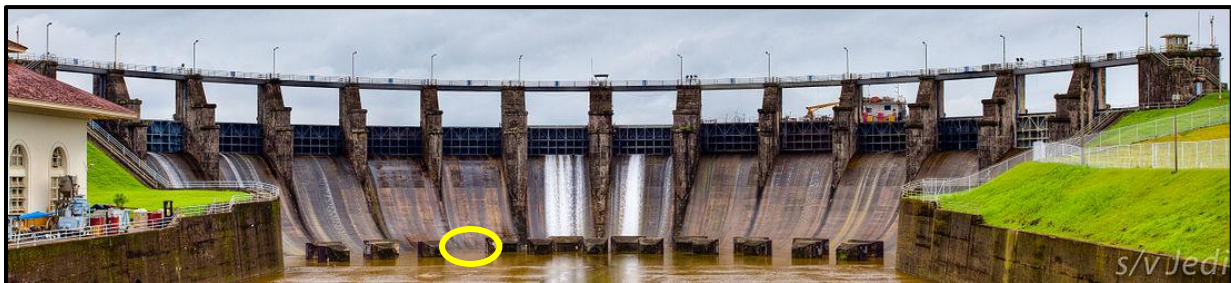
Figure 37: Panorama of Gatún Spillway (Wikipedia, 2016a)

During the operational lifetime of the spillway, changes have been made in order to keep the structure in working condition. In 1927, after 13 years of operation, two of the baffle blocks were removed in order to direct water away from the powerhouse during spilling (circled in Figure 37) (US Army Corps of Engineers, 1996). The original gates are riveted, but over time, riveted construction has become obsolete. Therefore, as new gates have been constructed for replacements, they have been changed to a welded design. Although Gatún Spillway has 14 gates in the structure, there are two extra in storage for inspection and repair purposes. This flexibility allows the ACP to fully remove and replace gates when they are in need of significant repairs. Due to the expansion project and the raised operating water level of the lake to 89 ft (27.1 m) (Alarcón et al., 2011), the gates of Gatún Spillway were extended. Originally 45 ft (13.7 m) in width by 19 ft (5.7 m) in height, an extra 1.5 ft (0.5 m) was added to the height of each for a total of 20.5 ft (6.3 m) (Panama Canal Museum, 2016).

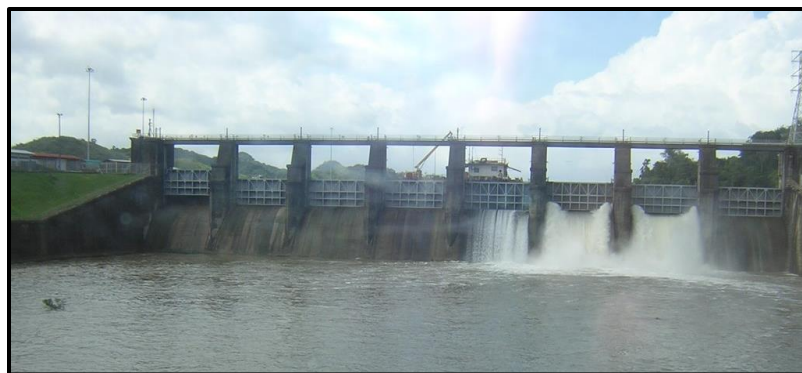
Figure 39: Miraflores Dam (Mitch, 2007)

The construction of the Miraflores Spillway was completed in 1914 (Panama Canal Flood Control Facilities, 1977b). It is an ogee spillway that is oriented linearly with a net length of 360 ft (109.7 m) (Figure 39). The crest is located at 38.6 ft (11.8 m) above sea level and provides a platform for eight 19 ft (5.7 m) tall vertical lift gates. The gates are identical in size and operation to the original gates at Gatún Spillway, which simplified replacement of any components.

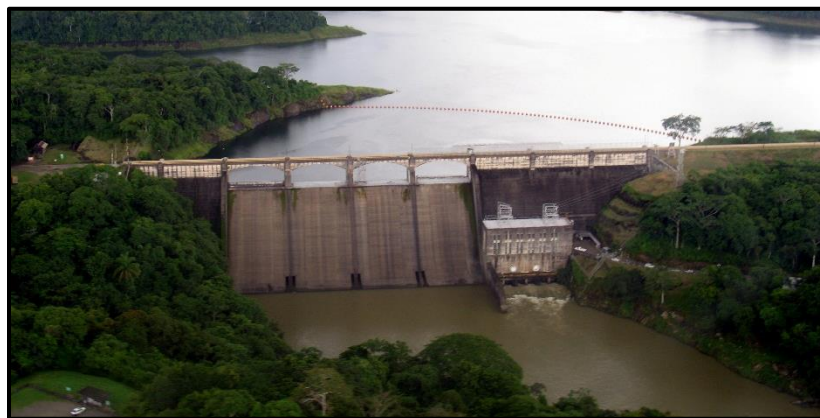
Figure 41: Madden Dam and Spillway with Alhajuela Lake in the background and the Chagres River in the foreground (justin\_n, 2007)

Madden Spillway has a concrete ogee design that is oriented linearly with a total length of 974 ft (297 m) and a height of 223 ft (68 m) (Panama Canal Flood Control Facilities, 1978). It has four drum gates, each with a length of 100 ft (30.5 m) and a height of 18 ft (5.5 m) (Figure 41). The structure also has six sluice gates, located at the base of the spillway, to flush sediment that accumulates in the lake. The spillway keeps Alhajuela Lake at an elevation of 260 ft (79 m) above sea level. To maintain this elevation and the elevation downstream, water is spilled once or twice a year, similar to Gatún Spillway.

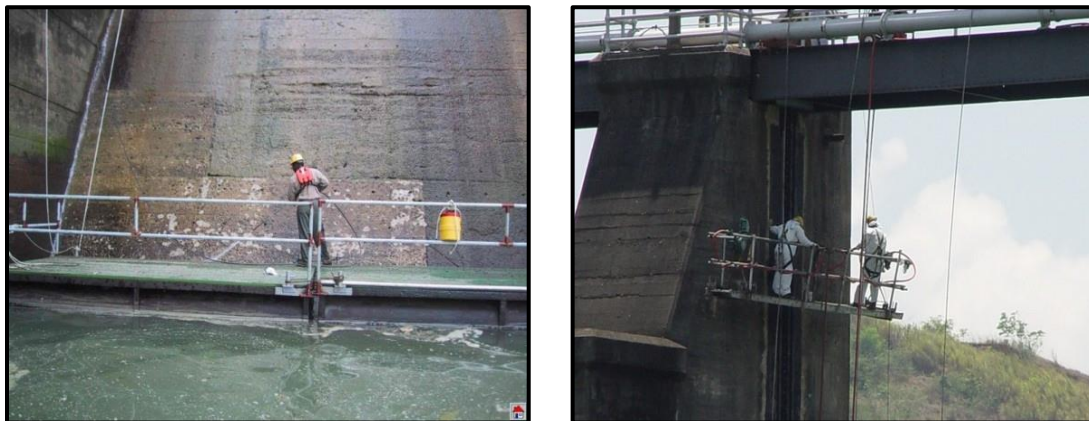
Figure 43: Existing floating (left) and mobile (right) scaffolding used by the ACP

Further conversations with the engineers indicated some room for improvement. They mentioned a need for ways to clean the concrete other than pressure washing. The current technique requires extensive setup and risks damaging the concrete. They also mentioned interest in different types of scaffolding that could be assembled and maneuvered more easily than the current structures (Figure 43).

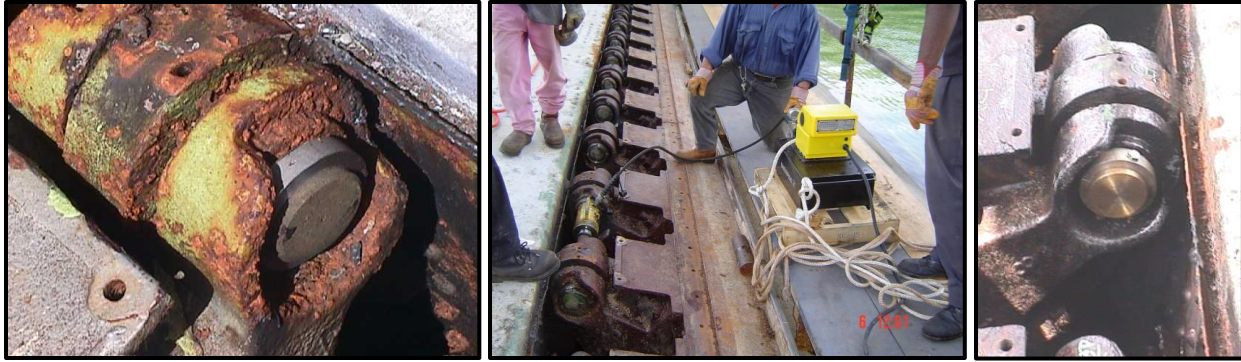
Figure 47: Corrosion on the hinges and the pin replacements (Chen & Cano, 2003; Autoridad del Canal Panamá, 2004)

The hinges of the gates consist of two key components: the pins and the casings. Each gate contains two end hinges, four contraction joint hinges, and 33 intermediate hinges. Failure of the hinges can cause the gates to lose their ability to rotate, preventing them from raising or lowering to control the water spillage. Damage to these structures can be caused by loss of thickness resulting from corrosion, vibration impacts from the drum gates during operation, loss of ductility, material weakening by chemical or environmental pollution, or wear due to friction. In 2003, severe corrosion was observed on all the hinges of all four drum gates. The repairs of the casings and replacement of some of the pins could only be completed on two of the gates at a time. Therefore, drum gates 3 and 4 were completed in 2004 and 1 and 2 were repaired in 2005 (Figure 47). Only the middle and contraction joint hinges were replaced because removing the end pins could affect the alignment of the drum gates. After the large tropical storm that occurred in 2010, a lot of sandy sedimentation had accumulated on all of the drum gates' hinges. To minimize damage to the casings and pins, the hinges were cleaned with a water pressure jet to remove the sedimentation. Based on the inspection and maintenance reports reviewed for this project, the hinges lasted for at least 68 years before needing replacement. Therefore, they do not deteriorate very quickly, leading to the conclusion that a risk analysis was unnecessary.

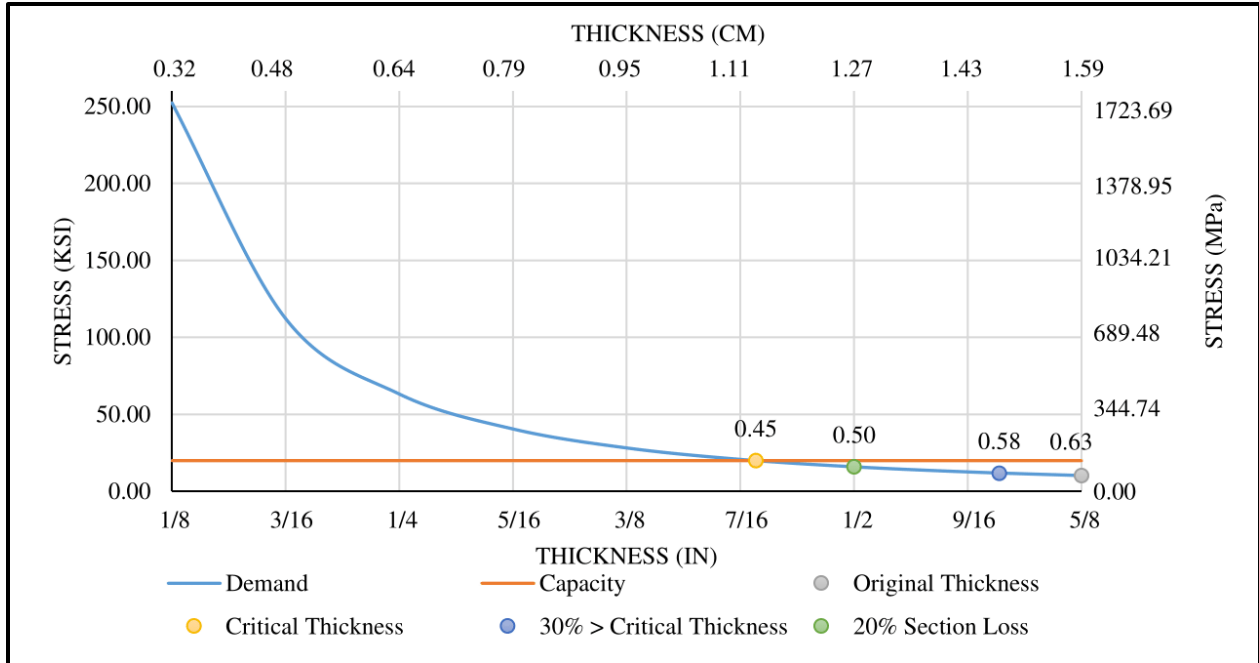
Figure 49: Demand and capacity stress equations for the bottom skin plate

The bottom skin plate's critical thickness occurs at approximately 0.45 in (1.14 cm). This corresponds to a section loss of 28.64%, or 0.18 in (0.46 cm) of thickness. According to the ACP guidelines, repairs or replacement of the plate should occur at 20% section loss from the original thickness. For the bottom skin plate, repairs would be considered at a thickness of approximately 0.5 in (1.27 cm). Using this standard, the plate would be repaired or replaced before reaching failure, but would only need to lose 0.05 in (0.13 cm) more of its thickness to become critical. Therefore, to maintain a greater factor of safety, a thickness 30% greater than the critical thickness was found. This number can be viewed as a warning indicator for maintenance workers to begin planning repairs or replacements of the existing plate. The warning indicator thickness occurs at approximately 0.58 in (1.47 cm) (Figure 49).

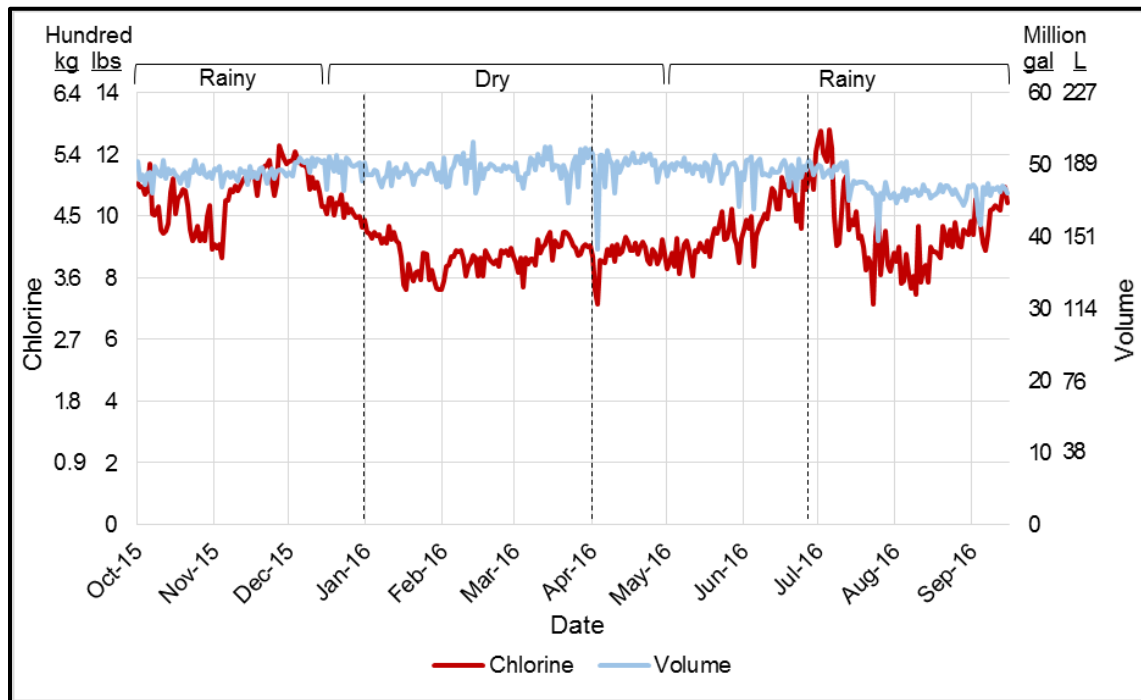
Figure 59: Chlorine consumption in relation to volume of influent

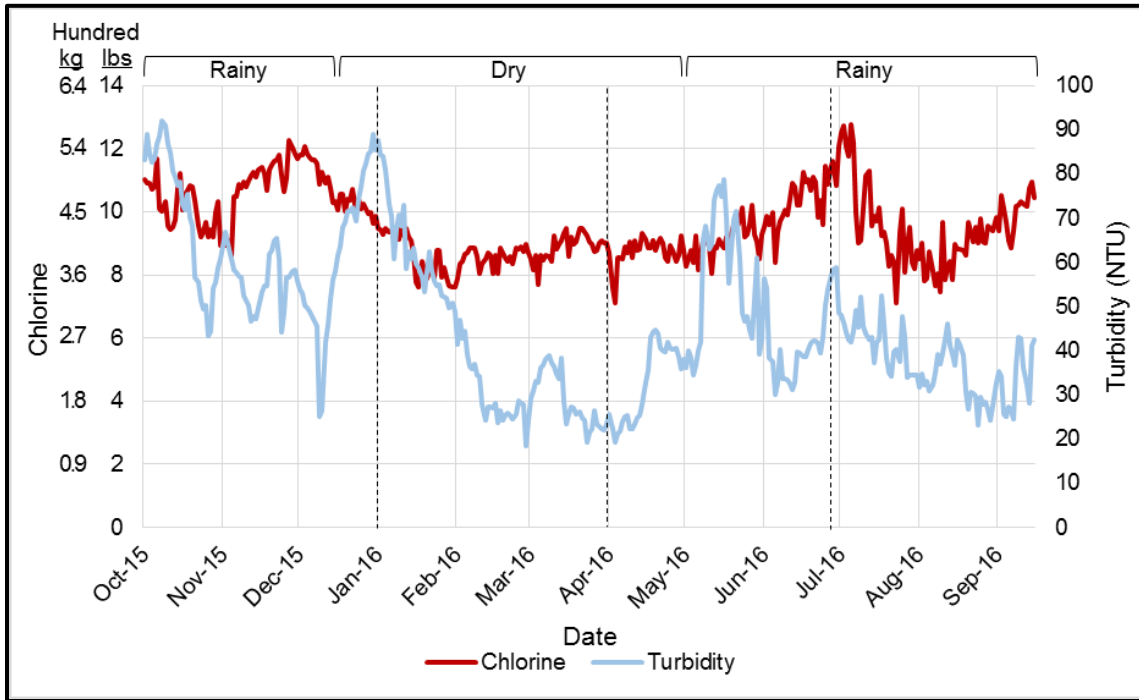
Figure 60: Chlorine consumption in relation to turbidity levels

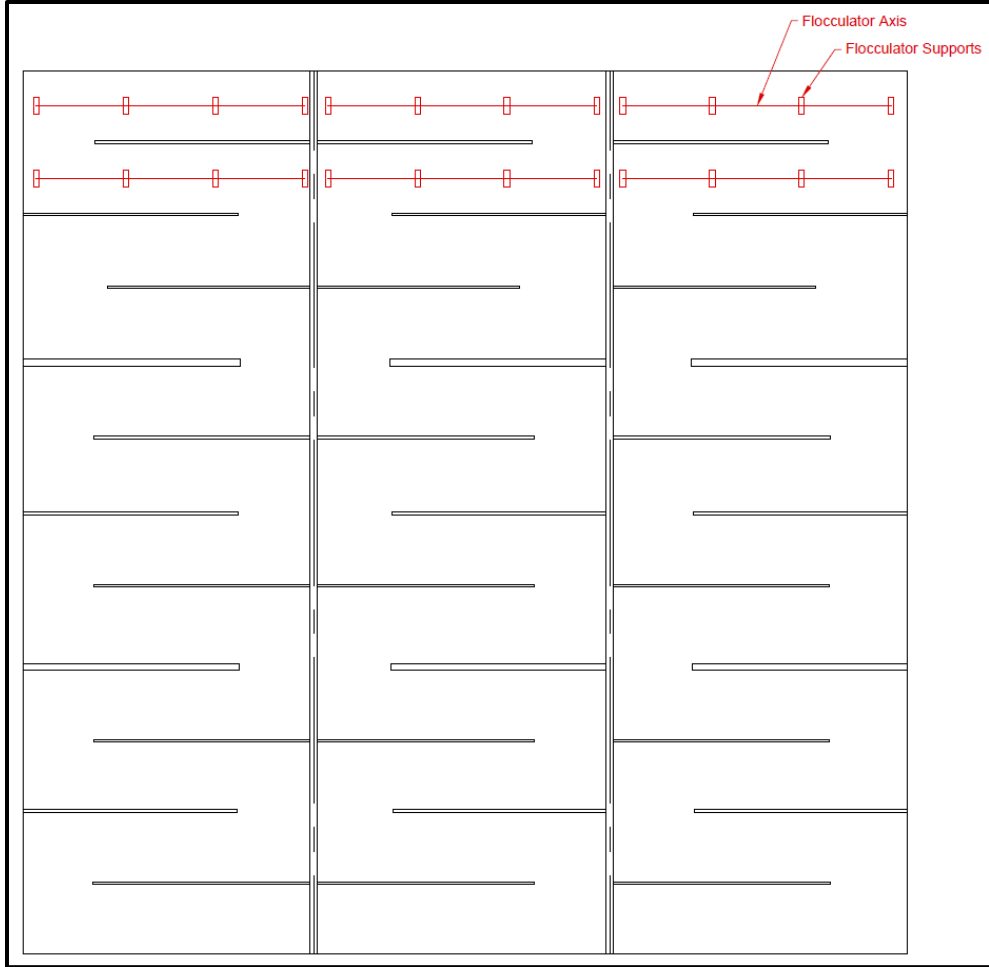
Figure 70: Location of the flocculators within the sedimentation basin (plan view) (Ring, 2016a)

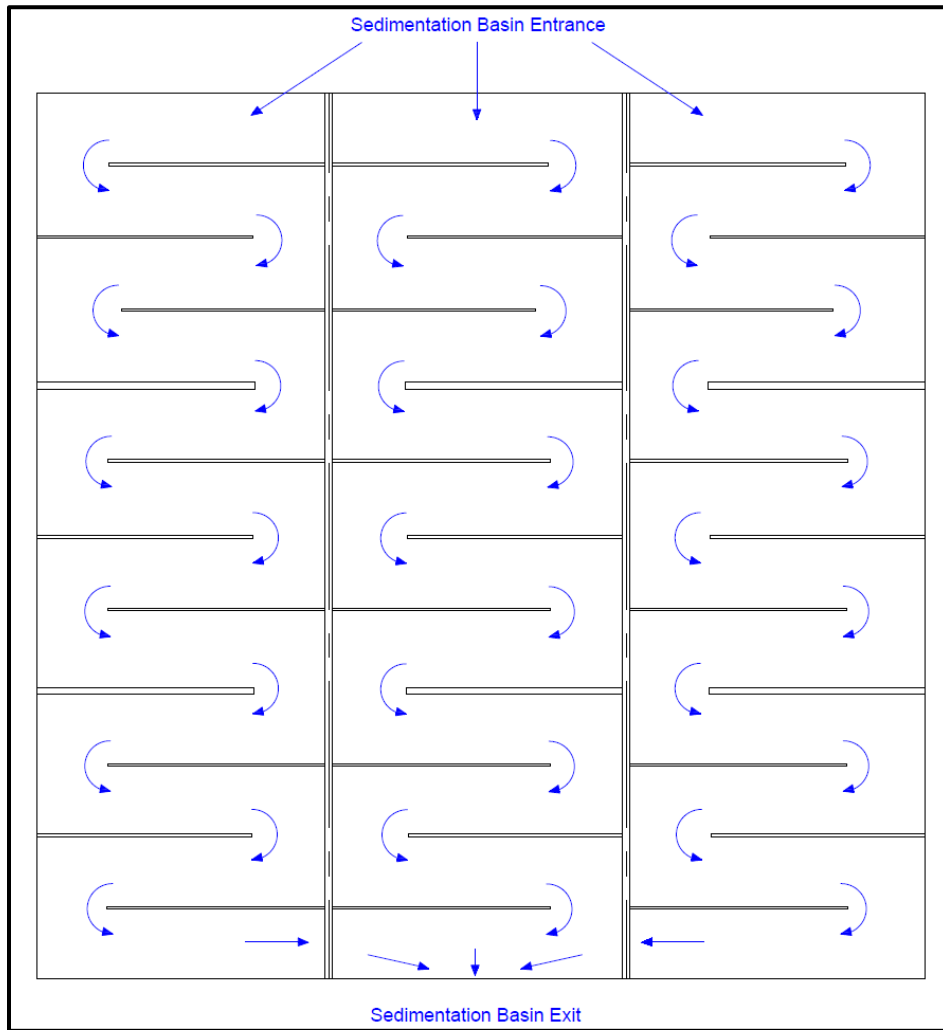
Figure 72: Flow pattern through the horizontally baffled sedimentation basin, entrance from rapid mixer, exit to filtration building (plan view) (Ring, 2016a)
