Lean Manufacturing of the Midframe Process

A Major Qualifying Project Report:

WORCESTER POLYTECHNIC INSTITUTE

General Electric Engine Services in Winfield, Kansas is a repair and overhaul site for the CT7 and T700 engine models. This plant desired to reduce their TAT for their midframe process from 60 to 30 days. Lean Six Sigma principles were used in order to attain this goal.

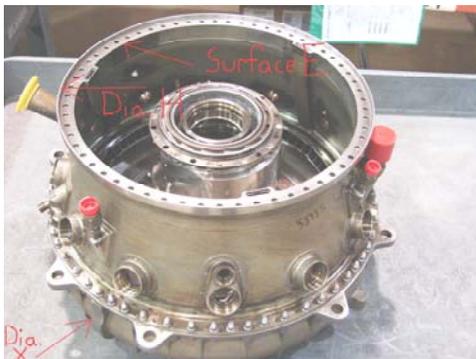
Figure 6.1.2.1 Midframe X, H, and E

The measurements are taken after the midframe has been chucked up on a lathe off Diameter X on the diffuser case (Refer to Figure 1 for location of the diameters and surface). The midframe is centered off one of the three rings in the BP Bore. If the diffuser case is not mounted to the midframe the B-sump which houses the BP Bore, it will be able to float around within the midframe making it impossible to center. The measurements of Diameter H and Surface E are recorded on the router and accepted or rejected depending on whether or not they are within the tolerance range. If the surface or diameter is out of range on the high end it will be machined down to be within the tolerance range. Most of the time at least one surface is undersized creating a need for it to be pre-machined and plasma sprayed.

Currently the midframes are broken down on the “As Received” router and then move through the shop on two new and different routers, one for the diffuser case and one for the midframe. The diffuser case will be cleaned and then have Diameter X plasma sprayed. The diffuser case will then finish up in the Midframe Rework Area and wait for the arrival of the its midframe. When the midframe catches up to the diffuser case, there is a sequence on the router to have them reassembled. After reassembly the midframe is routed to the machine shop where Diameter H and Surface E have the diameter and TIR measured.

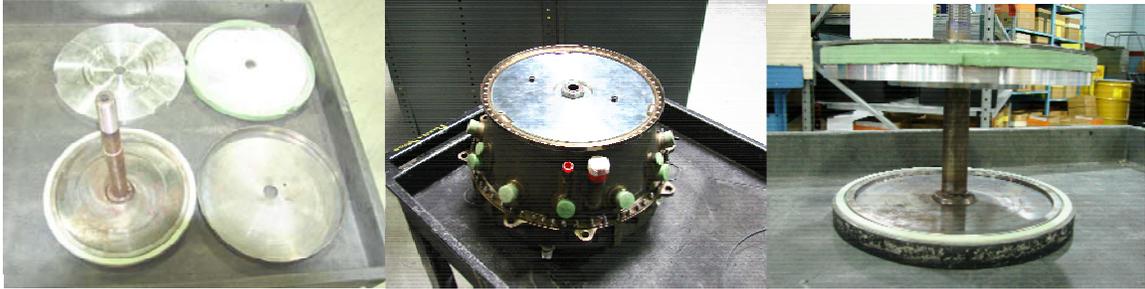
Figure 6.1.3.1 (Left) Tooling Pieces

Figure 6.1.3.2 (Center) Midframe with Tooling

Figure 6.1.3.3 (Right) Tooling

This way when the midframe and diffuser case are placed on the tooling they sit up a little higher until the top plates and gaskets are in place and the nut is tightened down. Once everything is tight the lower gasket has been crushed so that the lip of Diameter X is tight against the bottom plate. Last a piece of Lexan was cut so that it would fit over the tooling and cover the undesired areas from being sprayed with stencil ink. This version was tested with colored grit and found to be successful at keeping grit out of the midframe. The grit was dyed with a red food color to make it distinguishable between the grit used in different plasma spray operations. There was a slight problem when plasma spraying Diameter X though. The plasma built straight up and was hard to break off without chipping it below Diameter X. This was never a problem before because the over hang on the plate cause the plasma to step out and gave a surface to break the excess plasma spray on.

Knowing that the tooling worked keeping grit out the next step was to solve the problem of creating an area to break the plasma spray on. To solve this problem a cover was created that would sit on top of the diffuser case plate in the plasma spray booth. This cover would not be used during the grit blasting process and would get stencil inked before being place over the diffuser case plate. This cover is screwed on to keep from flying off during plasma spray and to make sure that it will only fit on one way. The cover creates an overhang like the plates currently in use and gives a surface to break the overspray on.
