Standards for Enclosed Canopies on Small Passenger Vessels

An Interactive Qualifying Project
Submitted to the Faculty of
WORCESTER POLYTECHNIC INSTITUTE
In partial fulfillment of the requirements for the
Degree of Bachelor of Science

Sponsoring Agency: United States Coast Guard

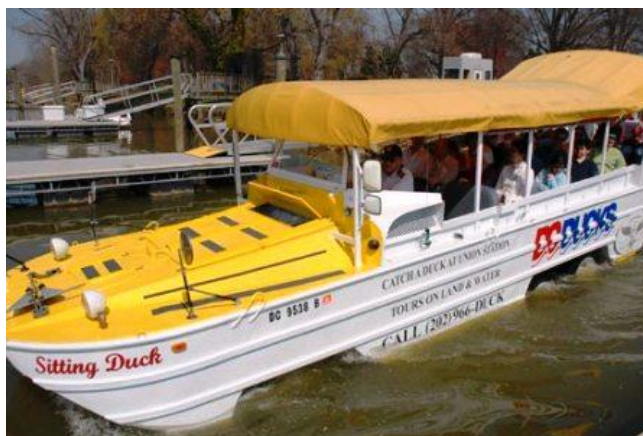
Many different kinds of vessel canopies are in use today, each varying in aspects of design, construction, and installation. Some canopies consist of canvas or vinyl supported by a metallic frame.

These canopies provide overhead shade and shelter while maintaining access to the open air. The DUKW shown in Figure 1 has an example of a canopy made of canvas.

Figure 1 - "Canvas canopy on DUKW" (Source: BigLorryBlog, 2009).

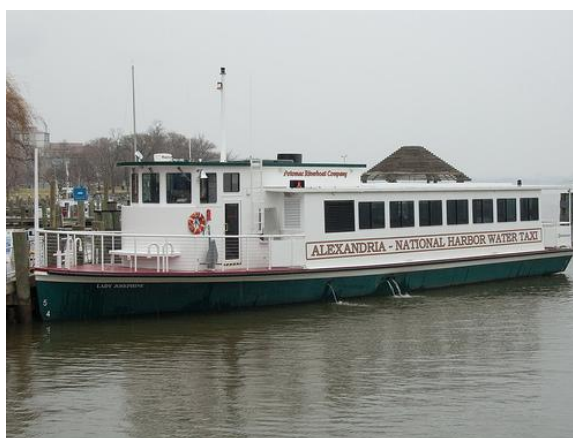
Other canopies, referred to as deckhouse enclosures, are permanent structures. These enclosures have walls and a ceiling, creating a small room aboard the vessel. There are often windows that passengers can open or close and doors that lead to an open deck. The water taxi shown in Figure 2 has an example of an enclosure.

Figure 2 – "Enclosure on a water taxi" (Source: Potomac River Boat Company, 2009).

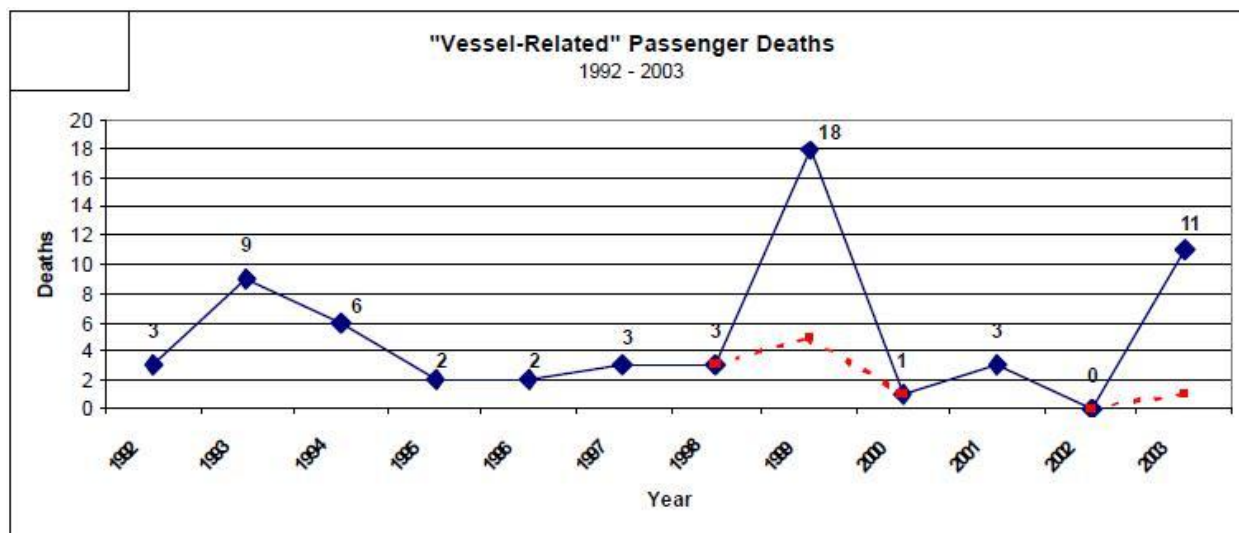
Between 1996 and 2003 there were 41 fatalities resulting from small passenger vessel casualties. There have been more fatalities on small passenger vessels, but these related to causes other than a specific vessel incident. Figure 3 is a graph outlining the number of vessel-related deaths. The high number of deaths in 1999 is a result of the Miss Majestic incident, in which thirteen people died, and the high number of deaths in 2003 is a result of the Taki-Too incident.

Figure 3 – “Vessel Related Passenger Deaths 1992-2003.” (Source: U.S. Department of Homeland Security, 2005, p. 9).

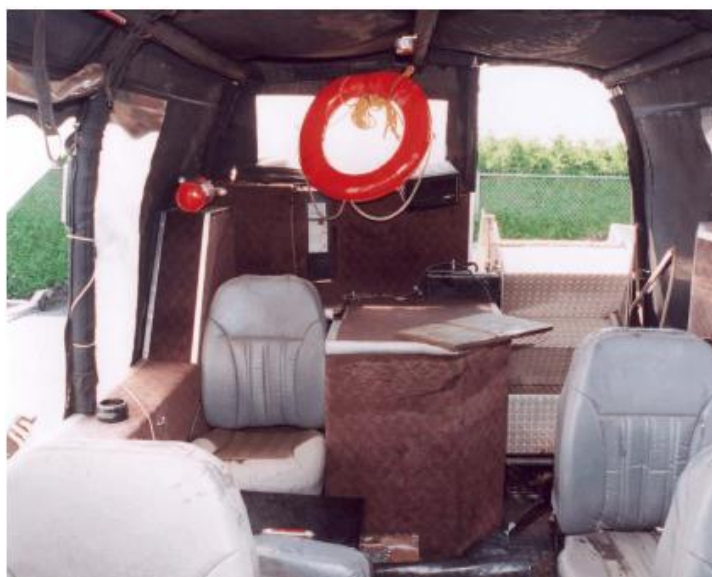
The Lady Duck was a Ford F-350 truck converted into an APV that sank in Gatineau, Quebec in 2002. The vehicle had a fabric canopy and roll-down transparent windows that provided shelter for passengers. This canopy limited passenger egress during the rapid evacuation and fatally injured 4 of the 12 passengers on board the vehicle. The Transportation Safety Board of Canada (TSB) incident report noted that two of the roll-down windows on the canopy were securely zipped in the lowered position upon recovery of the vessel, which impeded passenger egress through the windows. The congestion near the aft exits, as seen in Figure 12, inhibited passenger egress from within the canopy.

Figure 12: Stern of Lady Duck from inside the vehicle. (Source: Transportation Safety Board of Canada. 2004. p. 42).

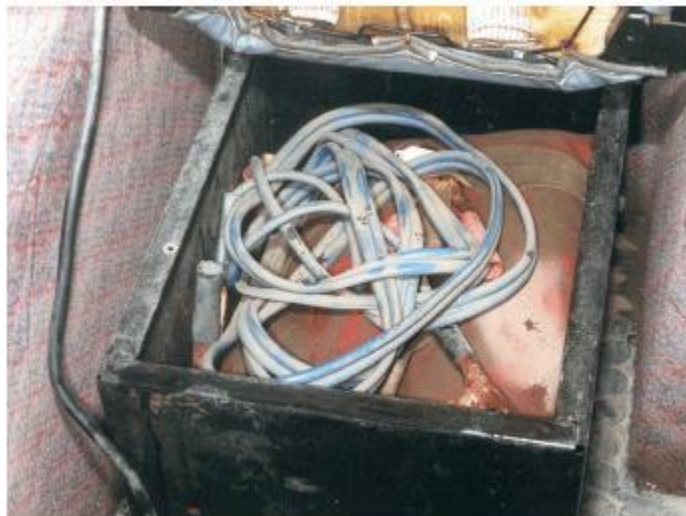
On the Lady Duck vehicle in Canada, the adults PFDs were stored under the seats and the child size PFDs were located at the stern of the vessel. The adult PFDs under the seats were not easily accessible because of the sharp metal edges on their storage boxes and the various items stored on top of the PFDs, as seen in Figure 13 below. Vessel operators also need to consider the locations of child size PFDs at the start of each voyage. If the children are sitting in the front of the vessel and cannot access the child size PFDs at the stern of the vessel, then operators should provide the children with PFDs at the start of the voyage. Conversely, if adults sitting at the stern of the vessel only have access to child size PFDs that will not support their weight in the water, then they need to have access to adult PFDs.

Figure 13: PFD with cables on top of it on Lady Duck. (Source: Transportation Safety Board of Canada, 2004, p. 40)

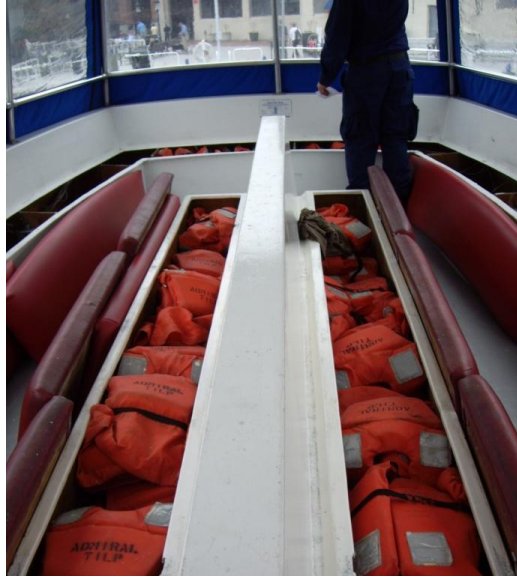
On the Admiral Tilp, a vessel we boarded in Alexandria, VA, we noticed how the location and access to PFDs could inhibit passenger egress on vessels. As seen in Figure 14 below, in order to access the PFDs on this vessel, passengers need to remove the seat cushions. By putting these cushions in the aisles, passengers are further narrowing the evacuation routes and preventing egress from within the canopy. For this vessel, the Officer in Charge, Marine Inspection (OCMI) could require that hinges attach seat cushions to the bench to ensure that the cushions do not block the aisles.

Figure 14: PFD storage on vessel in Alexandria, VA.

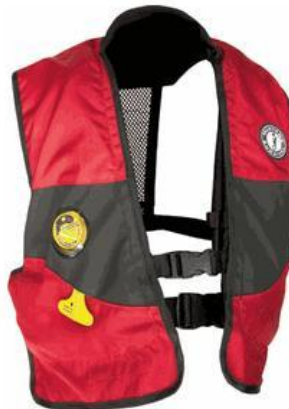
Because life jackets are vital to survival once a passenger has evacuated the vessel, we looked into the use of other types of PFDs such as inflatable PFDs and Type IV PFDs. Inflatable PFDs use carbon dioxide containers to automatically or manually inflate. Inflatable PFDs are less bulky than typical Type I PFDs. However, they are not suitable for non-swimmers and have hefty maintenance costs. The inflatable PFD we determined to be most effective is one with a hydrostatic release and LIFT Technology, seen in Figure 15 below.

Figure 15: Inflatable PFD (Source: <http://www.landfallnavigation.com/liftvestpfd.html>)

The hydrostatic release on this inflatable PFD automatically inflates the life jacket under water pressure and the LIFT technology allows the wearer's mouth to be 9 inches above the water, which keeps water out of his or her mouth in severe conditions. This inflatable PFD costs \$299.99 as compared to the same inflatable PFD without LIFT technology that cost \$229.99. LIFT technology would provide the

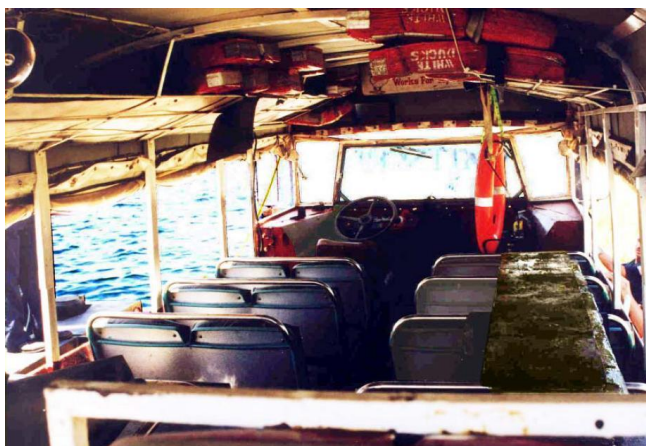
Subchapter T has regulations regarding passenger accommodations aboard SPVs (USCG, 2009c). It states that an aisle on an SPV must be 24 inches in width if the length of the aisle is less than 15 feet or 30 inches in width if the length is more than 15 feet. In determining if this is adequate, we considered the dimensions of the Miss Majestic vehicle. The aisle in the vessel was 18 feet 4 inches in length, which would mean the aisle width would need to be at least 30 inches. The actual aisle width was 12 inches, making the accommodations on board extremely cramped for the passengers. Subchapter T also states that the distance from seat front to seat front must be no less than 30 inches. On the Miss Majestic, the distance from seat front to seat front was 26 inches, restricting even more the movement of passengers. The discretion of the OCMI is very important in granting equivalencies for DUKW vessels due to their unique design. Following the Miss Majestic incident, the USCG wrote policy in the form of NVIC 1-01 to provide further guidance in this area. Figure 16 is the inside of the Miss Majestic vehicle.

Figure 16 - Post accident view of the Miss Majestic's main passenger compartment. (Source: USCG, 2001, p. 4)

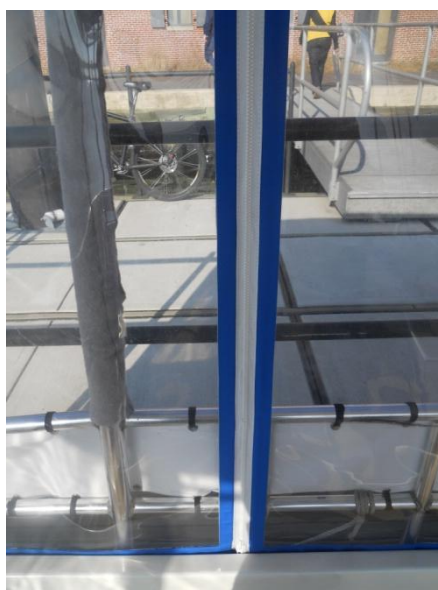
there be guidance similar to NVIC 1-01 for other SPVs, such as water taxis and small tour boats. NVIC 1-01 gives marine inspectors and DUKW owners a better understanding of what to do to DUKW vessels to make them safe for passengers. Owners and manufacturers now attempt to comply fully with this guidance. Frank English of Ride the Ducks explained that all DUKW vessels manufactured by Ride the Ducks have quick release windows (personal communication, November 5, 2009). Since the DUKW industry has implemented NVIC 1-01 almost fully and successfully, we will attempt to find parallels between DUKWs and other SPVs, such as water taxis. On the Baltimore Commuter Taxi, we noticed that the only way to open the side curtains was to unzip them, which we determined might not have been easy during an emergency. Figure 17 is the zipper used to open the side curtains on the Baltimore Commuter Taxi.

Figure 17 - Canopy zipper on Baltimore Commuter Taxi

The canopy on the Baltimore Commuter Taxi is similar to a canopy found on DUKW vessels. Because of this similarity, it is possible for these types of vessels to have the quick release feature recommended for DUKWs in NVIC 1-01. The USCG recommends in NVIC 1-01 that DUKW owners either have their canopies approved with a quick release feature or remove the canopy completely. On

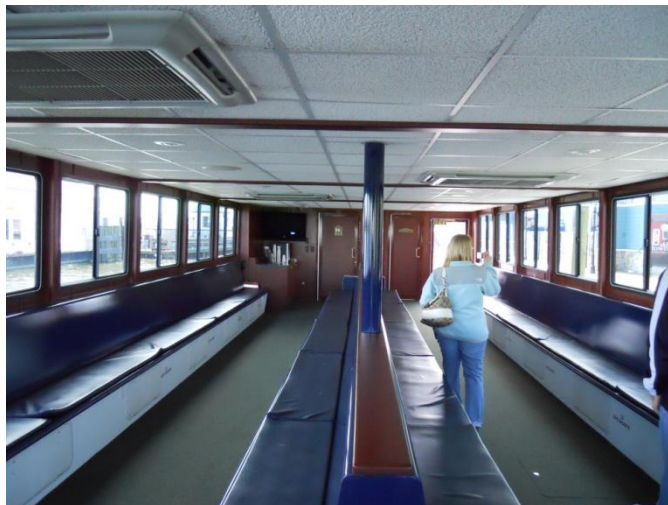
Whether it is doors or windows, a passenger must be able to open easily any means of escape in the event of an emergency (USCG, 2009c). After boarding several vessels, we became aware that this is not always the case. When we rode the Commander Jacques water taxi in Alexandria, VA, we tried to open the windows and found that it was extremely difficult to do so. There were also two doors located on the vessel, one at each end, which were the emergency exits. We realized that if passengers filled the taxi and we were sitting in the middle of the vessel, we would need to use the windows rather than the doors in order to escape during an emergency. Figure 18 shows the inside of the Commander Jacques.

Figure 18 - Inside Commander Jacques

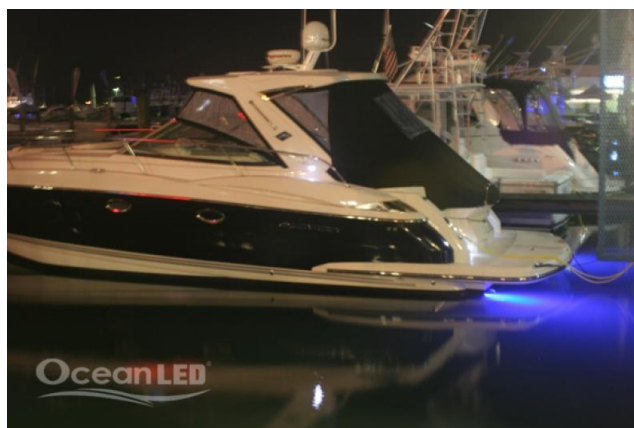
Underwater Kinetics (2009) has manufactured high performance underwater lights since 1971. On their website, they state, "...LED light penetrates water better than light from conventional incandescent lamps allowing greater visibility underwater." Underwater Kinetics primarily uses the LED technology to manufacture dive lights, but it is important to note their use of LED lighting. Another company, OceanLED (2009), also manufactures underwater LED lighting. They mainly manufacture lights that recreational boat and commercial vessel owners install on the outside of the vessel for aesthetic purposes. One of the lines of lights they manufacture, the Pro-Series, penetrates up to nearly 50 feet in average water conditions, depending on the model. The least expensive model, which penetrates up to 10 feet in average water conditions, is the X-520. Figure 19 is a boat that has two X-520 LED lights installed on the back.

Figure 19 - Monterey with 2 x X520s Blues. (Source: OceanLED, 2009).

Based on our analysis of incandescent and light-emitting diode (LED) lights, we recommend that vessels should have underwater LED lights, similar to those manufactured by OceanLED, which allow passengers to locate the exits. This light should be either blue or green, to allow for maximum visibility by most passengers. The master can control the light from the operator station, similar to the way the master operates the quick release feature on DUKW vessels.

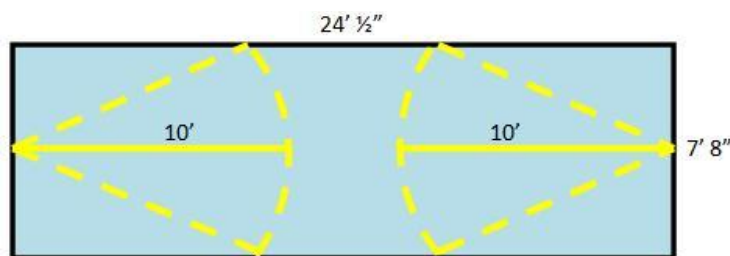
After comparing the different prices and light penetrations, we analyzed how effective this type of light would have been on Lady D. According to the NTSB report of the Lady D casualty, one passenger said he “...could not see anything in the murky water” (NTSB, 2006b). The deckhouse on the Lady D was 24 feet, ½ inch long and 7 feet, 8 inches wide. There were two doors in the deckhouse located at each end of the vessel and six windows on each side. Some survivors of the casualty told investigators that they escaped by opening the windows and jumping out, while other survivors said they were able to get to the door to escape. Had there been an OceanLED Pro-Series X-520 light, or a similar light, located above the each door at either end of the vessel, it is likely passengers would have been able to locate the doors. The light would have penetrated approximately 10 feet, almost half the length of the vessel. Figure 20 is an approximate scaled model of the Lady D deckhouse with the distance the lights would have most likely penetrated. The dotted lines represent how wide the light could have penetrated, but since there is no clear method of calculating this, we estimated using the typical path of light.

Figure 20- Possible Light Penetration on Lady D Deckhouse

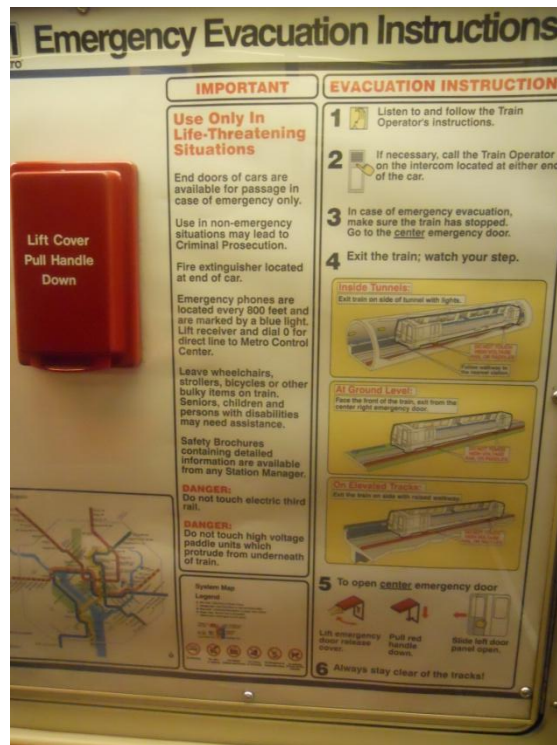
Figure 21 - Emergency Evacuation Instructions on the Washington, D.C. Metro

This signage indicates the procedures to follow in case an emergency were to occur on the train and evacuation became necessary. It is very detailed and includes all the relevant information a passenger would need to know to carry out an evacuation. However, this signage also relies heavily on text, which research has found to be a relatively ineffective way of communicating information to passengers. The aviation industry has done a better job of implementing pictograms into signage to explain to passengers what they must do during an emergency. Figure 22 shows an example of a safety brochure provided to all passengers on a JetBlue flight. This signage relies much more heavily on the concept of pictograms to convey information, and follows the principle of focusing on actions by showing series of pictures completing important evacuation procedures.

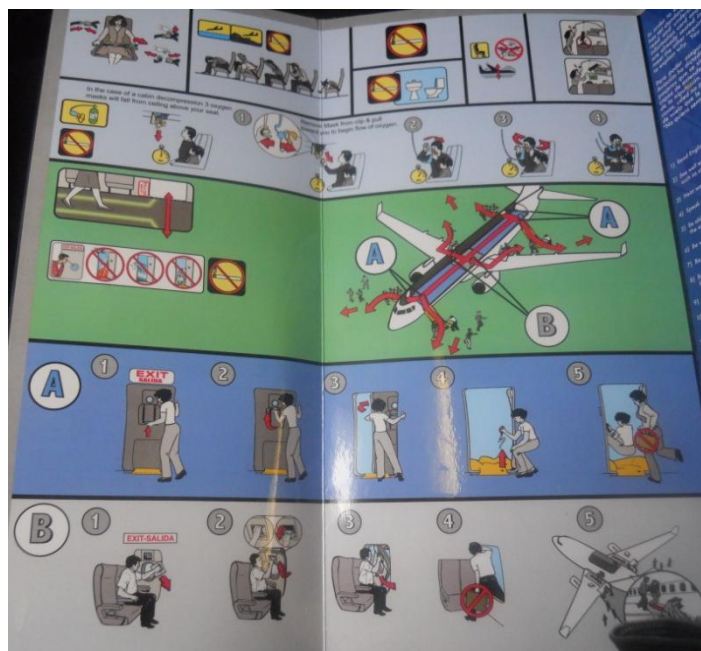
Figure 22 - JetBlue Safety Information Brochure

Vessel owners could apply these principles used in signage on airplanes to the signage that they use on their vessels to include information on evacuation procedures. There are two possible ways for vessel owners to accomplish this: through individual brochures and through bulkhead signage. Since the designs of different SPVs are often unique, vessel owners may need to have custom-made signage designed and ordered for use on their vessels. The cost of developing such signage would be minimal, and there would only be minimal maintenance costs to replace signs that may become worn and difficult to read. While some types of signage, such as the proper method for donning a life jacket, could follow the same standard for all small passenger vessels, the unique design and operation of many SPVs may prevent vessel owners from developing standardized signage for evacuation information. In some cases, vessel owners may need to design their signage to have information specific to their vessel, requiring custom-made signs that may have a higher cost. Appendix D shows some examples of signage that vessel owners could display on their SPVs.

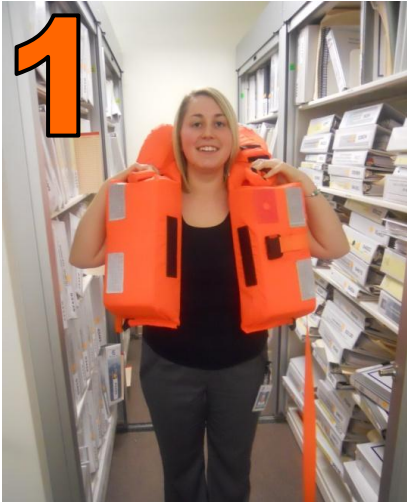
Place PFD over head

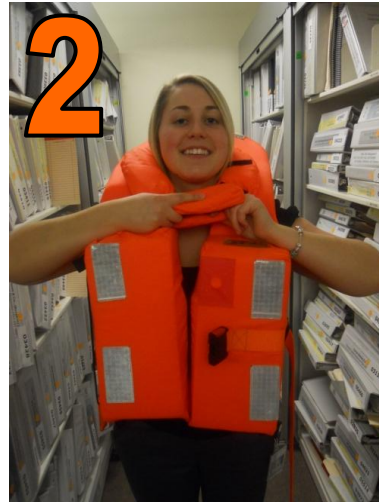
Secure neck ring

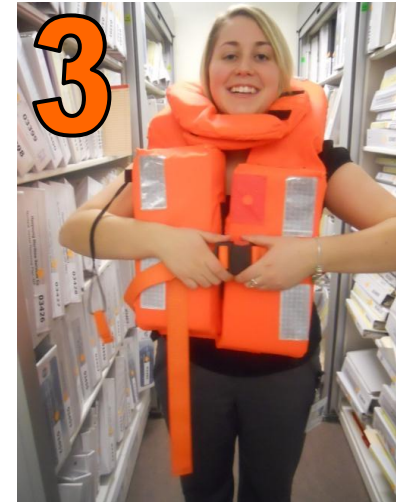
Bring strap around body and fasten closure

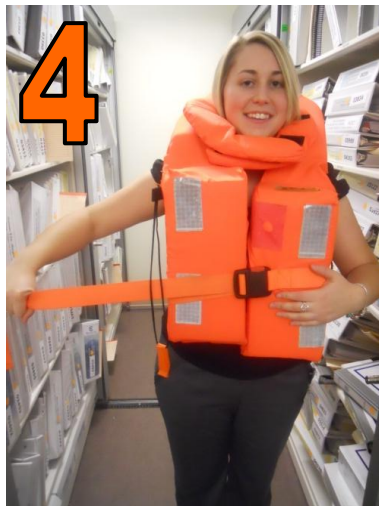
Adjust to a snug fit by pulling free end of strap

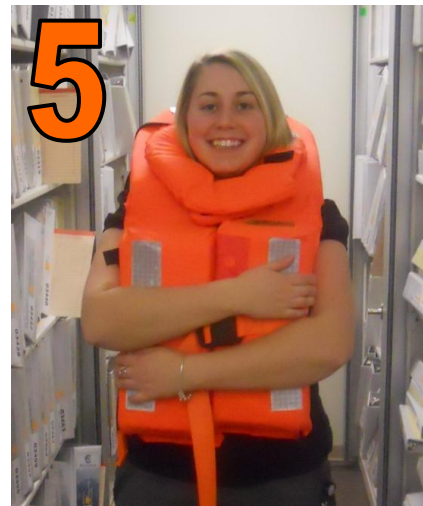
Cross arms across chest and enter water feet first
