Evaluating the Vulnerability of Boston's Inner Harbor Designated Port Areas to Sea Level Rise and Coastal Storms

An Interactive Qualifying Project Report
Submitted to the Faculty of the
WORCESTER POLYTECHNIC INSTITUTE
in partial fulfillment of the requirements for the

Degree of Bachelor of Science

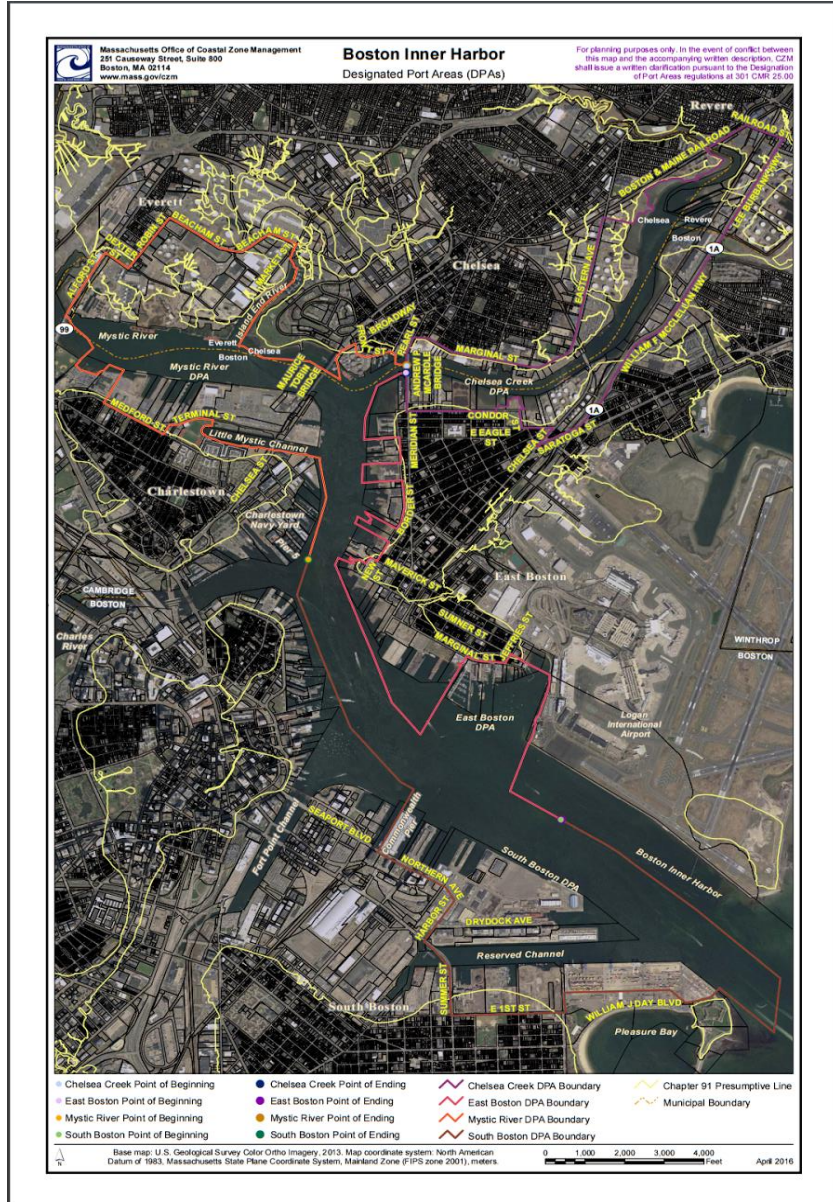
Figure i: Inner Boston Harbor DPA Boundaries courtesy of Massachusetts Government. (2016). Chapter 91, The Massachusetts Public Waterfront Act | MassDEP. Retrieved April 24, 2017

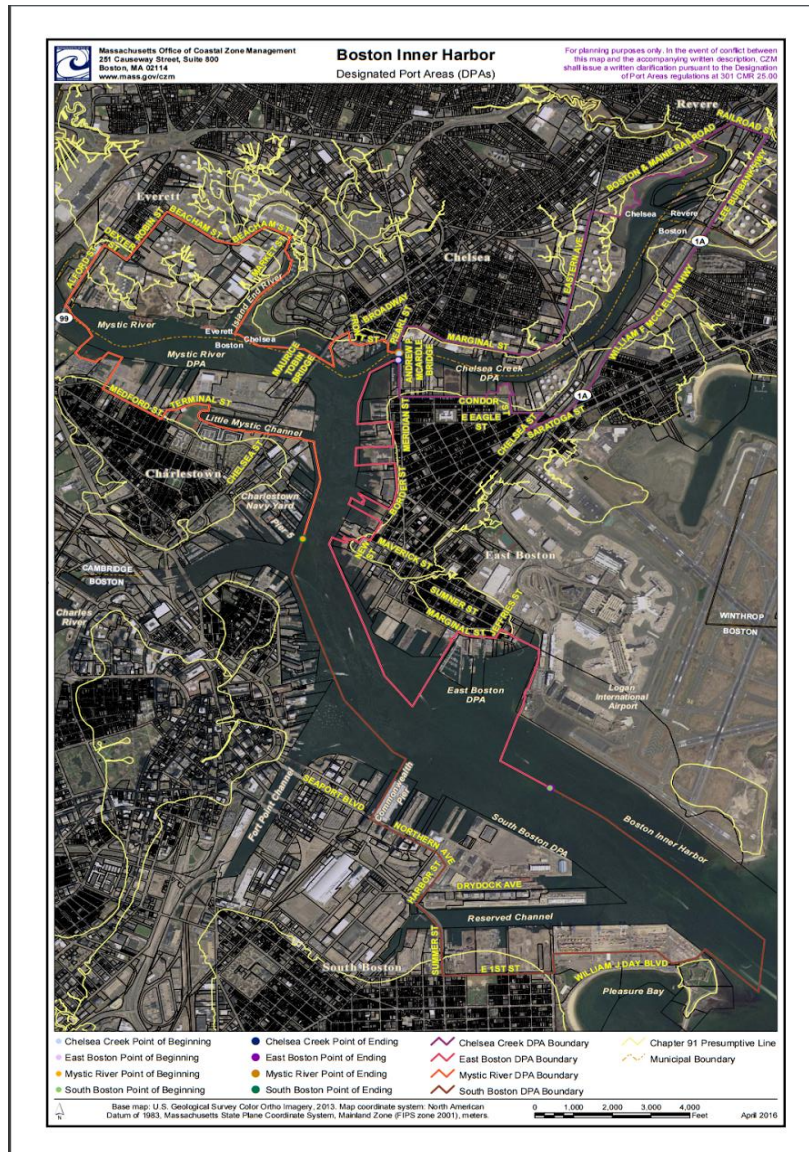
Figure 1: Inner Boston Harbor DPA Boundaries courtesy of Massachusetts Government. (2016). Chapter 91, The Massachusetts Public Waterfront Act | MassDEP. Retrieved April 24, 2017.

DPAs ensure that water dependent industries have access to Boston Harbor. There are 10 DPA's in Massachusetts, four of which will be the main focus of this project: Mystic River (Appendix A), Chelsea Creek (Appendix B), East Boston (Appendix C), and South Boston (Appendix D). A map of all four DPAs being investigated by our team can be seen in Figure 1. A variety of industries utilize access to the waterfront that these DPAs provide. Some examples of industries within the DPAs are commercial fishing and processing, fuel transportation and storage, as well as import and export businesses.

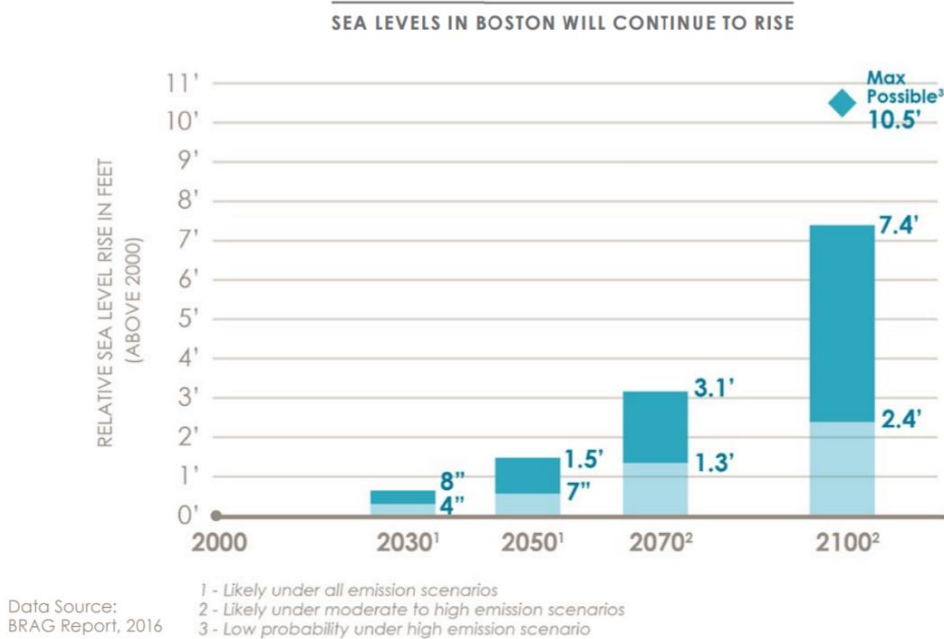
Cities along coastal Northeastern United States are predicted to encounter escalating sea level rise (SLR). In the Northeast, the relative sea level has risen by approximately one foot, since 1900, which has caused more frequent flooding of coastal areas (Climate Change in the Northeast, 2016). Boston’s sea level is predicted to have a minimum increase of 2.4 feet and a maximum of 7.4 feet, by the year of 2100, as shown in Figure 2 (Climate Ready Boston, 2016). Reducing Boston’s SLR to less than 2.4 feet. by the end of the century would require massive and unprecedented cuts in greenhouse gases worldwide (Climate Ready Boston, 2016). The lower end of this range assumes moderate cuts in global greenhouse gas emissions, with the upper end of this range assuming no changes in global emissions. SLR is driven by a combination of melting land ice, the expansion of water as its temperature increases, and changes in the amounts of water extracted from below ground or stored behind dams (Climate Change Indicators: Sea Level, 2014). Most of the coastal Northeast is expected to exceed the global average sea level rise due to local land subsidence, with the possibility of even greater regional sea level rise if the Gulf Stream weakens (Chapter 16 Northeast, 2014). Rising sea level will result in areas within coastal cities, such as Boston, to become more vulnerable to flooding by exacerbating impacts accompanied with storm surge.

Figure 2: Predicted Sea Level Rise in Boston From: (2016). Climate Ready Boston, | City of Boston. Retrieved April 24, 2017

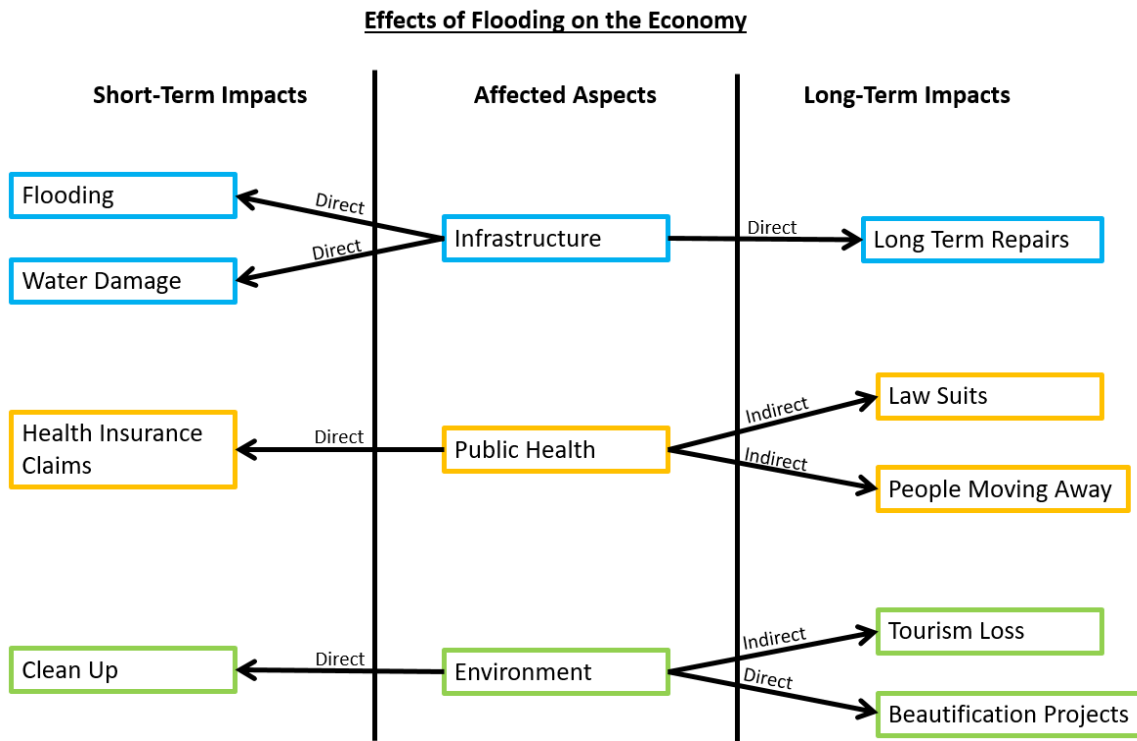
Figure 3: Effects of Flooding on Boston’s Economy

The economy of a region can be affected directly and indirectly by a changing climate. In the above sections, some of the general impacts of sea level rise, flooding, and storms have been described. In the end, all of these impacts can subsequently affect the economy of a region. Some effects from flooding will be more immediate, while others may take a while to appear and be fixed. Figure 3 below shows some of the potential long term or short term impacts that can come from flooding to coastal cities. If important structures fall into disrepair, then they will need to be repaired (Massachusetts Department of Conservation and Recreation, 2009). When Texas was

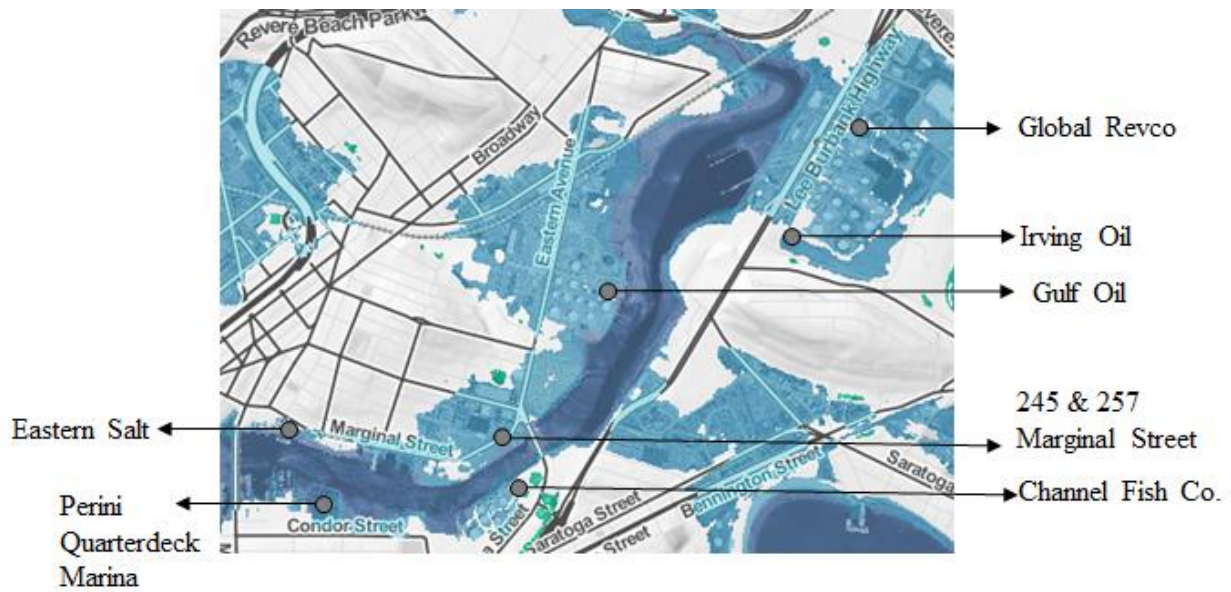
The exposure to SLR and coastal storms greatly increases the vulnerability of the majority of parcels within Boston's working port. With moderate cuts in carbon emissions, the likely amount of sea level rise by the year 2100 is 5 ft (Global Climate Change, n.d.). Of the investigated parcels, 88% are expected to be underwater by 2100. With the DPA's situated directly on the water, they are more exposed to the effects of SLR and coastal storms than other areas of Boston. Figures 4-7 are maps of the four DPA's, showing the predicted flood zones (PFZ) during 5 ft SLR.

Figure 4: Chelsea Creek DPA Flood Zone From: (2017). *Surging Seas: Risk Zone Map*, | NOAA. Retrieved April 5, 2017

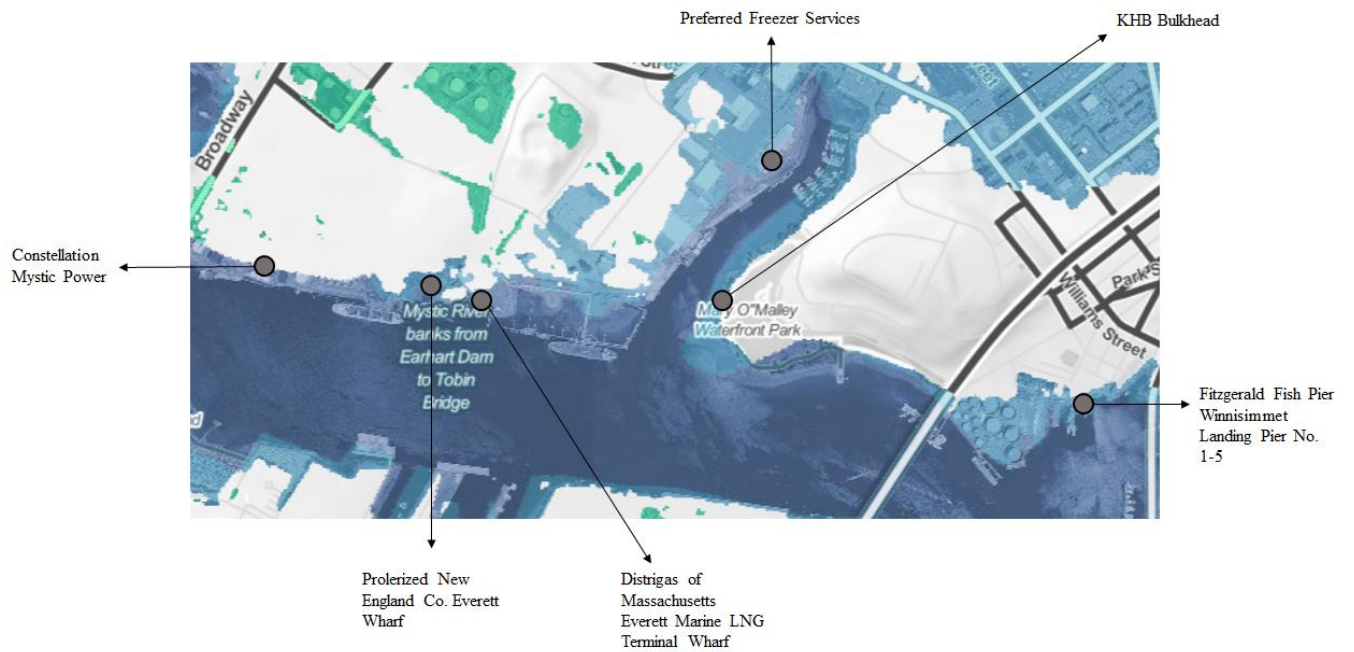
Figure 5: Mystic River DPA Flood Zone From: (2017). *Surging Seas: Risk Zone Map*, | NOAA. Retrieved April 5, 2017

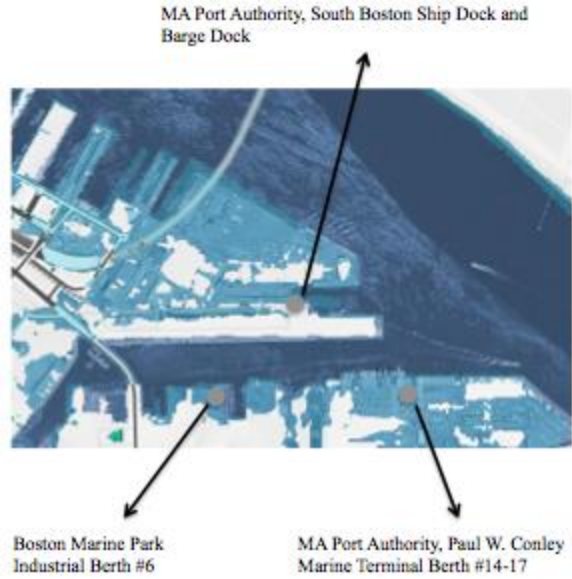
Figure 6: South Boston DPA Flood Zone From: (2017). *Surging Seas: Risk Zone Map*, | NOAA. Retrieved April 5, 2017

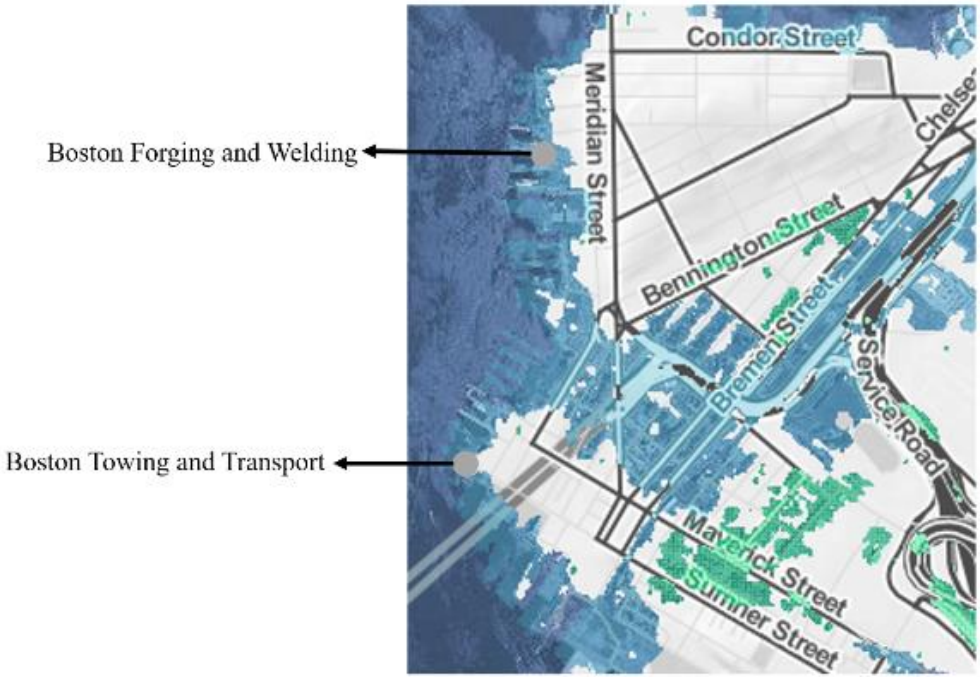
Figure 7: East Boston DPA Flood Zone From: (2017). *Surging Seas: Risk Zone Map*, | NOAA. Retrieved April 5, 2017

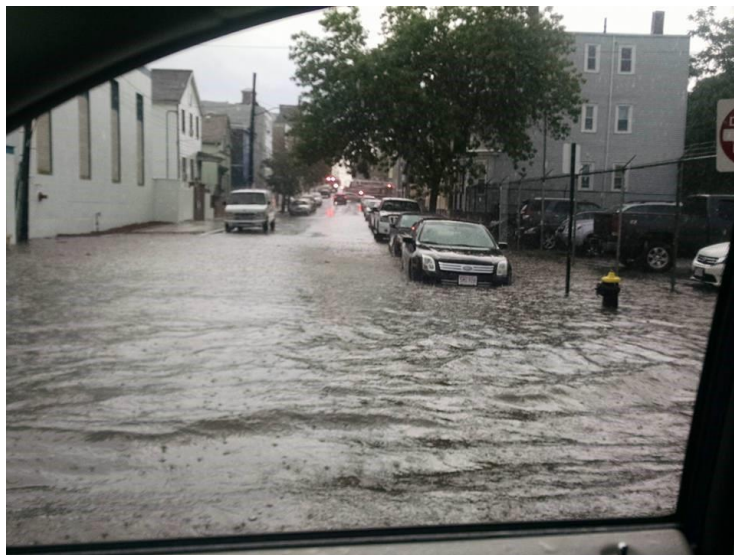
Channel Fish Co. is located in the East Boston DPA, with direct access to the waterfront along Chelsea Creek. The East Boston area has been prone to serious erosion along the coast, and is located within the boundaries of the PFZ with regards to 5 feet SLR, shown in Figure 7 above. The representative stated that his business has been prone to flooding in the past, with an example of this flooding shown below in Figure 8. In regards to flooding on this property, the representative said “It’s been pretty severe at times: the most recent occurrence on Aug. 2, the standing water was about a foot tall. It’s also gotten into our basement in the past.”

It is evident this business located within the DPA has extreme exposure to flooding, increasing its overall vulnerability to SLR and coastal storm surge.

Figure 8: Flooding Within East Boston August 2, 2017 From: Margaret Farmer

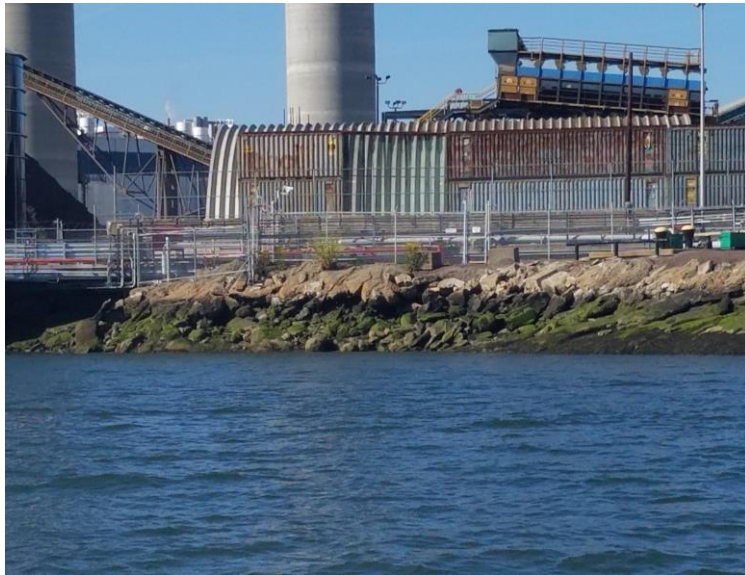
During our water taxi tour, we were unable to visit all of the parcels from our sample due to limited time and travel restrictions. We were able to look at some SLR preventative infrastructure near some of the sites. Figure 9 shows riprap located on Prolerized. It can be seen that the high water mark on the rocks is more than halfway up the structure. We were not able to gain the exact measurements of the height of the rip rap, but we can safely estimate there is less than 5 feet of riprap above the high water mark. This is concerning due to the fact that 5 feet of SLR is expected by 2100, and if coastal storms hit the area, they will most likely experience more than 5 feet of coastal storm surge, resulting in the Prolerized site being flooded. Similar flooding would be experienced at the Eastern Salt site under the same future conditions. As seen in Figure 10, the Eastern Salt parcel has bulkheads. However, the high water mark is also located less than 5 feet from the top of the structure. The quality of SLR prevention infrastructure on these sites demonstrates the exposure to SLR and coastal storms, adding to the vulnerability of these working port areas.

Figure 9: Riprap located at Prolerized

The committee should have a set of regulations to enforce on the DPA businesses. The two regulations that we are recommending this committee enforce are: that chemicals and hazardous materials used by businesses within the DPAs must be stored in flood-proof containers, and that more frequent inspections and repairs be performed on the SLR prevention infrastructure within the DPAs. The first regulation would reduce business sensitivity to SLR and coastal storms by reducing the risk of chemical spills. The second regulation would reduce the business's exposure to SLR and coastal storms by ensuring that the SLR prevention infrastructure on the sites are up to date and in good condition.

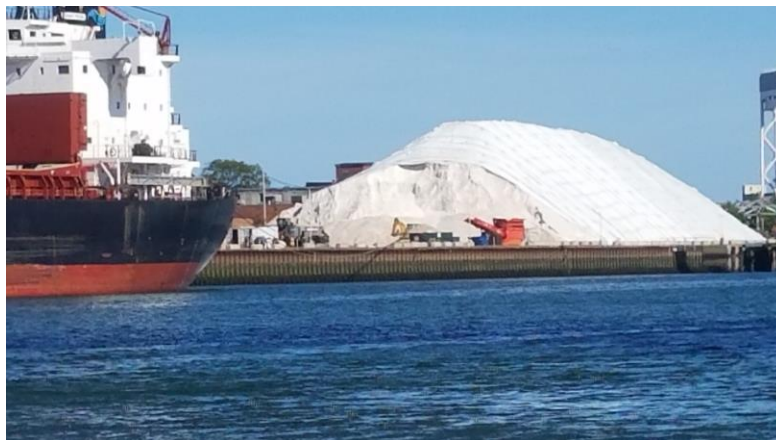
Figure 10: Bulkhead located at Eastern Salt

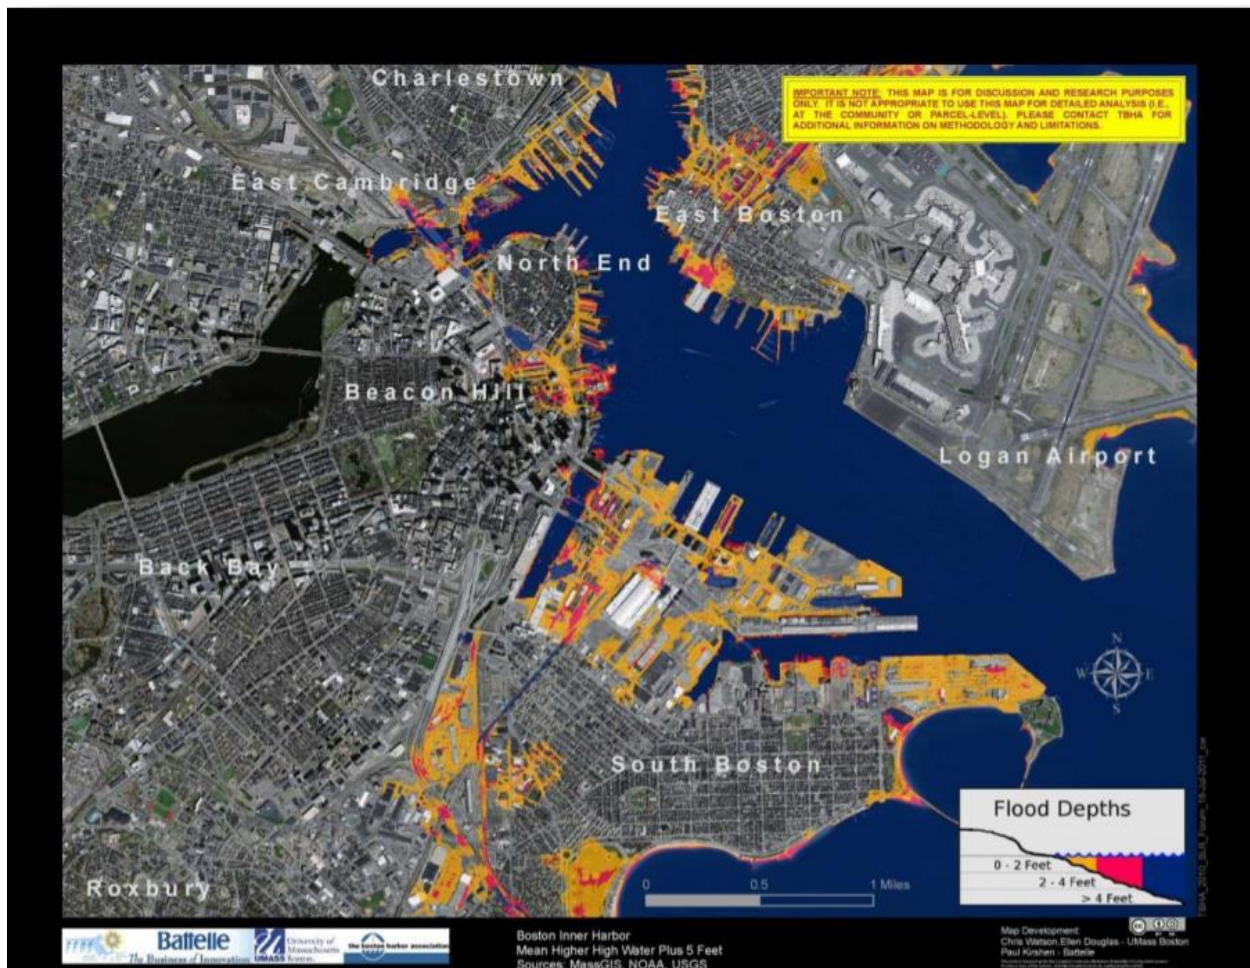
To complete our initial vulnerability assessment of the given DPA's parcels we utilized the Surging Seas: Risk Zone Map to gather information about potential flood zones. Using this source we were able to gather some preliminary information about sea level rise and its effects on the harbor, but no detailed information such as flood depths were available for our group. According to Paul Kirshen, a professor at the University of Massachusetts Boston, the Surging Seas: Risk Zone Map uses the "bathtub model" to predict sea level rise. This model is not the most detailed and or accurate ways to predict sea level rise. As we neared the end of our project, we were given access to an extremely accurate sea level rise viewer that is not open to the public, courtesy of the Massachusetts Department of Transportation. Due to the lack of time we were not able to utilize these GIS maps to their fullest potential. An example of this GIS can be found below in Figure 11. We recommend that whoever continues this research within the DPA's should utilize this resource as it will add extremely accurate and in depth data.

Figure 11: Potential Flooding of 5 Feet with Spring Tide From: given citation (2017). MassDOT-FHWA Pilot Project Report, | Bosma *et. al.*. Retrieved October 3, 2017

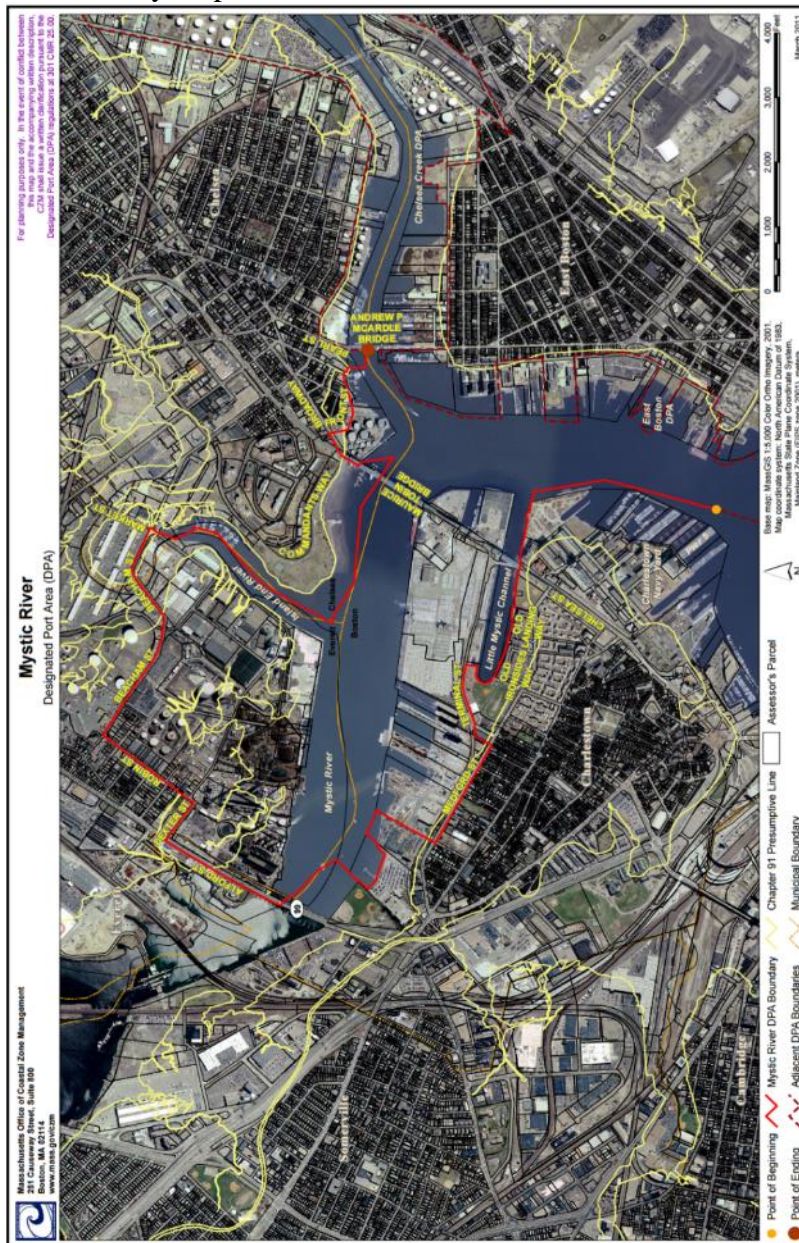
Appendix A: Mystic River DPA Boundaries

Mystic River DPA Boundaries courtesy of Massachusetts Government. (2016). Chapter 91, The Massachusetts Public Waterfront Act | MassDEP. Retrieved April 24, 2017.

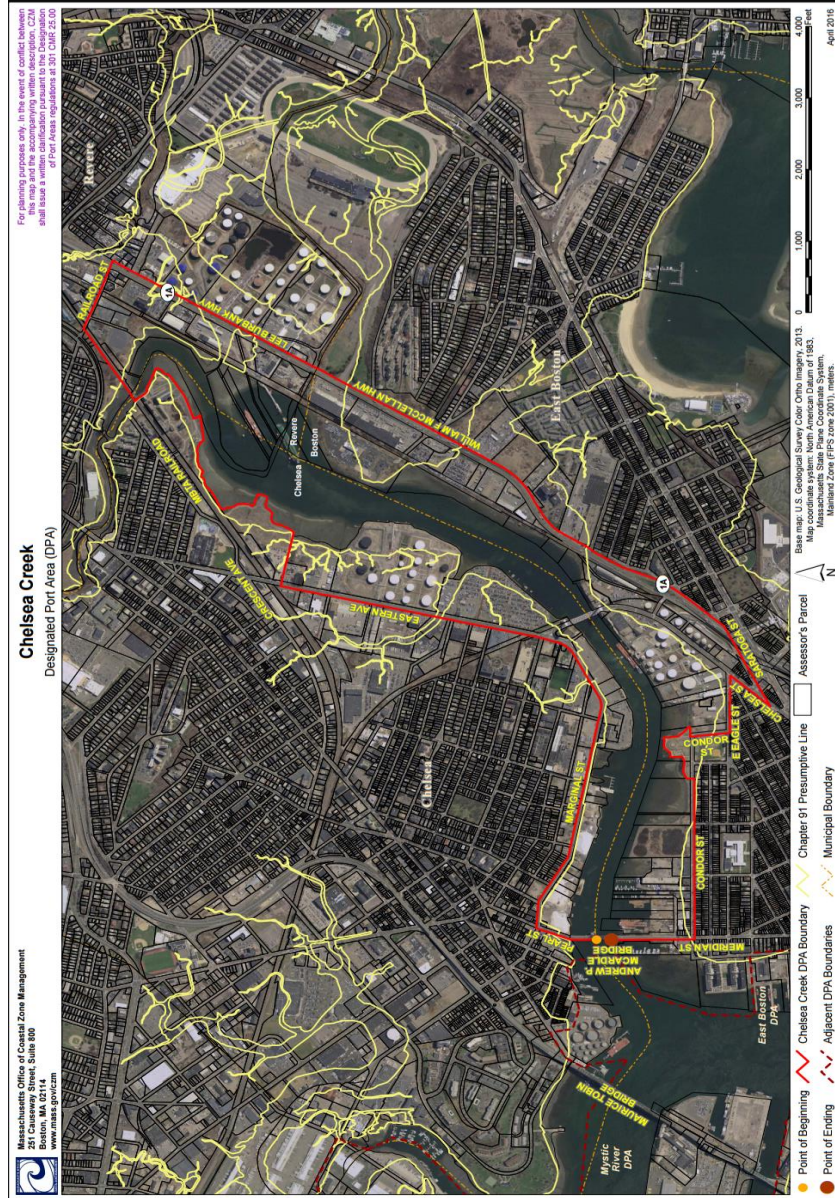
Appendix B: Chelsea Creek DPA Boundaries

Chelsea Creek DPA Boundaries courtesy of Massachusetts Government. (2016). Chapter 91, The Massachusetts Public Waterfront Act | MassDEP. Retrieved April 24, 2017.

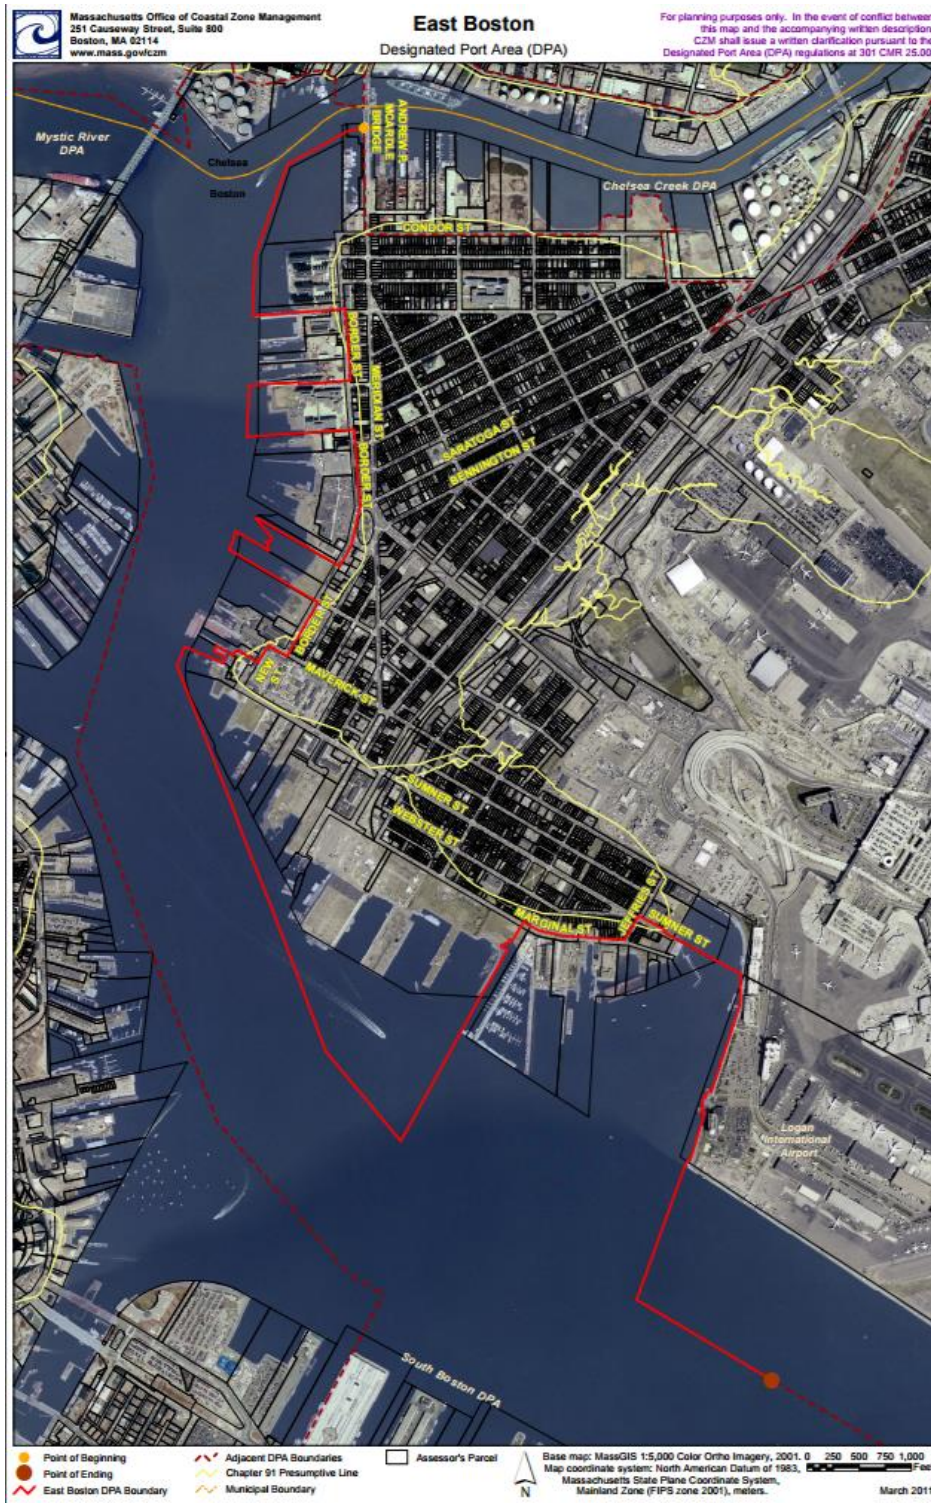
Appendix D: East Boston DPA Boundaries

East Boston DPA Boundaries courtesy of Massachusetts Government. (2016). Chapter 91, The Massachusetts Public Waterfront Act | MassDEP. Retrieved April 24, 2017

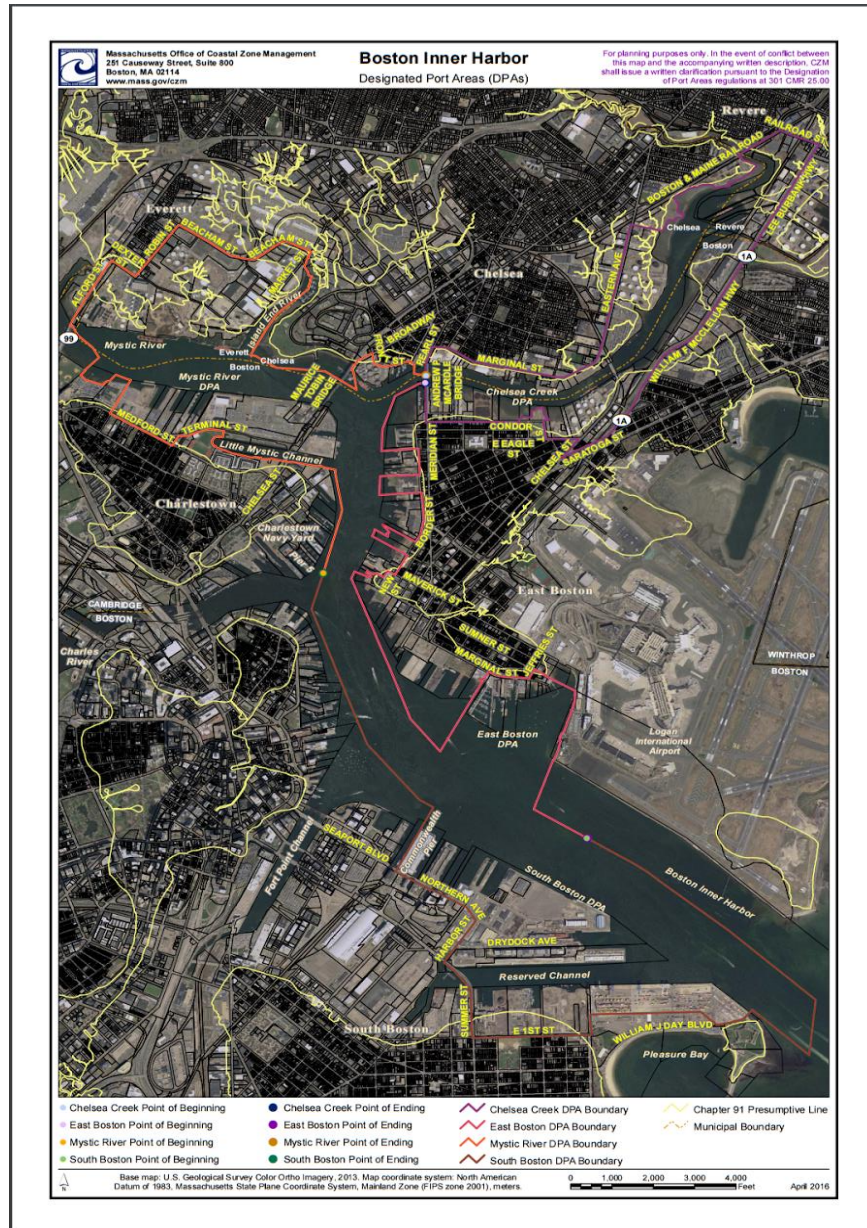
Appendix E: Boston Inner Harbor DPA Boundaries

Inner Boston Harbor DPA Boundaries courtesy of Massachusetts Government. (2016). Chapter 91, The Massachusetts Public Waterfront Act | MassDEP. Retrieved April 24, 2017.

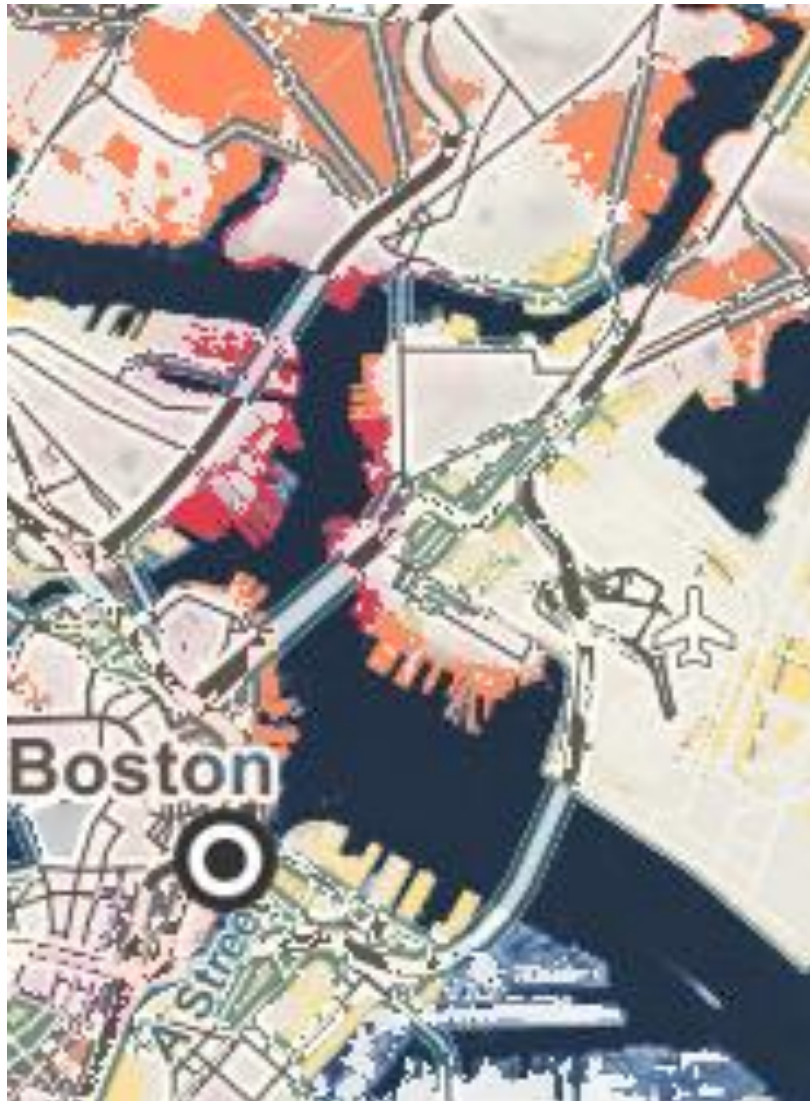
Boston Inner Harbor Vulnerability Population Exposure Map From: (2017). *Surging Seas: Risk Zone Map*, | NOAA. Retrieved April 5, 2017

This map defines social vulnerability as the ability of communities to prepare and respond to hazards like flooding. "High" and "low" indicate the 20% most and least vulnerable in coastal areas of each state during a 5 ft. SLR scenario. The yellow color represents low exposure, orange represents medium exposure, and red represents high exposure. Census tract resolution data. Data source: Hazards and Vulnerability Research Institute (HVRI)'s Social Vulnerability Index. (Map layer currently available only within the U.S.)

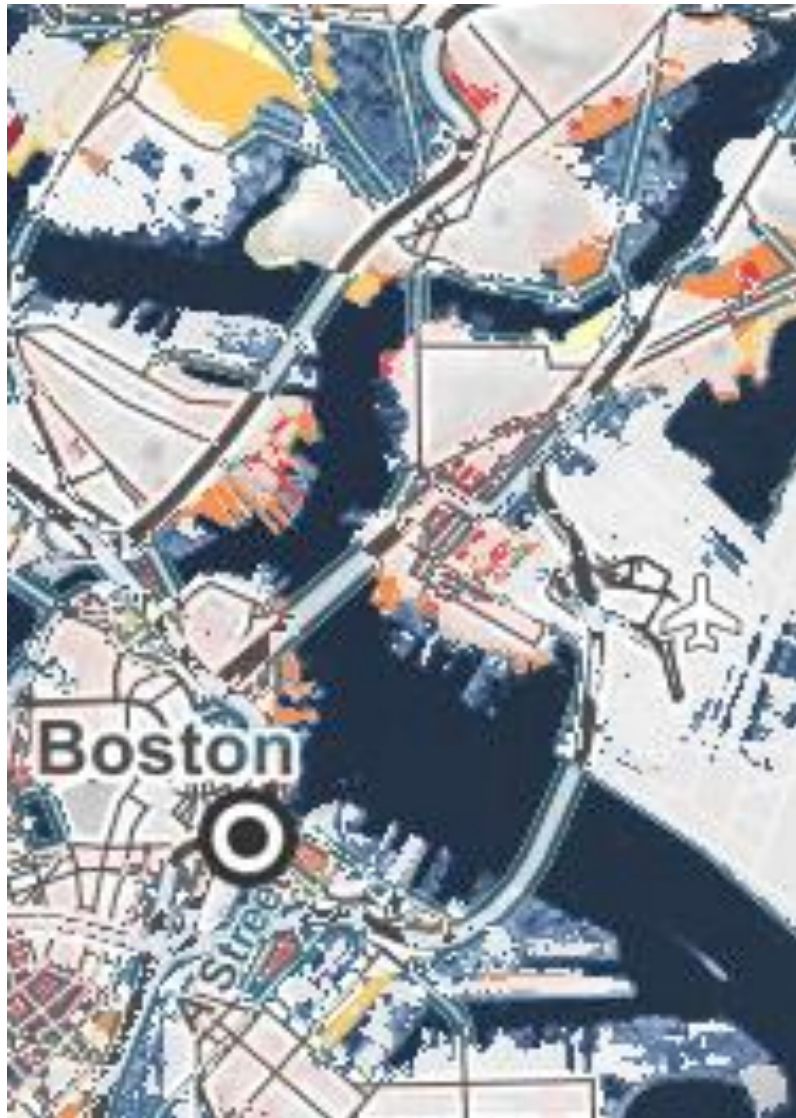
Boston Inner Harbor Affected Population Map From: (2017). Surging Seas: Risk Zone Map, | NOAA. Retrieved April 5, 2017

This map shows the people per square mile exposed to flooding events during 5 ft SLR. The key for this map can be seen below.
