## **A Protocol for Evaluating Lighting Practices and Light Pollution in Coastal Locations**

An Interactive Qualifying Project proposal to be submitted to the faculty of  
Worcester Polytechnic Institute in partial fulfillment of the requirements for the  
Degree of Bachelor of Science

December 18, 2014

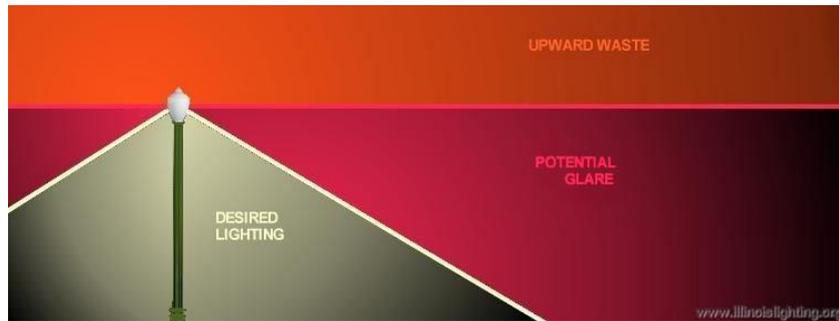
**Figure 2: Diagram of light trespass.** The section labeled “desired lighting” is the only beneficial light being emitted from the lamp. The purple area represents “potential glare” and the orange section represent “upward waste” which is a major contributor to sky glow.  
<http://www.illinoislighting.org/fixture1.html>

Light trespass is the most common form of light pollution and has varying spatial effects. Also referred to as spill light, or obtrusive light, light trespass occurs when light spills over its necessary boundaries into an area where light is unwanted or needed. A simple diagram of light trespass can be seen in Figure 2. Sky glow is a growing global phenomenon resulting from thousands of fixtures that each emits a portion of light directly upward into the sky where light scatters and cumulatively increases nighttime illumination. This scattering of light causes the brightening of the sky with an orange yellow glow which can be seen in Figure 3. Glare is any intense and blinding light that reduces visibility. In order to qualify as glare the light within the field of vision must be brighter than the eyes can adapt to (Figure 4). This is caused by poor lighting angles and shielding. Poor lighting techniques can also cause light clutter which, can be defined as an excessive grouping of lights well beyond what is required for necessary sight. All of these

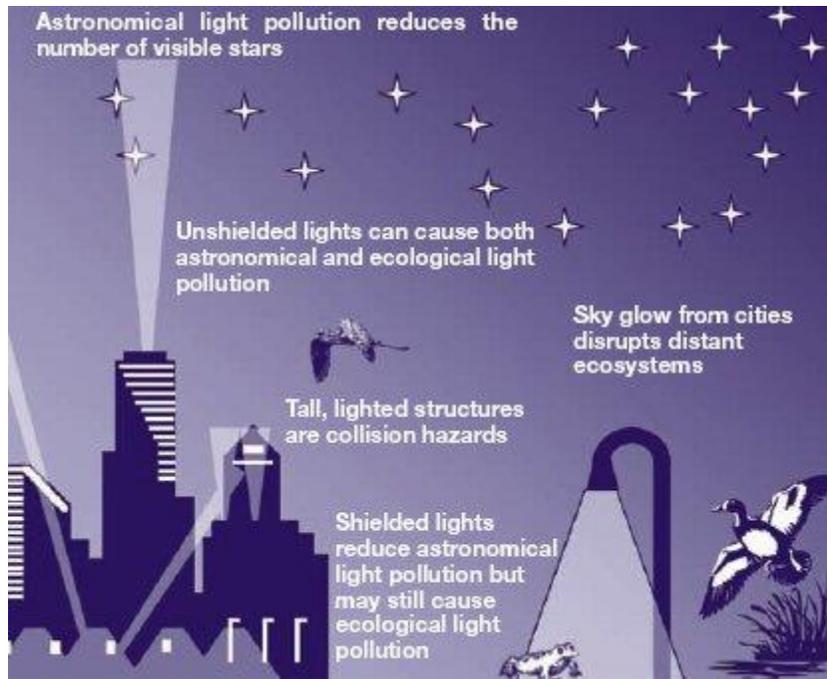
Figure 5: Diagram showing the causes and consequences of astronomical light pollution (Longcore & Rich, 2004)

Unlike astronomical light pollution, ecological pollution is a fairly new concept. It is lighting that alters natural light regimes in ecosystems, and is recognized as a major stressor for nocturnal organisms and a threat to biodiversity (Figure 5) (Kuechly et al., 2012). Ecological light pollution includes direct glare, chronically increased illumination and temporary unexpected fluctuations in lighting. Sources of ecological light pollution include but are not limited to lighted buildings and towers, streetlights, fishing boats, security lights, lights on vehicles, flares on offshore platforms, and light on undersea vessels (Longcore et al., 2004).

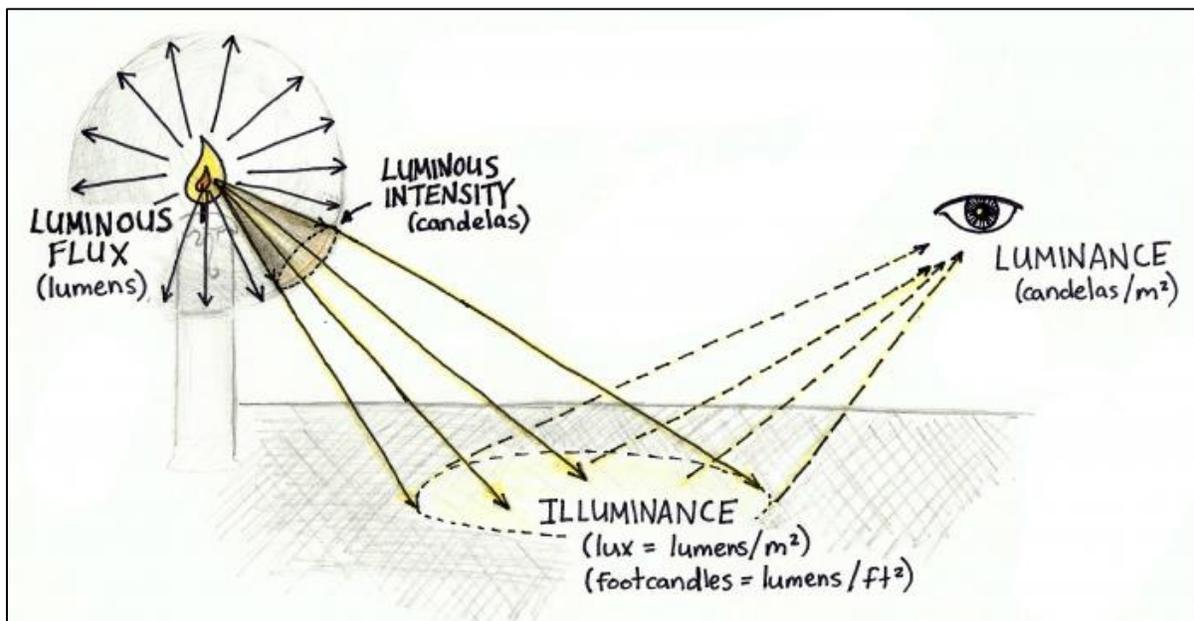
Figure 6: Basic metrics of light  
<http://sustainabilityworkshop.autodesk.com/buildings/measuring-light-levels>

Light follows what is known as the inverse-square law (Danby et al., 2011). For example, the flame from a candle will cause an illuminance of 1 lux on an object one meter away, but if this object is put two meters away it will only cause one fourth the amount of lux (Danby, et al., 2011). Figure 6 below is an excellent visual representation of this terminology.

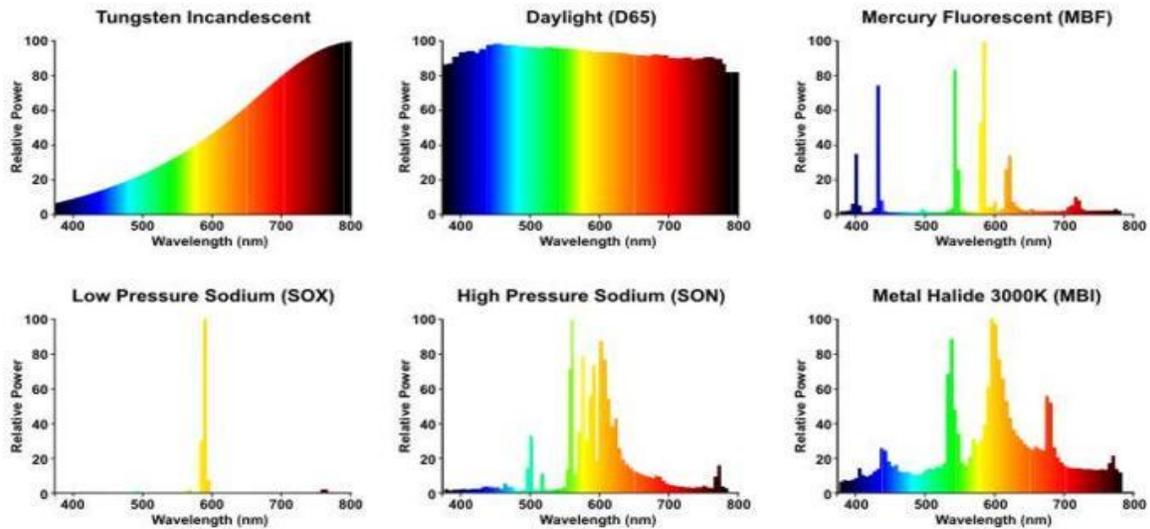
Figure 8: Spectrum and relative intensity of different bulbs and natural daylight  
<http://www.lamptech.co.uk/Documents/SO%20Spectral.htm>

Low-pressure sodium bulbs, or LPS bulbs, emit a yellow almost monochromatic light as can be seen in Figure 8 when compared to other common forms of lighting. The yellow wavelengths have less harmful effects than the blue or red wavelengths, which makes it ideal for lights such as street lights that will be on for most, if not all of the night. In addition, the monochromatic nature of LPS bulbs is a useful characteristic for astronomers as it is easier to filter out of astronomical observations than the complex spectrum emitted by fluorescent, incandescent, or metal-halide luminaires. Filtering light is a common practice in astronomy that is used to determine the conditions the light was emitted under. For example filtering out all light except for red and blue and examining the relative quantities of each color is used to calculate the temperature of a star (Luginbuhl, 2003). As long as astronomers do not need data from the spectrum that LPS light reside in, there is little to no interference with their studies.

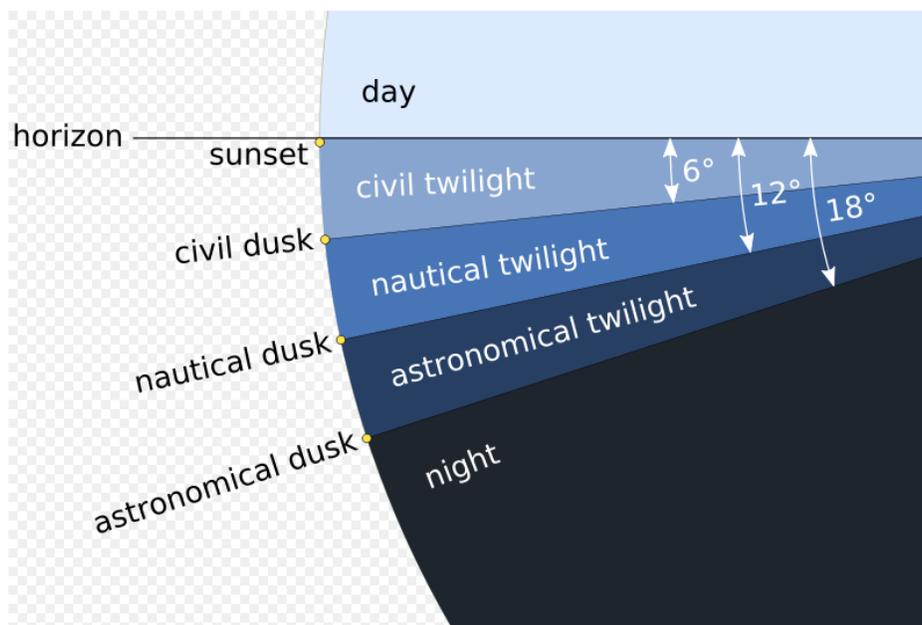
Figure 14: Twilight Sub-categories

To accurately measure the brightness of the sky without interference, measurements have to be taken after astronomical twilight and the moon has set (Carello et al., 2014). The moon is bright enough to interfere with light levels readings, therefore measurements cannot be taken until the moon has set. Astronomical twilight also interferes with light levels. Astronomical twilight, as illustrated in Figure 14, is the period when the sun is above a point 18 degrees below the horizon. During this time, the sun is illuminating the sky to some degree. Afterwards, the sky is only illuminated by the moon, stars, and artificial luminaires. When creating a sampling schedule, nights when the moon has set after astronomical twilight are selected so that it does not contribute to the overall brightness of the night sky.

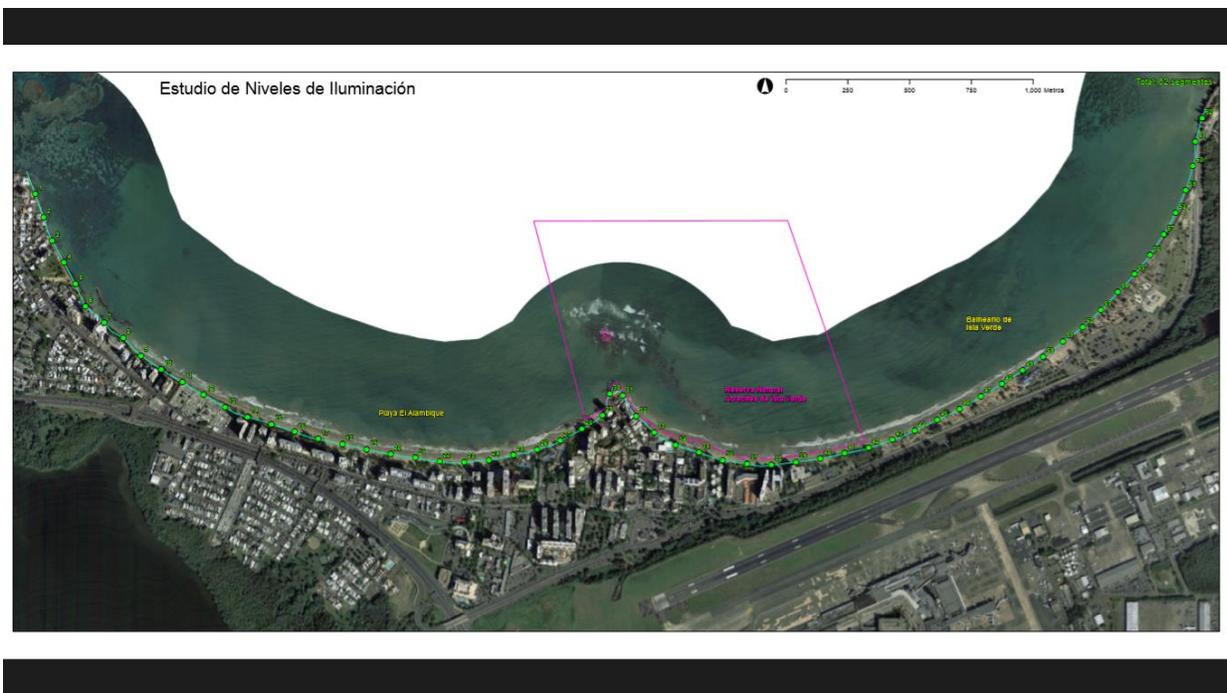
**Figure 16: Example Aerial Map of Selected Data Points along a Coastal Region**

system was first used much of the square was in the water. To accommodate this, our team decided that a point system along the coast was better suited than a 100x100 meter square system. Still using the GIS program single points were selected to be the center point of each 10x10 meter quadrant rather than dividing the entire coast into 100x100 meter squares than again into 10x10 meter quadrants. Seen below in Figure 16 the aerial map marks a green point every 100 meters along the desired coast. Each point has corresponding coordinates of latitude and longitude. The coast may be divided into multiple phases depending on the location. The purpose of dividing the coast into phases is to establish spatial priority to account for time constraints.

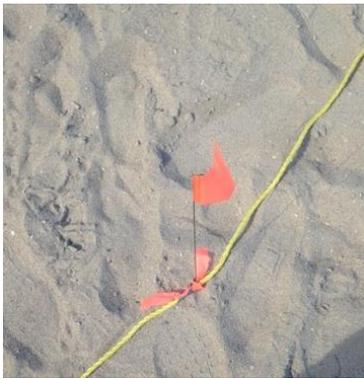
Figure 17: Place the center of the diagonal rope on the center

testing the initial preparation, the process for finding the corner points of the perimeter proved to be slow and inefficient. Our team developed a new strategy which included a diagonal rope that allowed our team to mark of the northwest and southeast corners of the quadrant Figures 17, 18 and 19. After these two corners were marked, the northeast corner could be found by connecting two 10 meter ropes, one to the northwest and one to southeast corners. Both 10 meter ropes were stretched out and where the ends met was the northeast corner. This same process was done to find the southwest corner. This system proved to be very effective and was very time efficient.

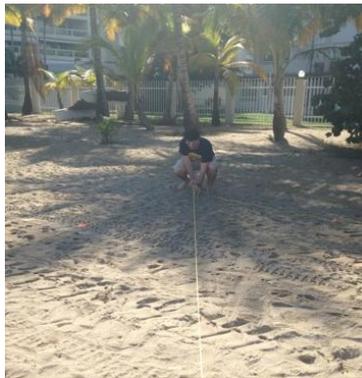
Figure 18: Mark off the northwest and southeast corners

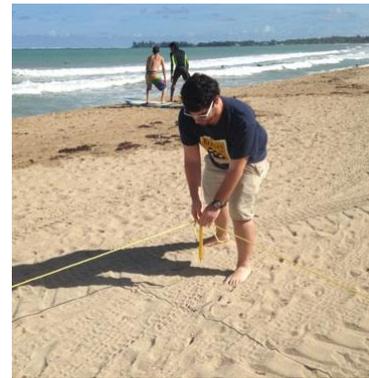
Figure 19: Mark off the northeast and southwest corners

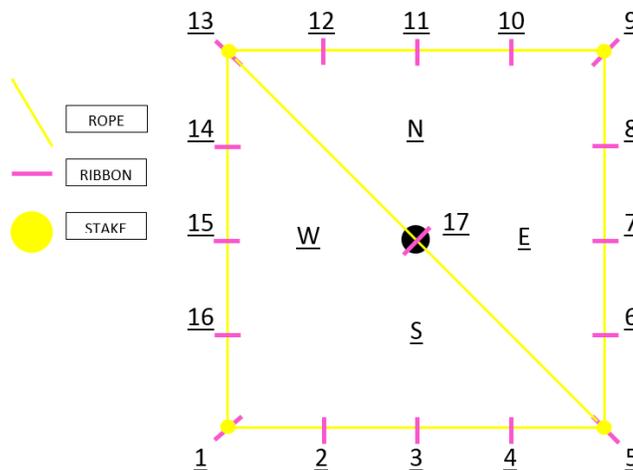
1. Place a stake in the center of the quadrant.
2. Take the 14.14-meter rope and align the center point on the rope with the center of the quadrant.
3. Using a compass, place one end in the northwest corner of the quadrant and the other end in the southeast corner. Stake each end into the ground.
4. Loop two 10-meter ropes around each of the two stakes you just put into the ground. All four 10-meter ropes should now have one loop around a stake.
5. Take the other ends of the 10-meter ropes to the approximate locations of the northeast and southwest corners of the quadrant. Now there should be two loops in each of these corners.
6. Put a stake through these two loops. Pull the ropes taut and put the stake into the ground.

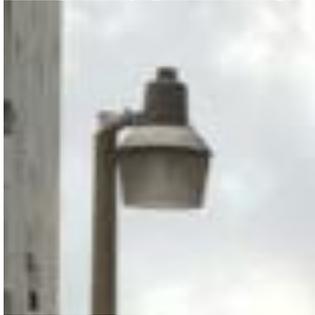
- Improper Shielding: Shield fully encompasses the bulb but does not prevent light from traveling above the horizontal due to the angle

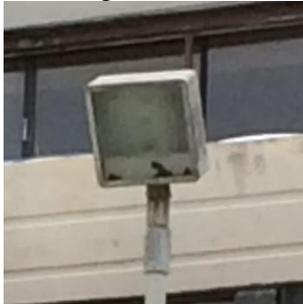
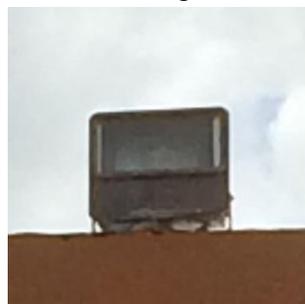
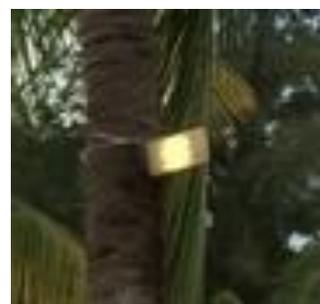
- Not Shielded: No shield present

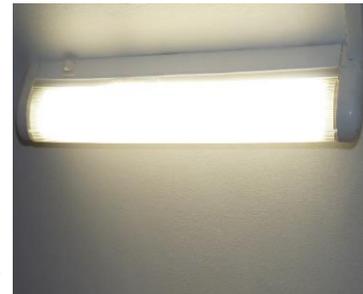
- LED
  - Produce white light
  - Can produce red, green or blue light
  - Does not emit light in all directions
  - Useful for specified area lighting
  - More efficient than Fluorescent and Incandescent
  - Higher cost
  - Low light output, need multiple LED's for a lamp

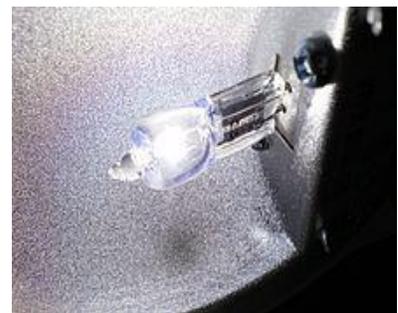
- Incandescent
  - Work well for lighting small areas
  - Low cost
  - No toxic materials
  - Not very efficient
  - Low lifespan
  - Produce yellow light color

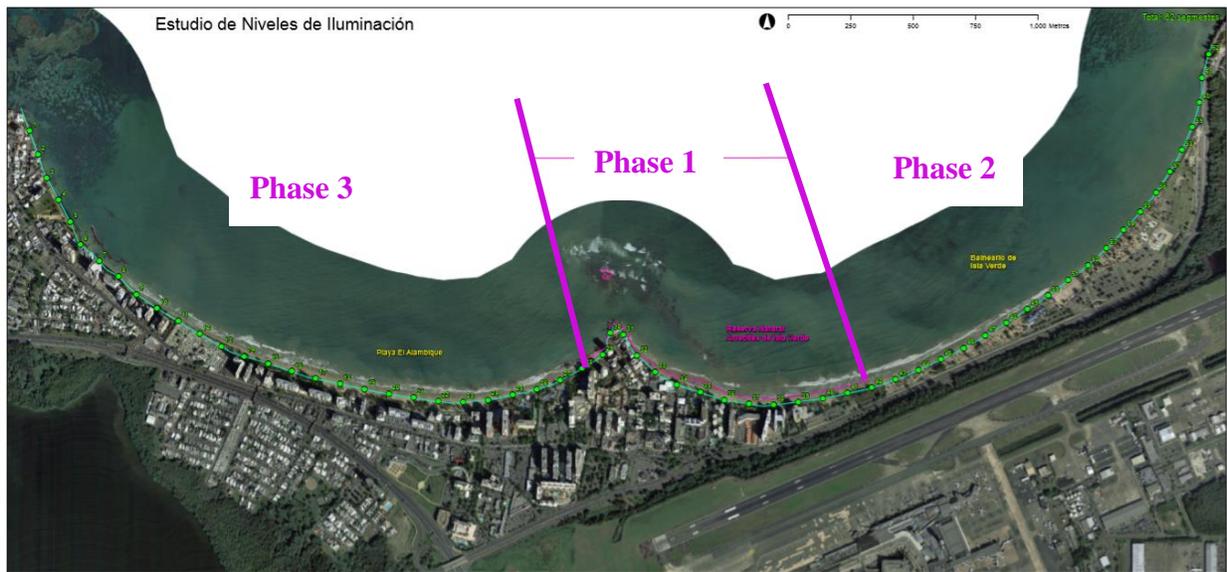
**Figure 21: Aerial map of selected data points on coast of Isla Verde. Phase 1 is located between the purple lines, Phase 2 is to the right of the purple lines and Phase 3 is to the left of the purple line**

The Management Program of the Coastal Zone of the Department of Natural and Environmental Resources identified points for our study using a GIS program to mark an aerial map of Isla Verde. The map marks a point every 100 meters along the coast, resulting in a total of 46 points. Figure 21 below shows the entirety of Isla Verdes coast followed.

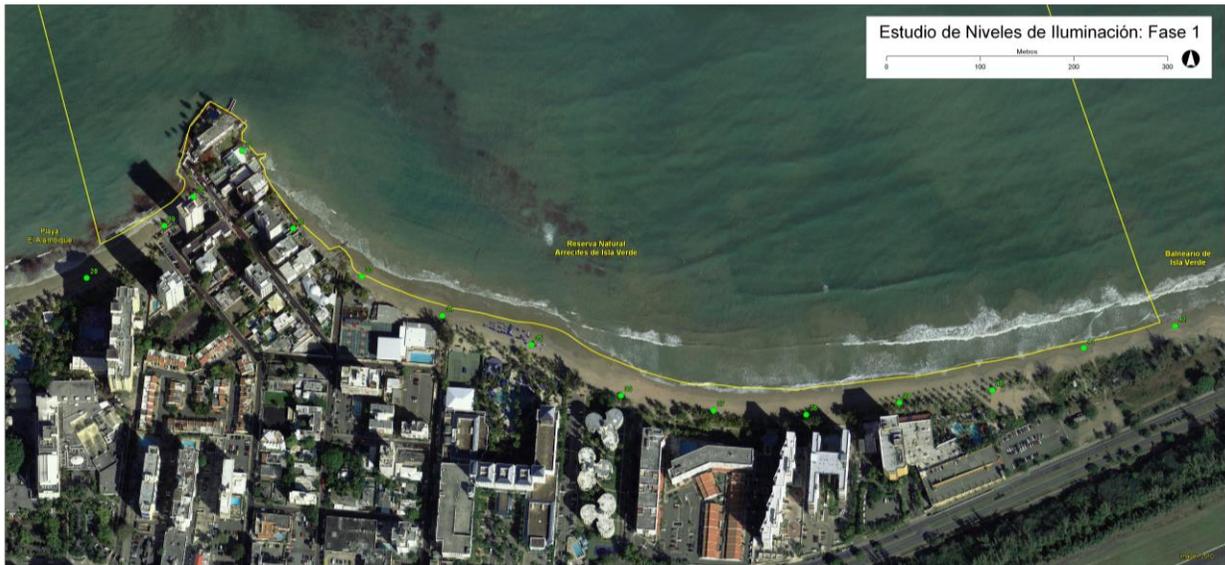
Figure 21b: Aerial Map of Phase 1, Site Numbers 28-42

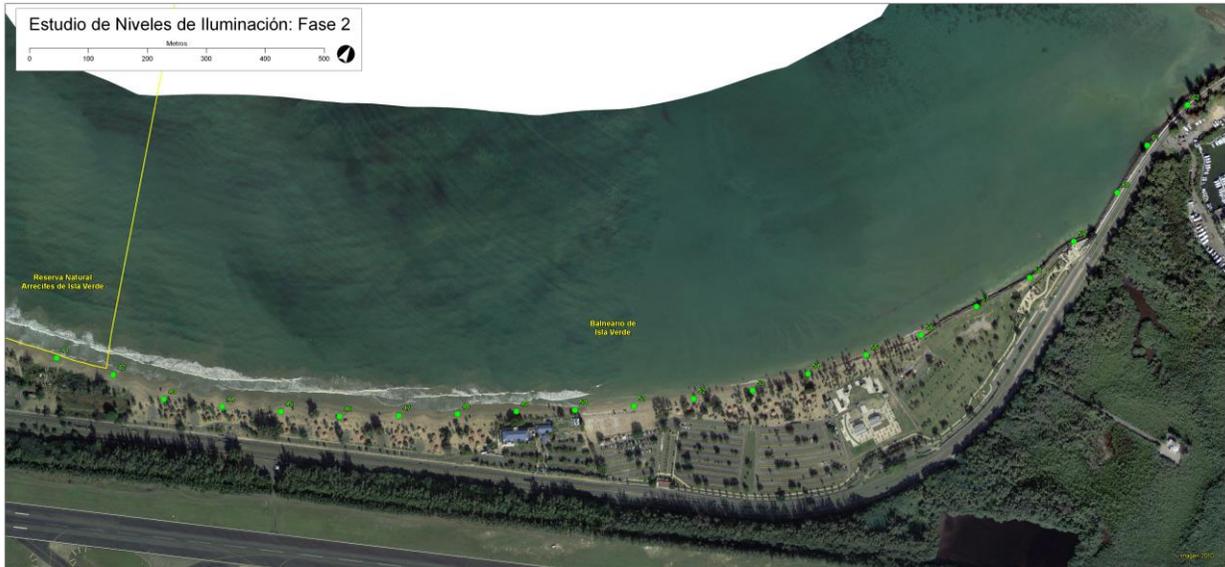
Figure 21c: Aerial Map of Phase 2, Site Numbers 43-58

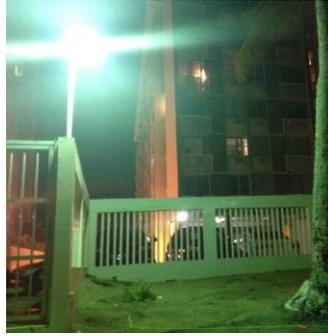
Figure 22: Luminaire in Quadrant 9

After completing the sky glow readings two values stood out from the rest of the sky glow measurements, 17.58 mpss at point 9 and 17.32 mpss at point 33. These measurements were consistent with sky glow readings typical at the center of a major city such as New York or Boston (Flanders, 2008). This level of sky glow was inconsistent with our hypothesis, therefore the team referred back to the site assessment sheets and inventory data to see if there was a potential explanation. For both site numbers 9 and 33, luminaires (Figure 22 and Figure 23) were discovered to be in close proximity to the center point where the measurement was taken. Mentioned earlier, lighted objects such as street lights could potentially hit the sensor of the sky quality meter at an angle and cause excessively low (bright) readings. Our team concluded that these two luminaires were the cause of such low readings.

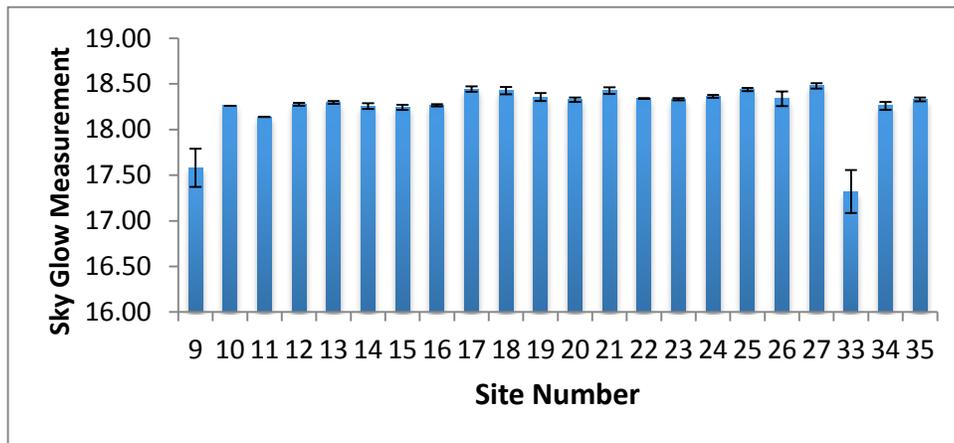
Figure 24: Average Sky Glow Measurement by Site Number  
Error bars are one standard deviation

Figure 24 shows the average sky glow measurements taken at each site number which are highlighted on the aerial map in Figure 25.

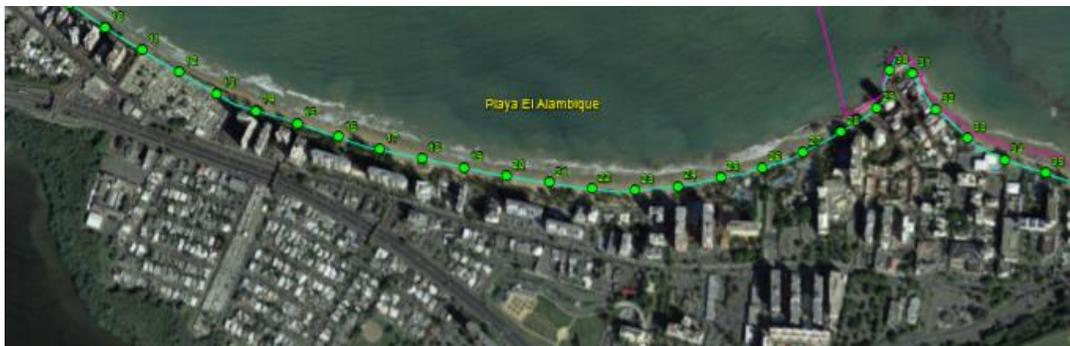
Figure 25: Data points 9-35 corresponding with sky glow measurements

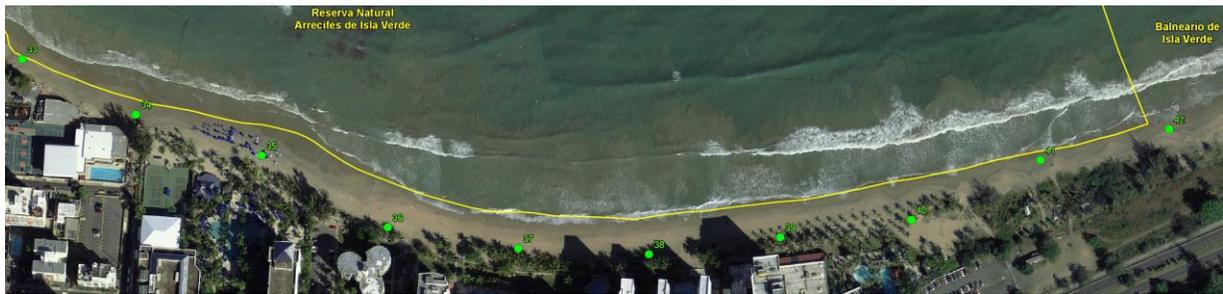
Figure 26: Local environment of sites 33-42

The levels of illumination varied greatly between the different sites, and different points along the perimeter of the sites. The light measurements were taken across almost three kilometers of beach, which changed drastically from high-rise hotels and condominiums to dense vegetation, as can be in Figure 26.

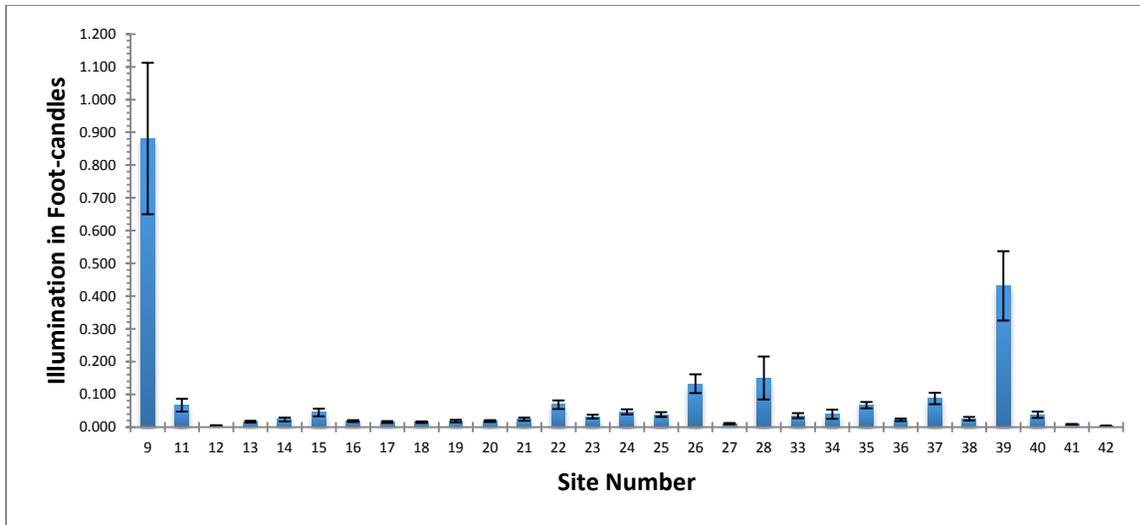
Figure 27: Mean light trespass per site  
Error bars are one standard error

In addition, we observed a considerable amount of variability in the distance to the nearest luminaire. Figure 27 shows the mean for the 16 readings per quadrant and depicts the scope of the variability. The change in local environment and distance the nearest luminaire contributed to data that ranged from a mean illumination of 0.881 foot-candles in quadrant 9 to 0.003 foot-candles in quadrant 42.

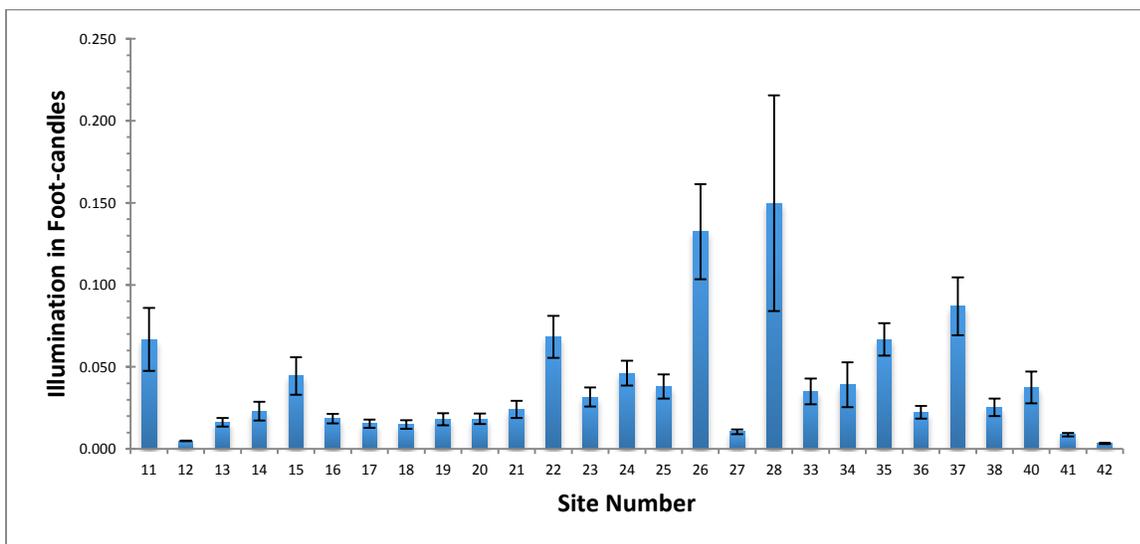
Figure 28: Mean light trespass per quadrant, excluding sites 9 and 39  
Error bars are one standard error

This large range makes it difficult to visualize the data. In order to draw any useful conclusions it was necessary to remove the major outliers from this data set. This data set has an upper outer fence of 0.213. Quadrants 9 and 39 both had mean light trespass values above this fence of 0.881 and 0.431 foot-candles respectively. These quadrants are still valuable data points, however due to the degree to which the average illumination levels are above the outer fence, these quadrants were excluded from Figure 28 to better illustrate the data acquired.

With the exclusion of the major outliers, it is easier to note there is high variability both between and within sites, even at darker light levels. Along the beach, there would often be a single or small group of very bright luminaires beside a path or for security around a building. This would significantly raise the average levels of illumination in the quadrant. An example of this practice was in quadrant 28, shown in Figure 29. With the exclusion of the two highest points, the ambient light level is 0.057 foot-candles. When point 1 and 10, which had light levels of 0.850 foot-candles and 0.750 foot-candles respectively, are included, the average for this quadrant increases 2.6 times to 0.150 foot-candles. This accounts for the unusually high standard error between light trespass measurements of 0.263.

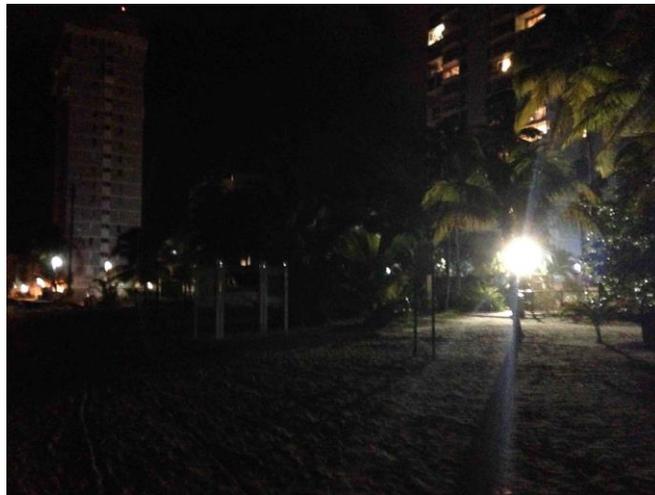
Figure 29: East nighttime assessment photo of site 28

A single or small set of bright luminaires also accounts for the variability between adjacent sites. The beach to the east of the luminaire in Figure 29 is relatively dark and is sparsely developed. Higher light levels are usually proportional to more human activity, however the coast of Isla Verde is dotted with these exceptionally bright luminaires in otherwise dark regions.

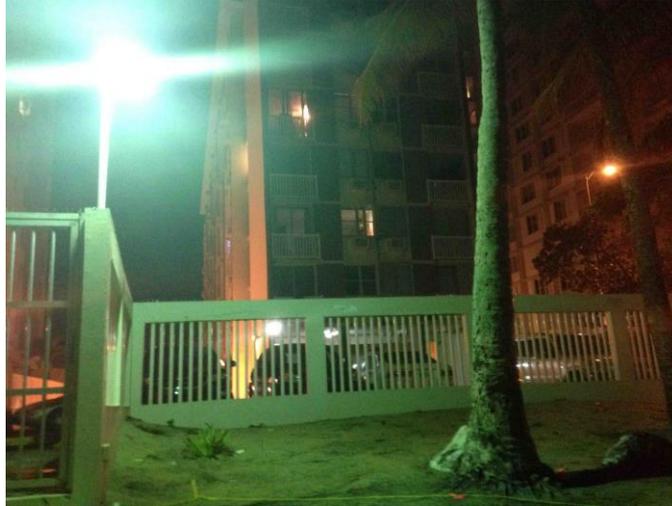
Figure 30: South nighttime assessment photo of site 9

Quadrant 9 is another example of a single bright luminaire contributing to higher than normal measurements. This was the brightest quadrant on average and had the single brightest point of 4.100 foot-candles in the northeast-facing corner. This quadrant, shown in Figure 30 was almost directly beneath a very bright luminaire.

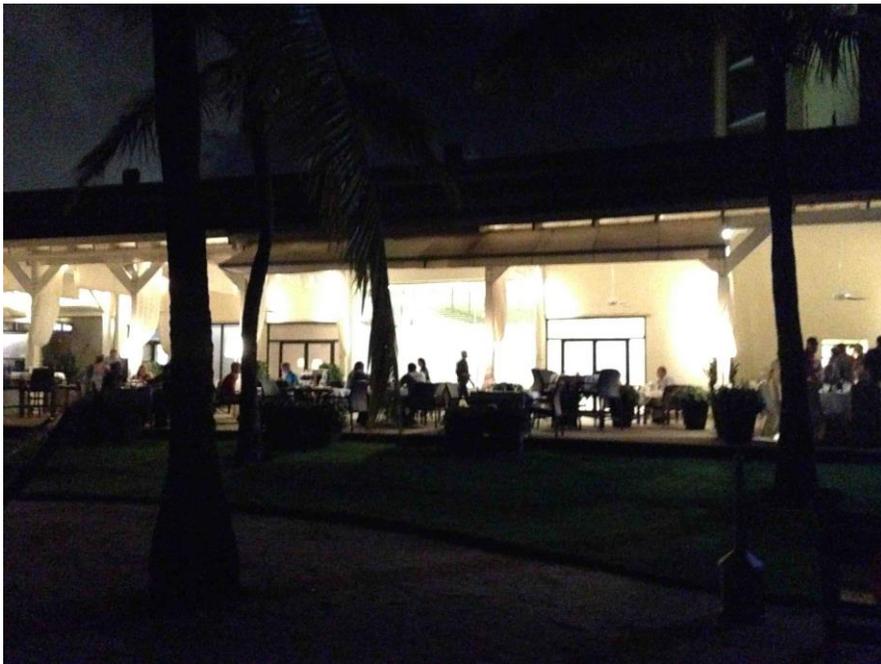
Figure 31: South nighttime assessment photo of site 39

The quadrant with the next highest light measurements was taken directly outside of a hotel's open-air restaurant. The restaurant can be seen in Figure 31.

This quadrant has an average level of illumination 17 times higher than the adjacent quadrant to the west and 11.5 times higher than the adjacent quadrant to the east. The highest reading in this quadrant was 1.268 foot-candles, which is 6.4 times higher than the outer fence of the entire data set. Figure 32 was taken from quadrant 38 and shows quadrant 39 in the distance. This image illustrates the stark difference between the light emitted from this restaurant and the ambient lighting.

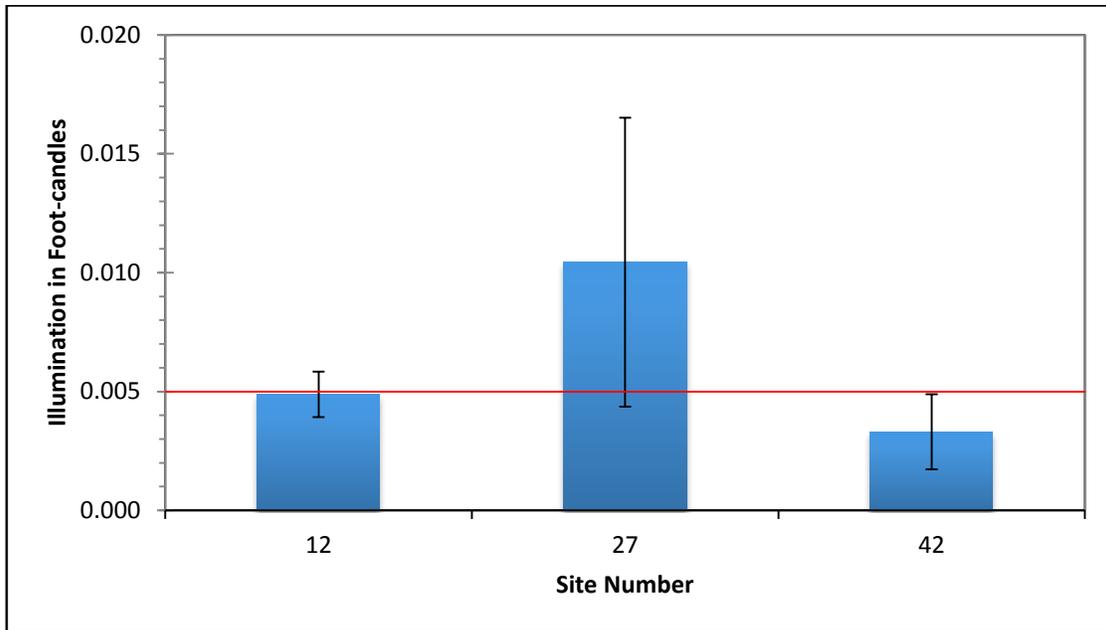
Figure 33: The three darkest sites with 0.005 limit in red  
Error bars are one standard deviation

illumination of 0.0049 however this is rounded up to 0.005 when significant figures are accounted for.

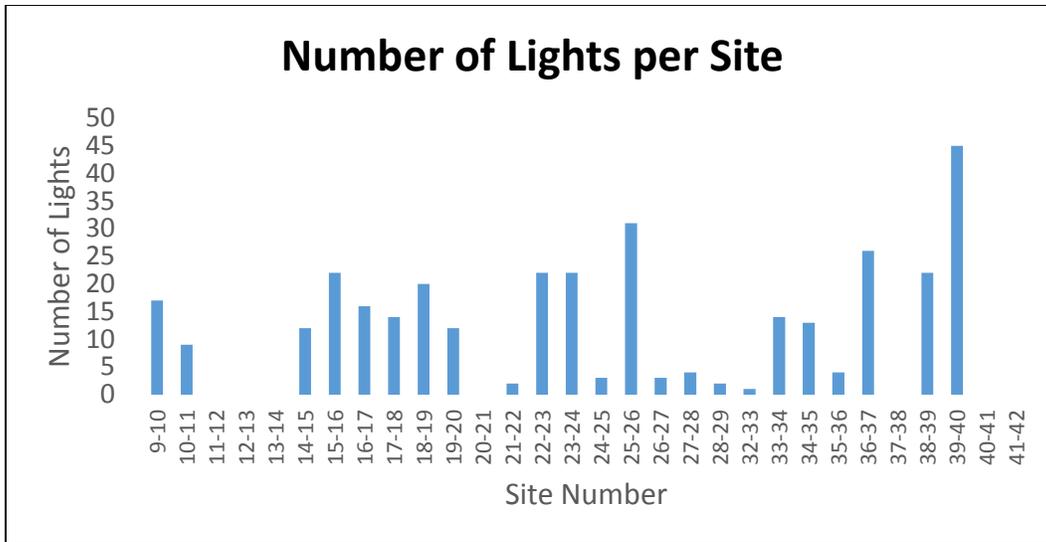
Figure 34: Lights by Site Number

The inventory was completed from quadrant 9-42, excluding sites 29-32 due to their location not being accessible. Phase 1 had a total of 125 lights while Phase 3 had a total of 211 lights making the total number of lights on the coast of Isla Verde 336. The number of lights per quadrant ranged from 0-45 with the average number of lights per quadrant being 11.2. The exact number of lights per quadrant can be seen below in Figure 34.

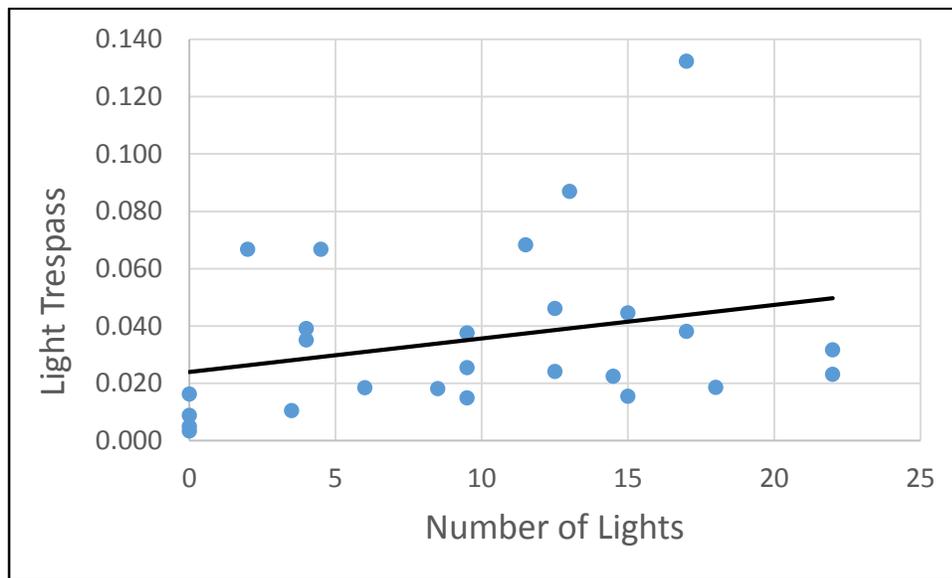
**Figure 35: Light trespass vs. number of poorly shielded lights per site**

Figure 35 below visually shows the correlation between light trespass level and number of poorly shielded lights by using a best fit line of the correlation.

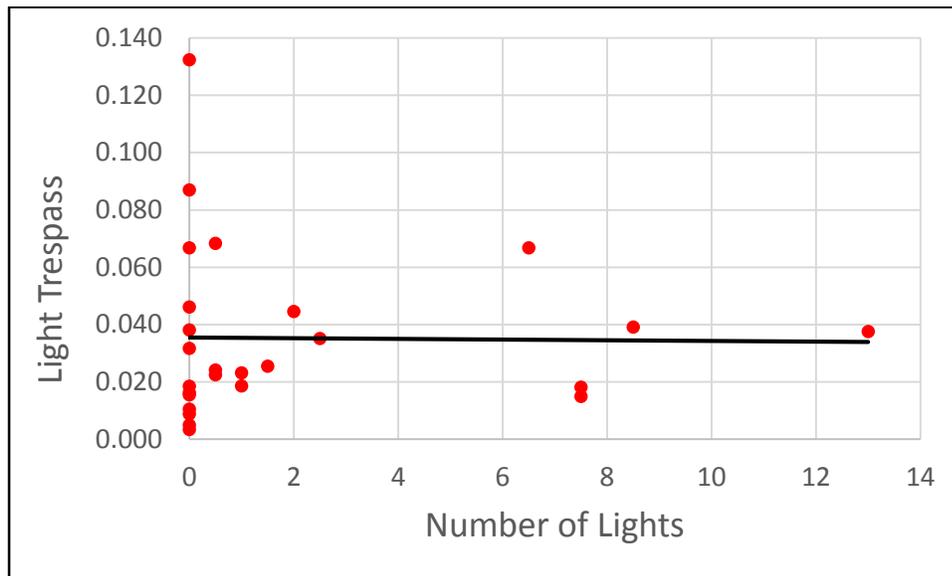
**Figure 36: Light trespass vs fully shielded lights**

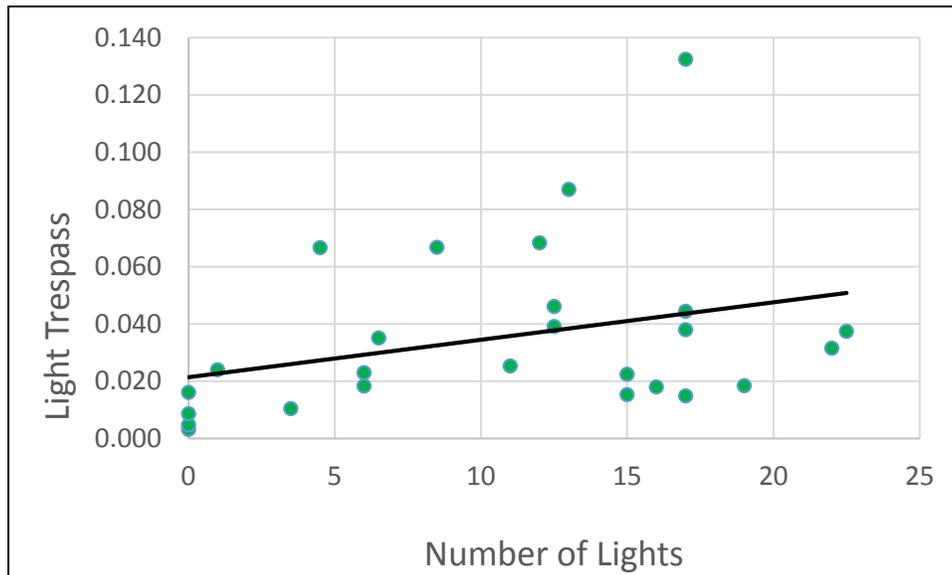
**Figure 37: Light trespass vs. total number of lights per site**

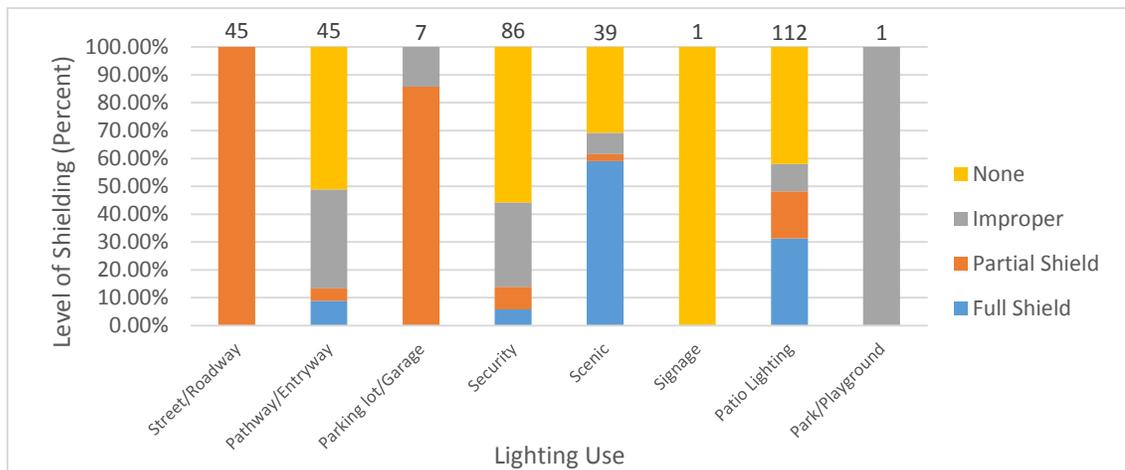
**Figure 42: Level of shielding by light use for commercial, residential, public and industrial properties**

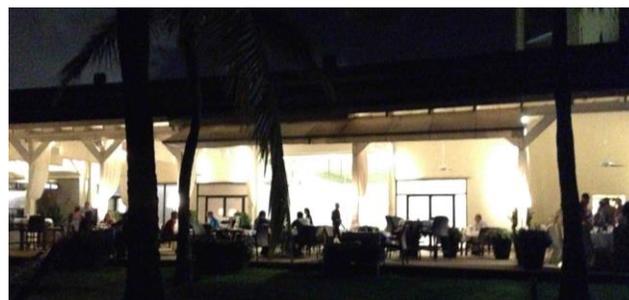
**Figure 45: Partially enclosed patio, demonstrates the type of partially enclosed patio seen on many commercial properties**

Figures 43 and 44 showed that 57.14% of all commercial patio lighting was unshielded while only 22.45% of residential patio lighting was unshielded. We suggest that the difference can be attributed to the fact that a lot of commercial patios are either for outdoor restaurants or bars. Such places were partially enclosed, such as in Figure 45, and consequently unshielded indoor lighting was often used, explaining the high number of unshielded patio lights. This was most likely due to the restaurants and bars wanting to provide a high amount of light for dining purposes. Likewise, the number of residential patio lights that use full shielding can be explained by their function: these lights are to enhance the experience of residents and patrons on the beach rather than hinder it.

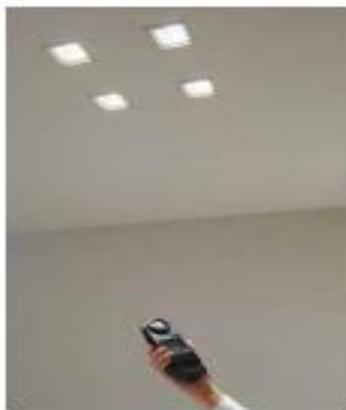
- Government testing organizations
- Research/inspection at illumination equipment makers
- Maintenance at factories, offices, hospitals, etc.
- Illuminance control of security lighting, street lighting, etc.
- Checking light sources for construction

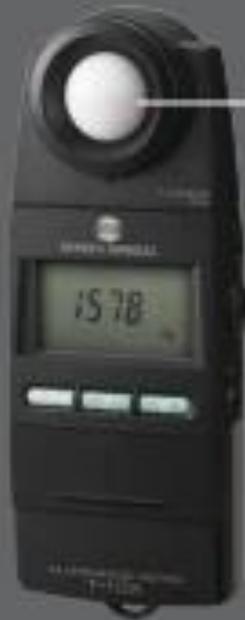
T-10A

<Standard receptor>

Receptor  
diffuser  
window:  
Ø 25 mm

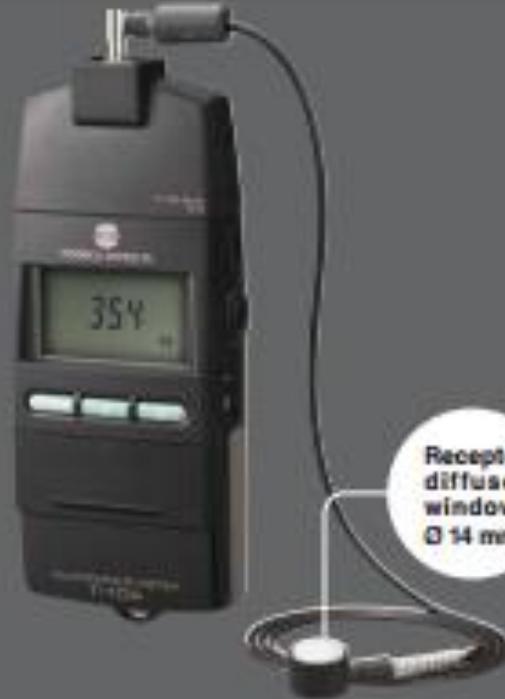
T-10MA/T-10W<sub>S</sub>A/T-10W<sub>L</sub>A

<Mini receptor >

Receptor  
diffuser  
window:  
Ø 14 mm

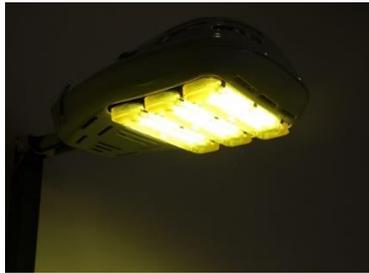
Low-Pressure

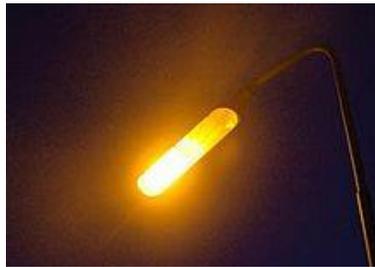
High-Pressure

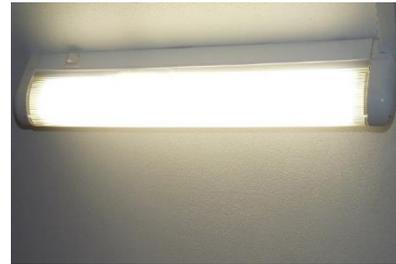
Fluorescen

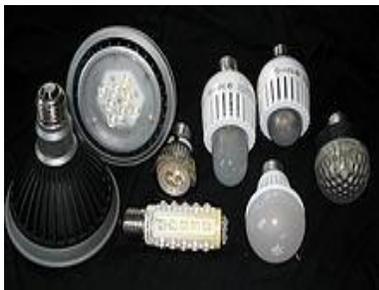
LED

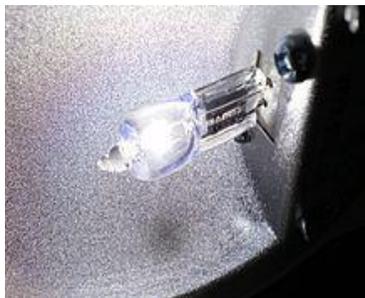
Halogen

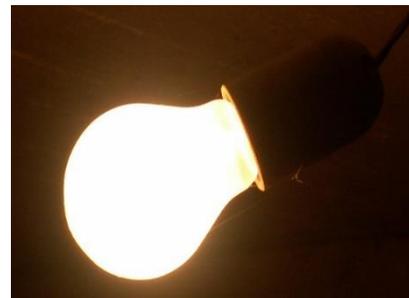
Incandescent
