Rhône River: Restoration Recommendations for the Miribel Canal

An Interactive Qualifying Project (IQP) Submitted to the Faculty of

WORCESTER POLYTECHNIC INSTITUTE

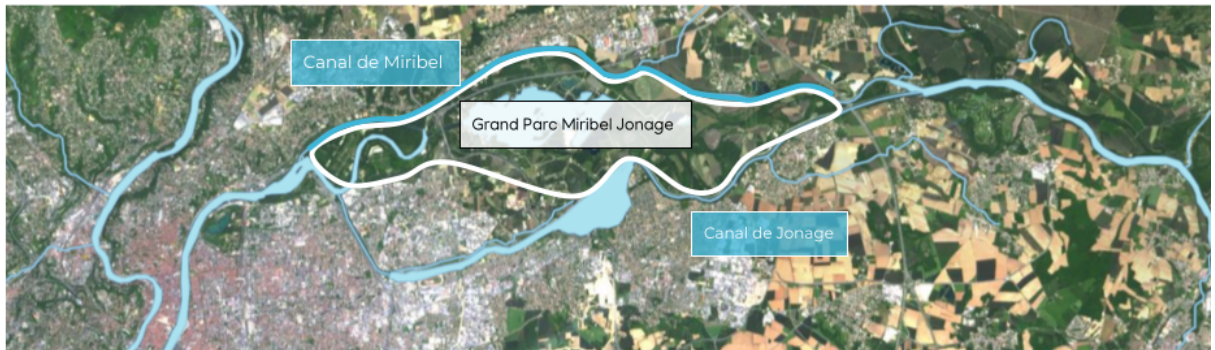
Figure 2: Map of Miribel and Jonage Canals

The Miribel canal was first created in 1848-1857 to improve transportation (See *Figure 2*). In 1899, part of the flow was diverted to the Jonage canal. The Jonage canal led to a hydroelectric station that provided power for riverside communities (Petit et al., 1996). Because of the Jonage canal's hydroelectric purpose, it requires a constant and steady flow of water. The constant diversion of flow resulted in erratic conditions for the Miribel. In 1937, the Jons dam was constructed to better distribute flow between the Miribel and Jonage canals. Starting in the
