Preservation of Venetian Bell Towers

An Interdisciplinary Qualifying Project

Worcester Polytechnic Institute

Date: July 31, 2004

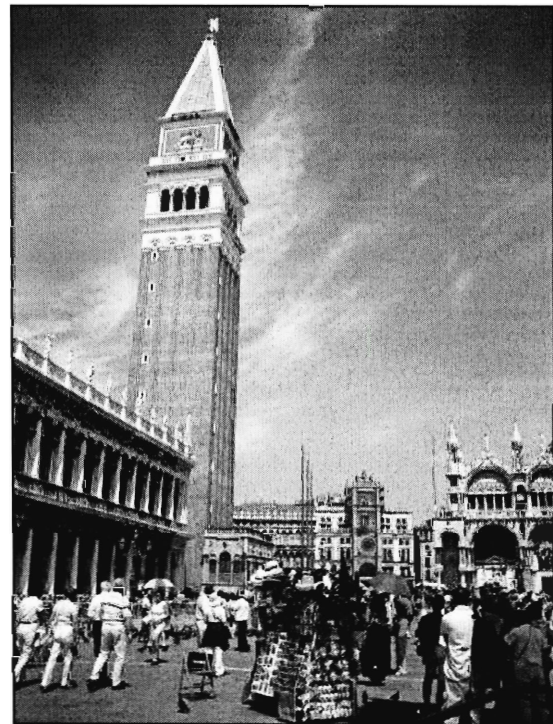
Figure 2- Campanile di San Marco ¹

The newest bell tower, the bell tower of San Marco, is located in San Marco's square across from the Doge's palace. It was built in the 9th Century but then collapsed and was replaced by an exact replica in 1912. Towering at 314 ft above the piazza, the tower San Marco is by far the tallest building in Venice. This bell tower is shown in Figure 2.

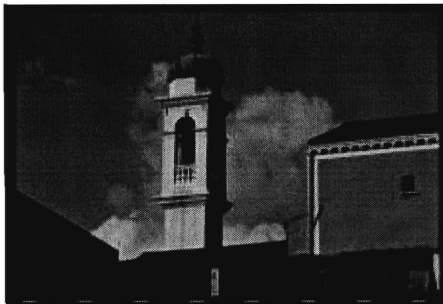
Figure 20- Santa Maria di Nazareth

Shown in Figure 20, Santa Maria di Nazareth, otherwise known as Scalzi, was originally built in 1680. It is located adjacent to the S. Lucia Train Station in the center of Canneregio. A spiral staircase, 175cm in diameter leads up to a caged-in belfry housing two extremely discolored bells. Neither of the bells in this tower have been rung with a hammer, making it safe for us to assume that all the damage done to the tower through the ringing of the bells was done by the rotation of the wheel and the swinging of the bells against the clapper.

The brick walls inside the tower have been covered by a thin layer of concrete for aesthetic purposes. Large cracks in the walls have started to break through the concrete covering, leaving piles of cement all along the stairs. The lower parts of the shaft feature ancient graffiti that prove that the towers shaft has had no major restorations. The condition of the tower drastically worsens the higher you are, and cracks and splits in the wooden stairs become very noticeable.

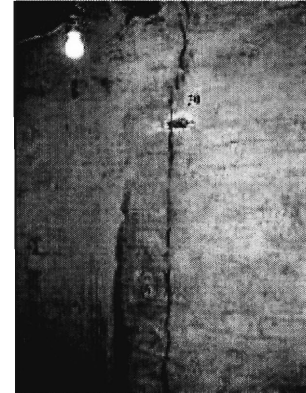
Figure 22- Crack and Strain Gage

one of the strain gages currently in the tower that the civil engineers are using to collect data. Notice the huge crack in the wall of the tower that the strain gage is placed on.

Monaci Camaldolesi, more commonly known as San Michele, is a church on the island of Cimitare. It is well-known because it is the bell tower of the only church on the only cemetery in Venice. The bell tower, shown in Figure 21, is actually currently being monitored by an architectural firm from Trieste because of its alarming condition. When the bells were originally hung, the frame was installed incorrectly, which led to a lot of excess strain on the tower's shaft. Figure 22 shows

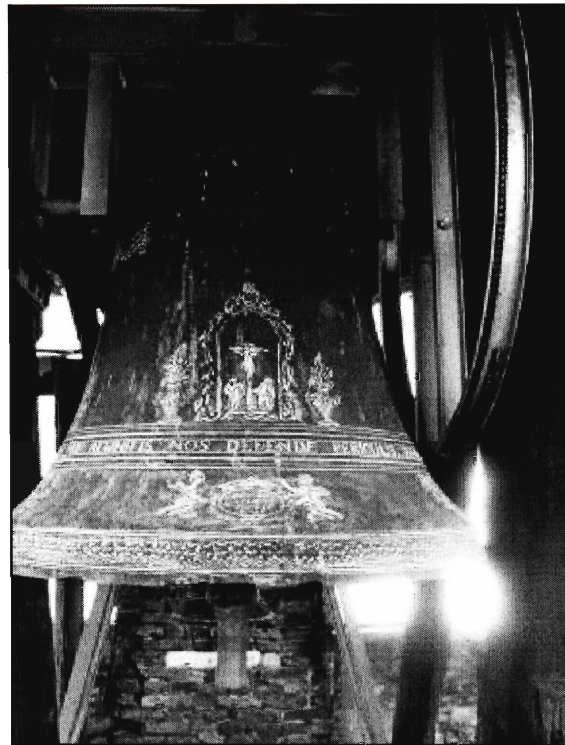
Figure 35- Pristine bell

The most noticeable renovation that has been completed on the tower was performed on the belfry and the bells. The belfry was replaced within the past two or three years and is in pristine condition. The clappers of the bells are also in perfect order with no rust or rot present anywhere on the body of the clapper or the belt. Some routine maintenance has also been performed on the bells. The bells have been cleaned and detailed at the top where they were hung from the frame. The only damage that has occurred to the bells as a result of the re-hanging is that the second bell has a small chip taken out of the lip to make room for the new wheel. This may be significant because that small chip may affect the pitch of the bell. A photograph of one of the bells showing the cleanliness of the bell, the clapper and the wheel is shown in Figure 35. Although this tower has some minor structural issues, the tower is close to the canal and there for may be used potentially as a surveillance point or a tour destination.

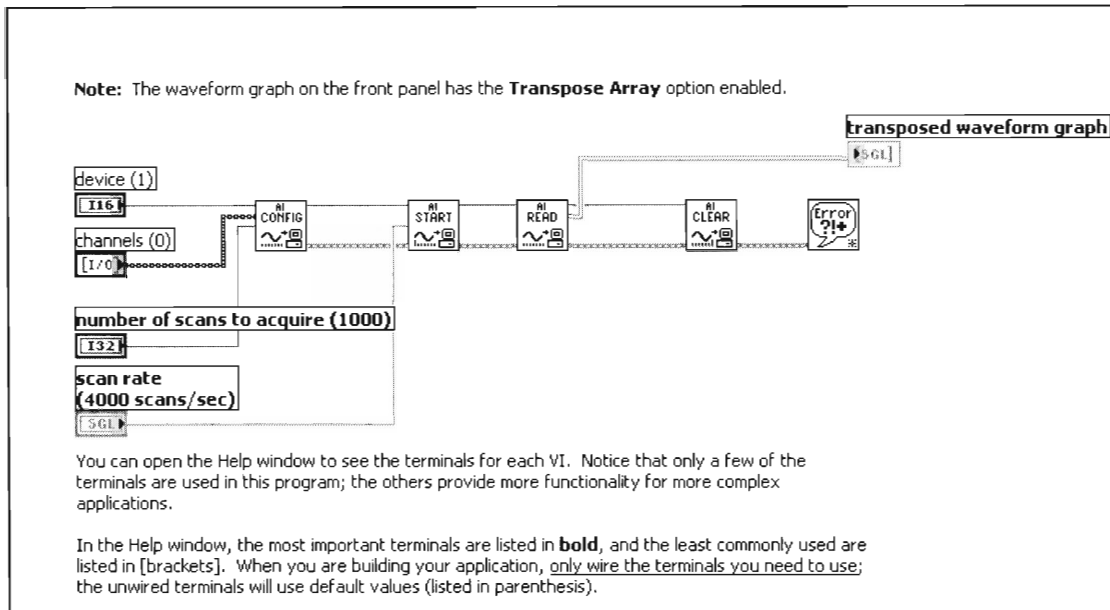
Figure 42- Backend of GetReadings.vi

The acquisition of data is managed by Get Readings.vi, a subVI used in Bell Towers Recording. The back end is shown in Figure 42.

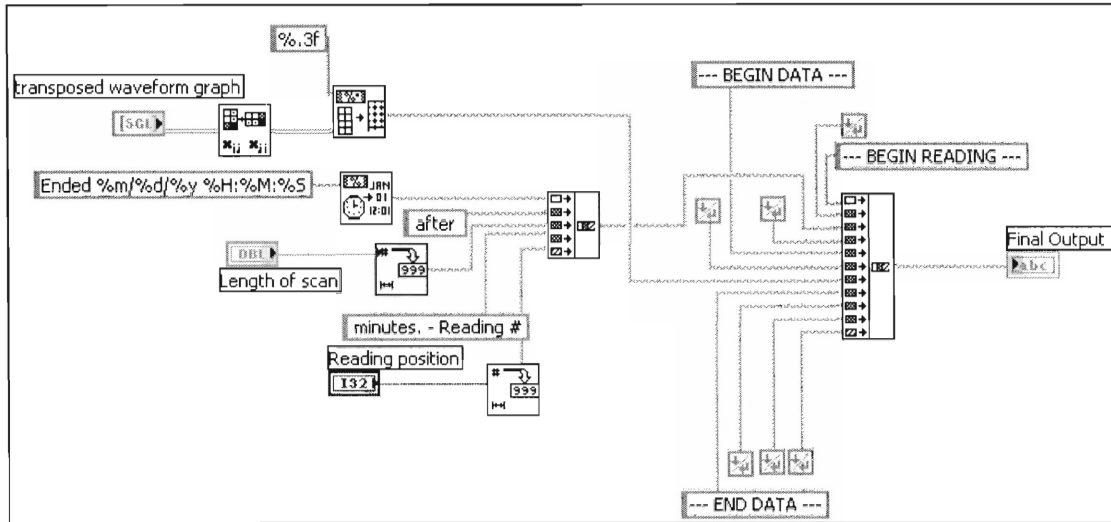
Figure 45- Backend of MakeReadingOutput.vi

Make Reading Output.vi, shown in Figure 45, runs once every time data is read from the instrument. It takes the data from Translate Data.vi and constructs a block of information to be written to the data file.

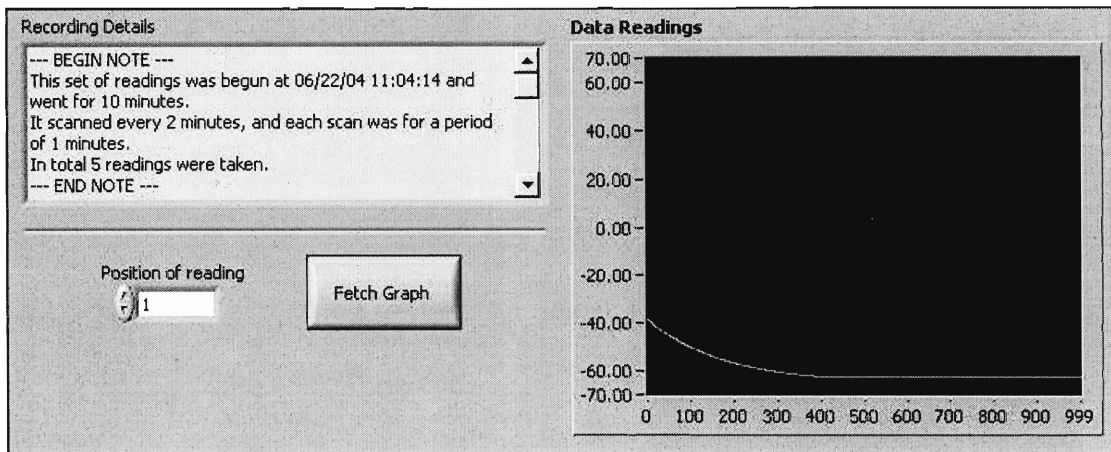
Figure 46- User Interface of BellTowersViewer.vi

The other main VI we built is Bell Towers Viewer.vi. This is not used during the recording of data, but rather a helpful tool for viewing the data we have recorded. Figure 46 is a picture of the interface and Figure 47 back end.
