# Water Accessibility in La Carpio

Costa Rican Humanitarian Foundation (CRHF)

An Interactive Qualifying Project  
Submitted to the Faculty of  
WORCESTER POLYTECHNIC INSTITUTE  
In partial fulfillment of the requirements for the  
Degree of Bachelor of Science

Date:  
March 1, 2024

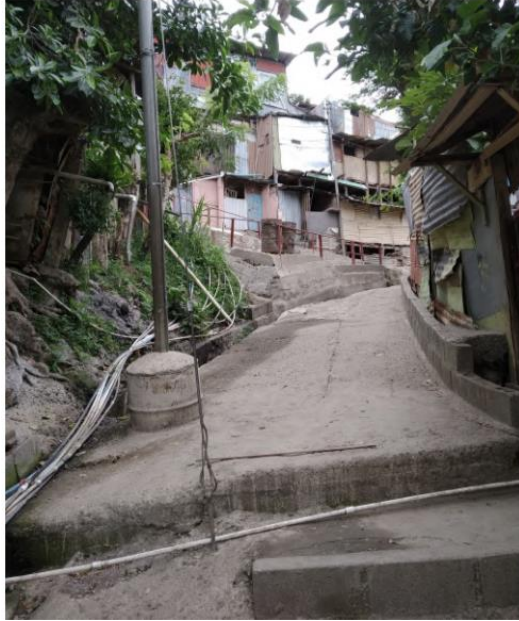
The current water piping system of La Carpio is old and unstable. The primary water storage is one of the aforementioned aquifers, the source of which originates on a nearby mountain in the neighboring province of Heredia<sup>20</sup>. From this natural source, water travels through underground six-inch PVC pipes. The water enters La Carpio in one-inch PVC pipes. **Figure 4** and **Figure 5** below show examples of above ground pipes. Above ground water pipes are exposed to dangerous elements. The pipes are also continuously damaged by trucks and animals<sup>20</sup>. Damage to the pipes can cause infiltration of urban run-off into the water system. Broken pipes also cause leaks that reduce water pressure and limit water availability for lower-elevation homes. A lack of water supply forces residents to store water in open, household water storage containers when water is scarce<sup>20</sup>.

**Figure 5:** La Carpio's PVC Piping System<sup>21</sup>

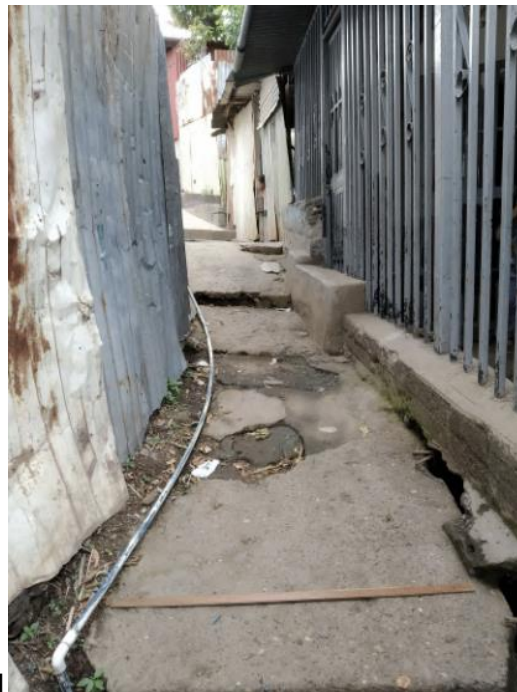
**Figure 6:** La Carpio's PVC water piping in an alley way<sup>21</sup>

the main line. These “tee’d” pipes are often done illegally and without appropriate tools or materials. Improper connections result in leaks.

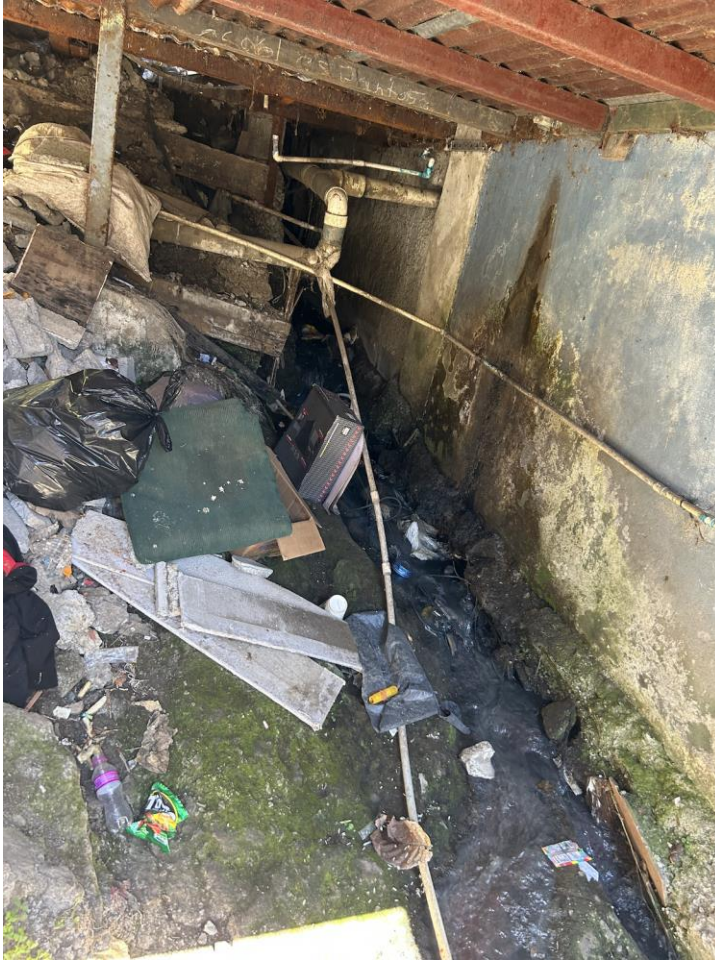
**Figure 7:** A street in La Libertad, La Carpio showing littered trash next to pipes.

The people of La Carpio should try to keep their streets waste-free. Picking up trash and animal excrement could possibly reduce the dangers of cross-contamination of broken pipes with urban runoff. Another way to reduce cross-contamination is to allocate a percentage of their

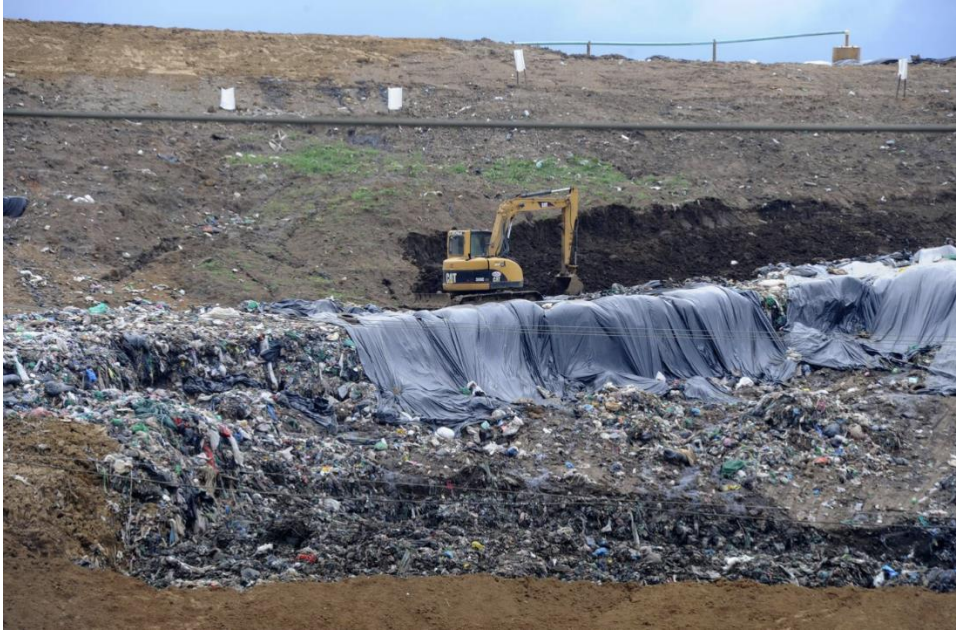
**Figure 8:** EBI Landfill located in La Carpio, less than 500 meters away from a home<sup>17</sup>.

One notable industry in La Carpio is EBI, a Canadian-owned waste management company that established a landfill on the outskirts of the settlement. The introduction of this landfill faced resistance from the local residents who were concerned about the landfill and the additional heavy-truck traffic it would bring<sup>25</sup>. In response, community leaders organized protests to represent the growing population of migrants residing in this unclaimed area. However, these protests were met with government intervention, including the use of tear gas to disperse crowds and threats of deportation by Costa Rican authorities if residents did not comply<sup>25</sup>.

After these interventions, EBI proceeded to establish the landfill, which accepted 15% of Costa Rica's daily waste at its peak, with all waste transported through the main street, Avenida 61, of La Carpio<sup>26</sup>. Initially, there was an agreement between EBI and the residents that the landfill would be active for a 10-year period and then capped. Additionally, EBI pledged to construct a park at the former landfill site to mitigate its impact on the community. However, as of 2024, the EBI landfill has surpassed the initially agreed upon duration, marking a prolonged challenge for the community of La Carpio.

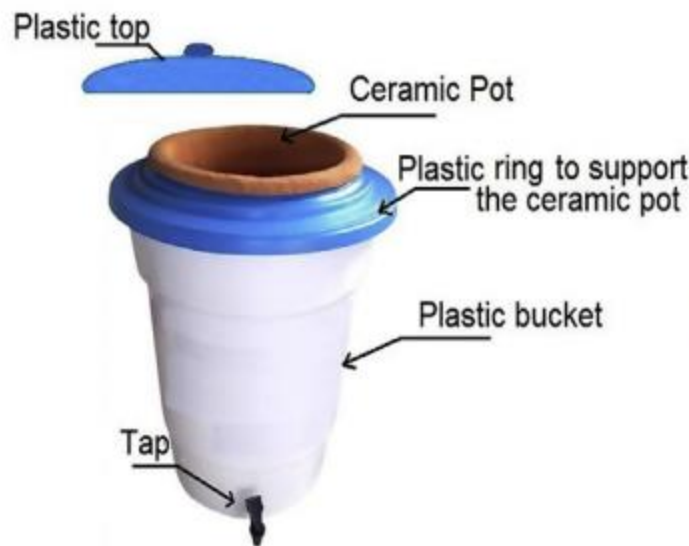
**Ceramic filtration** is a low-cost filtration method in which a clay container is used to filter water. Tiny pores present on the surface of the ceramic vessel filter bacteria, sentiment, and chemicals present in the water. In addition, some ceramic filtration systems contain a colloidal silver lining to increase removal of bacteria. According to the U.S. Centers for Disease Control (CDC), ceramic filtration is an effective way of improving water quality and removing pathogens<sup>14</sup>. In addition, the CDC reports a 60-70% decline in diarrheal disease when these filtration units are implemented<sup>14</sup>. This water filtration system is commonly used in rural neighborhoods struggling with water quality. In Colombia, the low-income areas in the Choco, Valle del Cauca, Cauca Cordoba, Antioquia, and Caquetá regions use this water filtration system as a primary method in households. A ceramic filter can be seen in **Figure 10**. To use, unfiltered water is poured into the top of ceramic and the resulting water drains into a storage unit ready for use.

Figure 10: Ceramic Filtration System used to remove bacteria (Pérez-Vidal, et al 2019)

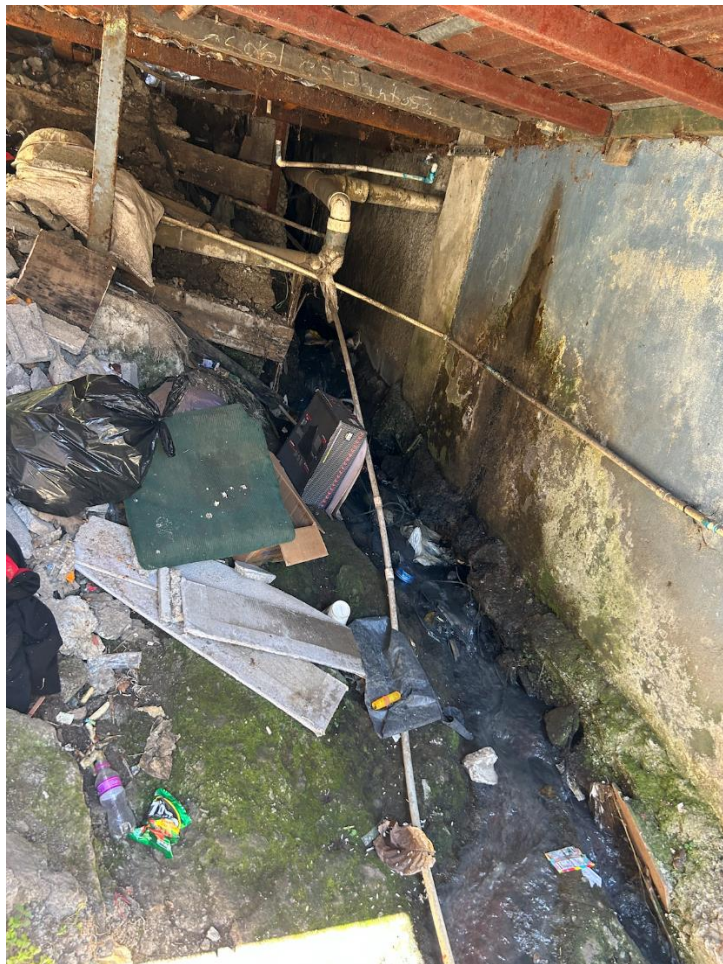
**Damaged pipes** throughout the community allow contaminants to enter the pipes through urban runoff. PVC pipes become brittle with prolonged exposure to UV light and other natural elements. Thus, above ground pipes are susceptible to breakage and are exposed to urban runoff<sup>25</sup>. Urban runoff was observed to collect pollutants such as trash, sediment, chemicals, animal excrement, and bacteria. Crossflow between runoff and damaged pipes exposes the closest households to a plethora of contaminants.

**Figure 12: Rio Torres Pipes Surrounded in Trash**

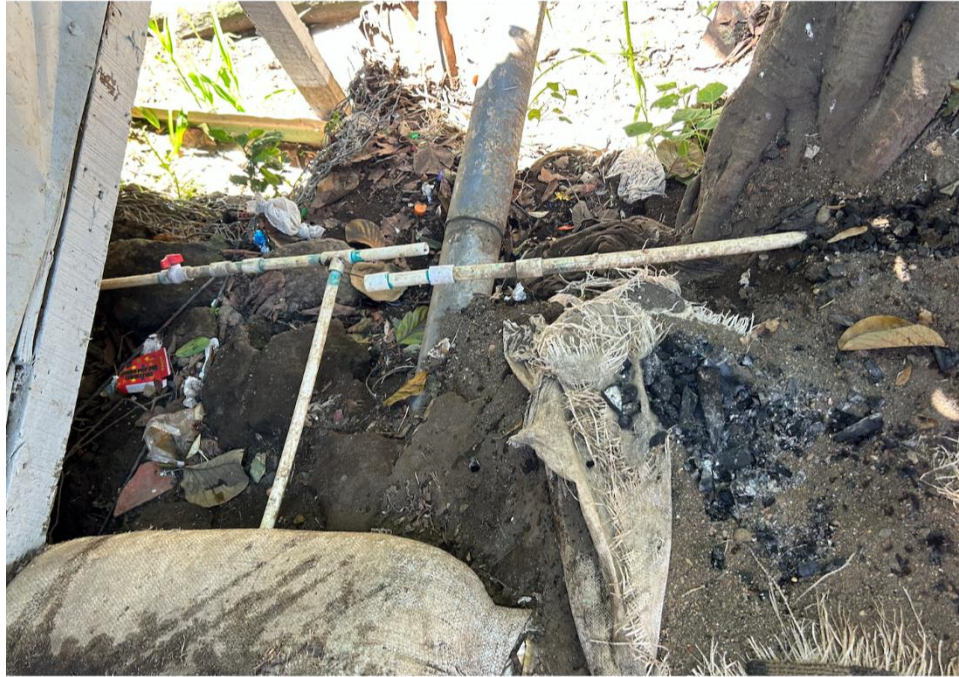
**Figure 13: Broken Pipe** located in Rio Torres

The cause for the destruction of the pipes was the installation of an A y A owned water tank located at the top of the hill that La Carpio is built on<sup>25</sup>. The tank became operational about two years ago. The head pressure of the tank was too great for the one-inch PVC pipes and caused many to break. Since then, the residents of La Carpio have reported worse water quality and accessibility. Each household is responsible for their own repairs. Over 50% of residents have a family member, or a neighbor in charge of repairs, 25% of surveyed households have no one repairing their pipes, and renters said that their landlord fixed them. Another element that

damages above ground pipes are the cistern trucks that transport potable water to sectors lacking piped water<sup>25</sup>.

These large trucks run over the pipes. It was also reported that A y A workers dug holes to observe damage in the underground pipes. This exposes the underground infrastructure to elements of the street such as animal excrement, rainwater, and urban runoff. Some households reported that sediment and silt were regularly found leaving their faucet. One household stated that they stopped receiving water due to a build-up of rocks in their pipes. Cracked pipes allow contaminated water to enter the infrastructure while also causing leakage of potable water. The damage then causes a reduction in pressure and water availability, forcing the people of La Carpio to collect any available water.

Our team could not address the dominant issue of consistent water access in La Carpio. The inadequate infrastructure must be addressed by A y A or a government organization. The piping system needs to be completely replaced resulting in a multi-million-dollar project.

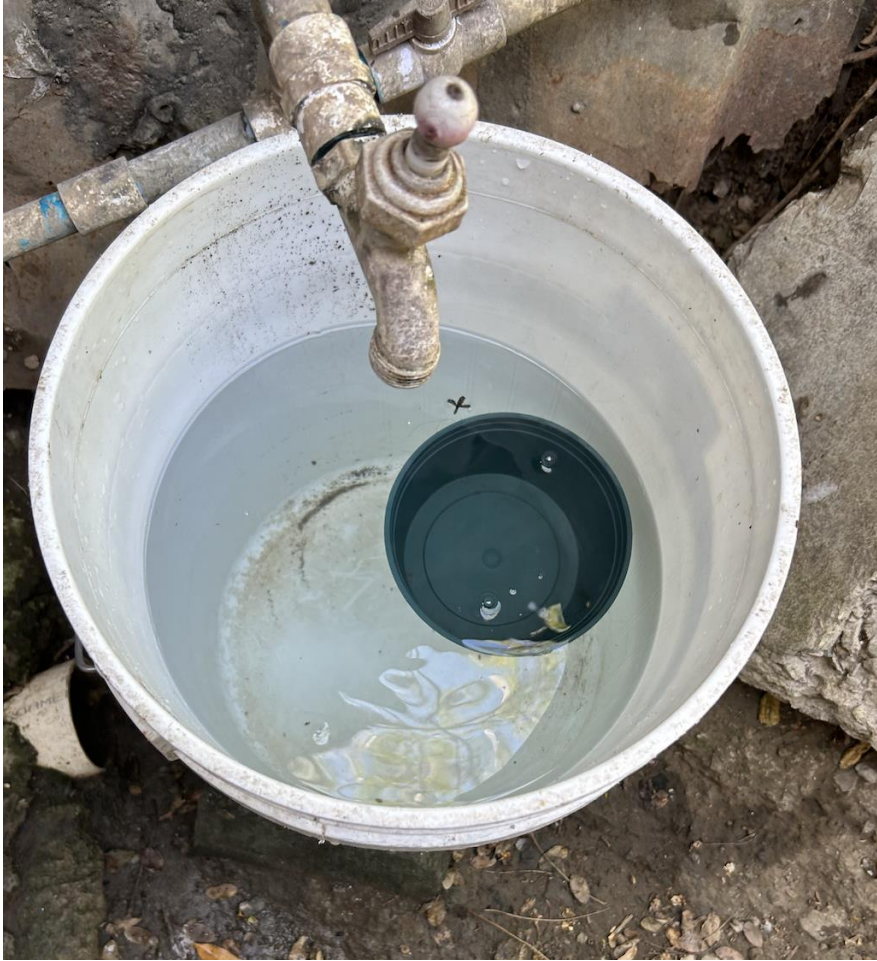
**Open holding buckets** were the observed solution to water accessibility issue of La Carpio. Almost all residents reported that their household receives piped water for a maximum of two to three hours per day. Therefore, the available water is collected in either 5-gallon buckets or 55-gallon drums. These containers are open and lack any filtration system. The local health clinic reported that these containers were the cause of a public health concern<sup>5</sup>. Stagnant water collects bacteria over time. Common symptoms caused by consuming water contaminated with bacteria are diarrhea, stomach pain, nausea, fever, and headaches<sup>5</sup>. These symptoms were reported in four out of the seven sectors that participated in our survey. This past year, 2023, had the most cases of diarrhea and hepatitis, suggesting that the damage caused by the water tank has significantly worsened the infrastructure<sup>5</sup>. The health clinic has tracked many cases of E. coli, Salmonella, and Hepatitis A, which can all be traced back to waterborne bacteria. The results from our water quality tests showed a case of E. coli in a holding bucket in La Libertad.

**Figure 14: 5-gallon Holding Bucket** in La Libertad showing visible sediment and bugs present in the water (tested positive for *E.coli*)

income to fixing any damage in their piping. They should also consistently wash their buckets, drums, and any kitchenware used in the process of drinking water. This would reduce the spread of germs and the build-up of bacteria. Available and effective cleaning supplies that should be used sparingly are bleach and laundry detergent. The people with holding buckets should consistently check them for mosquito larvae to prevent contracting Dengue.

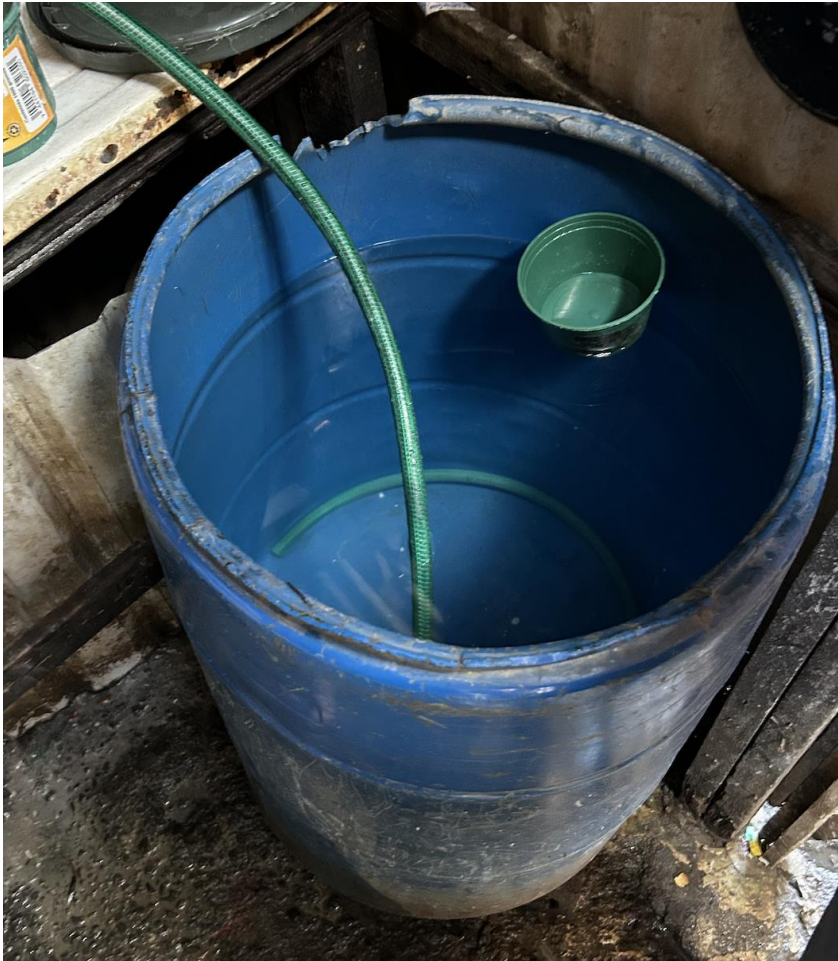
**Figure 15: 55-gallon Holding Bucket in La Libertad**

Due to the infrequent hours of water availability, the holding buckets were often used to collect rainwater in the wet season. Rainwater collects silt and other minerals from the roofs. To collect rainwater, the residents do not use covers for their buckets. Animal interference is then another issue presented by the holding buckets. Dogs, cats, and other animals can drink, bathe, or excrete in the water, introducing more bacteria and viruses. A prominent example of this issue is mosquitoes. Mosquitoes lay their eggs in water, and this has been observed frequently with respect to the holding buckets. Mosquitos, as well as their larvae, carry Dengue fever. This virus causes a high fever, rash, muscle pain, and vomiting<sup>5</sup>. Dengue has plagued the community of La Carpio for years. The nurses from the health clinic stated that Dengue fever was significantly more difficult to control than Hepatitis, indicating the severity of the mosquito problem<sup>5</sup>. These

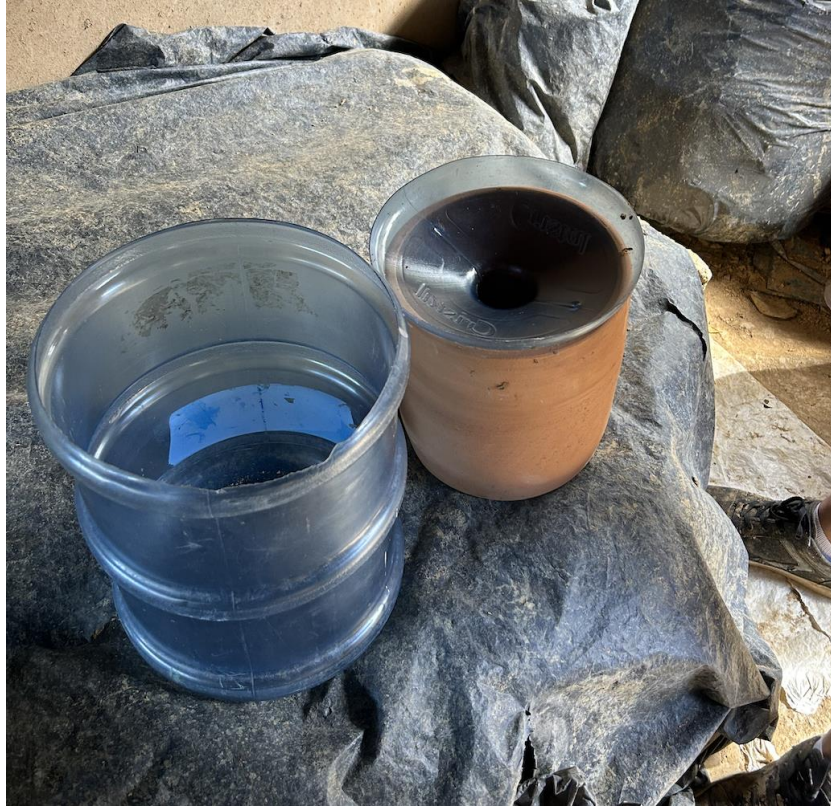
To develop a working prototype our team visited three clay sites. The first clay site was a local businessman located in Santa Ana hand sculpting and selling his clay work to a business down the road. He explained he could not put sawdust or cornmeal into his clay because his clay was too fine causing it to fall apart when fired. However, he created a visual prototype seen in **Figure 17**, for us to use in demonstrations and present the idea to other clay studios.

**Figure 17: Prototype Obtained** from first Clay Site

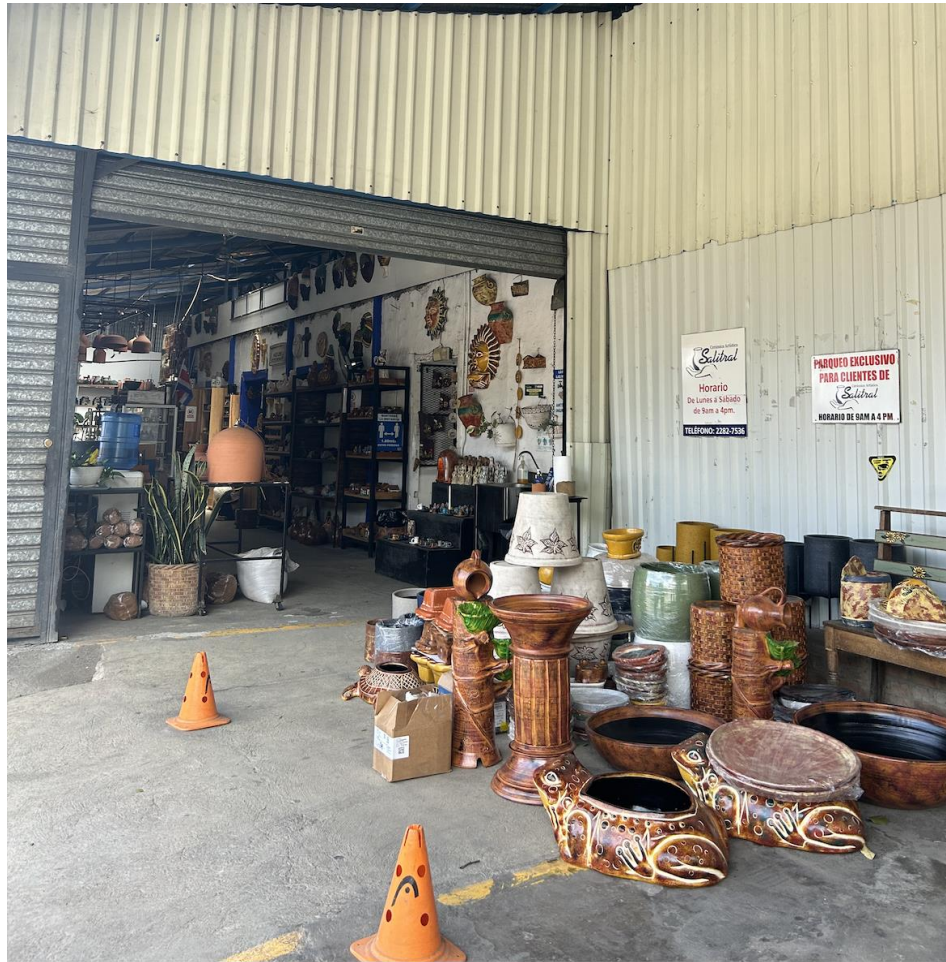
**Figure 18:** Successful Santa Ana Clay Studio Producing a Working Prototype

The final clay place, located in Santa Ana, was a local business with a variety of ceramic products. When proposing our idea to the head sculptor, he understood immediately. He explained that in Guatemala they have a wide-scale production of ceramic filters. A few migrant workers came to the studio and taught him how to make these ceramic filters. This main sculptor was the key to making our ceramic filter. He said he would have a working prototype done in 22

days. Unfortunately, the projected completion date of March 14th was after our departure from Costa Rica.

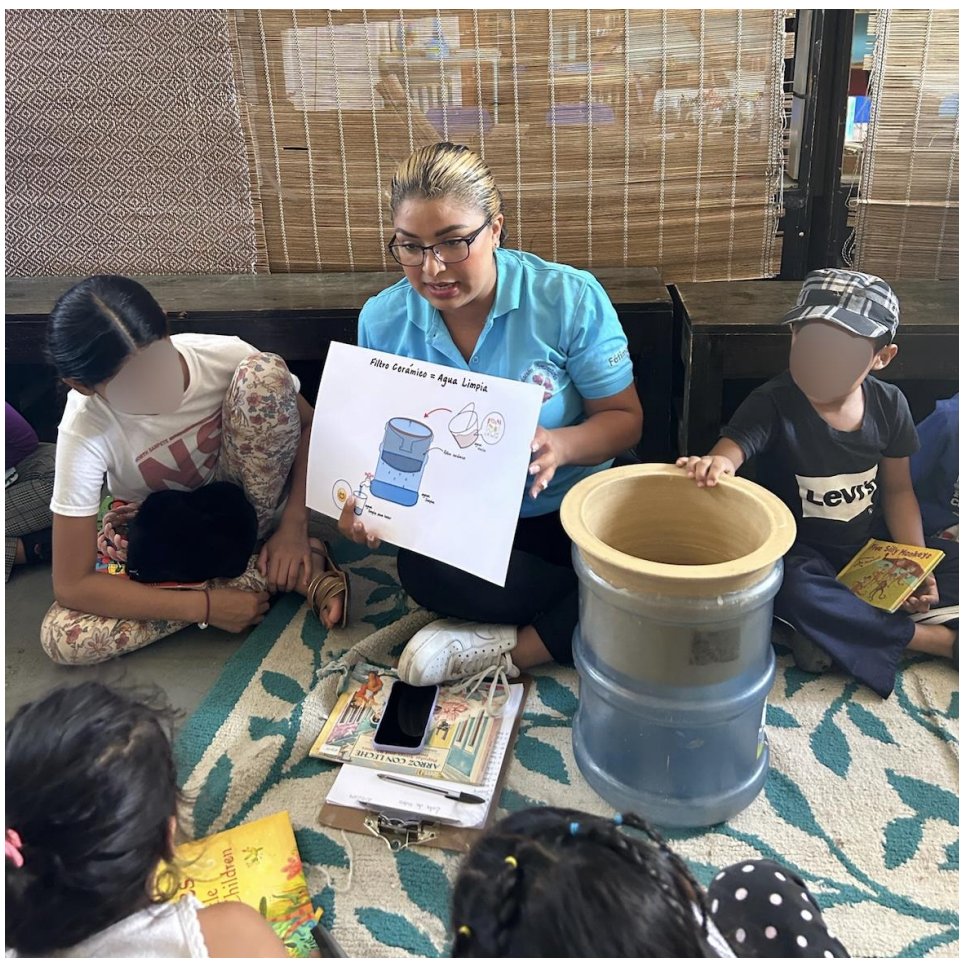
**Figure 21: A Teacher in a FHCR Preschool Demonstrates our Ceramic Filter**

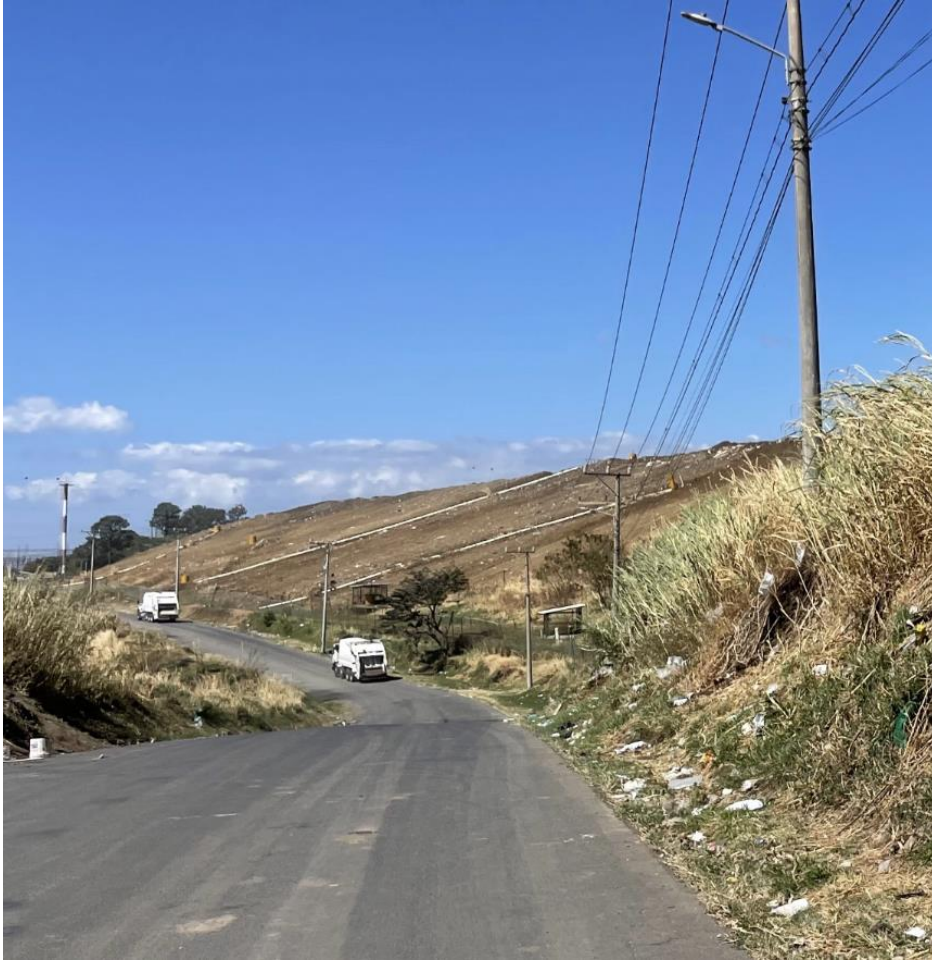
**Figure 25: EBI Landfill** located less than 500m away from a home in La Carpio

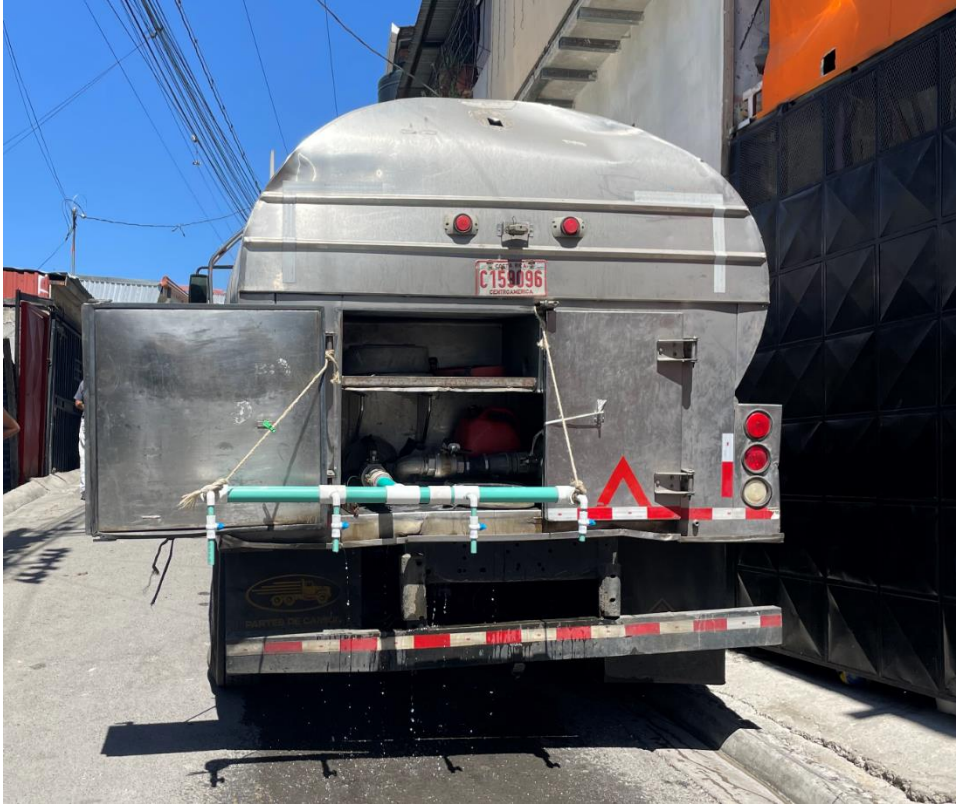
**Figure 26: Municipality Truck** bringing water to Pequeno Gran Ciudad
