# Investigating Potable Water Quality at Schools in Doi Tung, Thailand

An Interactive Qualifying Project and Interactive Science and Social  
Project submitted to the faculty of Chulalongkorn University and  
Worcester Polytechnic Institute.

**Submitted on:** March 7, 2020

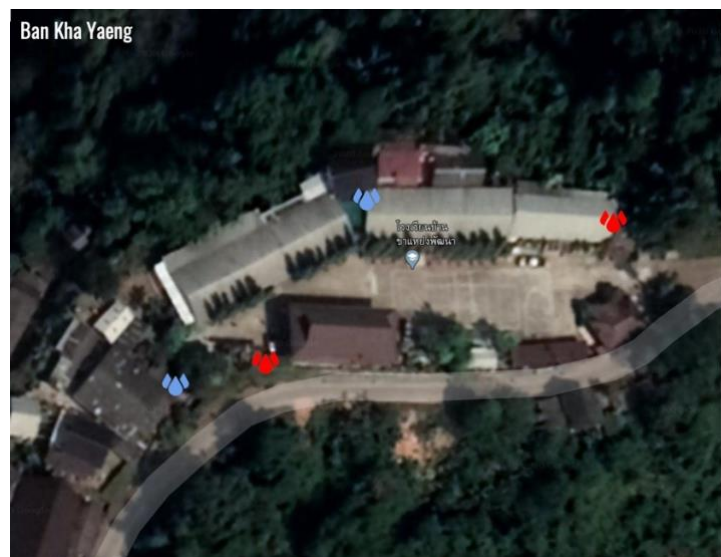
Figure 7. A map of the Ban Kha Yaeng school, including storage (red) and dispenser (blue).

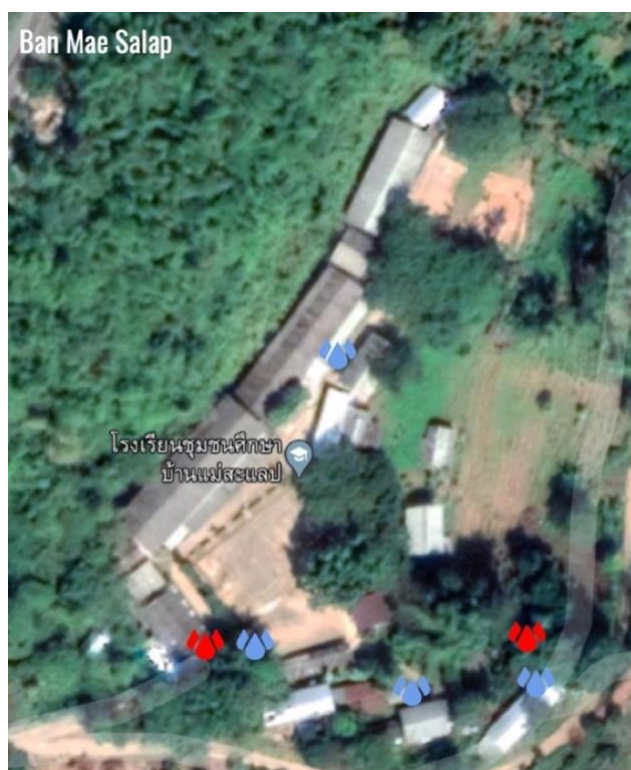
Figure 9. A map of the Ban Mae Salap school, including storage (red) and dispenser (blue).

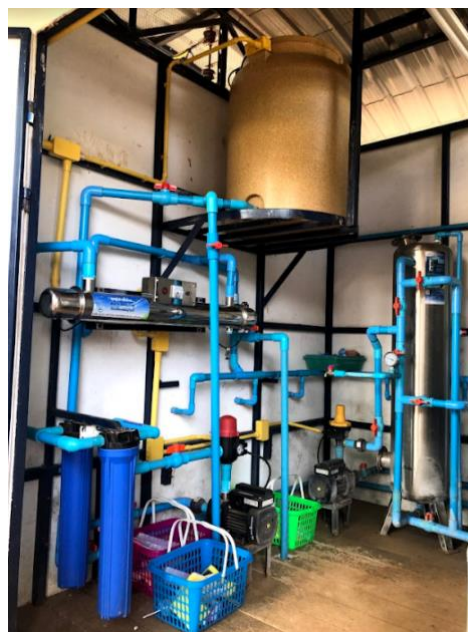
*Figure 10.* The water filtration systems at Ban Mae Salap including carbon filtration, sand filtration, UF, MF, UV, and RO.

Our first objective was to determine the quality of the water at the source and after filtration at each of the three schools. The filtration systems at each school were donated and put into place at various times. An image of the filtration system in place at Ban Mae Salap can be seen in Figure 10. Each school had different sources of water and different filtration systems. We conducted a thorough analysis to understand the quality of the water at each site to fully understand the water contamination problems. By measuring the water quality before and after filtration, our team was able to determine the efficacy of each filtration system. The purpose of collecting this data was to gauge the success of the filtration system by monitoring the changes in water quality over time and identifying the components of the system that contribute to elevated contamination levels.

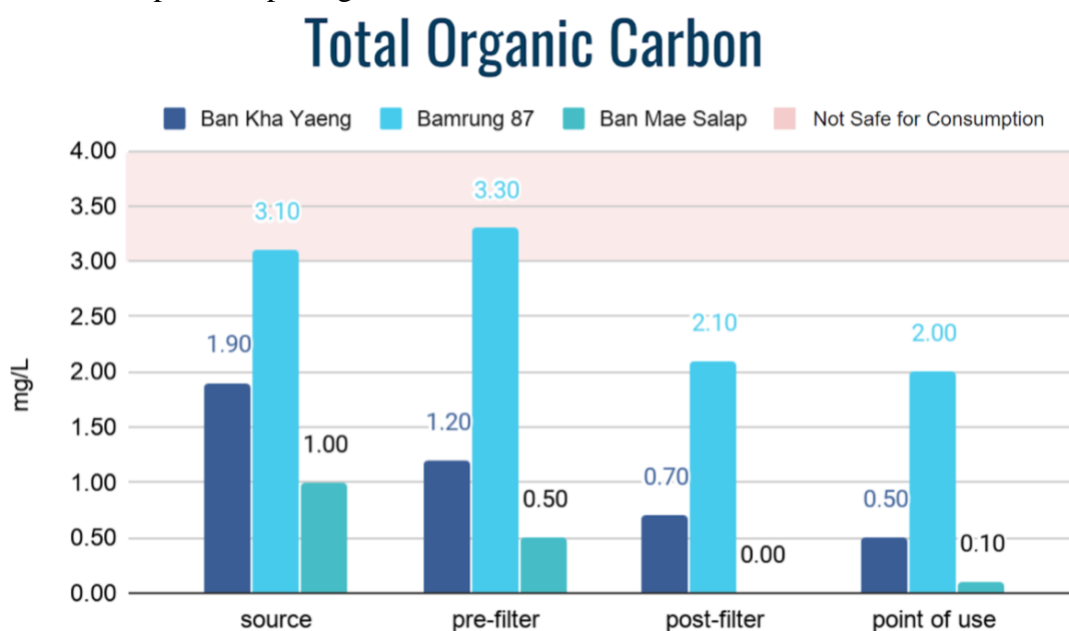
Figure 17. Changes in total organic carbon (TOC) at each point in the drinking water system. Water that exceeds the standard value of 3 mg/L is not safe for consumption.

The TOC at each school declines from the source to point of use as seen in Figure 17. The total organic carbon in water is a chemical indicator of the presence of waste and organic molecules such as proteins, fats, sugars, and genetic material. TOC levels above the maximum allowable quantity of 3 mg/L constitute water with dangerous amounts of organic matter that can contribute to the spread of pathogens.

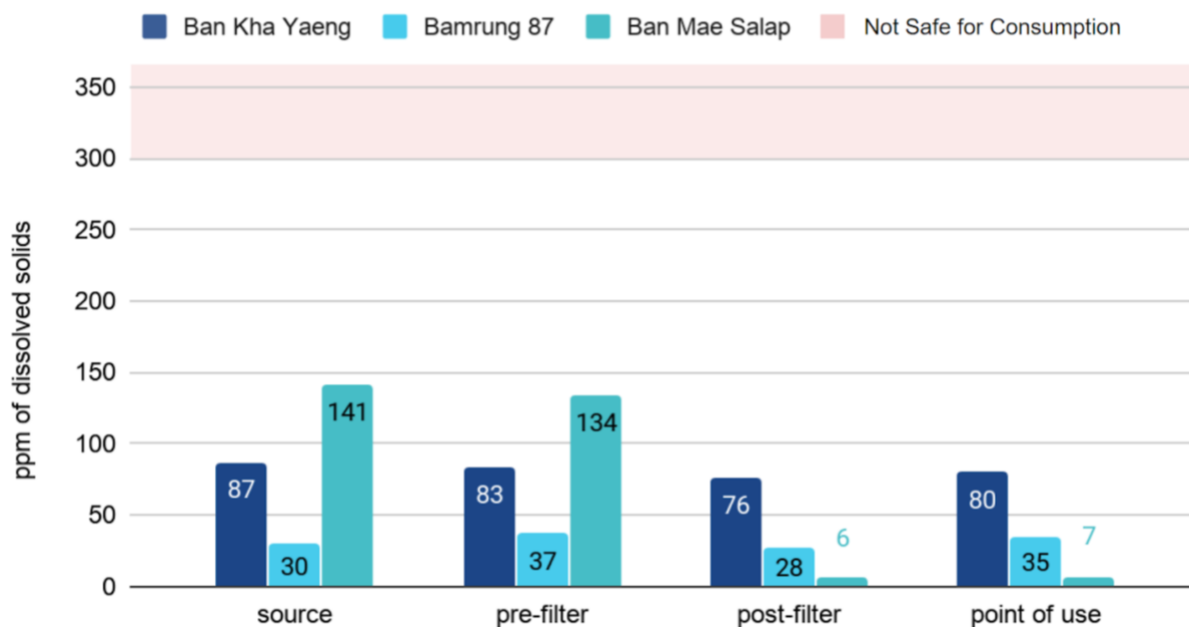
Figure 18. Changes in total dissolved solids (TDS) at each point in the drinking water system. Water that exceeds the TDS value of 300 ppm is not safe for consumption.

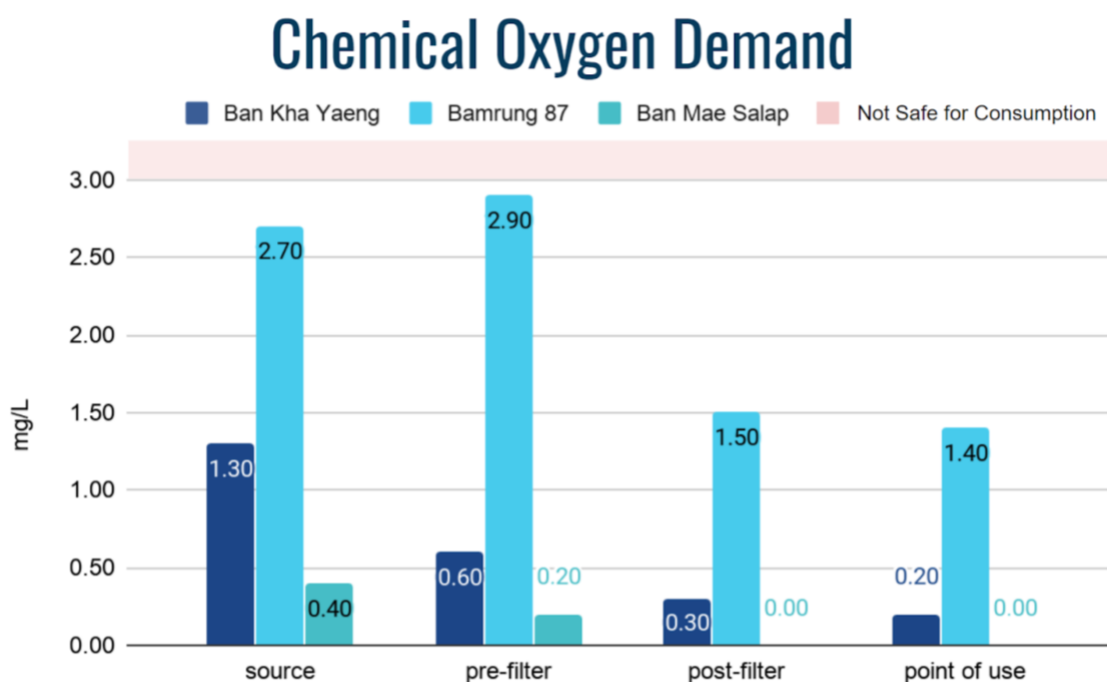
Figure 19. Changes in chemical oxygen demand (COD) at each point in the drinking water system at three schools. Water that exceeds the COD value of 3 mg/L is not safe for consumption.

The chemical oxygen demand (COD) levels were measured at the source, pre-filtration, post-filtration, and at the point of use for each of the three schools. Chemical oxygen demand increases as the amount of available dissolved oxygen in an aquatic ecosystem decreases. Therefore, chemical oxygen demand is an indicator of the environmental health of a water system, demonstrating the impact of human activity and sewage disposal on the water quality. High COD levels in water mostly detrimental to local aquatic species that rely on dissolved oxygen for their oxygen intake. However, long-term exposure to water with COD levels higher than 3 mg/L pose a potential health risk to humans. Each school aligned with the maximum allowable drinking water standard of 3 mg/L, so COD levels did not indicate poor drinking water quality at any of the three schools.

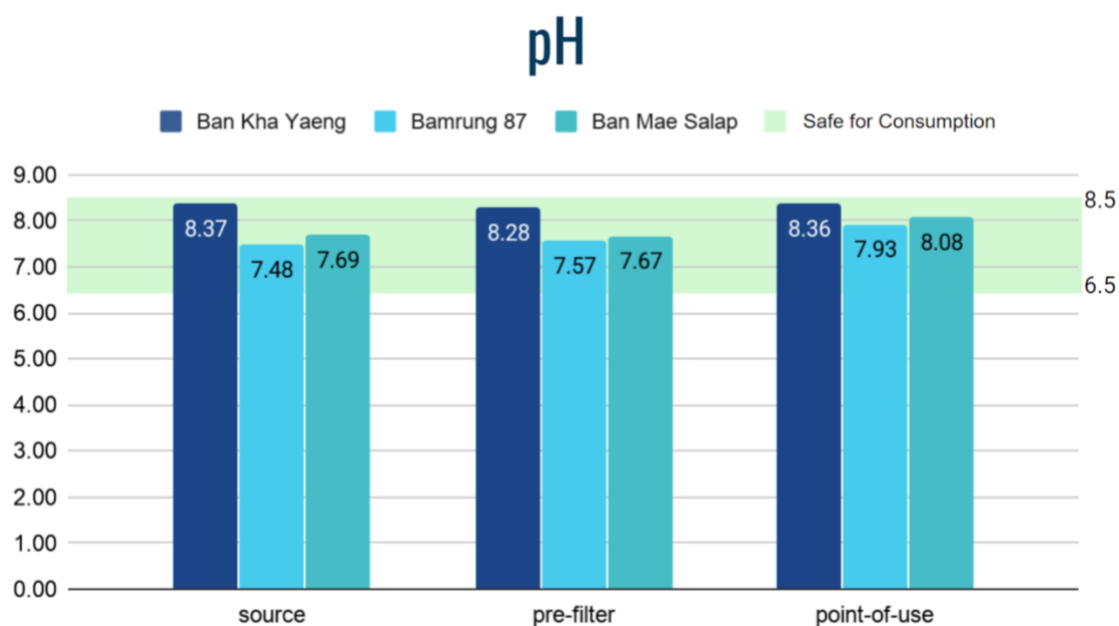
Figure 20. Changes in pH at each point in the drinking water system. Water below the value of 6.5 or above the value 8.5 is not safe for consumption.

The pH levels in water measure the levels of dissolved hydronium ions in water, with pH lower than 7.0 indicating acidity and pH higher than 7.0 indicating alkalinity. Slight changes of pH from the source, pre-filter, and point of use may be affected by concentrations of carbon dioxide, dissolved minerals in water and temperature. The pH values of three schools were within an acceptable range of 6.5 to 8.5 which is the standard of drinking water, as seen in Figure 20. Despite the neutral results of the pH test, we could not confirm that there was an absence of chemical contamination in the water; however, this specific test did not indicate any imbalances. We concluded that there are no contaminants that are significantly affecting changes in the pH of water.

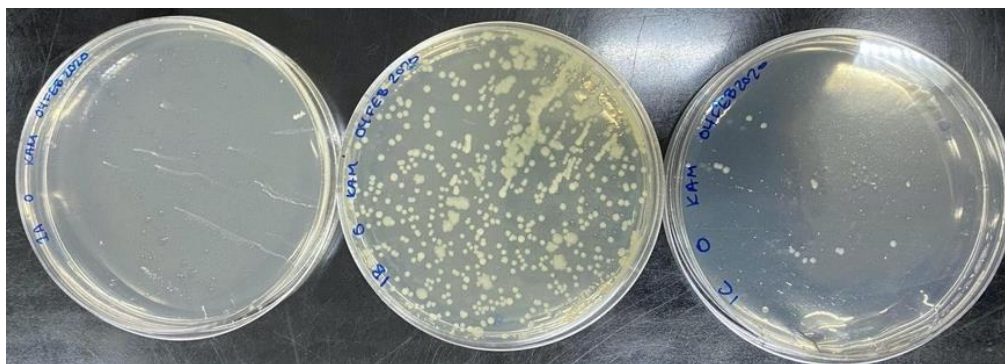
Figure 22. From left to right: Source, pre-filter and point of use bacterial contamination at the Bamrung 87 school. All plates non-diluted, 100  $\mu$ L water sample incubated at 36°C for 24 hours.

While bacterial growth was prolific at the source and pre-filter points at the Bamrung 87 school, minimal bacterial growth arose from the point of use plated sample as seen in Figure 22. This extreme decline in biological contamination was likely due to the appropriately maintained and functioning UV filter in place at the school. Minimal bacterial growth on the point of use plate indicated that the water quality was not poor at the point of use.

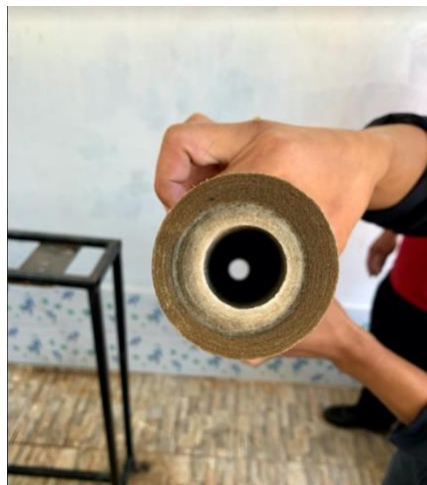
*Figure 24. Microfilter membrane at Bamrung 87 school after three months.*

The water filtration systems at the schools require maintenance to ensure that the systems are working effectively to filter the water. The schools informed us that when there is a buildup of algae in the storage tank, students go into the tank to scrub and rinse the algae and biofilm. This was the only form of sustainable maintenance practice at the school. Filters are not being replaced or cleaned, resulting in buildup of contaminants, as seen in Figure 24. The Mae Fah Luang Foundation held an orientation for teachers, however, it was ineffective due to various factors. The schools were previously provided with manuals, which have been reported to be challenging to understand. The teachers and schools are unable to be self-sufficient and continue to rely heavily on the MFLF.

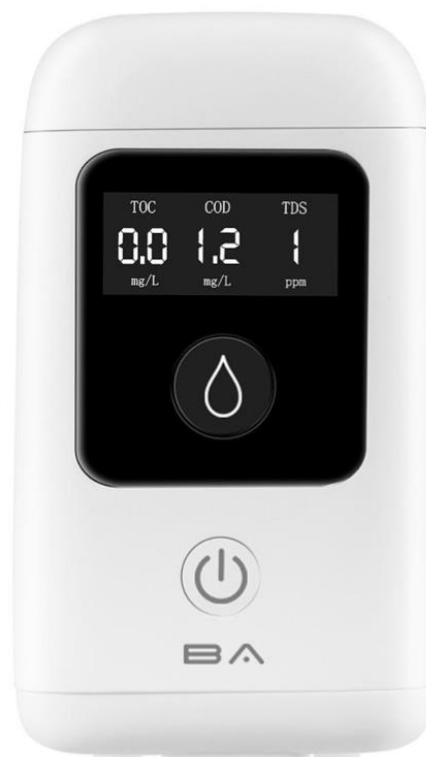
*Figure 25.* The 3-in-1 Water Quality Detector that detects TDS, TOC, and COD in water.

The 3-in-1 Water Quality Detector, seen in Figure 25, is a water quality tool that accounts for contamination that cannot be observed. It tests for three parameters including total dissolved solids (TDS), total organic carbon (TOC), and chemical oxygen demand (COD). The test requires the device to first be calibrated by distilled water. The school must remove the lid and insert a sample of distilled water into the device. Next, they must press the central button that is in the shape of a raindrop and let the device run through a test. The device must read zero under the three categories TDS, TOC, and COD to be properly calibrated. After the machine is calibrated, the machine can be emptied and filled with a drinking water sample. The central button can be pressed again and the test will begin. The test will run until three numerical values appear on the screen under the categories TDS, TOC, and COD. Each school is recommended to record the results for TDS, TOC, and COD to ensure that it aligns with the drinking water standards provided by the Mae Fah Luang Foundation, as listed in Table 2. The schools are asked to record their findings in their database to keep track of their water quality over time. This test is important for it

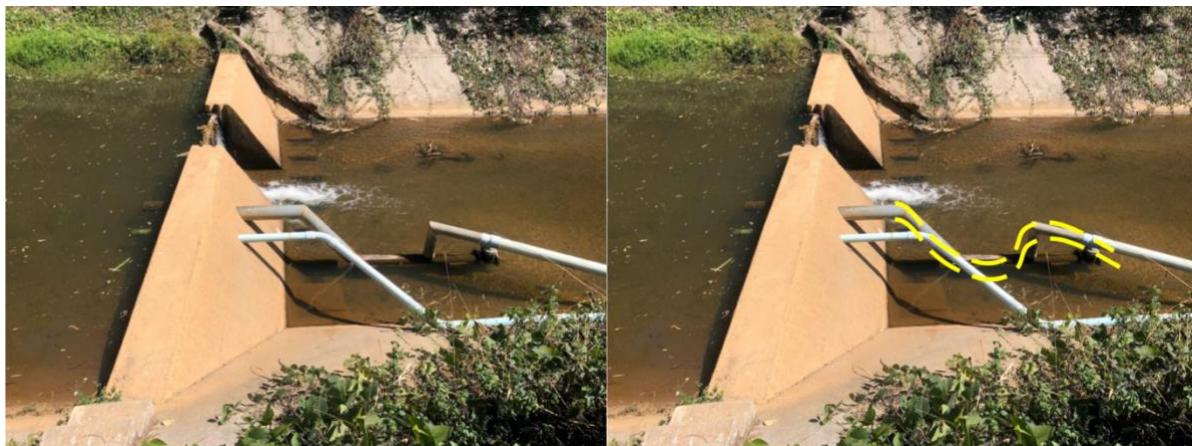
Figure 29. An image of the Klong Plack reservoir at Bamrung 87 and our team's recommendations.

There are several structural problems with the piping at Bamrung 87. Our team recommends repairing the piping system so that the wastewater is disposed of appropriately. Our team recommends this school to re-design the clean-out portion of the piping with a P trap, so that it is more curved. This will allow sediments to be cleared and removed more efficiently. As opposed to having the pipe go directly through the dam's wall, our team recommends that the school redesign the beginning of the distribution system with a curved inlet to decrease resistance and increase the flow of water in the system. The lack of maintenance and cleaning of the pipe entrance contributes to unsafe drinking conditions. The school should clean out the system more frequently to eliminate the contamination added to the system pre-filtration.

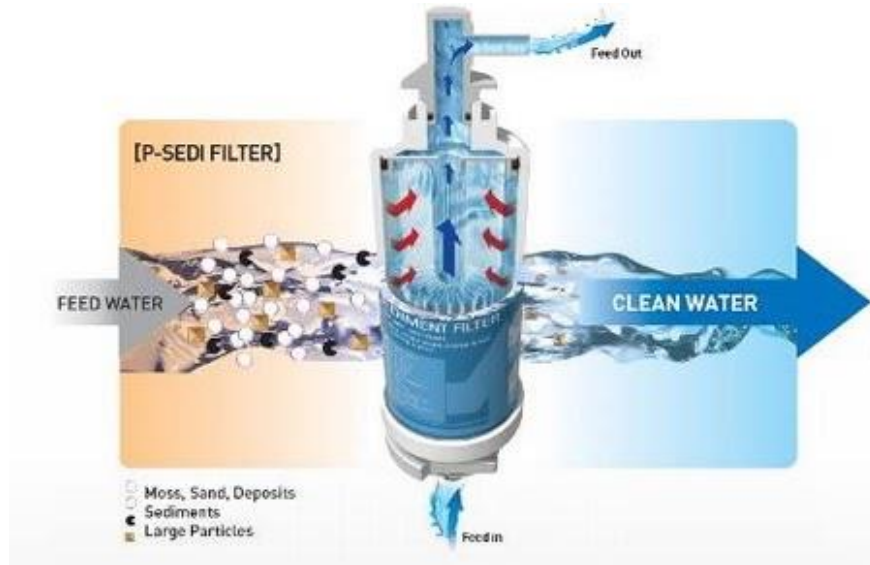
*Figure 35.* A microfiltration system filtering out sediments and solid particles for clean drinking water.
