Material and Design Optimization for an Aluminum Bike Frame

A Major Qualifying Project

WORCESTER POLYTECHNIC INSTITUTE

April 26th, 2012

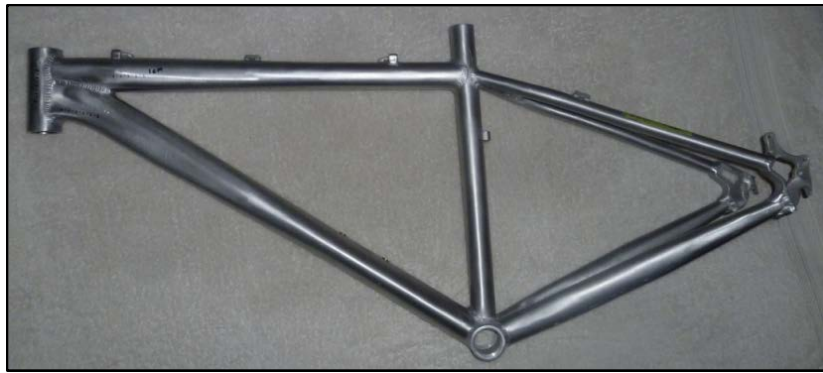
Figure 1: Donated mountain bike frame.

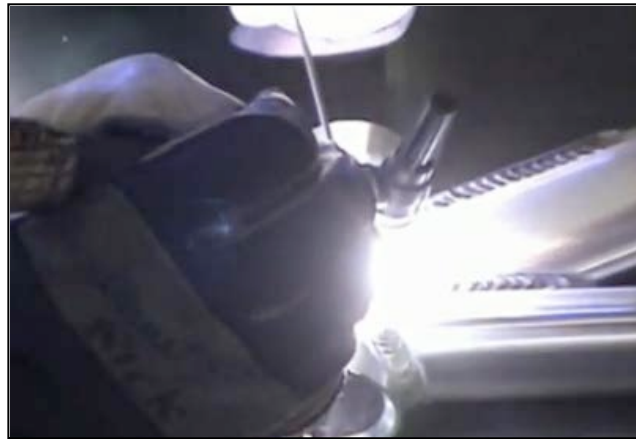
work metal. TIG welding utilizes the inert gas, argon, to keep the weld area clean which prevents the metal from oxidizing during the welding process. TIG welding is commonly chosen as the welding method for thin tubes and is desirable for the bicycle industry since it provides a high quality finish on the weld surface [2]. Aluminum 4043 filler rod was used during TIG welding of the donated frames.

Figure 9: TIG welding the head tube of an aluminum bicycle frame [38].

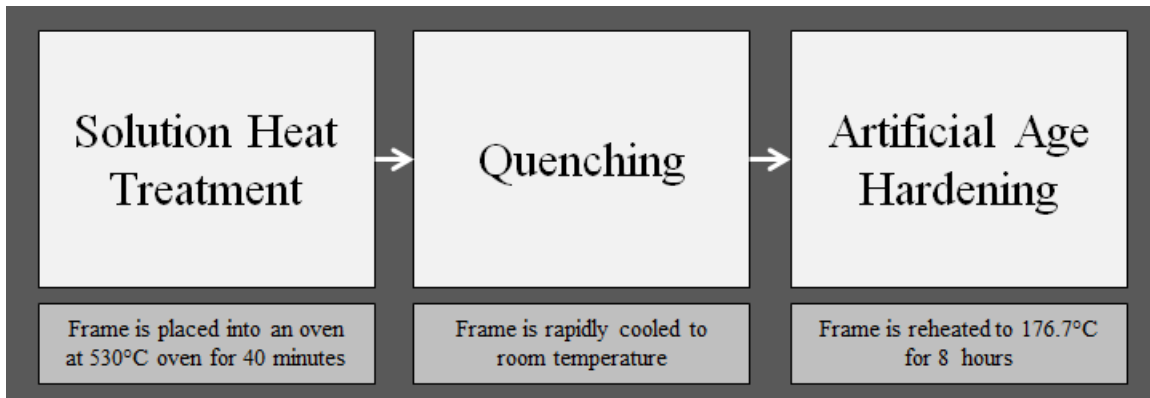
After aluminum frames are TIG welded, the frames are heat treated in an effort to recover the mechanical properties that are lost during TIG welding. Heat-treating is a term used in manufacturing to describe the changing of the metallurgical structure, residual stress state, and mechanical properties of a metal by heating and cooling. With aluminum alloys specifically, the term heat-treating describes increasing the strength and hardness of precipitation-hardenable wrought alloys. The bicycle frames donated for investigation in this project were T6 heat-treated. T6 heat-treating is considered an optimal operation for recovering the mechanical properties of 6061 after TIG welding [17]. The steps for the T6 heat-treatment of the donated frames can be seen in Figure 12.

Figure 12: T6 heat treatment process steps [17].

Solution heat treatment causes the dissolution of soluble phases to get a virtually homogenous solid solution to form. The soak time for solution differs depending on the thickness of the piece of aluminum undergoing the solution heat treatment and can be seen in Appendix A [17]. At the completion of the solution heat treatment phase, 6061 is designated to be T4 heat treated.

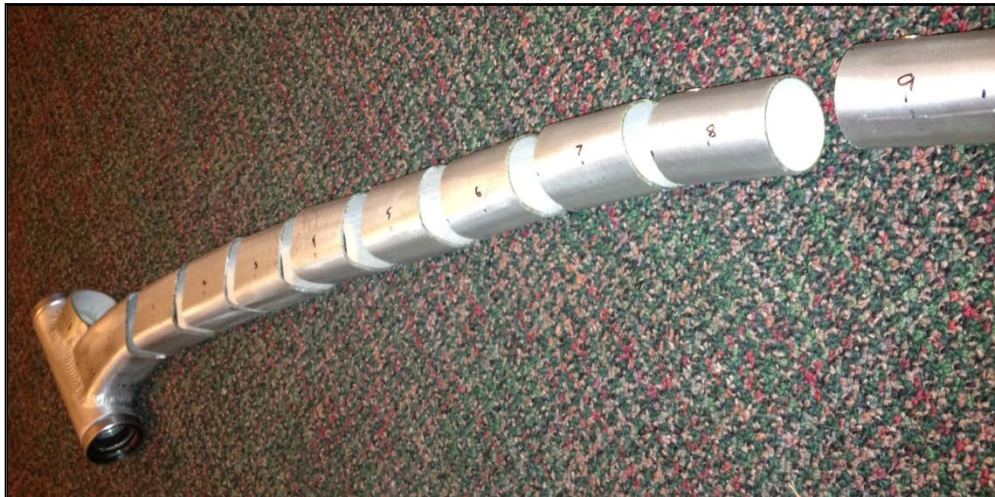
The down tube of the donated frames features a complex geometry including both a variable cross section and wall thickness. As seen in Figure 17, the down tube was sectioned into 10 total pieces to accurately model the tube. Vernier calipers were used to take measurements of the cross section and wall thickness of the 10 different sections.

Figure 17: Sectioning of the down tube for cross section measurements.

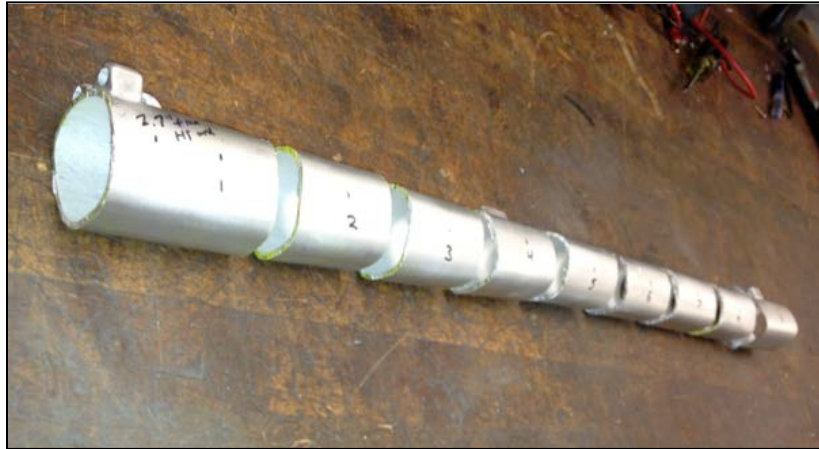
The top tube also featured a complex geometry with variable cross sections. Similar to the down tube, the top tube was cut into 9 sections to analyze the cross section dimensional characteristics. The sectioned top tube can be seen in Figure 19.

Figure 19: Sectioned top tube for cross section measurements.

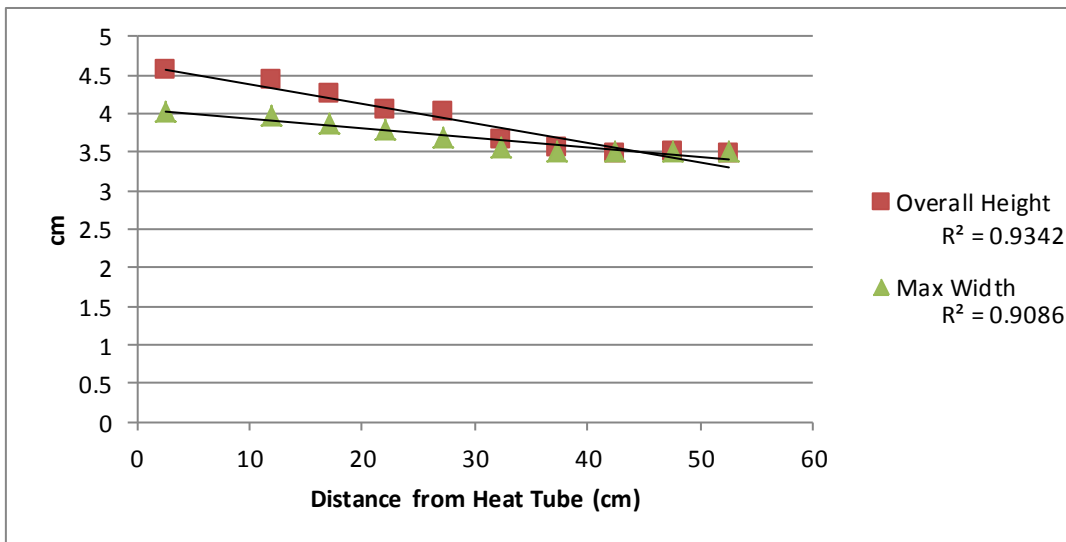
Once dimensions were taken from the frame sections they were plotted. As shown in Figure 20 the top tube dimensions change linearly, allowing for a simple swept blend to be used to model the tube. The correlation coefficients, as seen in Figure 20, were close to 1 which justifies the decision to use swept blend with linear dimension change.

Figure 20: Top tube dimensional data from sectioning.

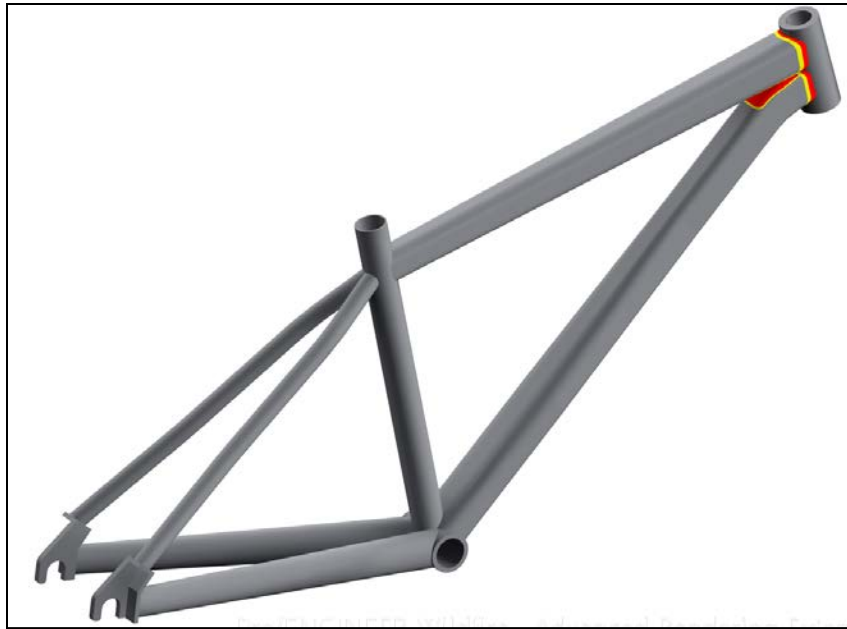
The entire frame solid model can be seen in Figure 24. This includes all of the assembled tubes and the weld zones.

Figure 24: Completed solid model of physical frame.

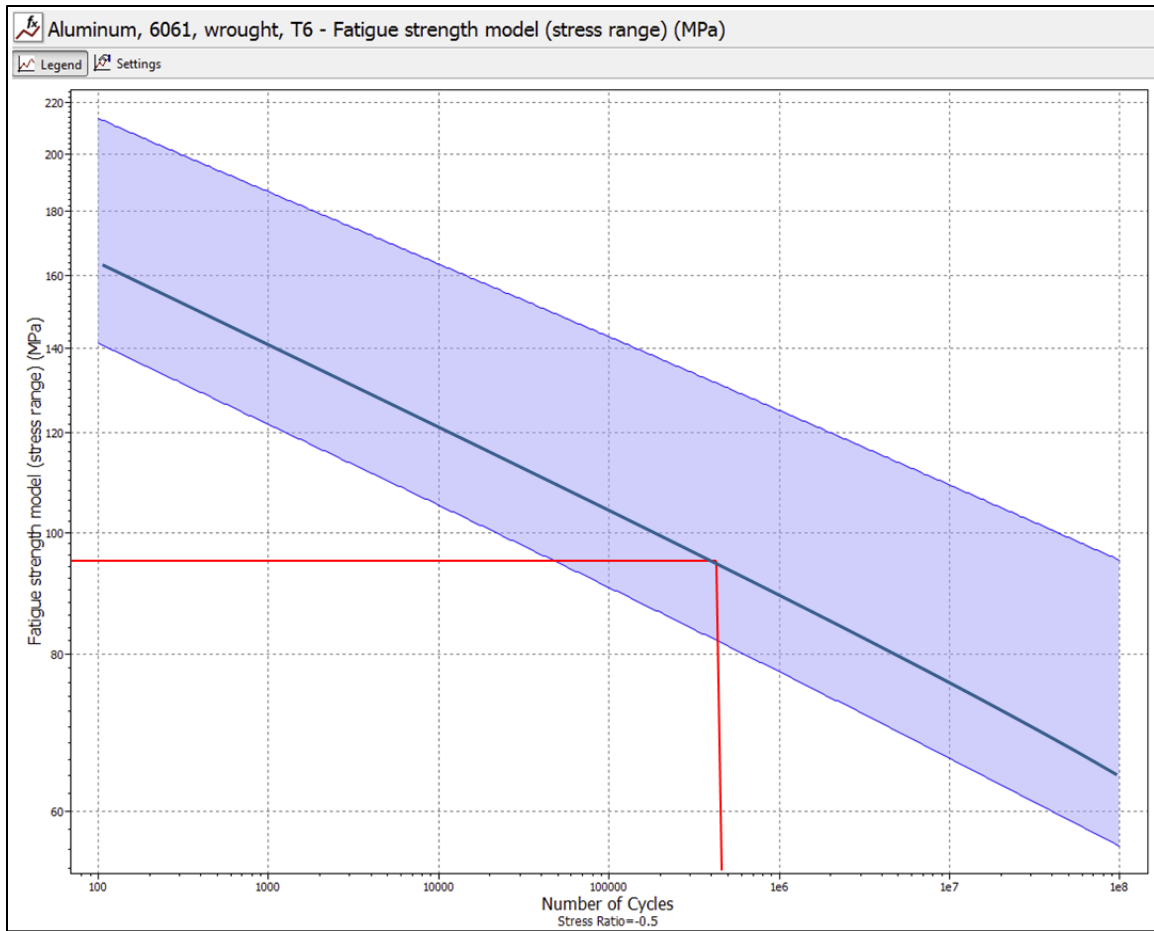
Since the S-N curve provided a wide range of cycles to failure for a given stress, the group decided to create a line in the range that represents the predicted level to failure. This can be seen in Figure 28. The line was made on the conservative side of the center of the range, and was compared with other S-N curves for 6061-T6.

Figure 28: Aluminum 6061-T6 S-N curve showing predicted failure at 490,000 cycles.

From the S-N curve, the group concluded that the predicted cycles to failure for the bicycle frame was 490,000 cycles on the top tube near the weld with the down tube, and on the down tube near the weld to the seat tube.

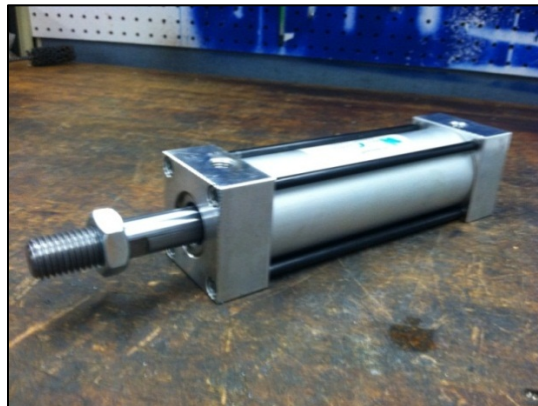
Four quarter inch mounting holes were drilled into two of the cross beams on the 80/20 test frame to mount the air cylinder to the test rig. These holes matched up with the mounting holes provided on the air cylinder, allowing for it to be bolted directly to the support structure.

Figure 31: Air cylinder used to exert forces onto tested bike frame.

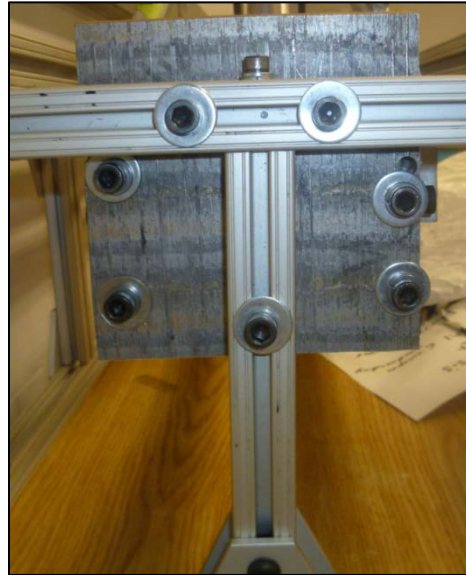
force. This concept is illustrated in Section 2.6.1. The rear dropouts were secured to a plate which was then bolted to the end of the rig opposite the air cylinder. Additional 80/20 extrusions and bolts were used in securing this section to ensure its stability. This setup can be seen in Figure 32.

Figure 32: Rear dropout base plate fixtured to test rig frame.

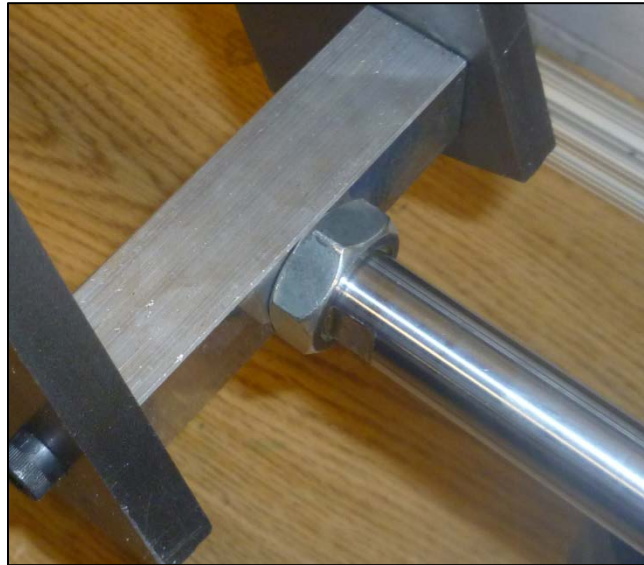
ease of manufacturing to make the center hole, and was of adequate strength due to the large cross sectional area. This setup can be seen in Figure 34.

Figure 34: Threaded rod of air cylinder screwed into front dropout.

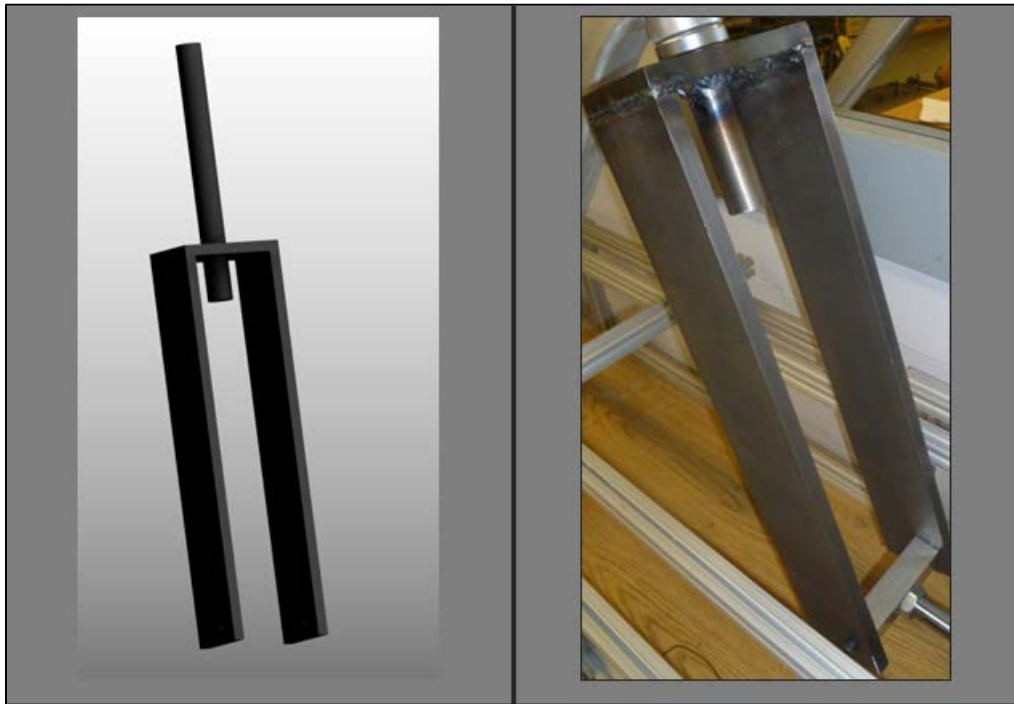
The group manufactured the test fork using a lathe, overhead mill, and band saw. The steerer tube was turned using the lathe to 2.86 cm in diameter. A close fit hole for the steerer tube was cut through the cross member using an overhead mill. The test fork arms and cross member were cut from a 1.27 cm thick plate using a band saw. The test fork arms were welded onto the cross member, and the steerer tube was welded into the hole of the cross member. A standard 1 1/8 inch headset was used for mounting the fork to the frame. The solid model of the test fork along with the completed test fork can be seen in Figure 35.

Figure 35: Solid model of test fork and fabricated test fork.

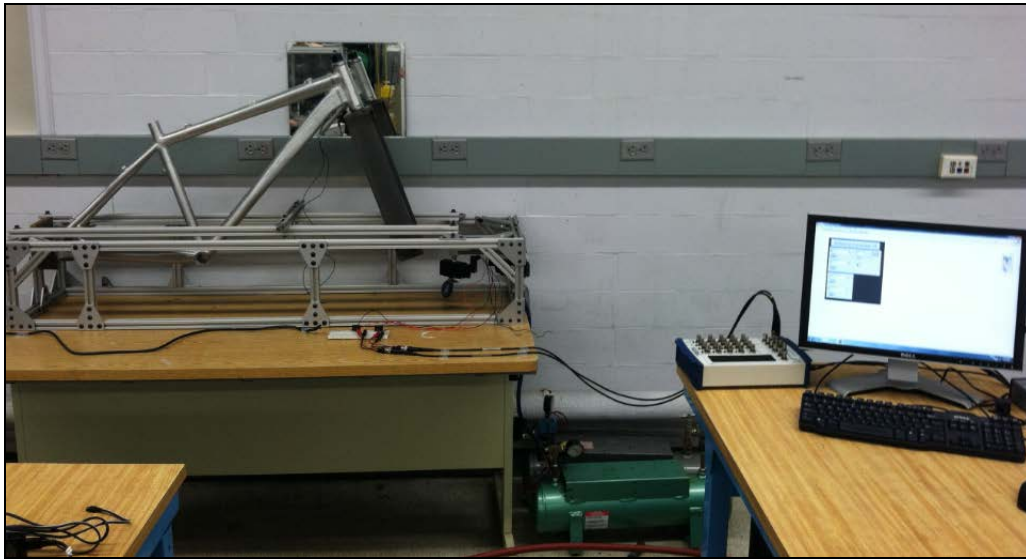
Figure 41: Testing rig with structure and controls.

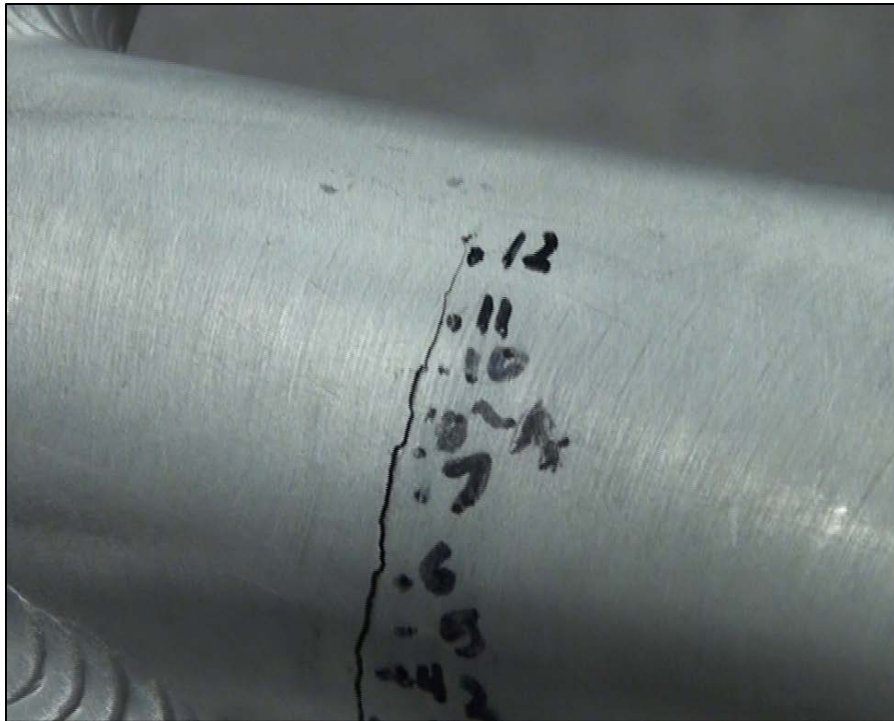
Figure 47: Extent of crack propagation on front side.

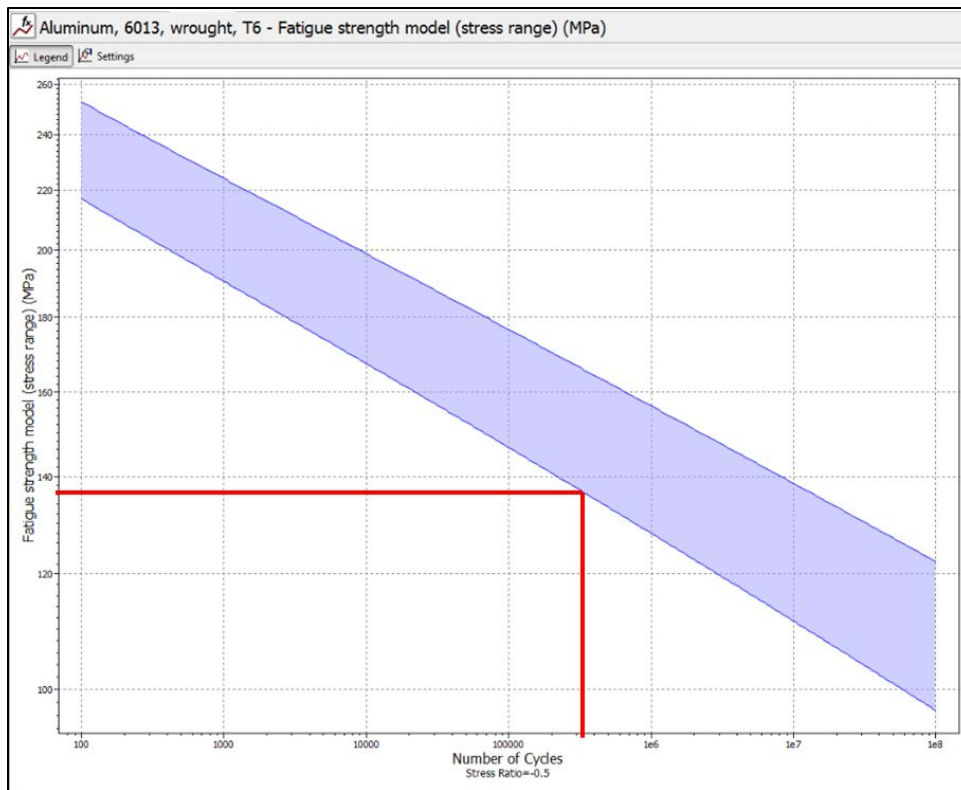
Figure 53: Aluminum 6013-T6 S-N curve showing extended fatigue life.
